Whiting Oil & Gas Corporation

HORSETAIL 02D-0204 CORRECTIVE ACTION INSPECTION PHOTOS

Location ID: 437025
Sec 2 T10N R57W

1/5/21

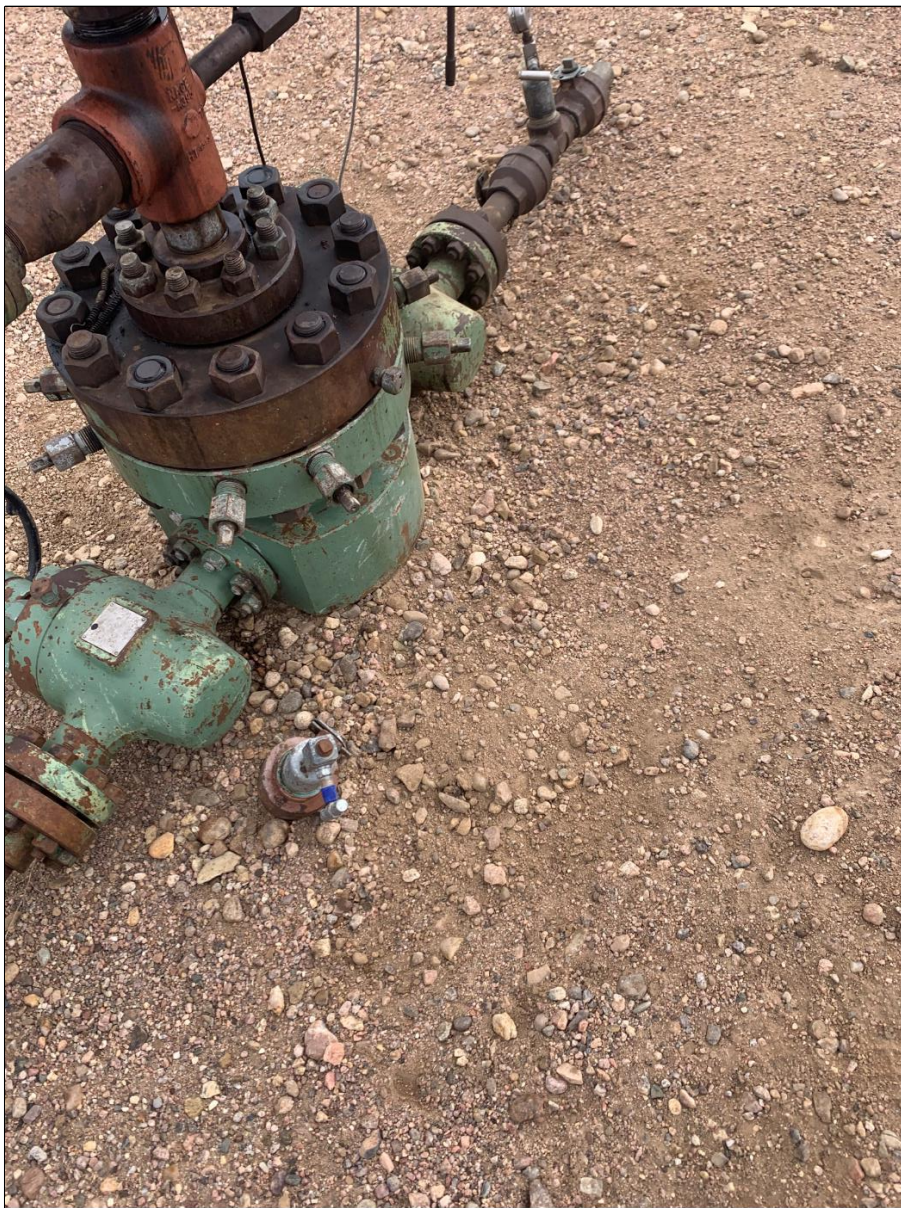
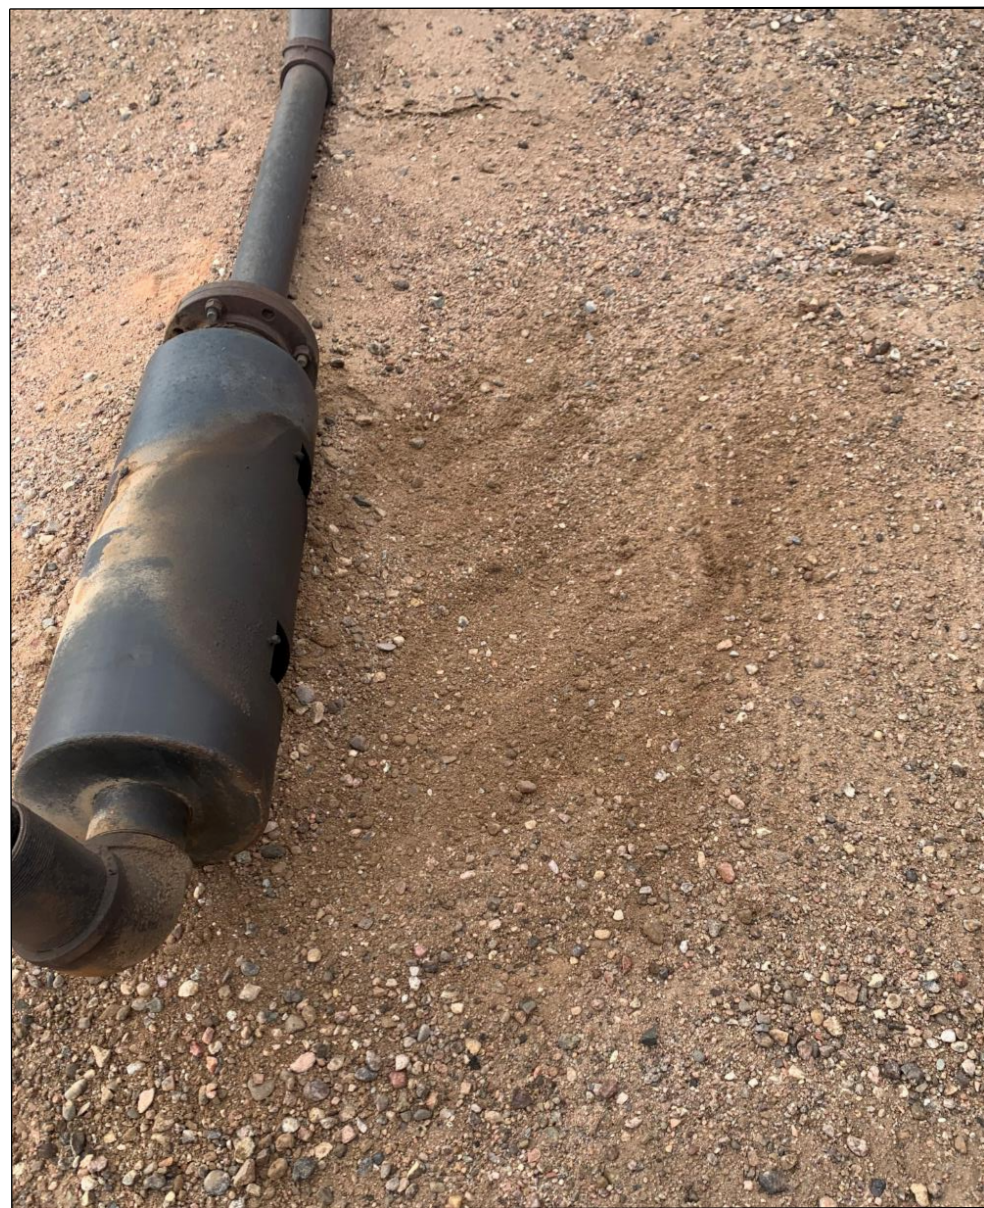
Impacted soils no longer at Wellhead or Exhaust

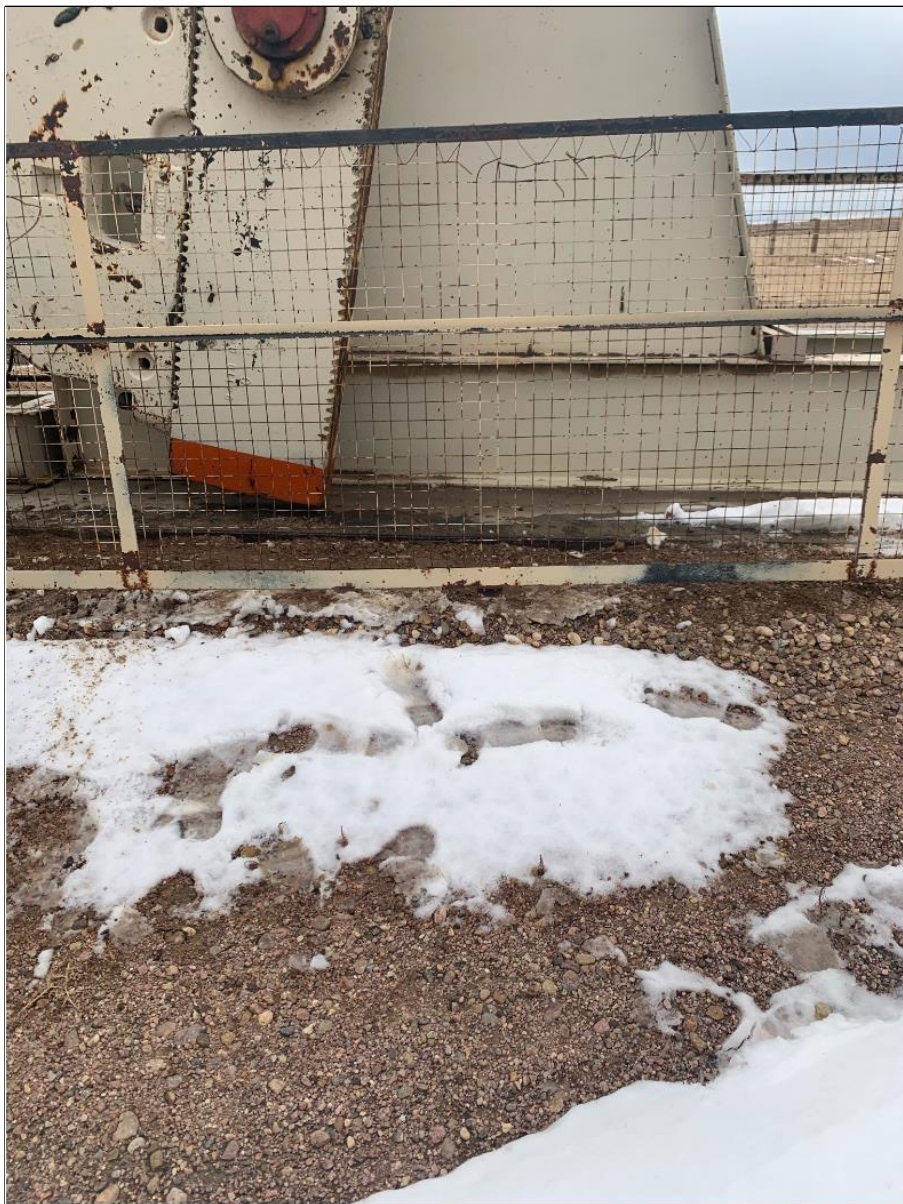
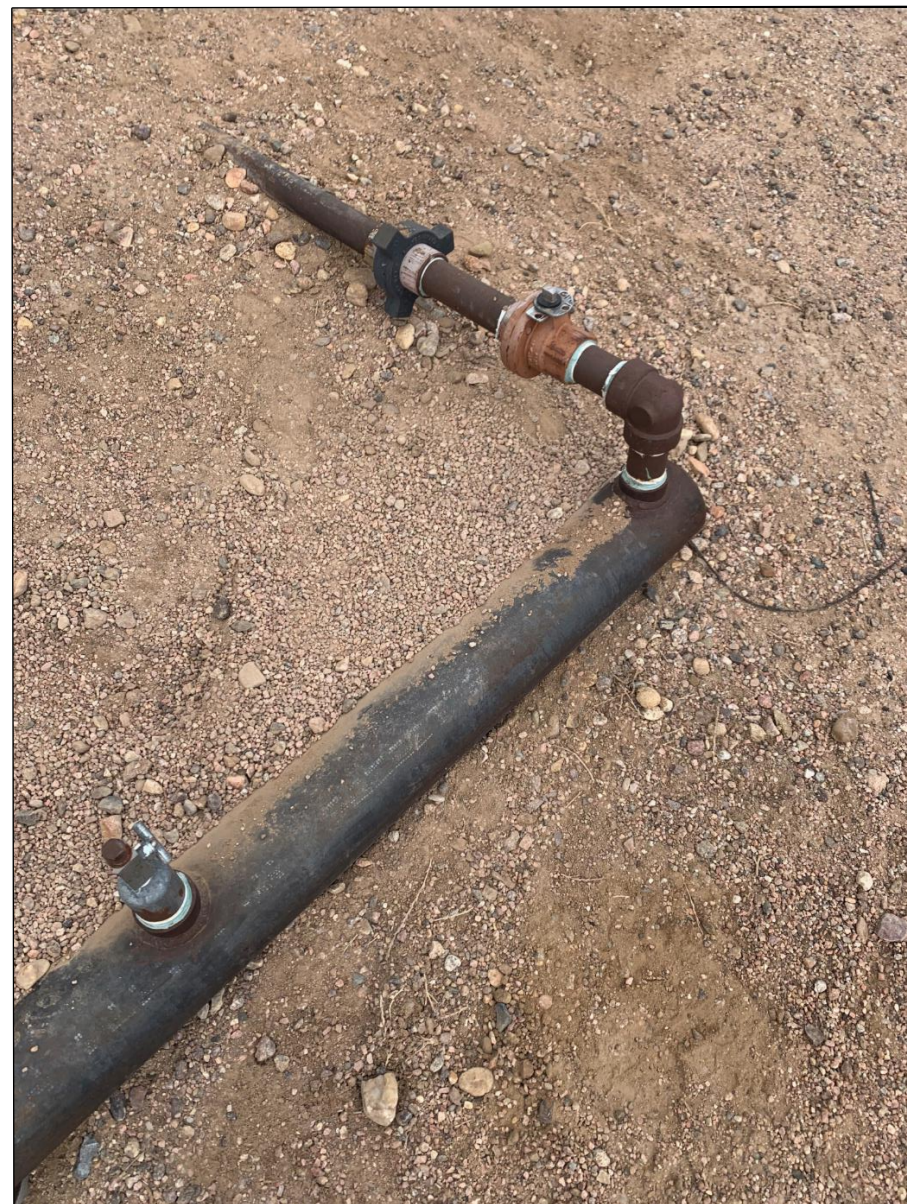
Impacted soils no longer along the side of Pump Jack or at Scrub Pot

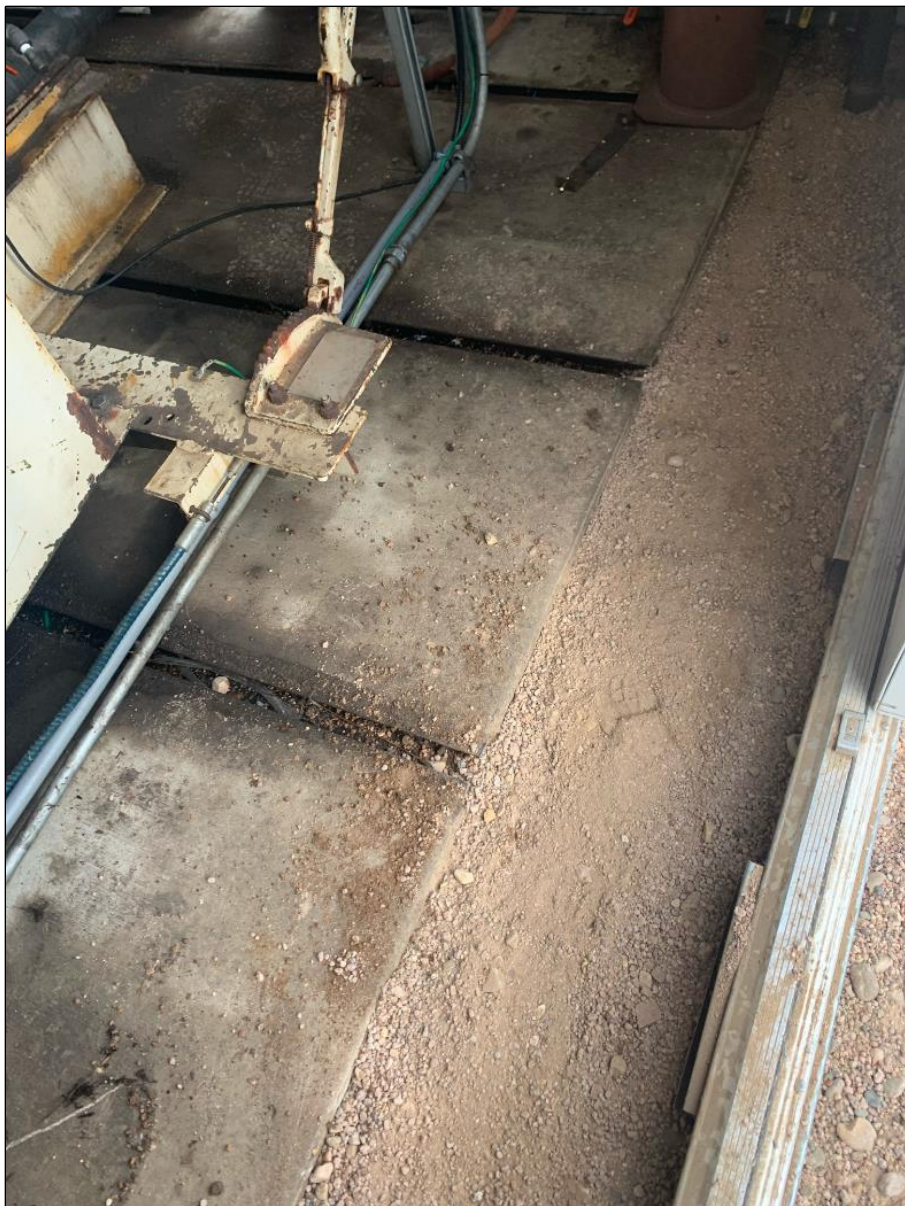
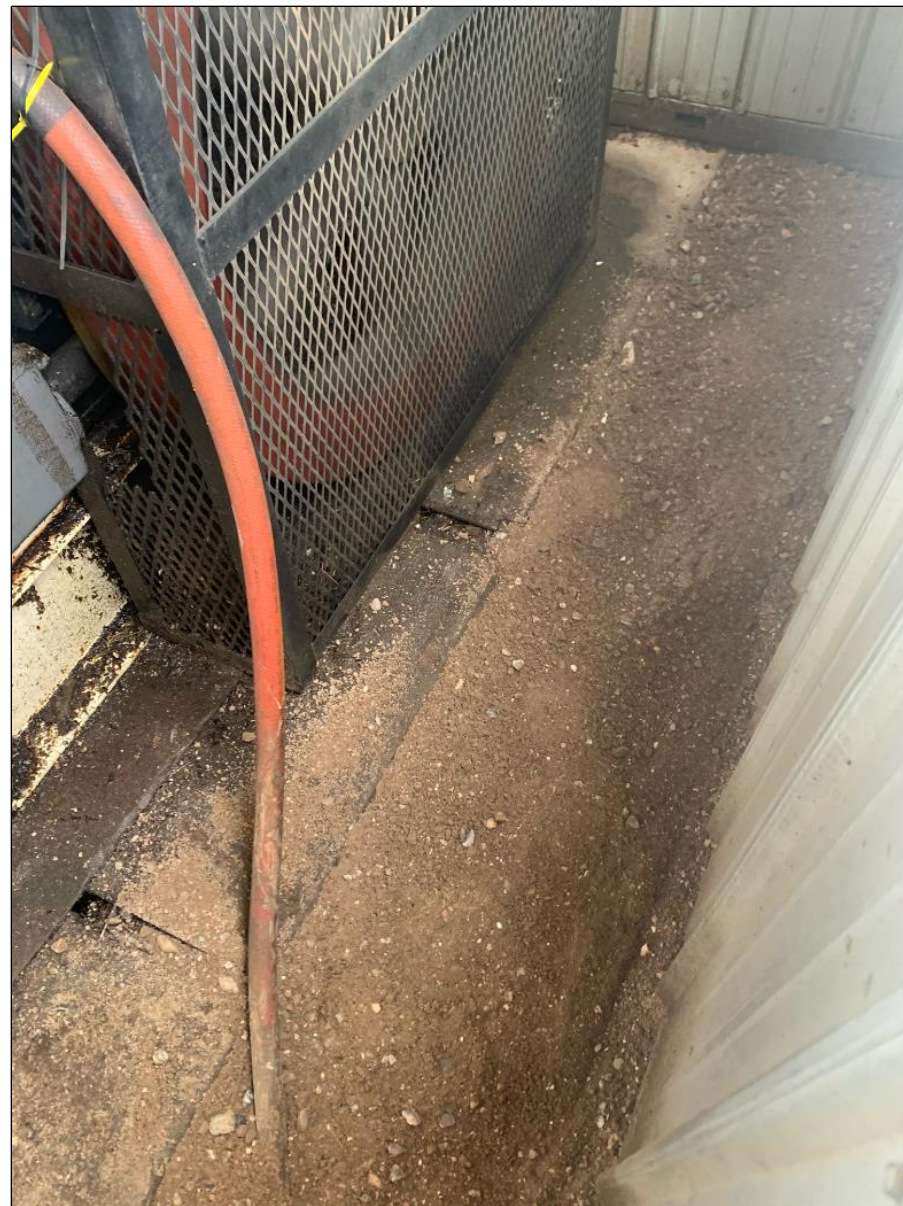
Impacted soils no longer at the Pump Jack Engine
