Ward and Sons, Alfred - COGCC Inspection Photos

Location: Pierce 1 OL Flowline Release

Spill ID #478817 Date 01/08/2021

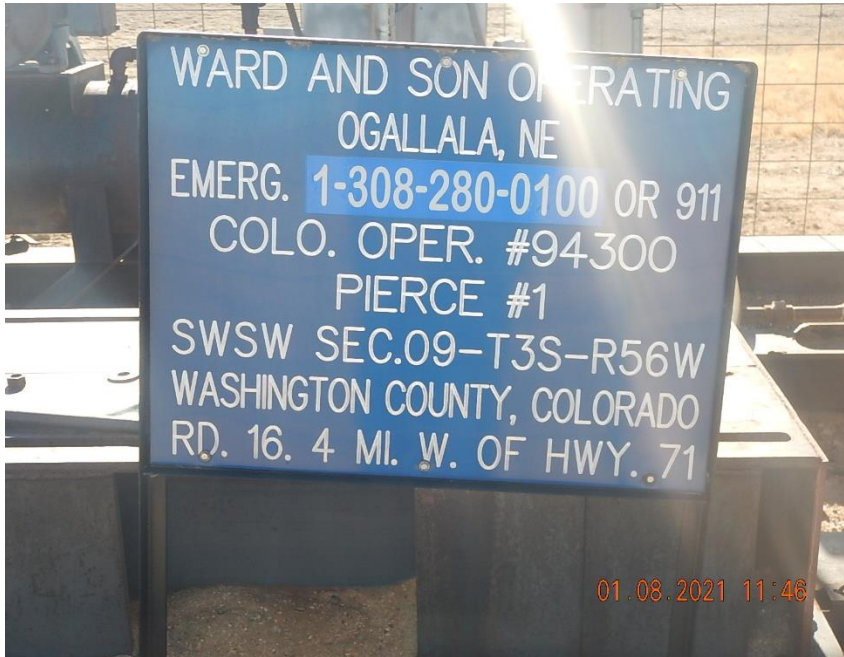
Wellhead signage

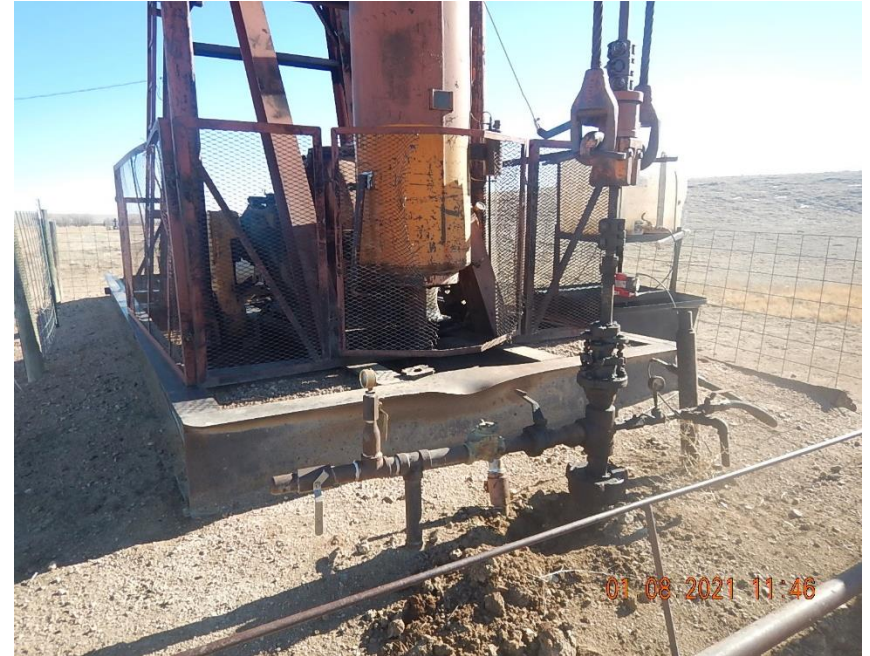
Pierce 1 wellhead (Shut in); No OOSLAT

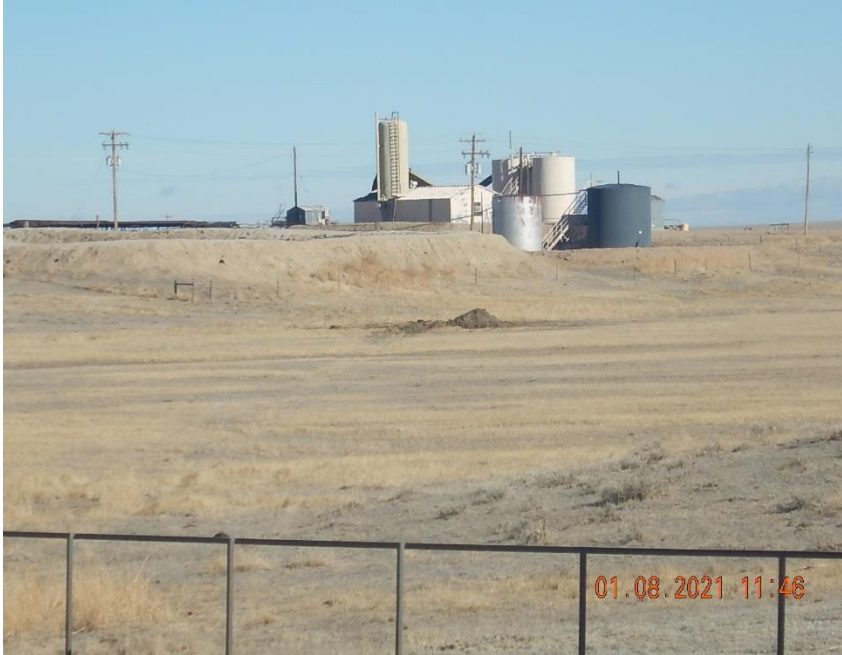
View of excavation at off location flowline release; looking NE from wellhead to battery.

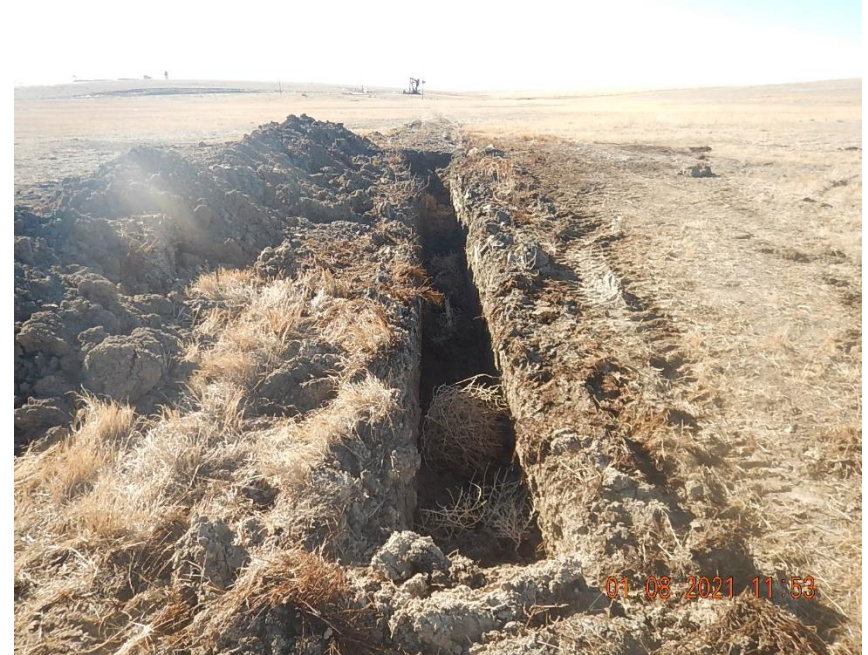
View from trench excavation at spill point; looking SW toward Pierce 1 well.

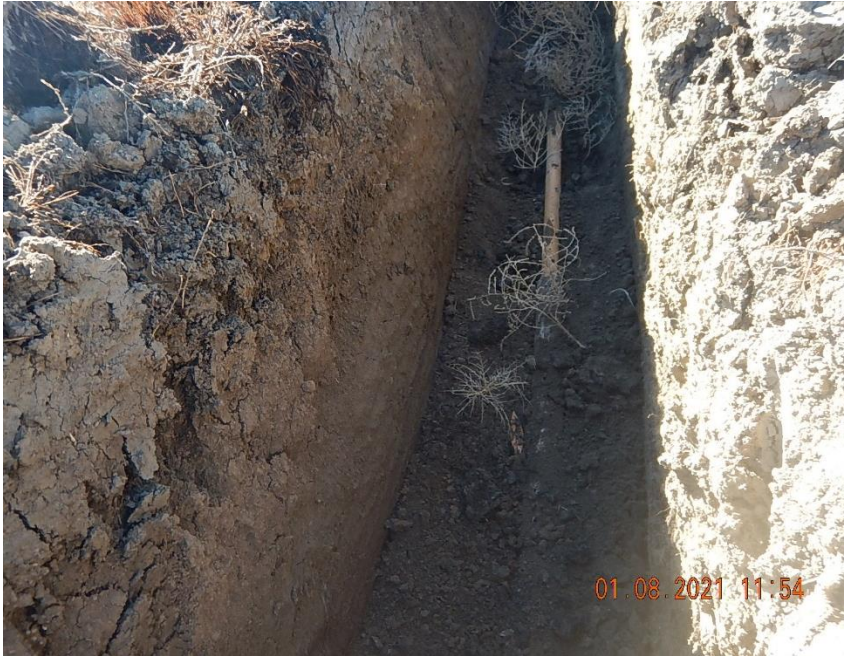
Flowline pipe exposed in trench excavation (yellow jacket pipe/ yellow external coating) .

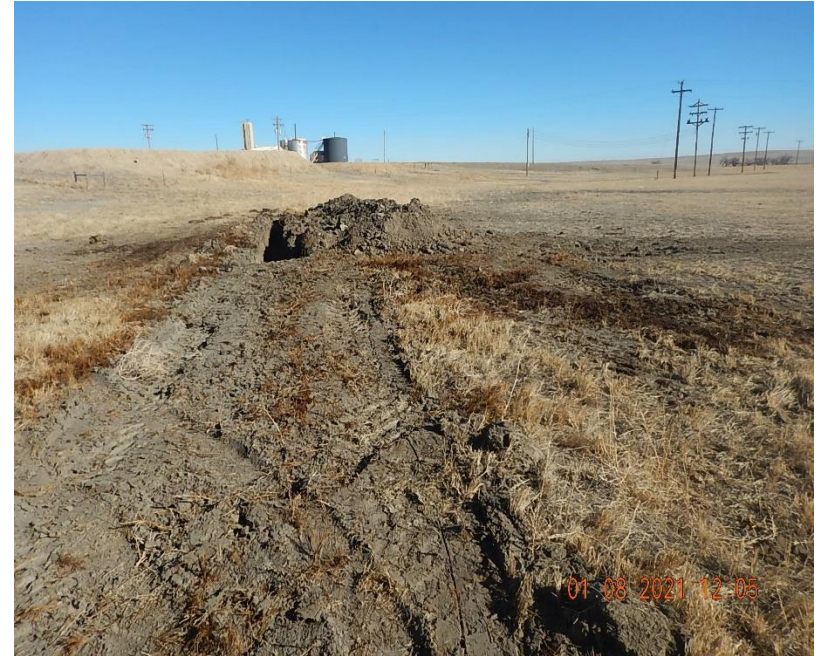
View of surface impacts at flowline release; looking NE toward Pierce battery.

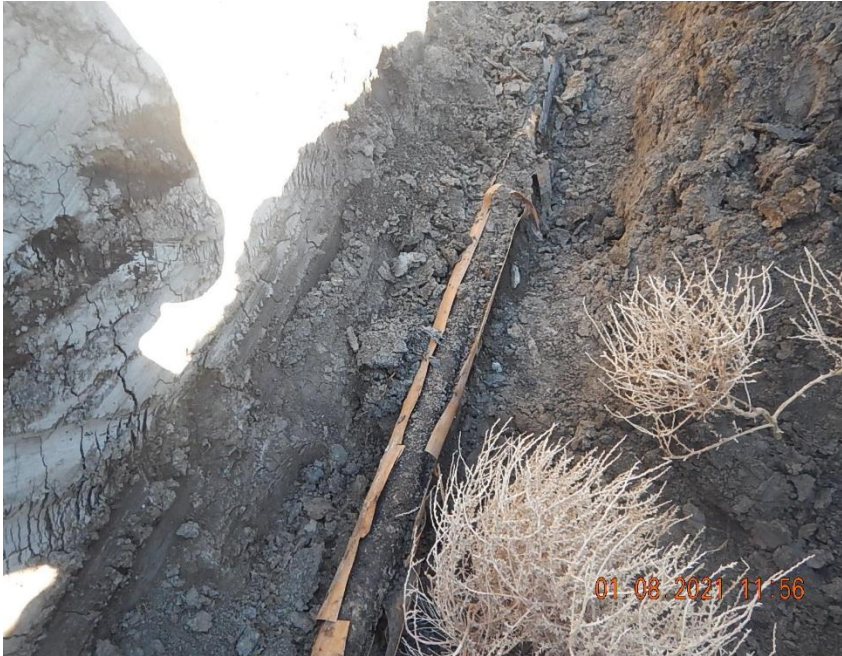
**View of Pierce 1 off location flowline exposed in excavation;
Significant external coating damage observed.**

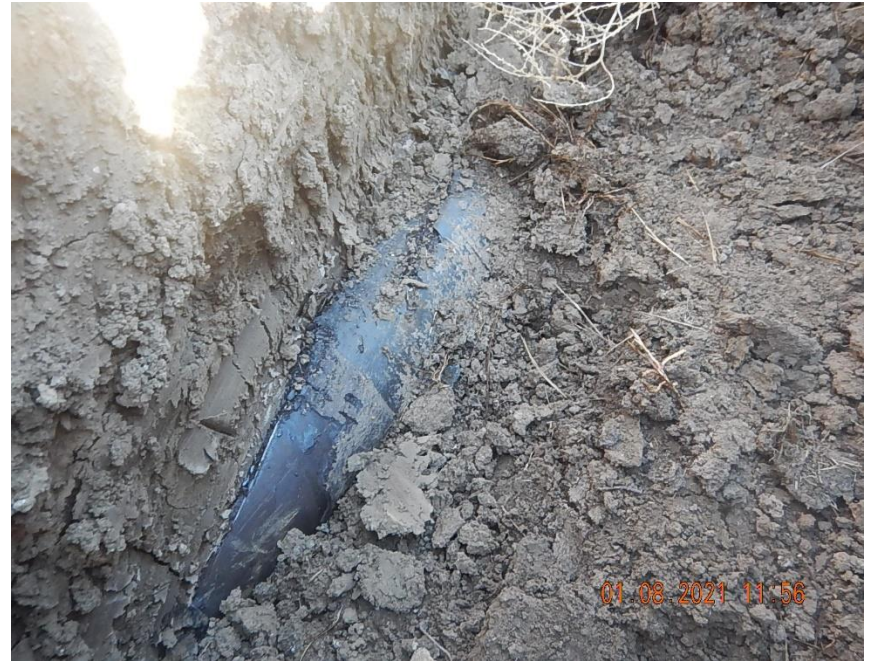
**Larger black pipe exposed at NE end of trench excavation;
Excavation equipment scored pipe coating.**
