Inspection Photos

Location Name: TEP ROCKY MOUNTAIN LLC KNIGHT-67S95W /4SENW

Location ID: 334697

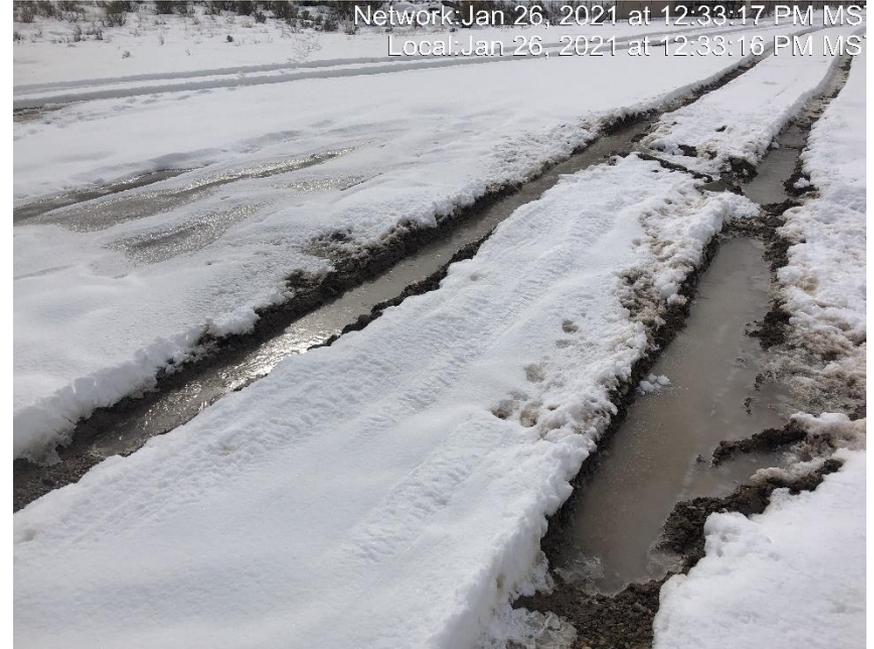
Photo #2707 Rutting present on location due to lack of stabilization.

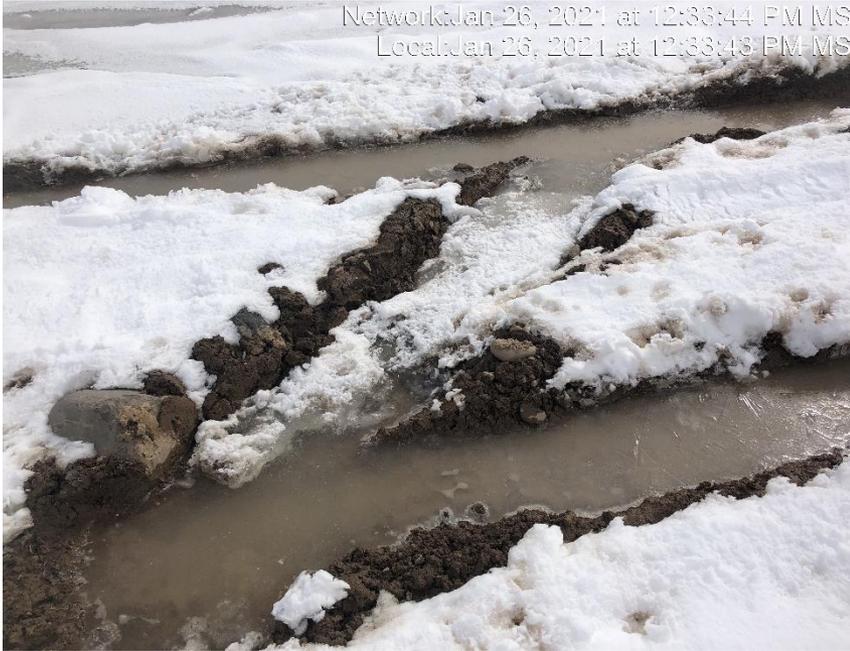
Photo #2708 Rutting present on location due to lack of stabilization.

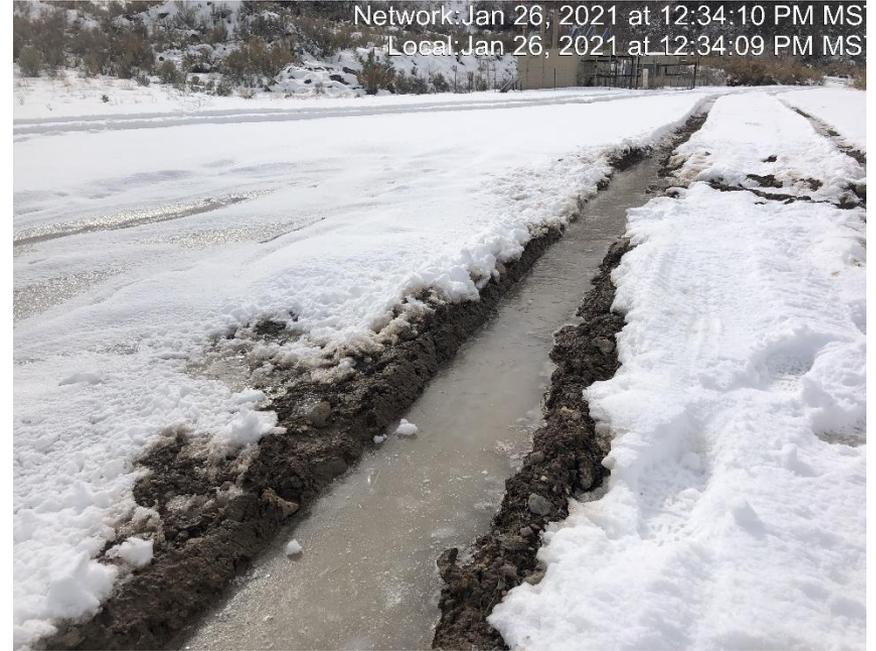
Photo #2709 Rutting present on location due to lack of stabilization.

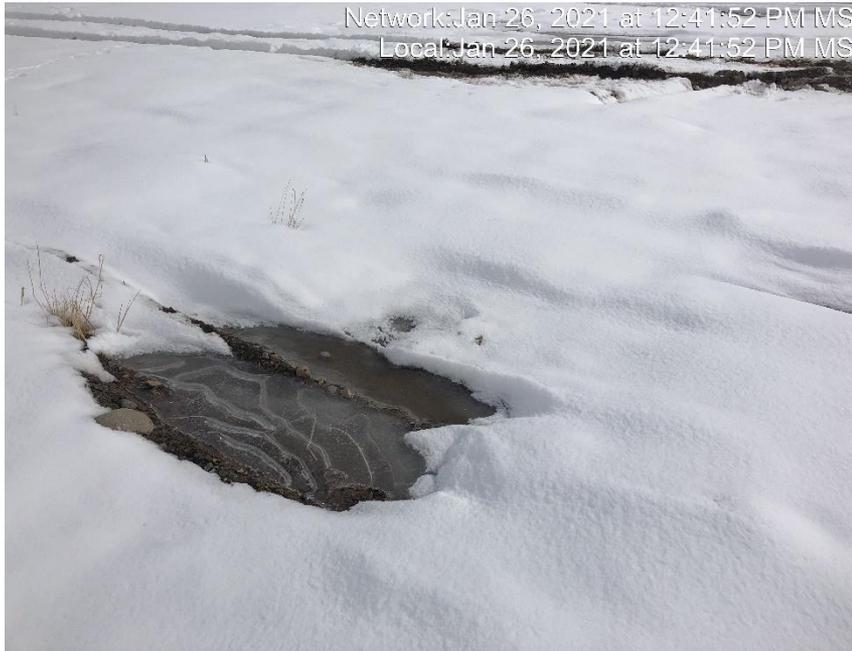
Photo #2710 Rutting present on location due to lack of stabilization.
