Inspection Photos

Location Name: TEP ROCKY MOUNTAIN LLC KNIGHT-67S95W /4NWNW

Location ID: 311547

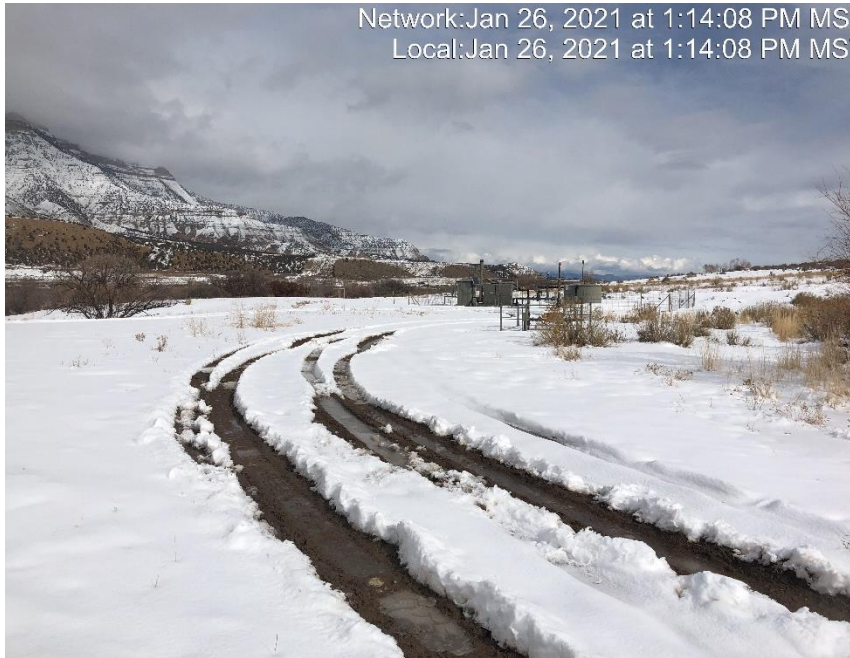
Photo #2711 from entrance to location.

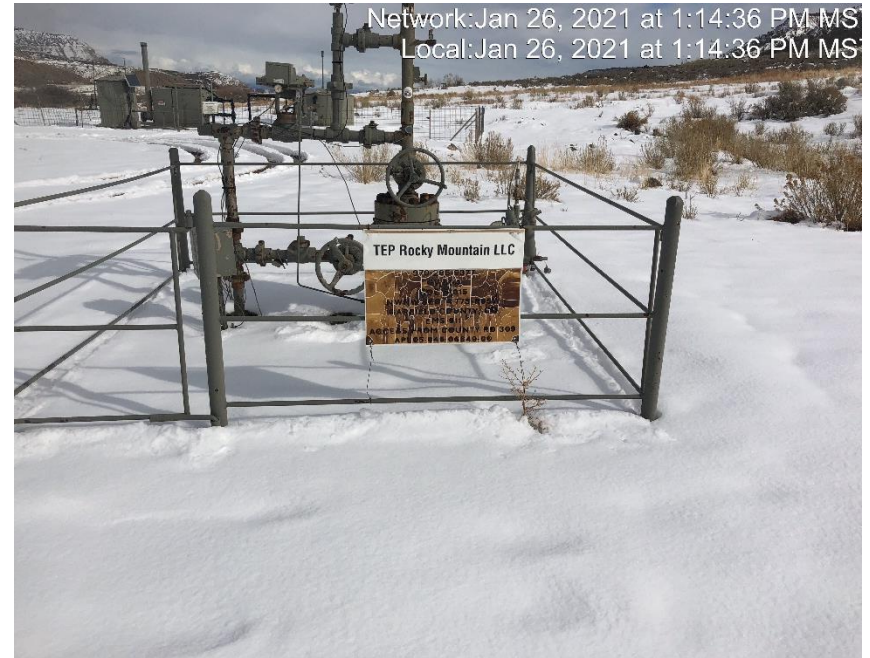
Photo #2712 Wellhead sign weathered and not legible.

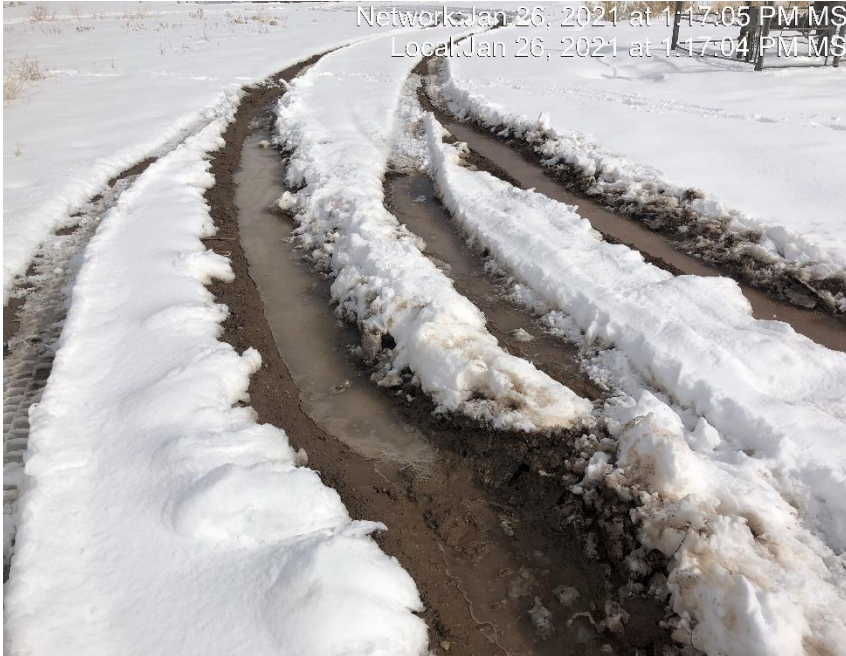
Photo #2715 Ruts present on location due to lack of stabilization.

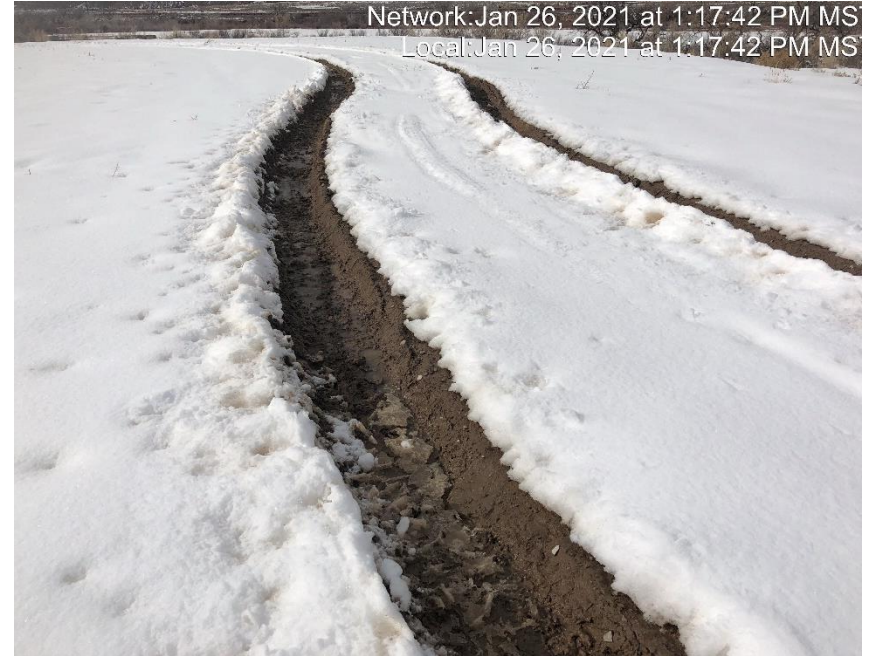
Photo #2716 Ruts present on location due to lack of stabilization.

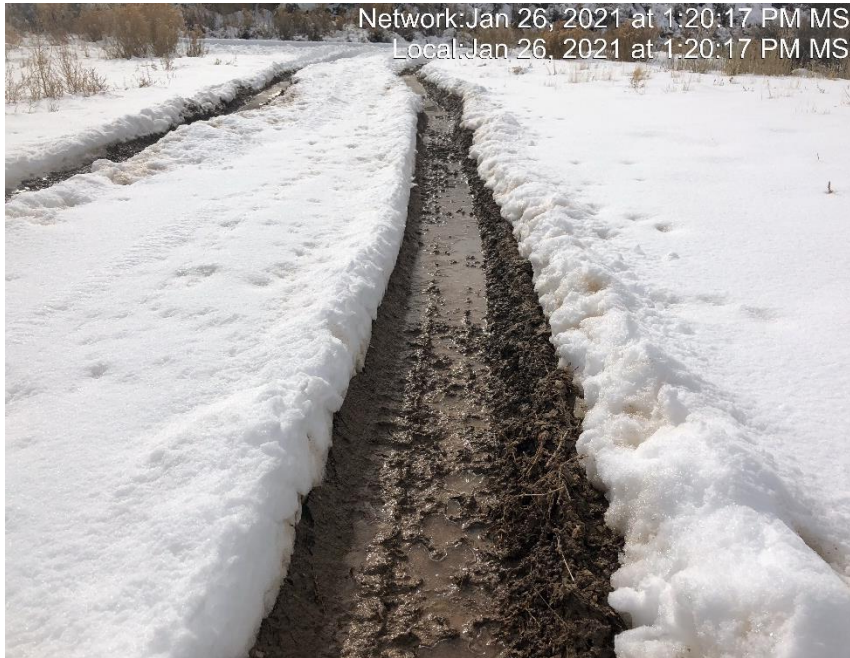
Photo #2717 Ruts present on location due to lack of stabilization.
