**TEP ROCKY MOUNTAIN LLC  
UNOCAL-66S96W 35SWSW  
Location # 334773**

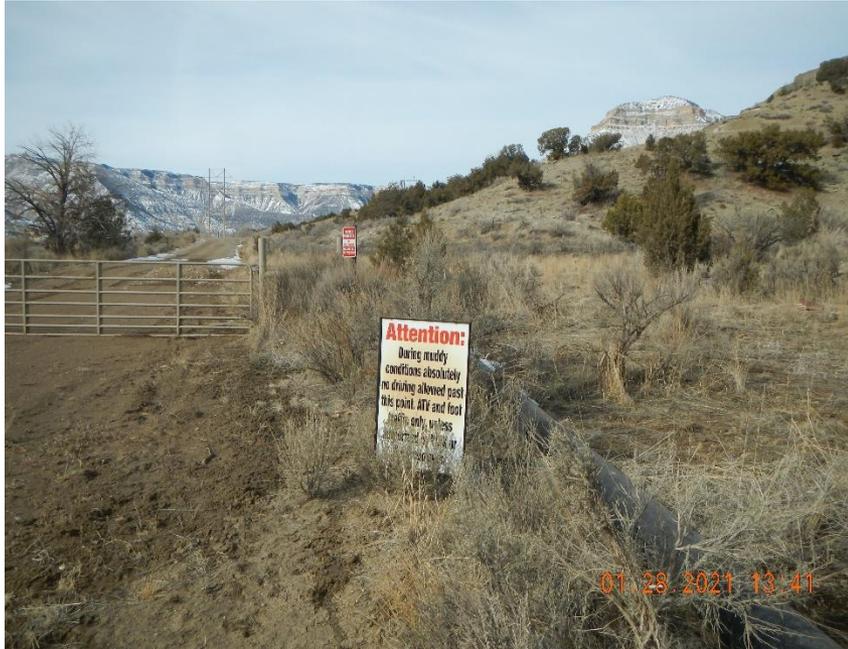
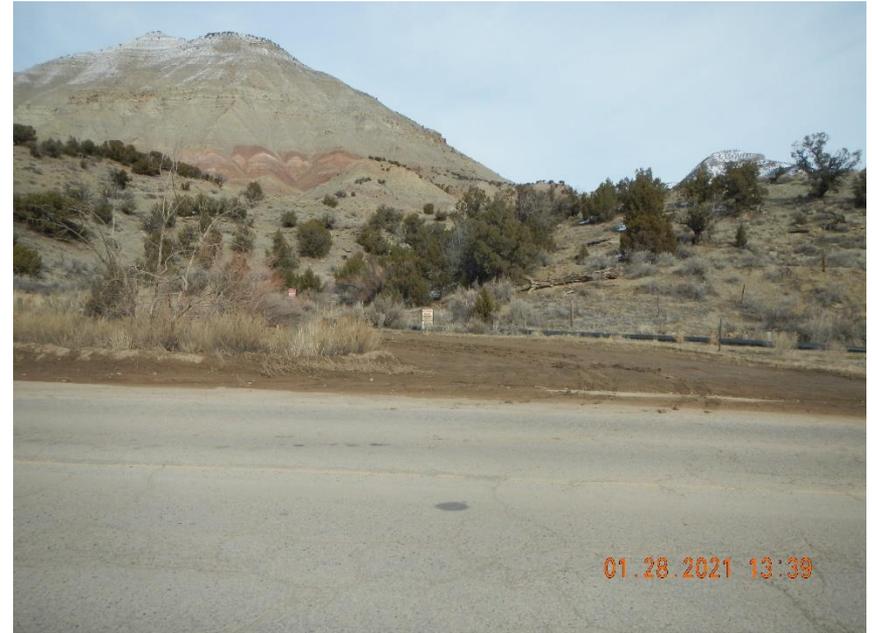
**Access road shows signs of lack of stabilization BMP's in some areas (rutting is present). No tracking bmps observed for access road.**

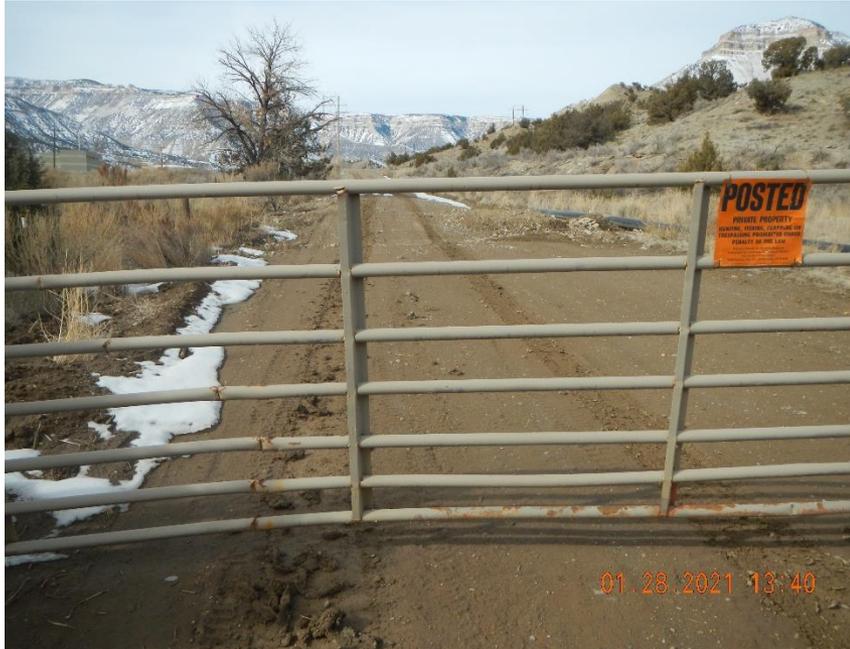
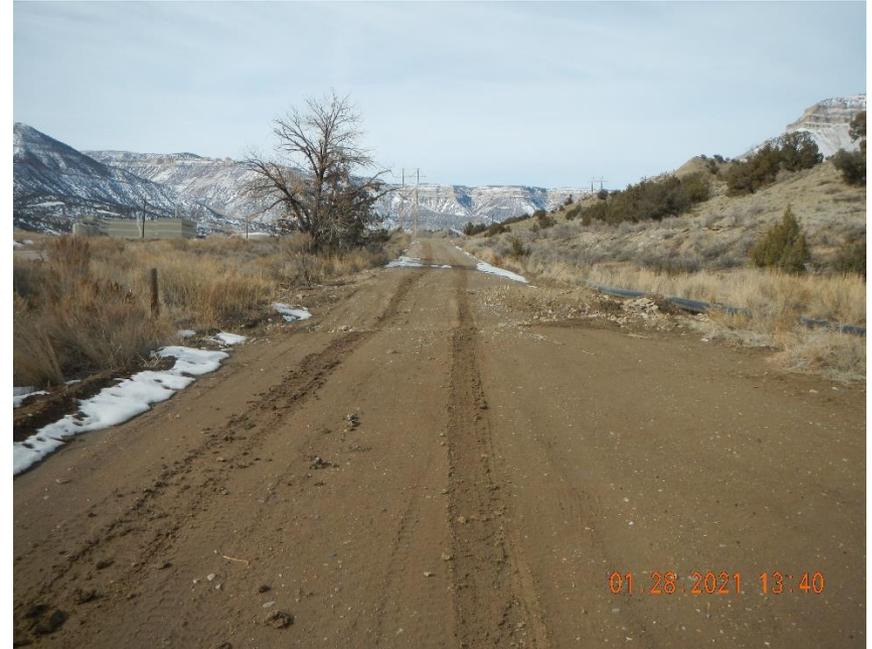
**Access road shows signs of lack of stabilization BMP's in some areas (rutting is present). No tracking bmps observed for access road.**

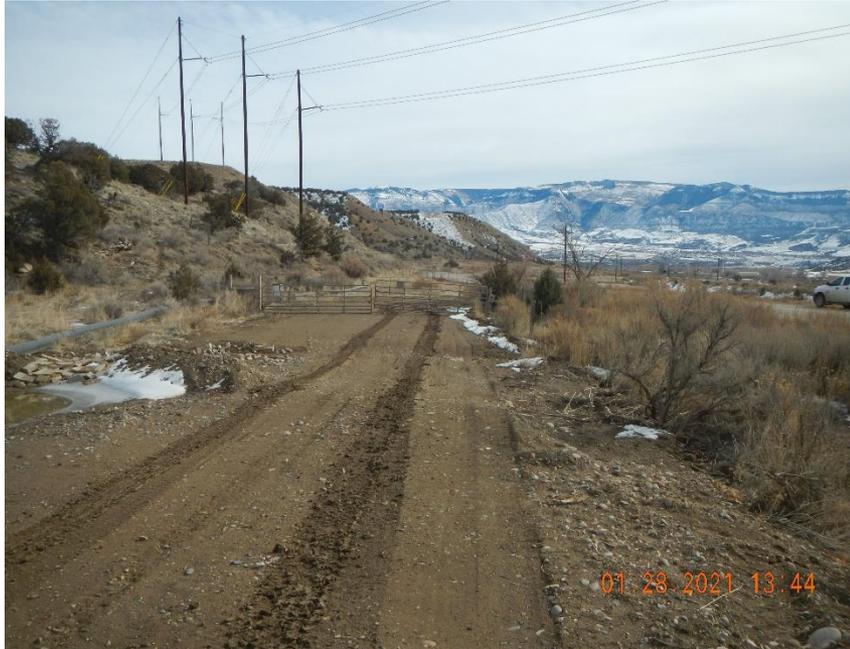
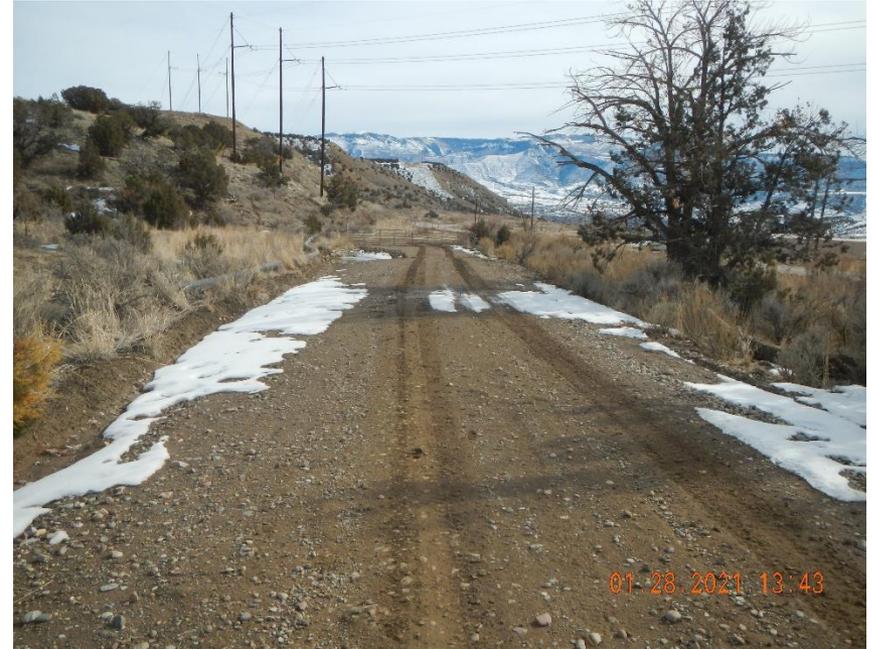
**Access road shows signs of lack of stabilization BMP's in some areas (rutting is present). No tracking bmps observed for access road.**

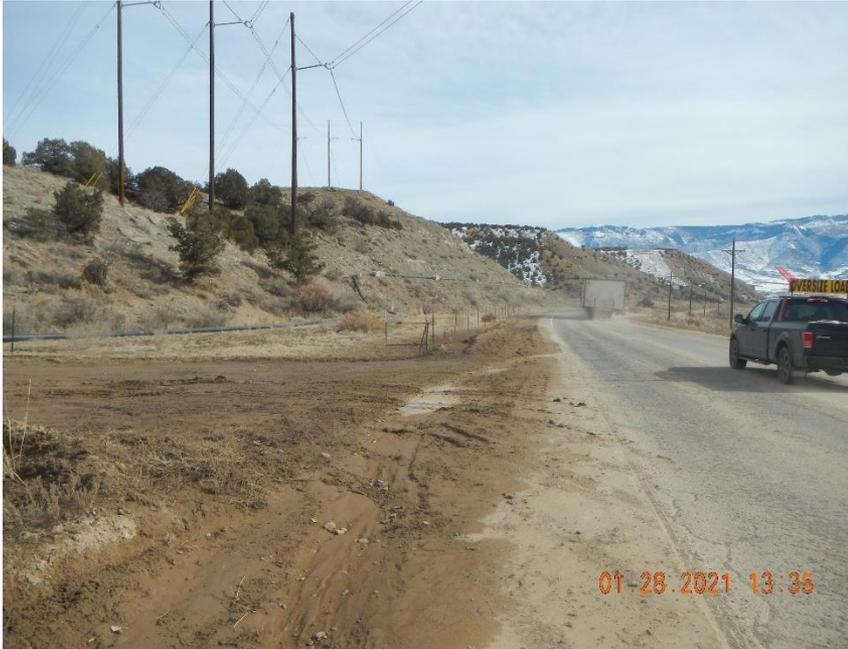
**Tracking visible on shoulder to white line.**

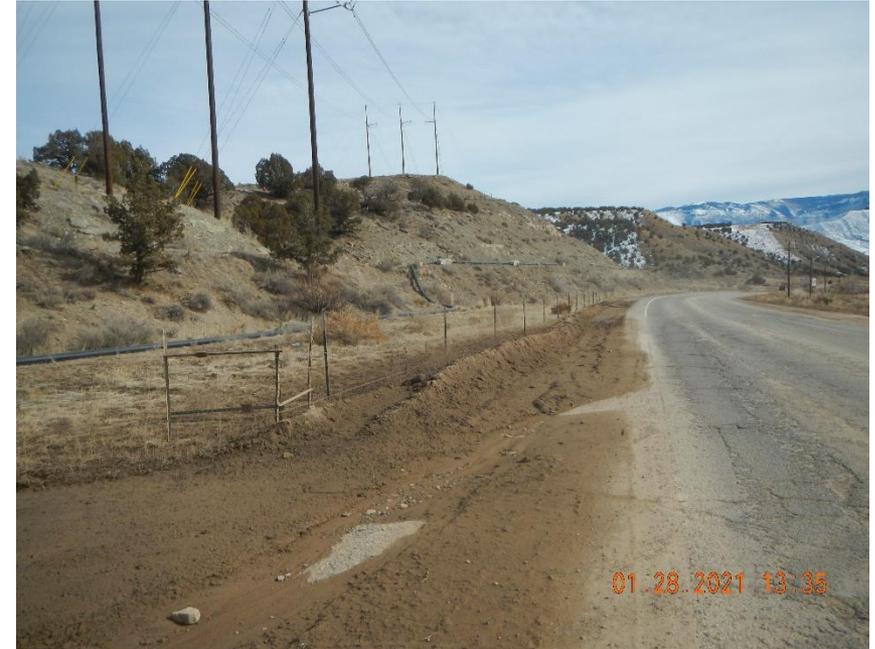
**Sediment moving on to shoulder of CR215**

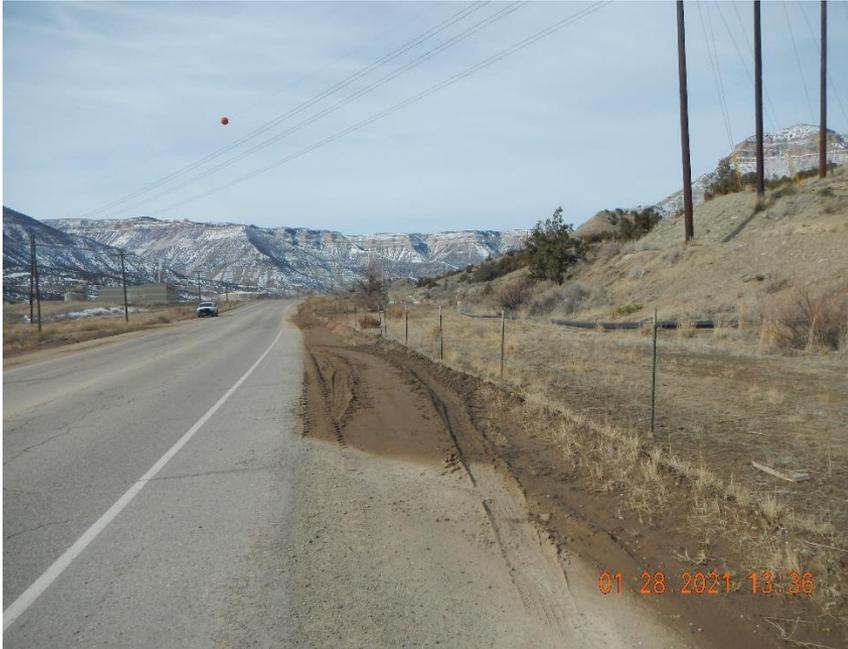
**Sediment moving on to shoulder of CR215**

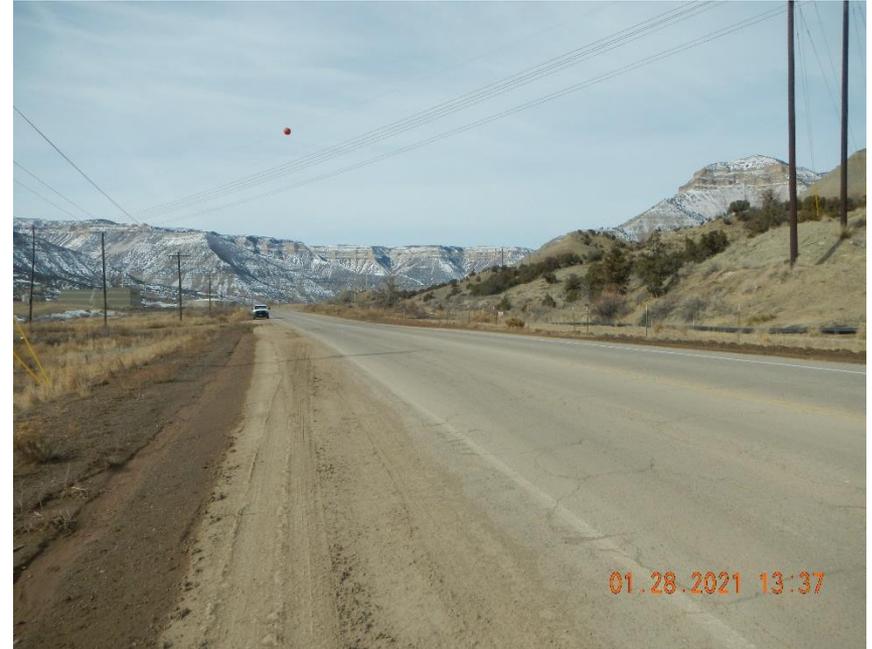
**Storm water bmps are failing at access  
right away and CR215.**

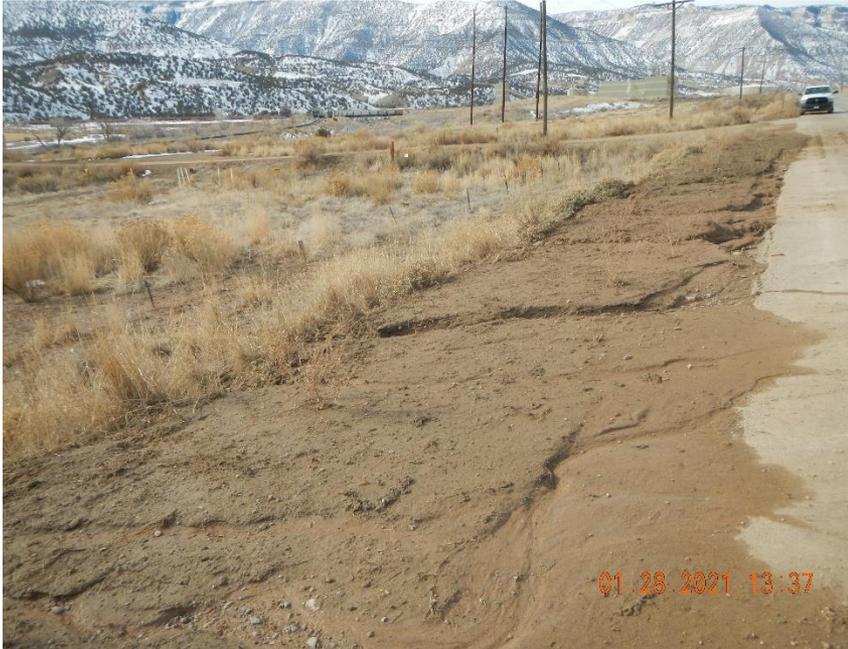
**Storm water bmps are failing at access right away and CR215.**

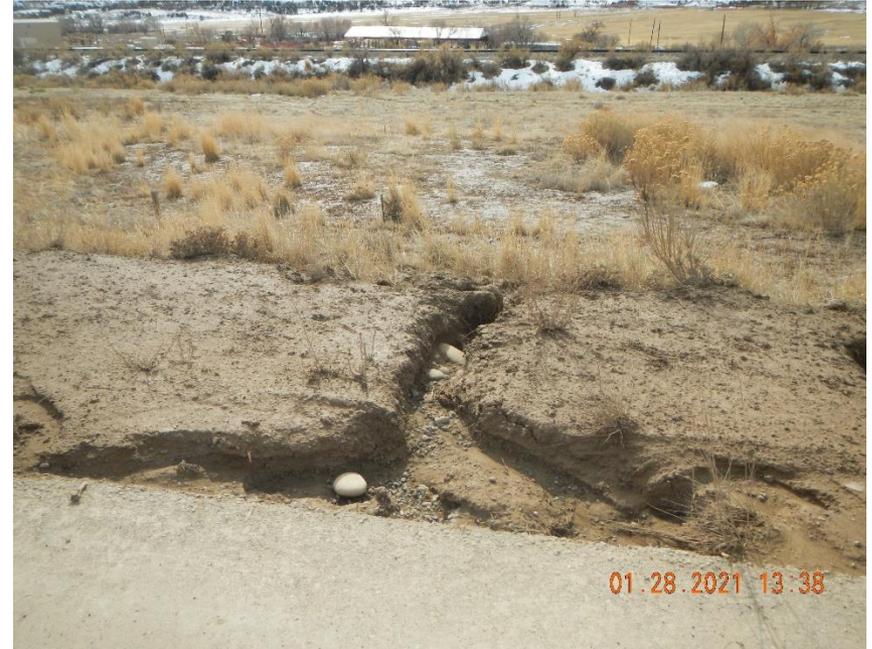
**Washing and eroding of shoulder of road.**

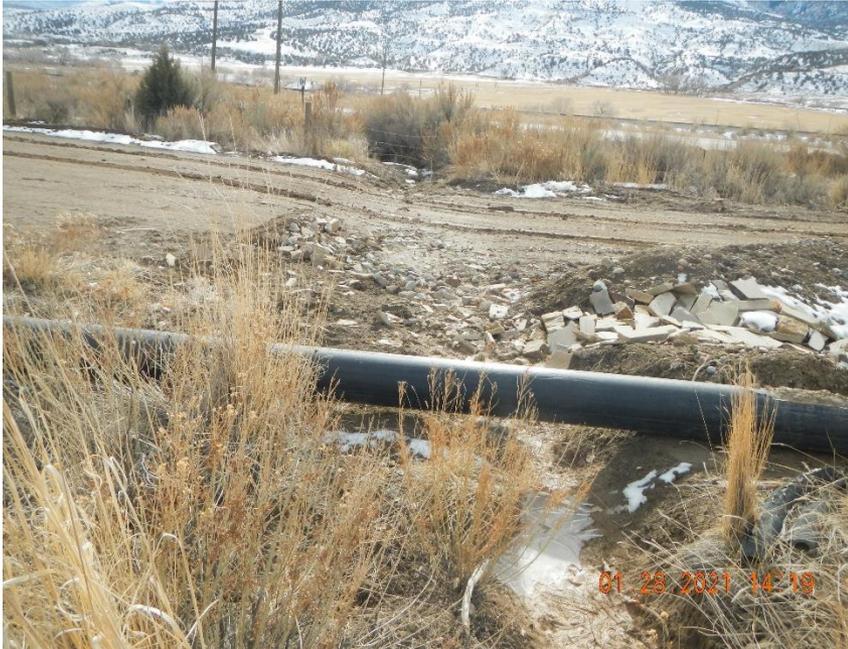
**Drainage merging with access road ditch check dam. Low water crossing across road.**

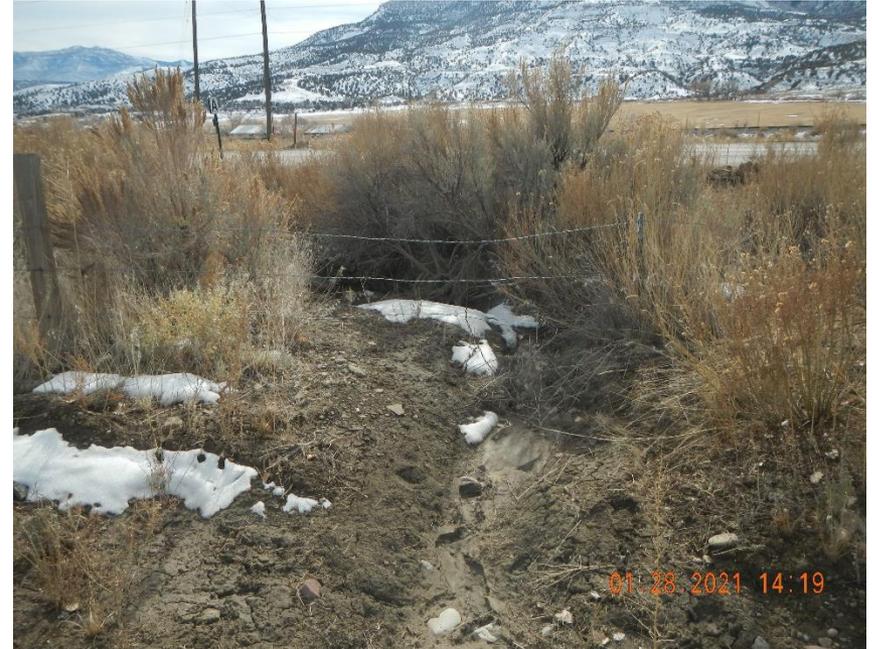
**Inadequate ditch for flow.**

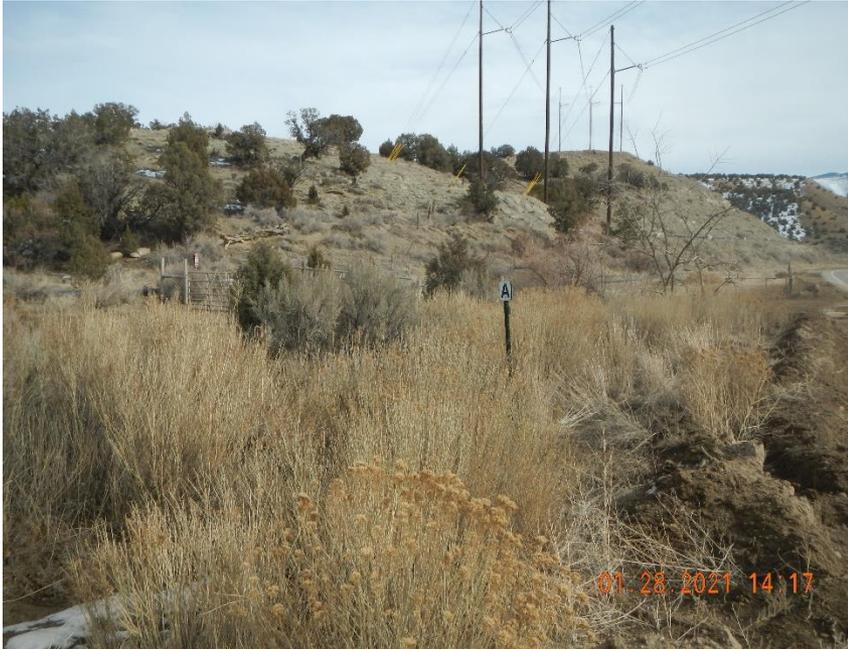
**Catch basin in brush near post marked A.**

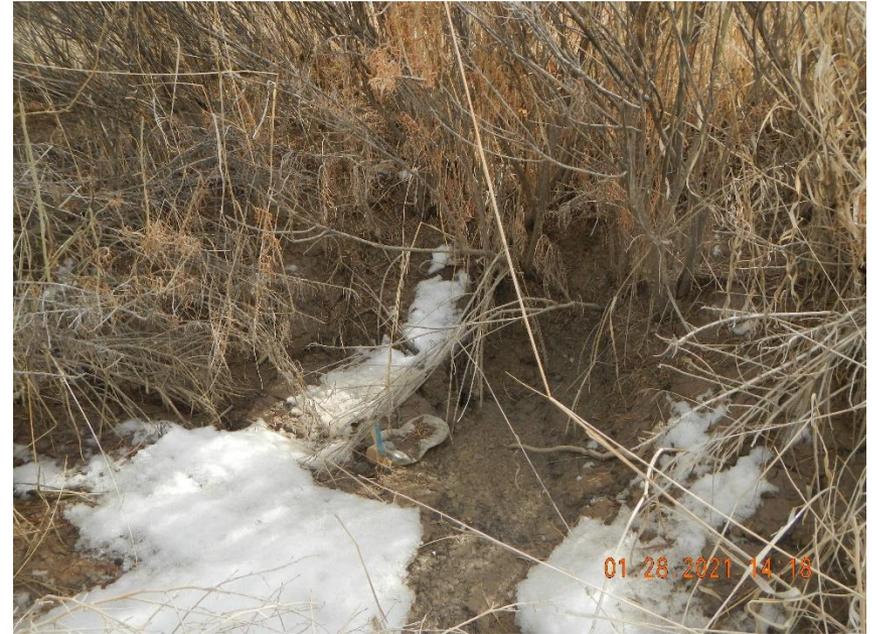
**Basin is inadequate size**
