Inspection Photos  
Operator: Logos  
API: 067-08104  
Date: 1/29/2021

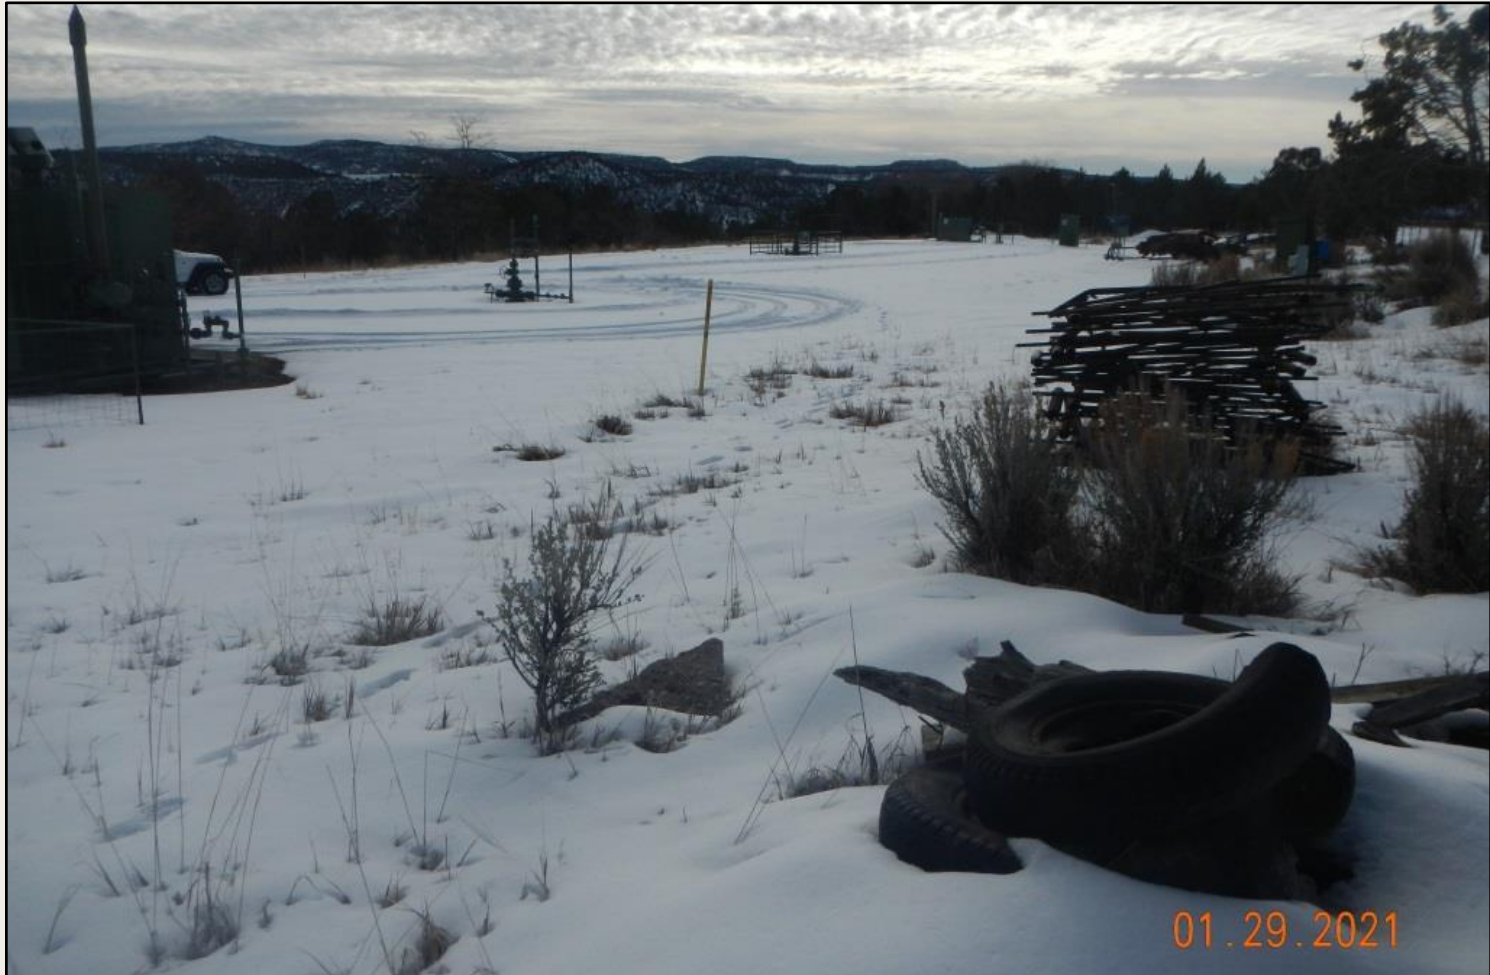
Photo 1. View of the project area from the northwestern corner facing center.

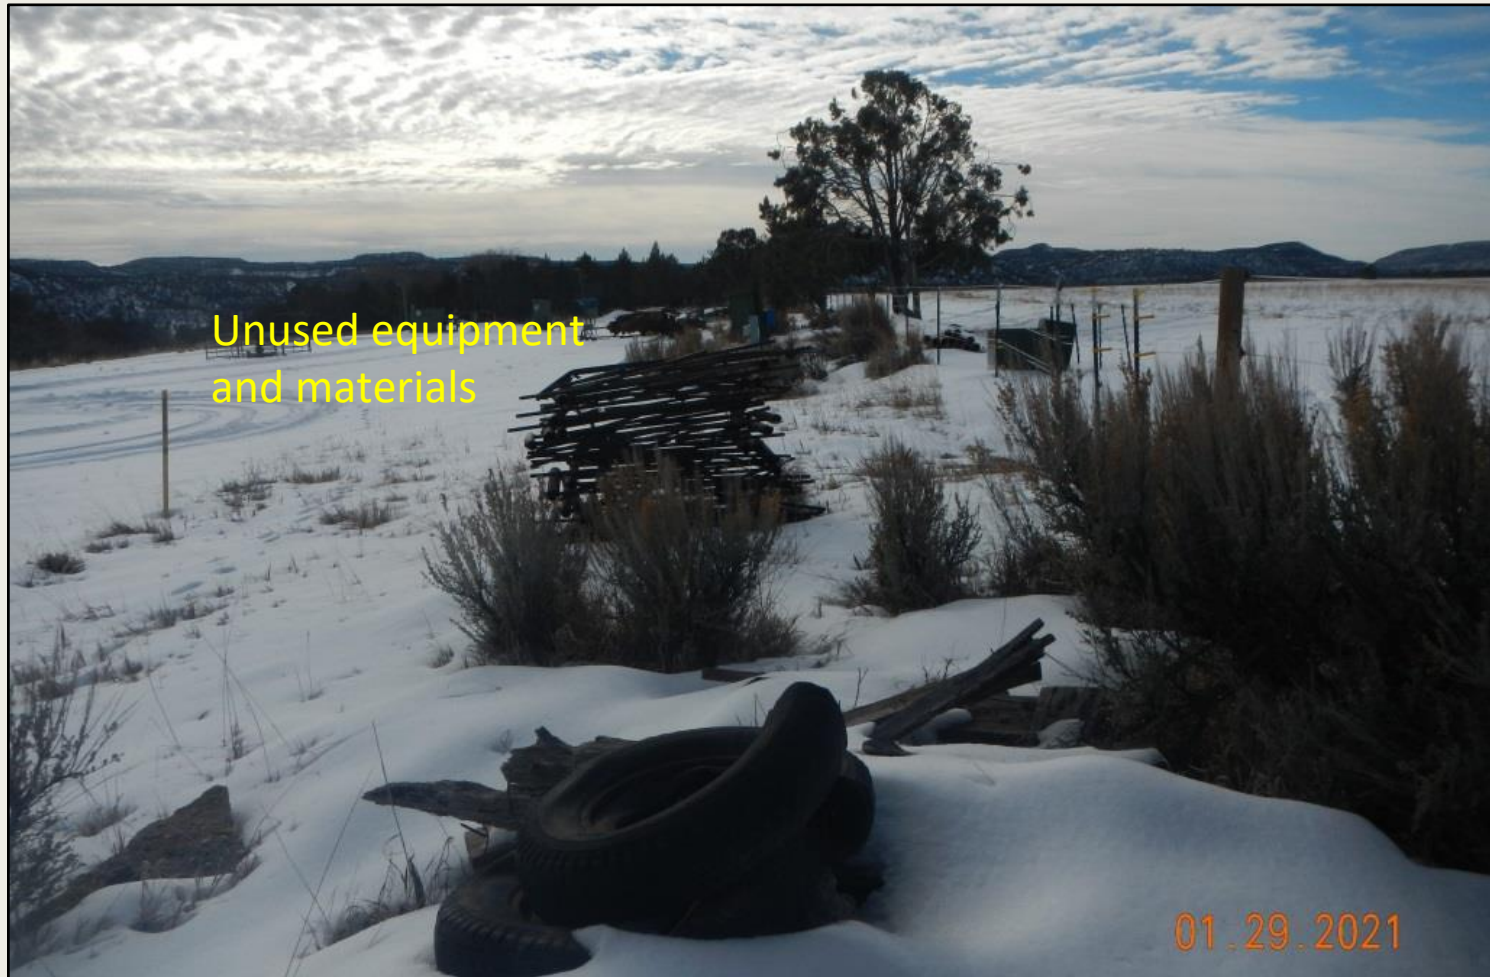
Photo 2. View of the western project area from the northwestern corner facing southward. Location largely snow covered. Taller perennial vegetation such as sand dropseed, smooth brome, and sagebrush observed through snow. Unused equipment and materials stored along the western edge.

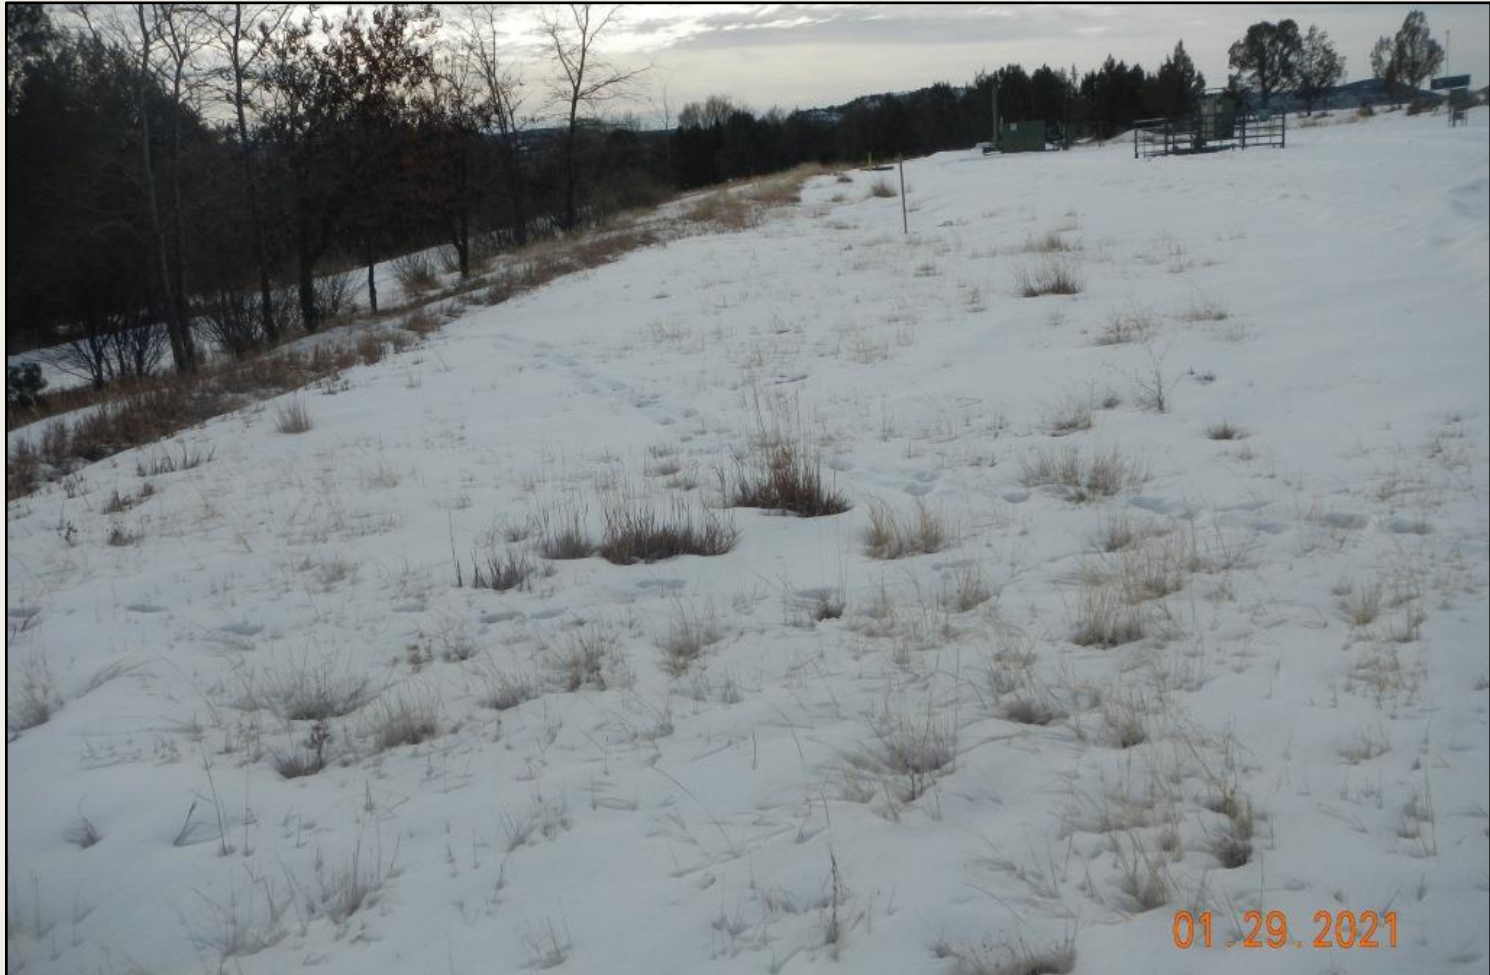
Photo 3. View of the eastern project area from the northeastern corner facing southward.

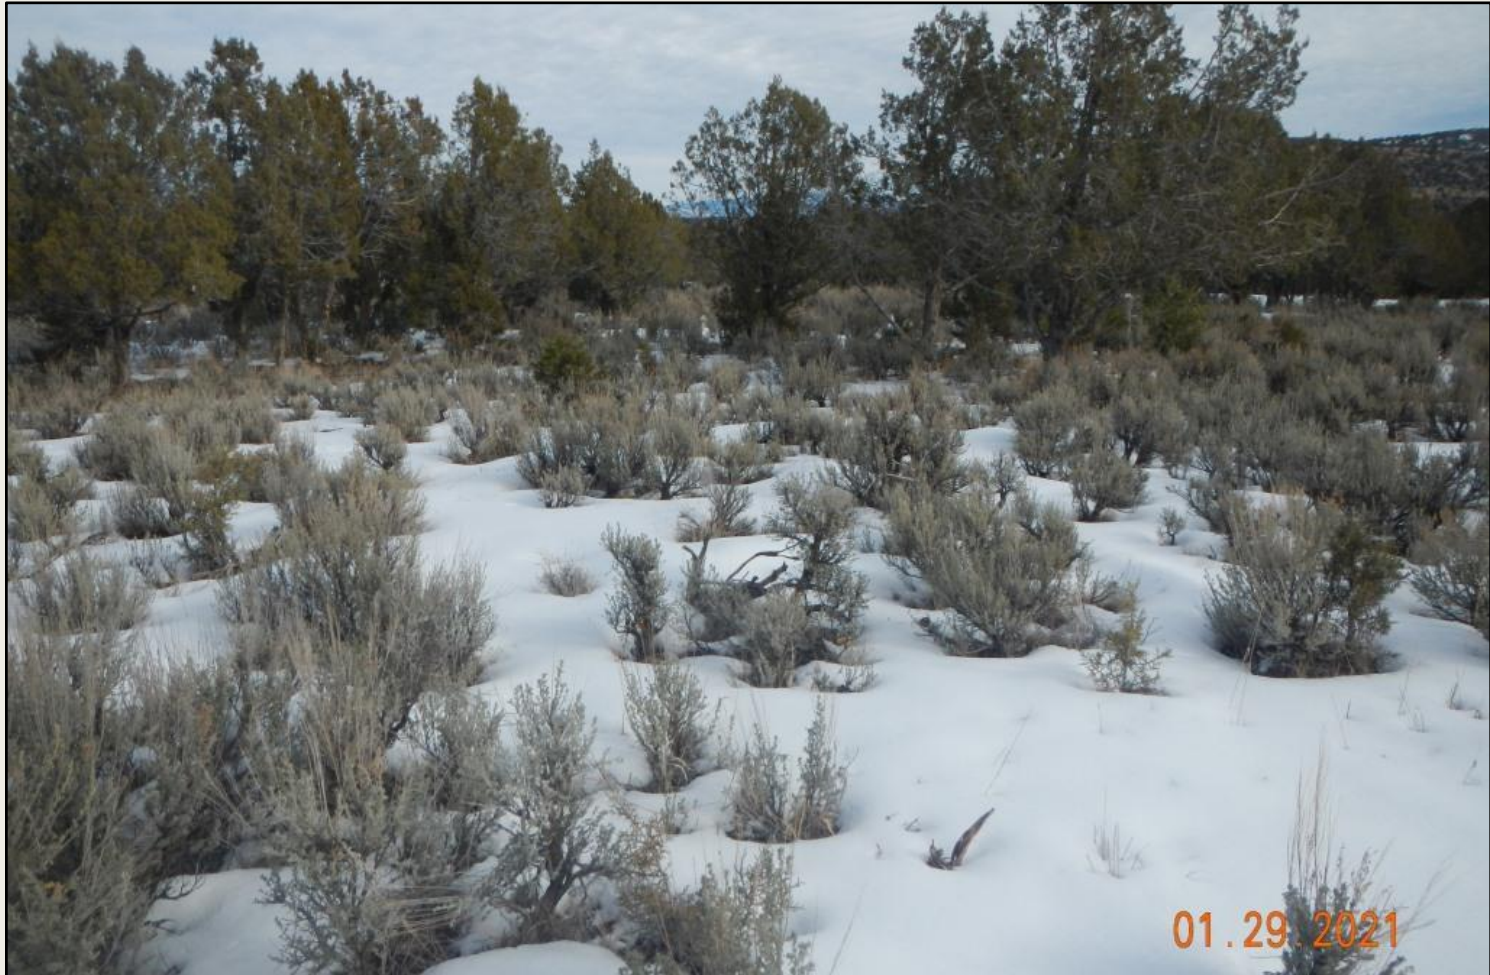
Photo 4. View of the reference area comprised of pinyon and juniper woodland with sagebrush in the understory. Snow cover prevents identification of grasses and forbs.
