Inspection Photos

Location Name: CAERUS PICEANCE LLC FEDERAL-67S95W /19SWSW

Location ID: 335005

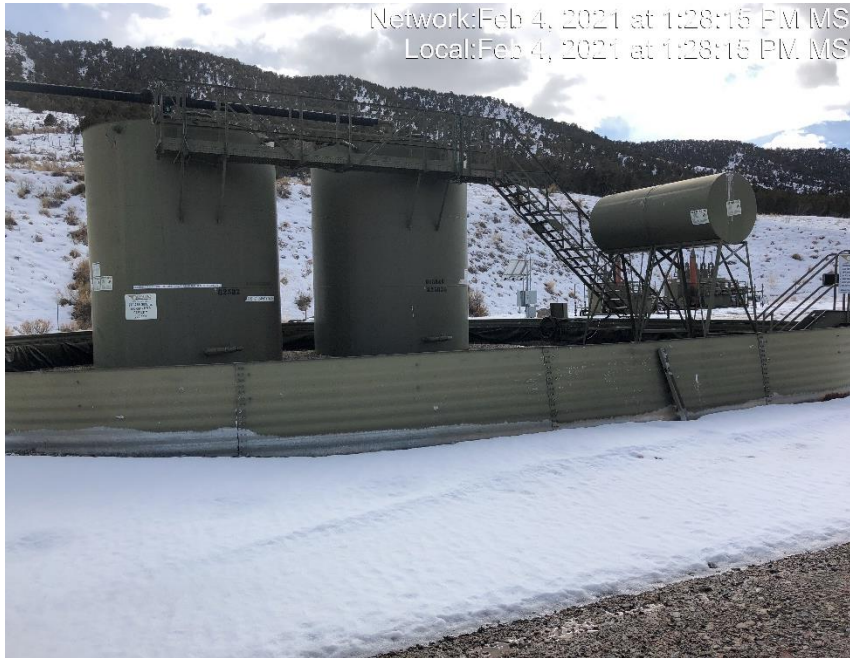
Photo #2810 from entrance to location.

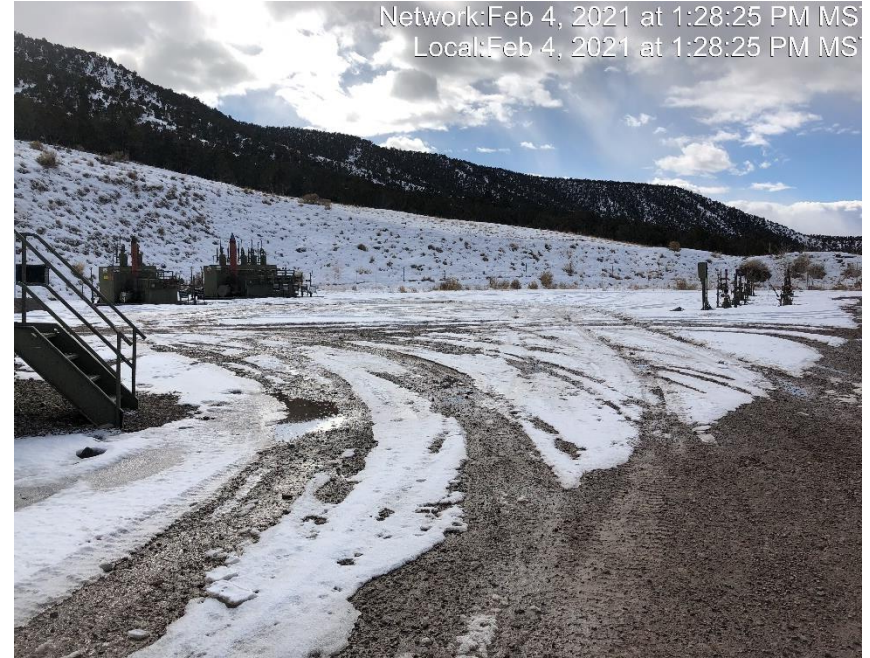
Photo #2811 from entrance to location.

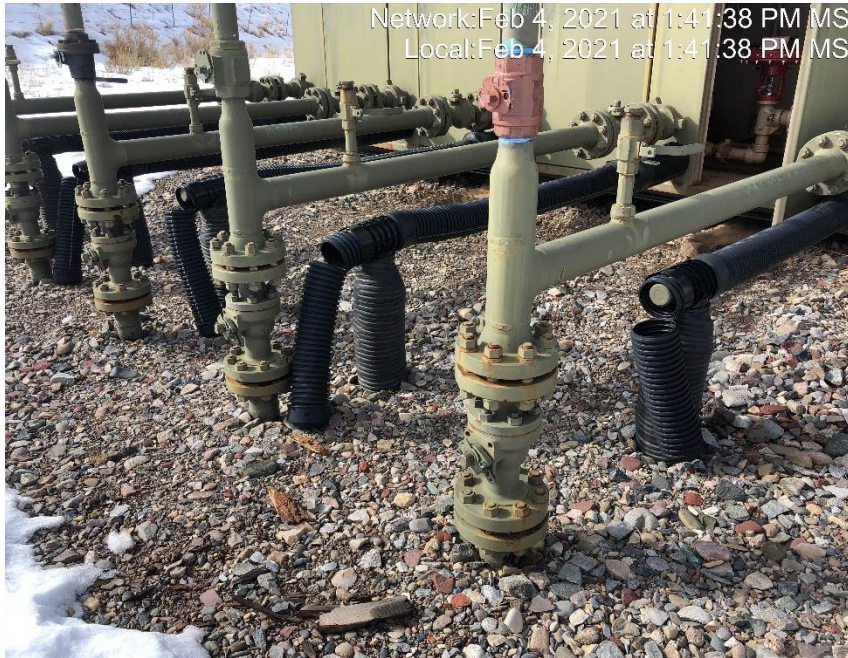
Photo #2812 Multiple flow line exhaust heating insulation open ended and not capped.
