Inspection Photos

Location Name: CAERUS PICEANCE LLC FEDERAL-67S95W /19NESE

Location ID: 335031

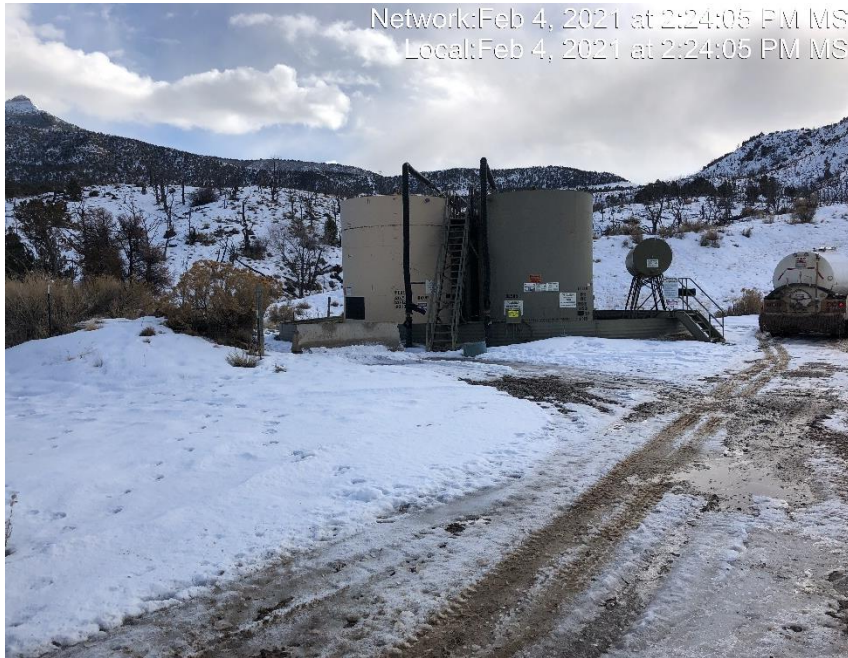
Photo #2817 from entrance to location.

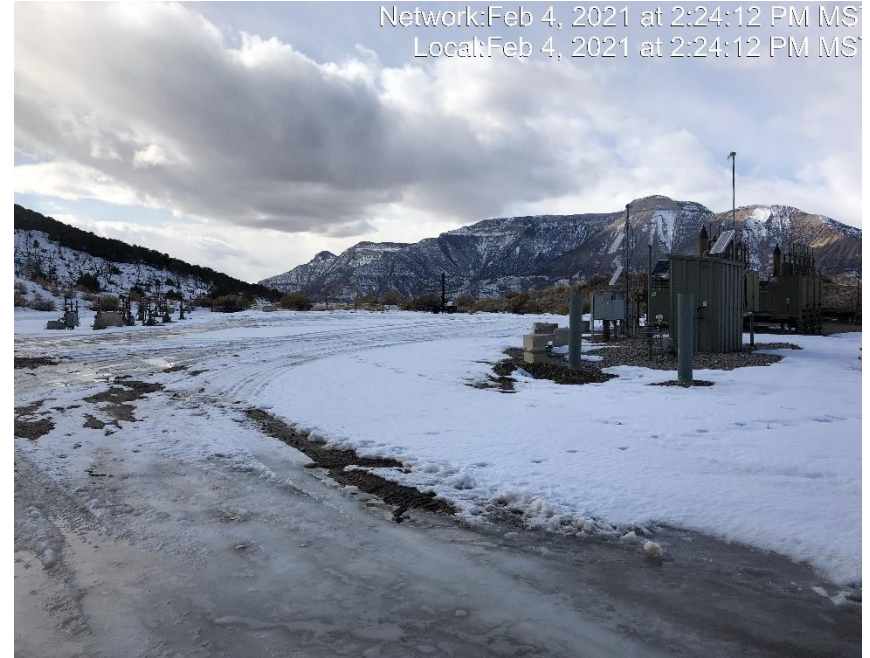
Photo #2818 from entrance to location.

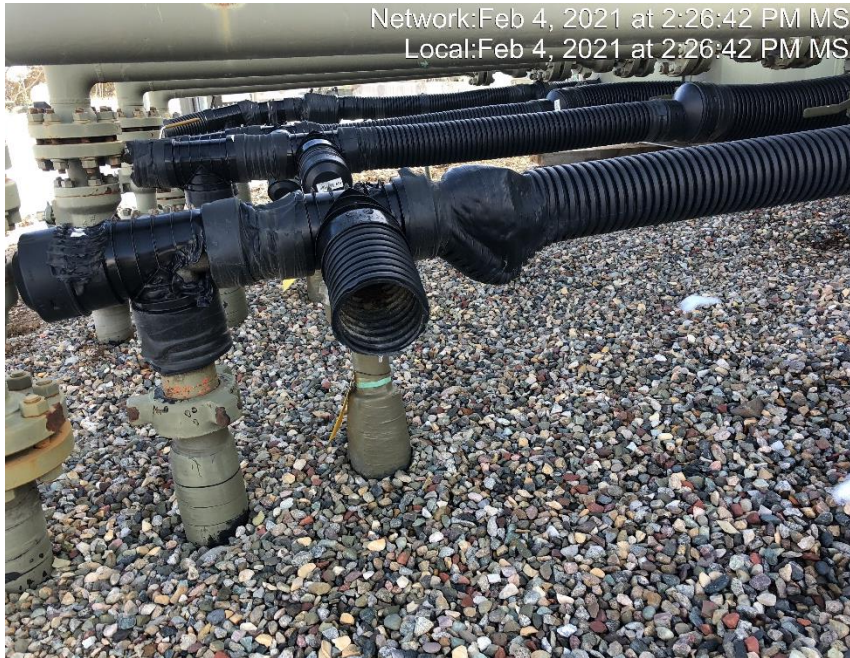
Photo #2819 Flow line exhaust heating insulation open ended and not capped.
