**CAERUS PICEANCE LLC  
UNOCAL-66S96W 9SW SW  
Location # 335687**

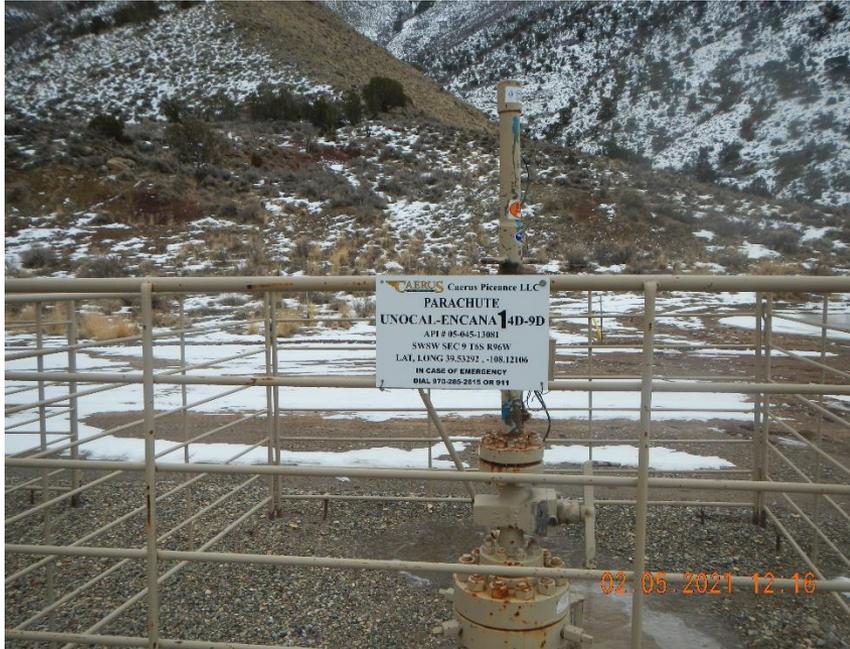
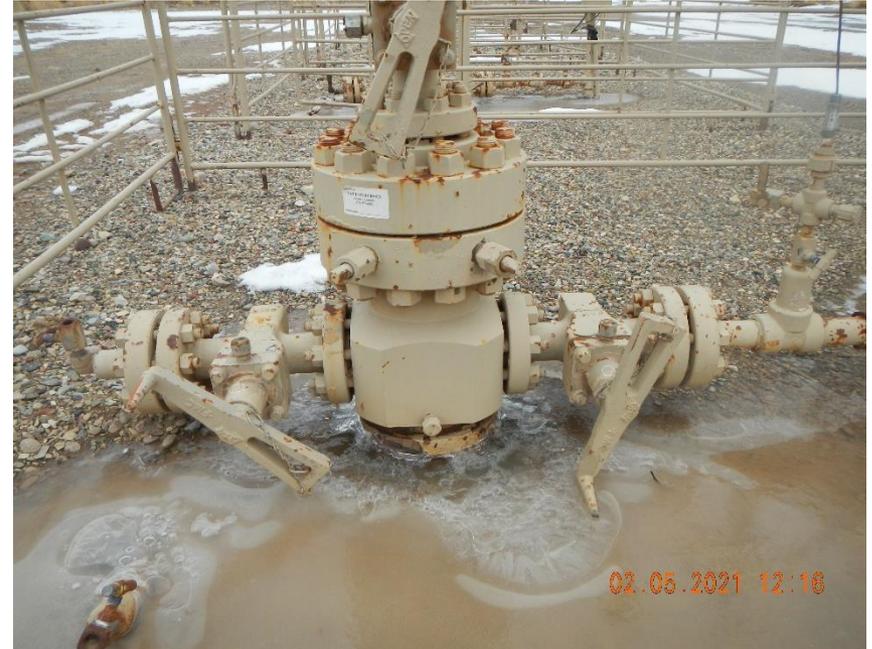
**UNOCAL-ENCANA 14D-9D**

**Gas bubbling around surface casing of well.**

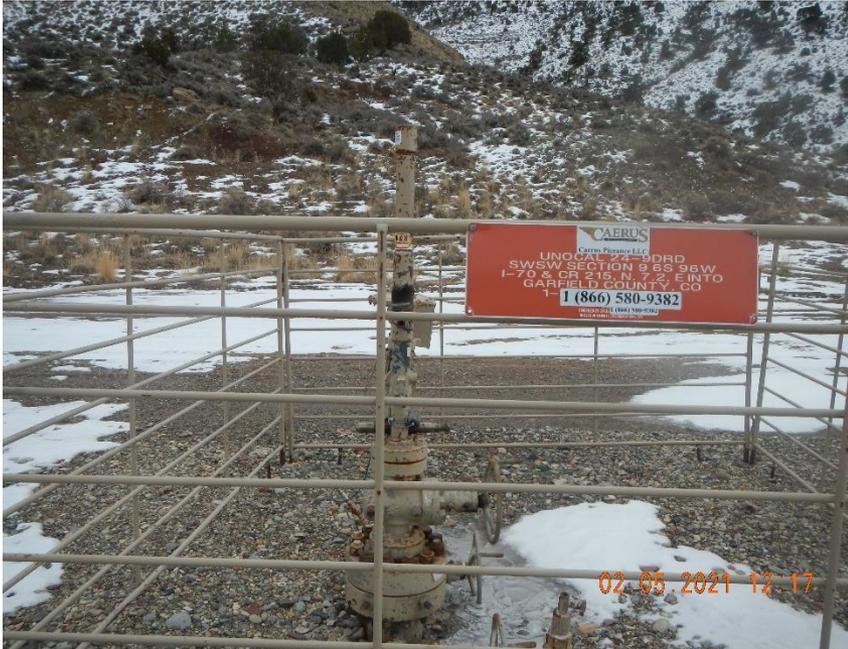
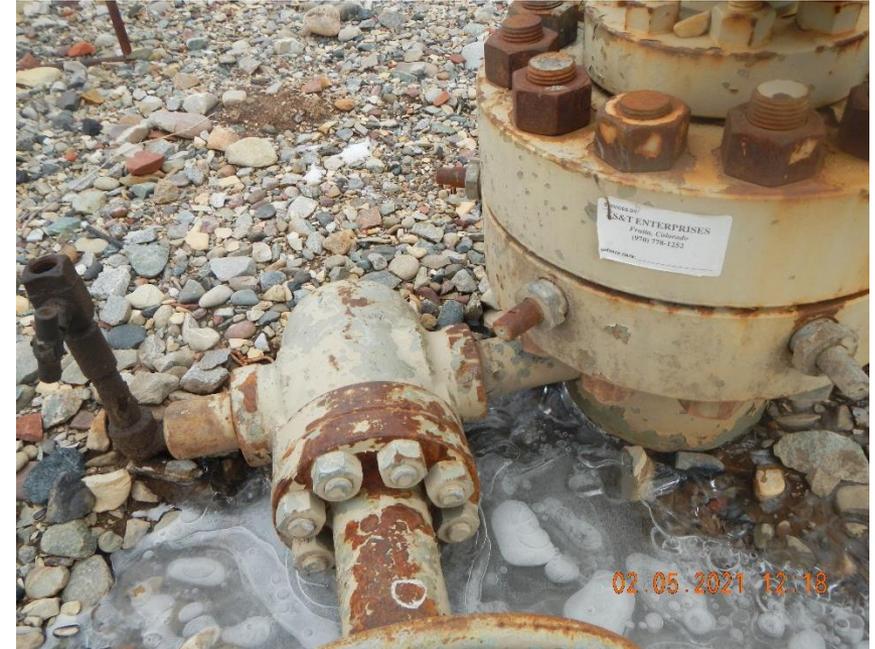
**UNOCAL-ENCANA 24D-9DRD**

**Gas bubbling around surface casing of well.**

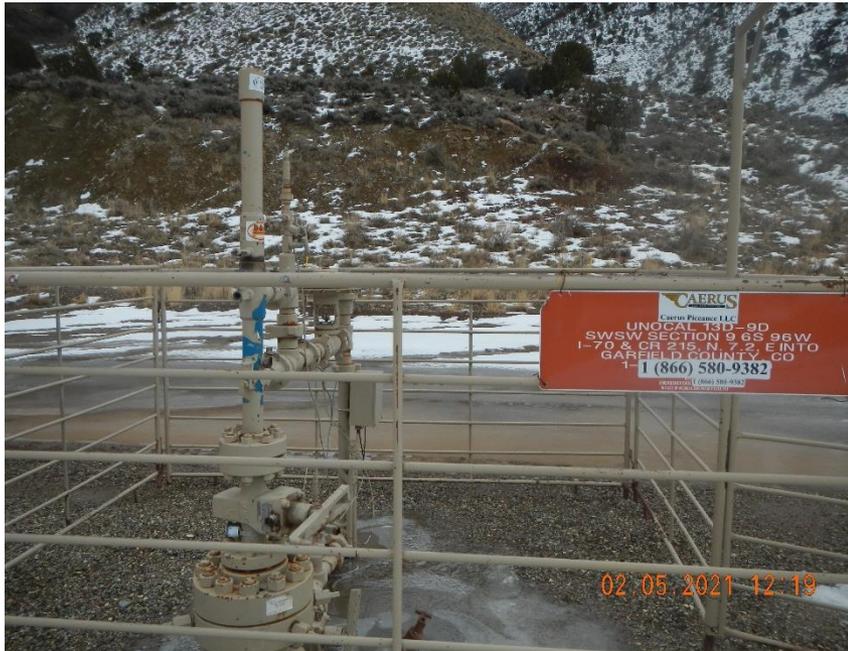
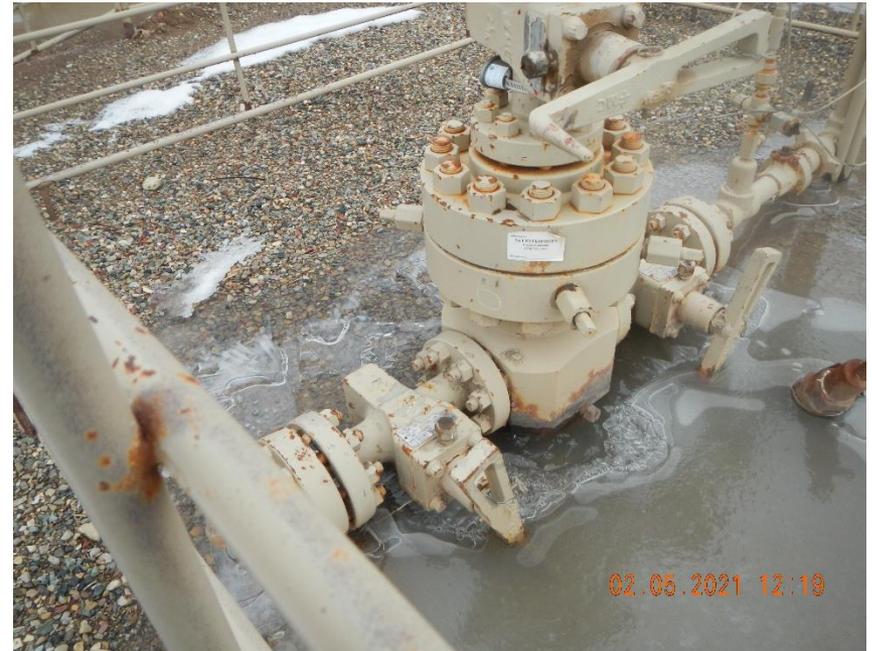
**UNOCAL-ENCANA 13D-9D**

**Gas bubbling around surface casing of well.**

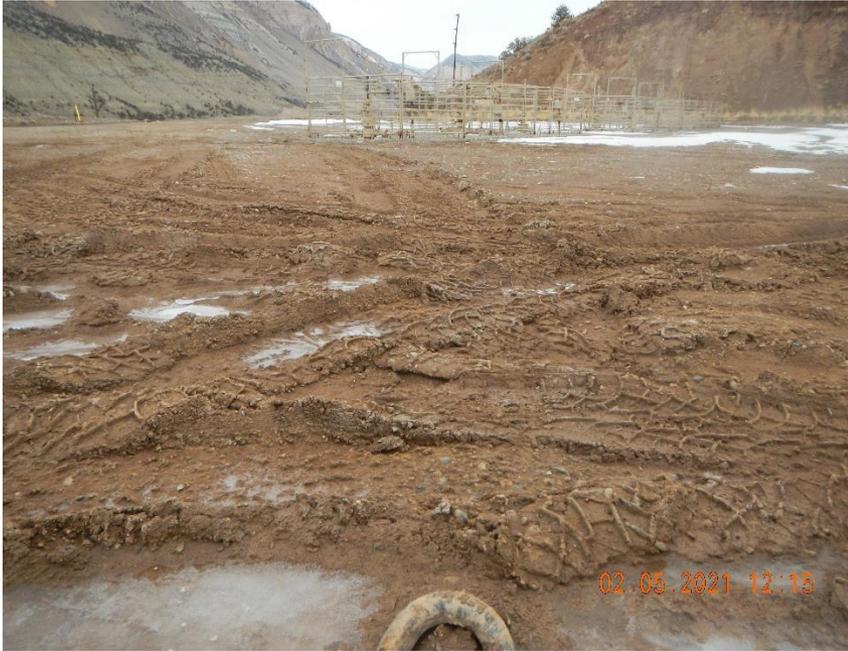
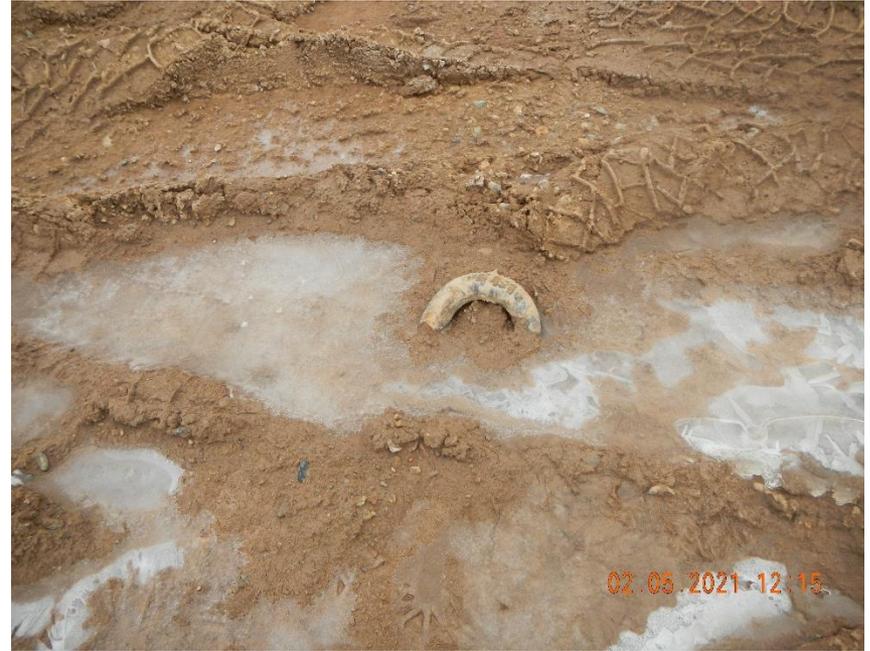
**Unmarked deadman.**

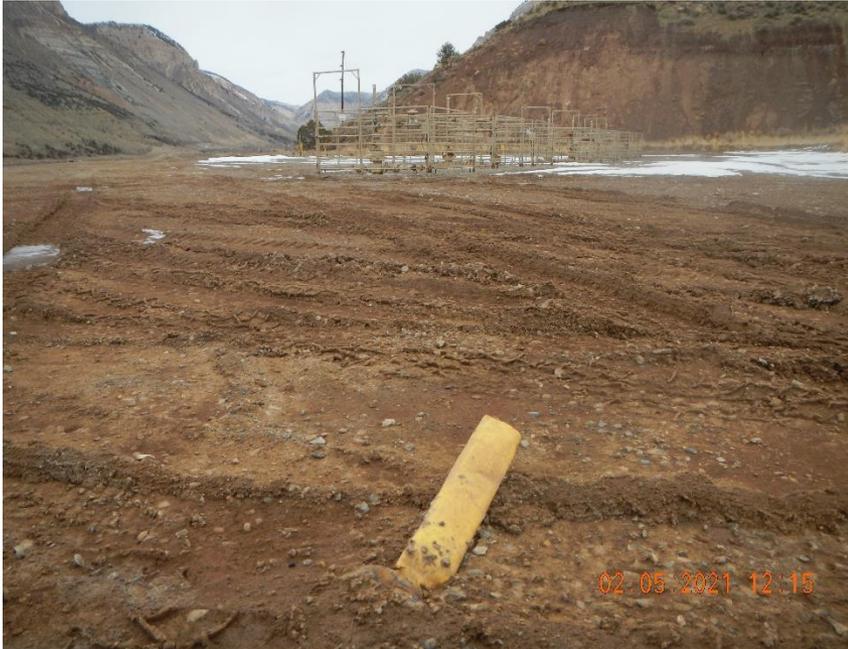
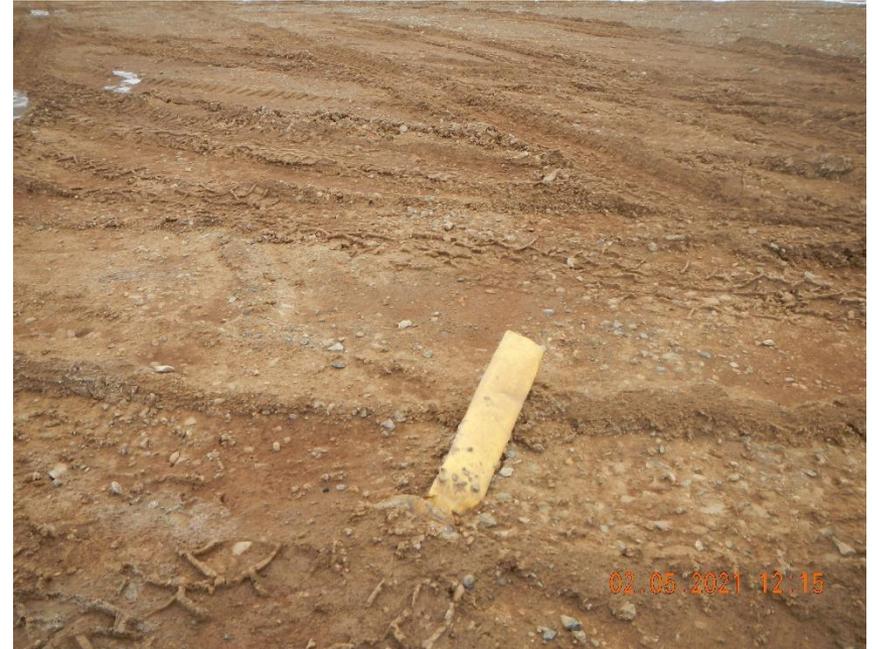
**Deadman marker is broken and inadequate.**

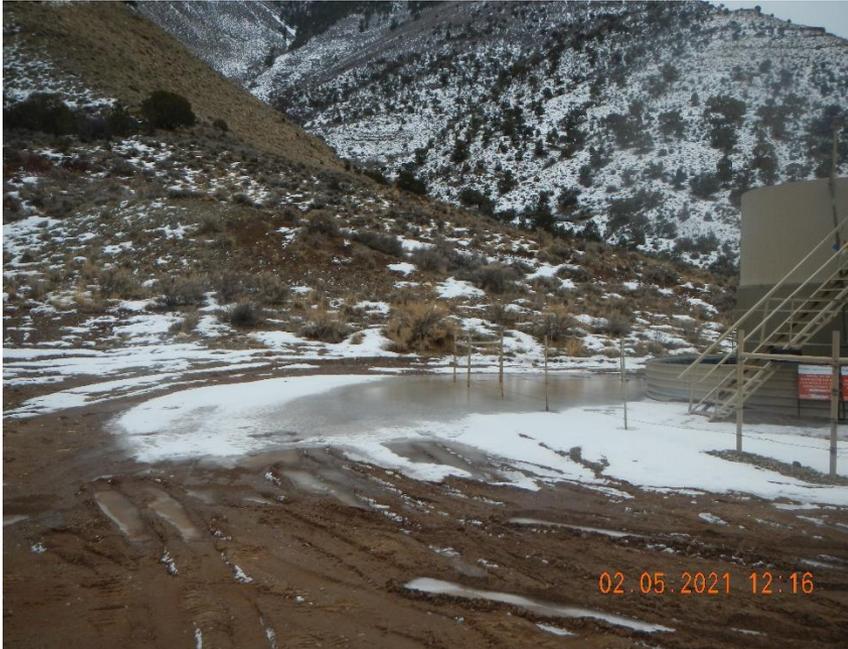
**Impoundment of storm water behind tank battery.**

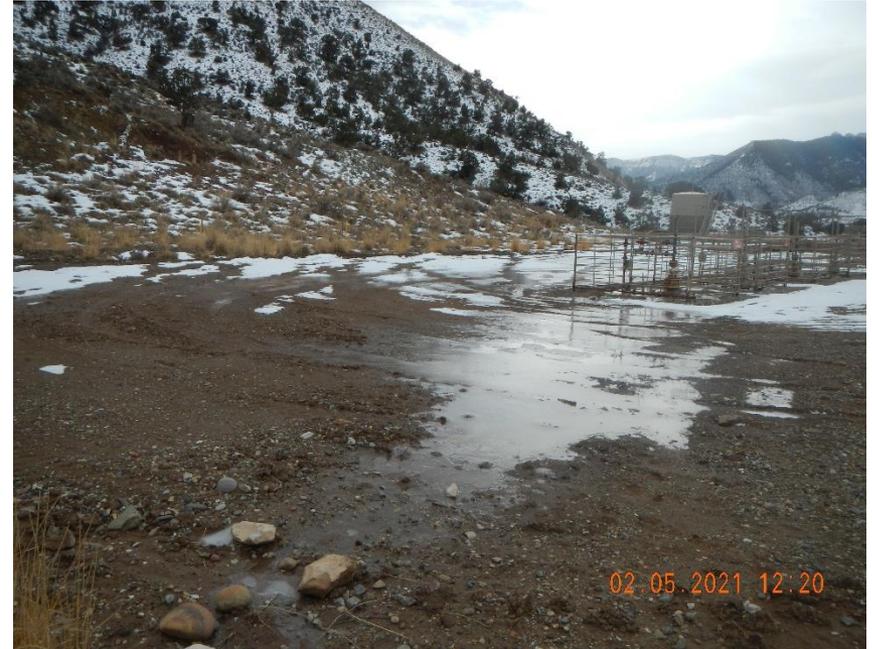
**Impoundment of storm water between wells and check dam.**

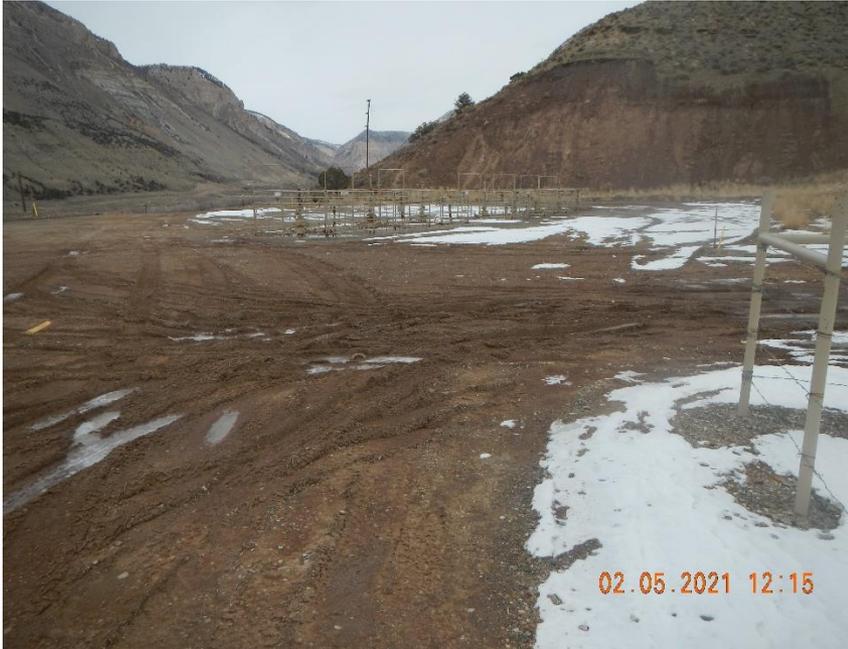
**Location shows signs of lack of stabilization  
BMP's in some areas (rutting is present).**

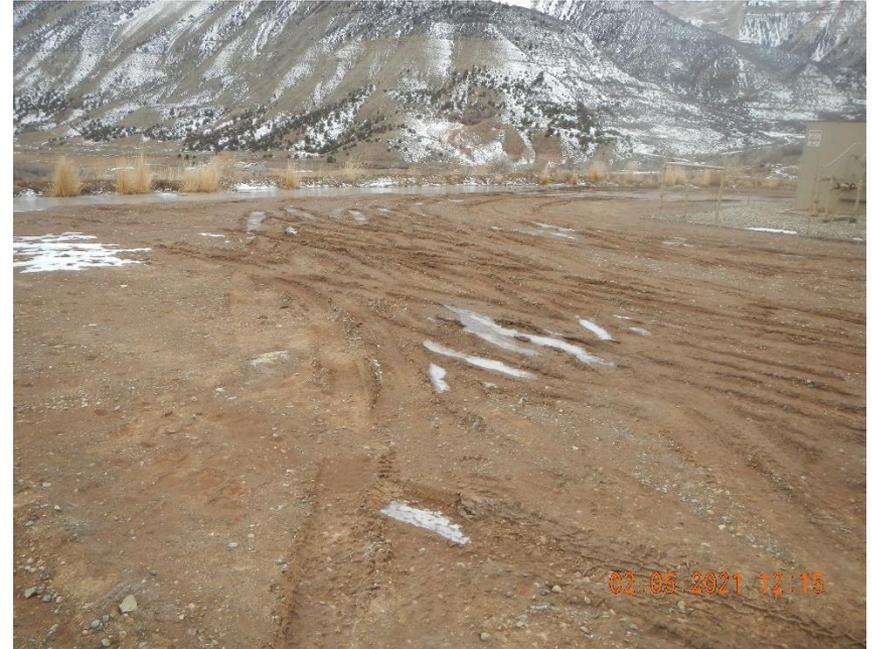
**Location shows signs of lack of stabilization  
BMP's in some areas (rutting is present).**

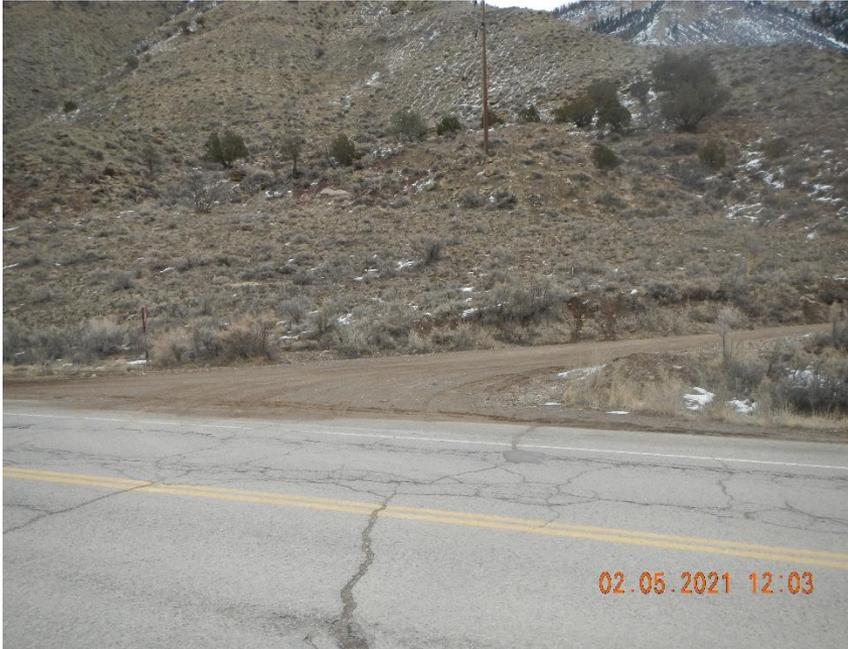
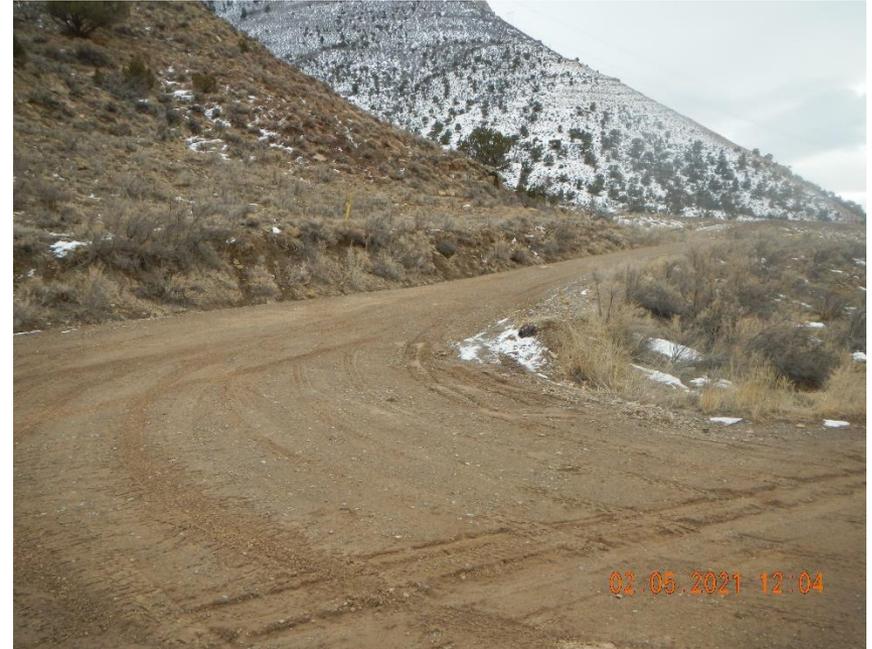
**No tracking bmps observed for well pad.**

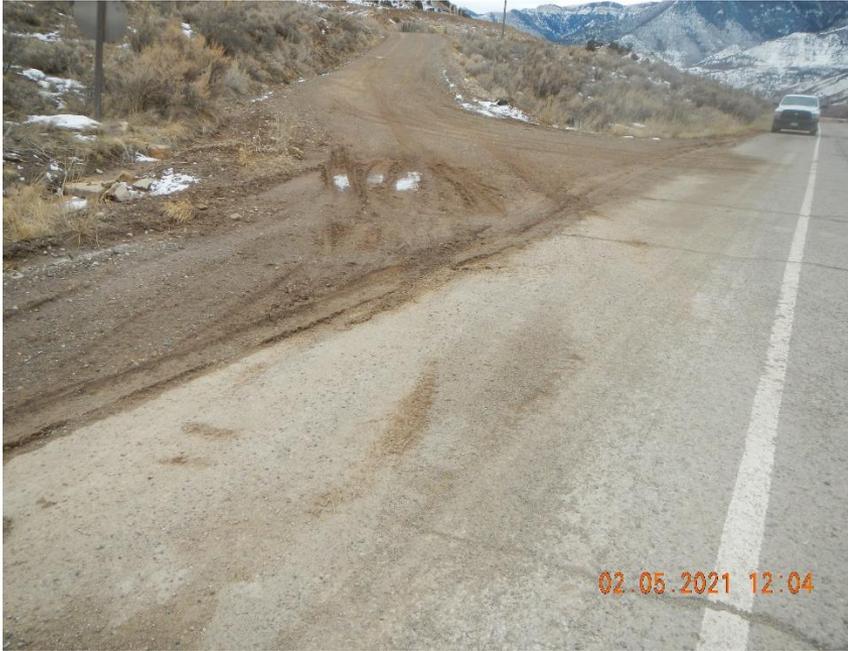
**No tracking bmps observed for well pad.**

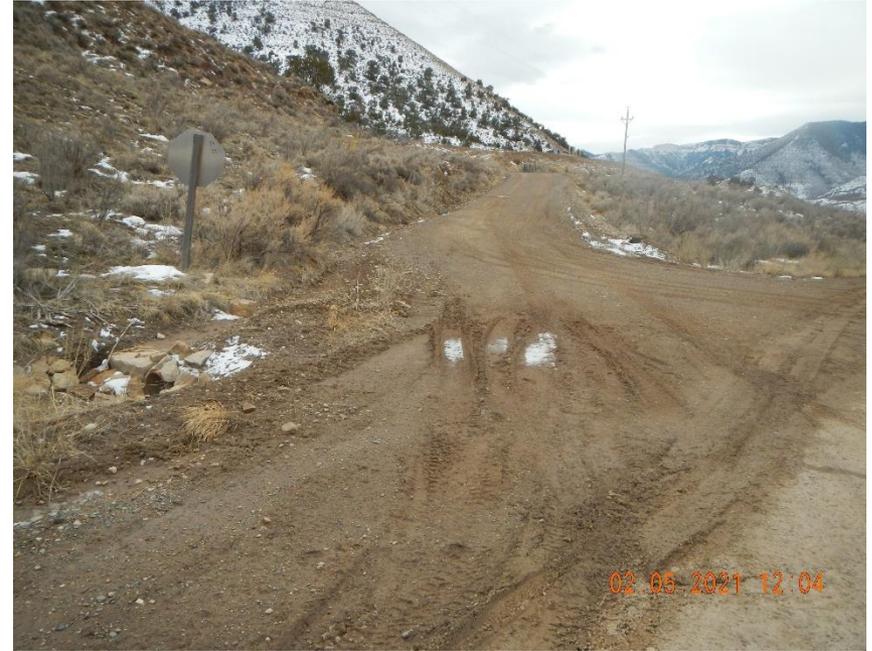
**No tracking bmps observed for well pad.**
