**Inspection Photos**  
**Location Name: Loomis 2-1H PAD**  
**Location ID: 438327**

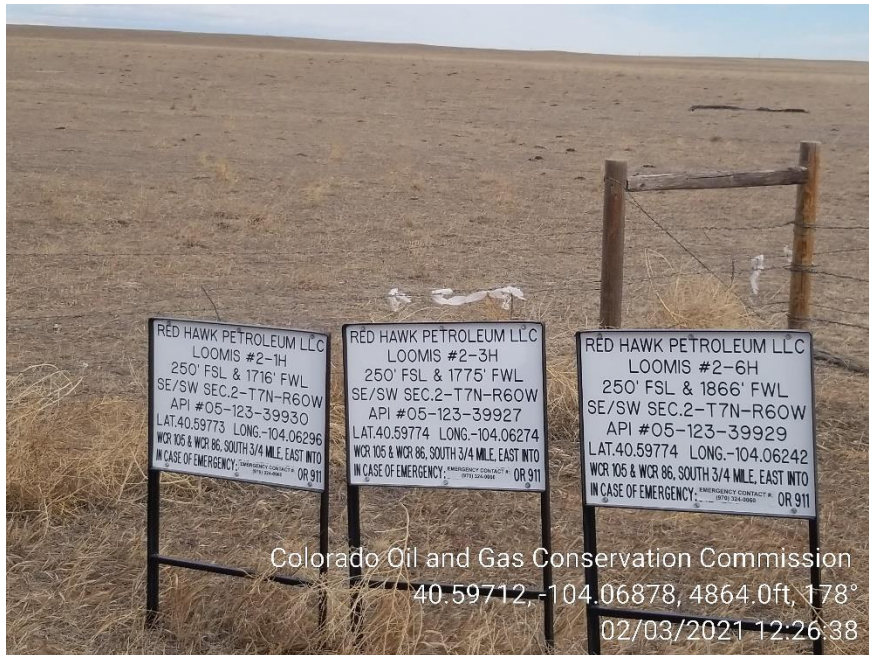
**Photo 1 – Lease Signs by Entrance**

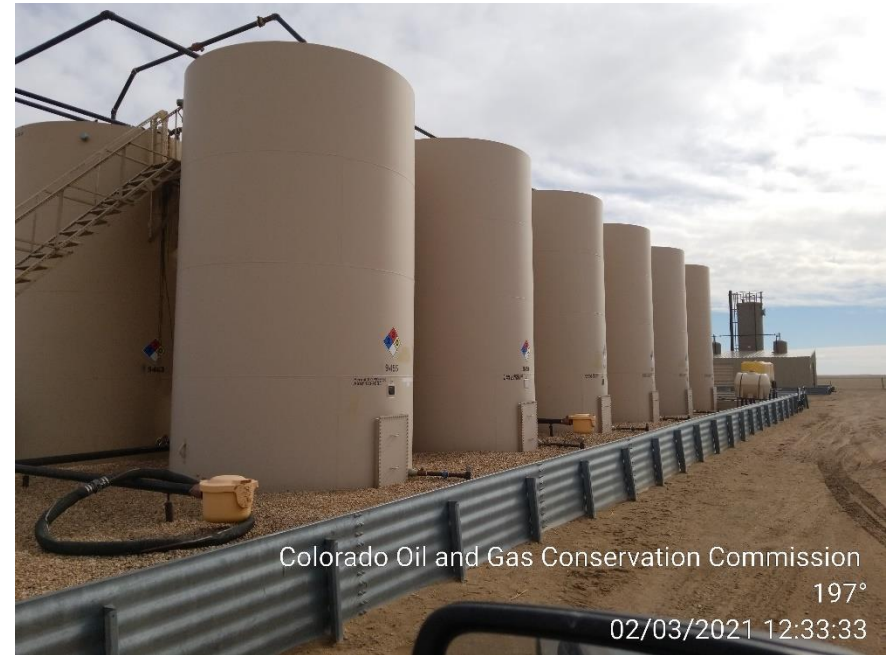
**Photo 2 – Tank Battery**

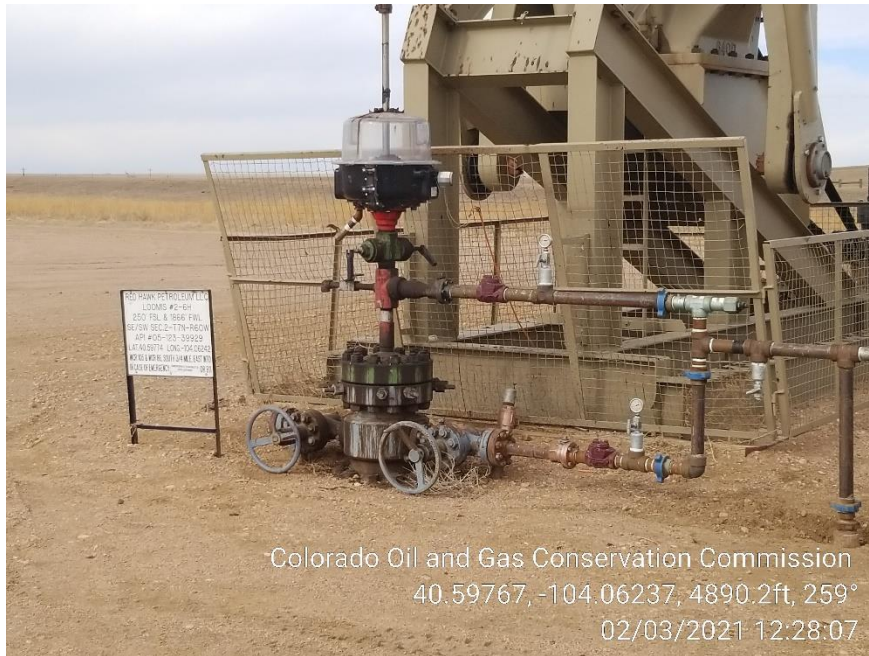
**Photo 3 – 2-6H Wellhead**

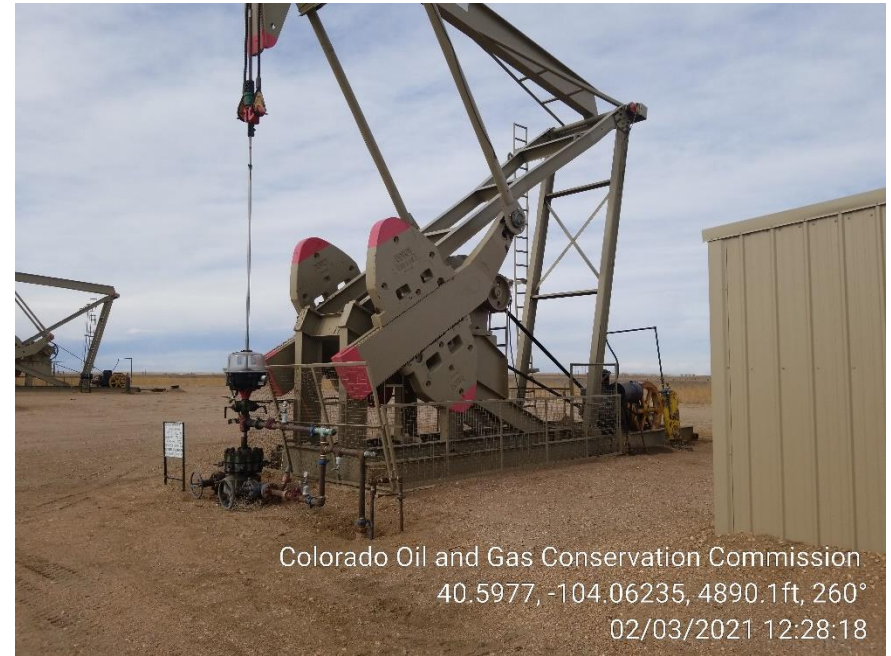
**Photo 4 – 2-6H Pumping Unit**

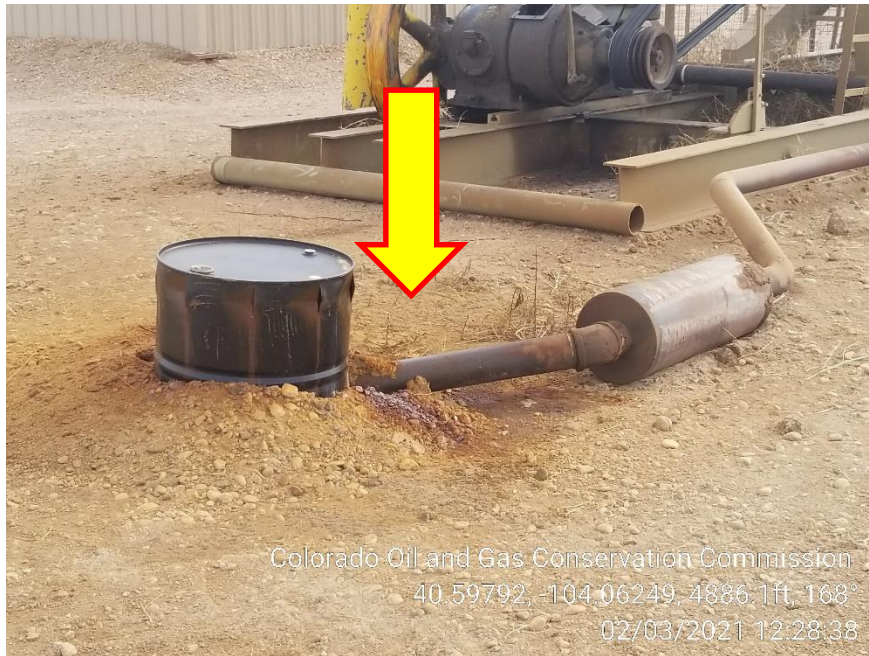
**Photo 5 – 2-6H Exhaust – Stained Soil**

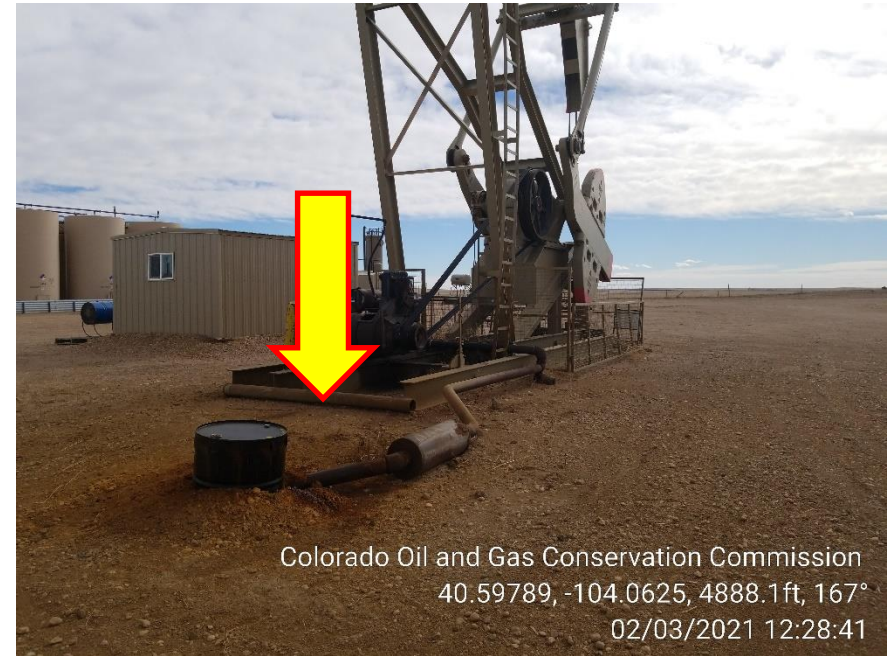
**Photo 6 – 2-6H Exhaust – Stained Soil**

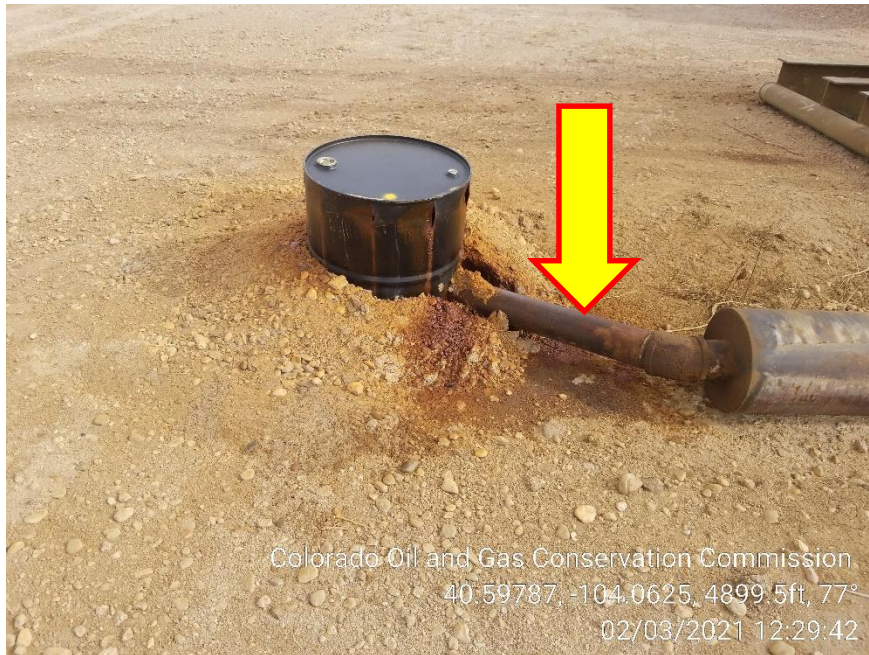
**Photo 7 – 2-6H Exhaust – Stained Soil**

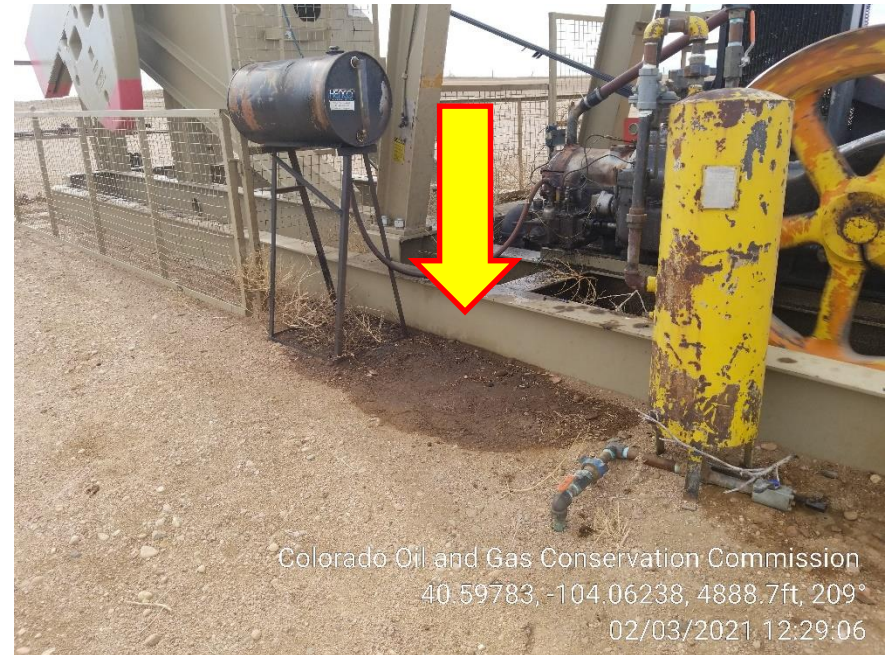
**Photo 8 – 2-6H Gas Engine – Stained Soil**

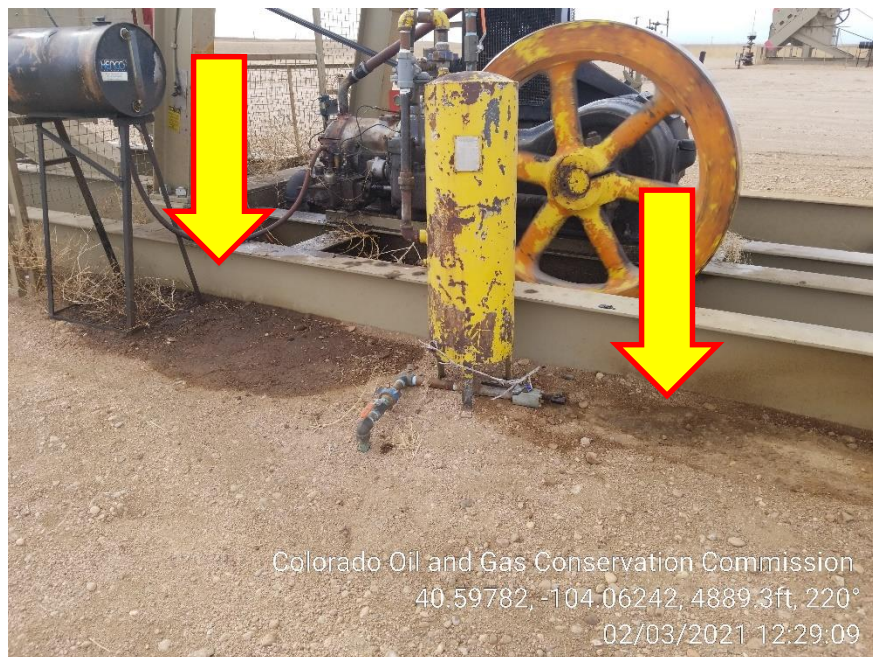
**Photo 9 – 2-6H Stained Soil at Gas Engine**

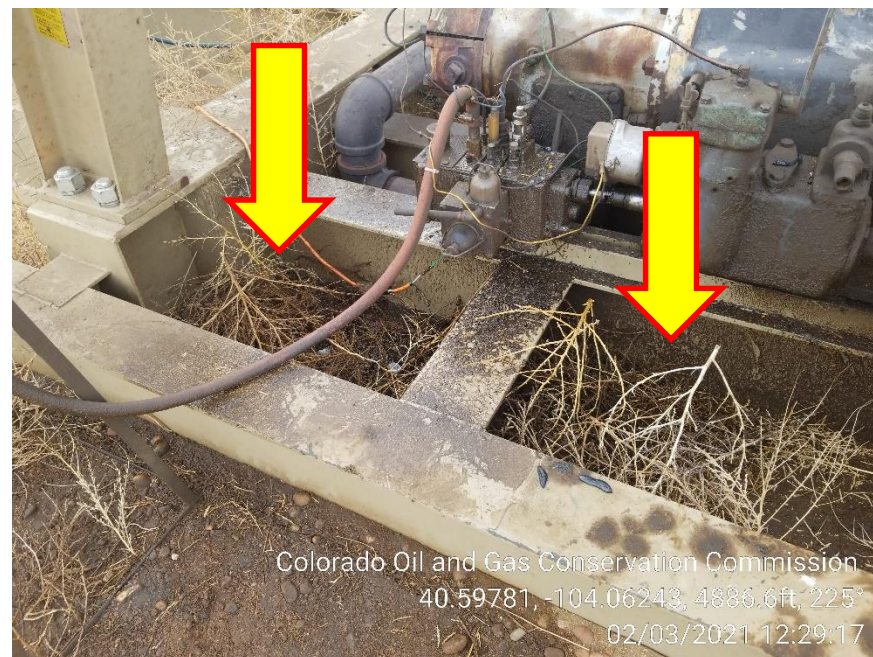
**Photo 10 – 2-6H – Gas Engine – Stained Soil and Debris**

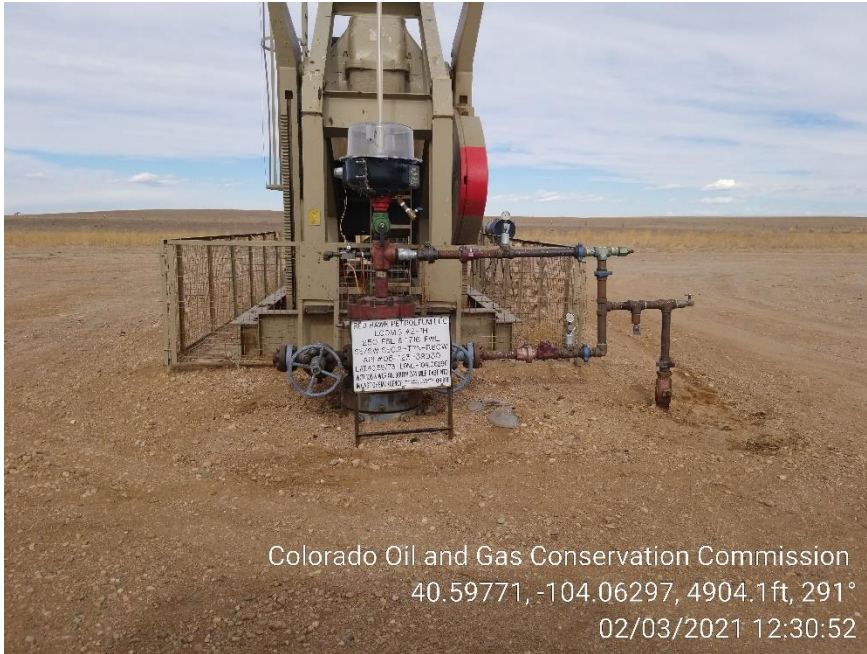
**Photo 11 – 2-1H Wellhead**

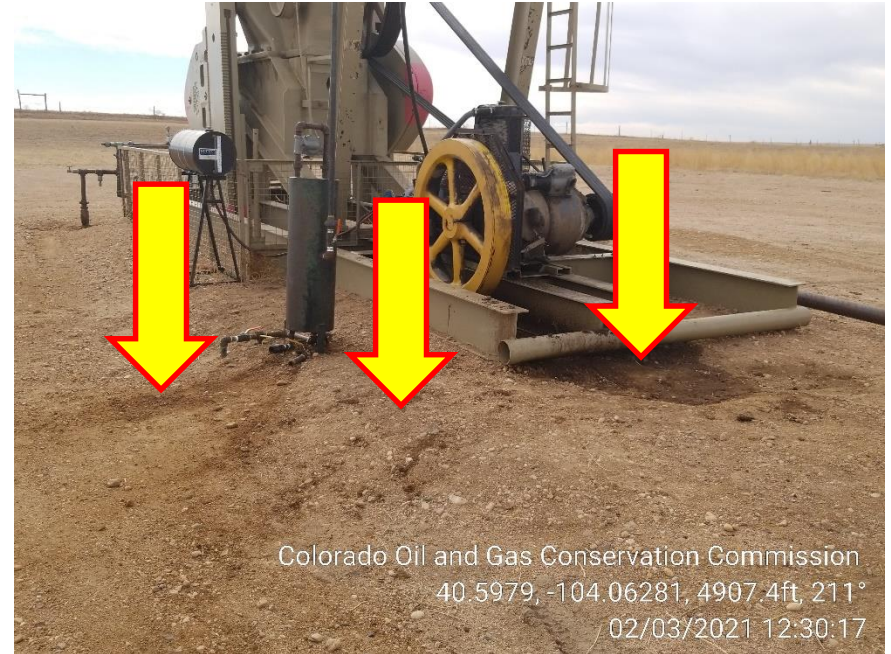
**Photo 12 – 2-1H – Gas Engine – Stained Soil**

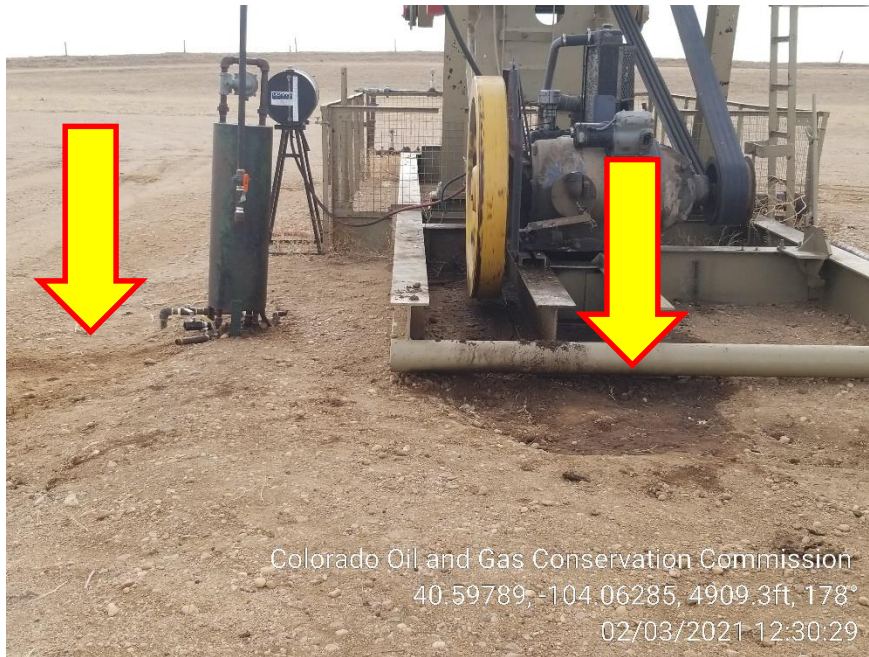
**Photo 13 – 2-1H – Gas Engine – Stained Soil**

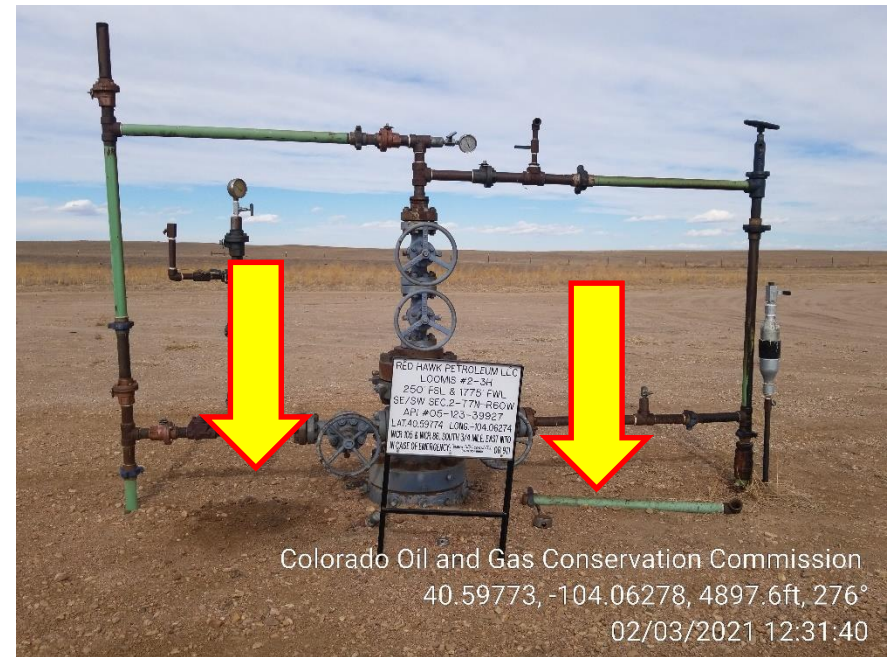
**Photo 14 – 2-3H Wellhead – Stained Soil and Unused Wellhead parts**

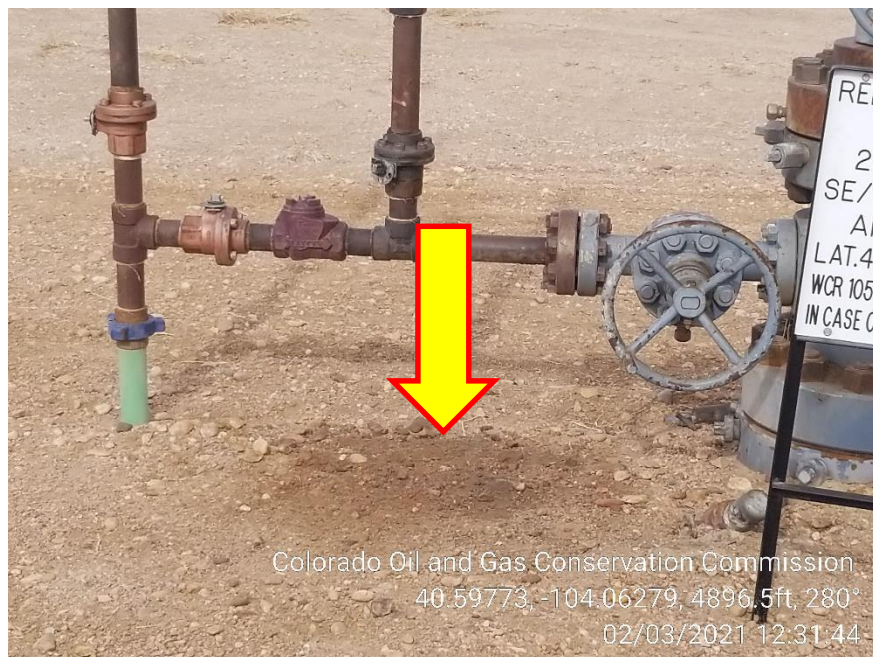
**Photo 15 – 2-3H Wellhead – Stained Soil**

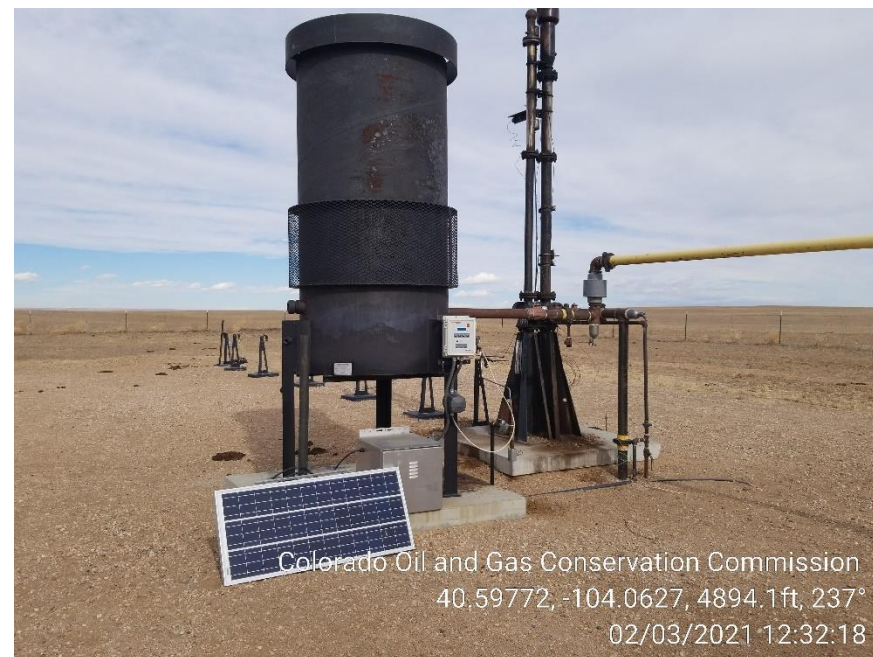
**Photo 16 – ECD and Flare**

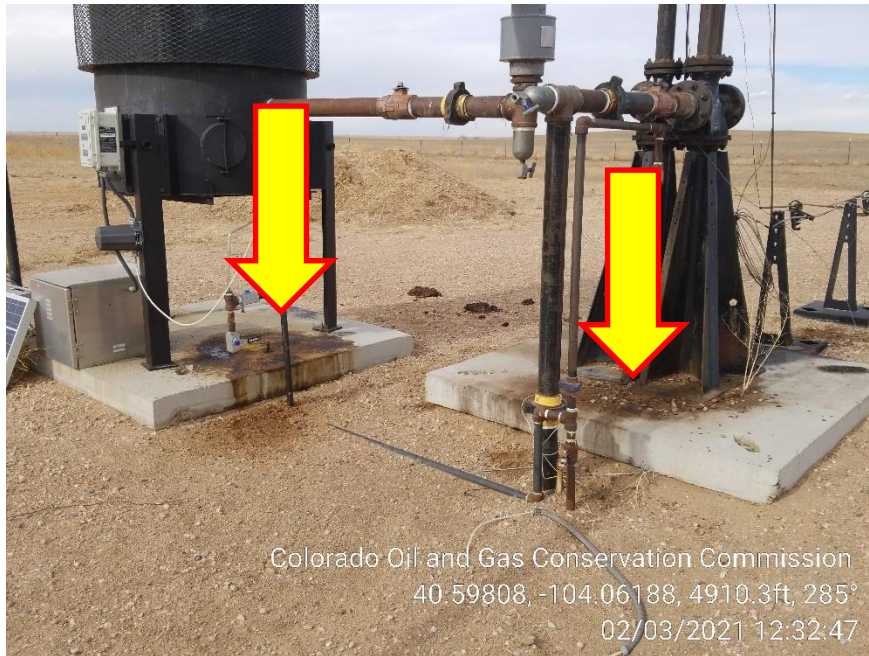
**Photo 17 – ECD and Flare – Stained Soil**

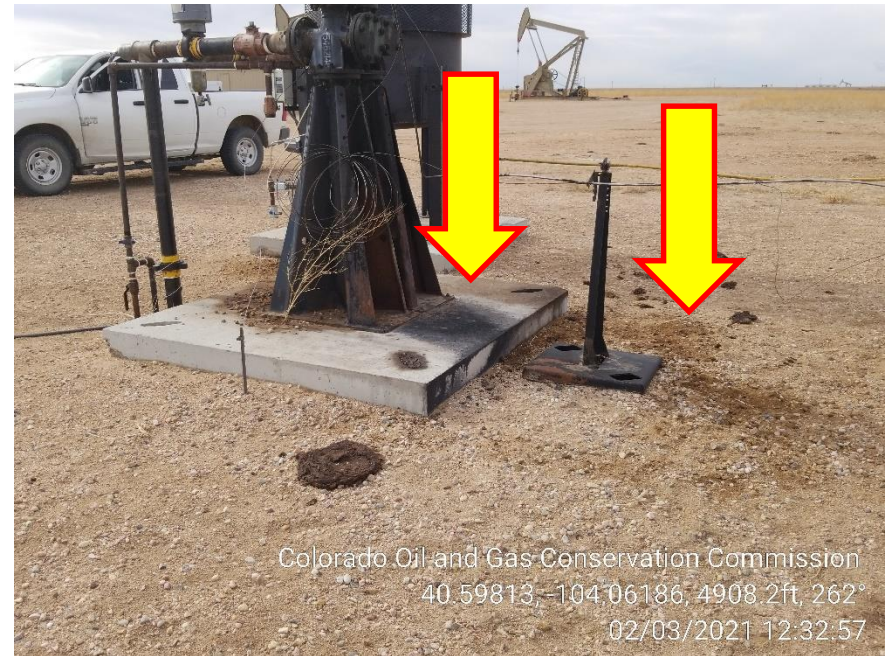
**Photo 18 – ECD and Flare – Stained Soil**

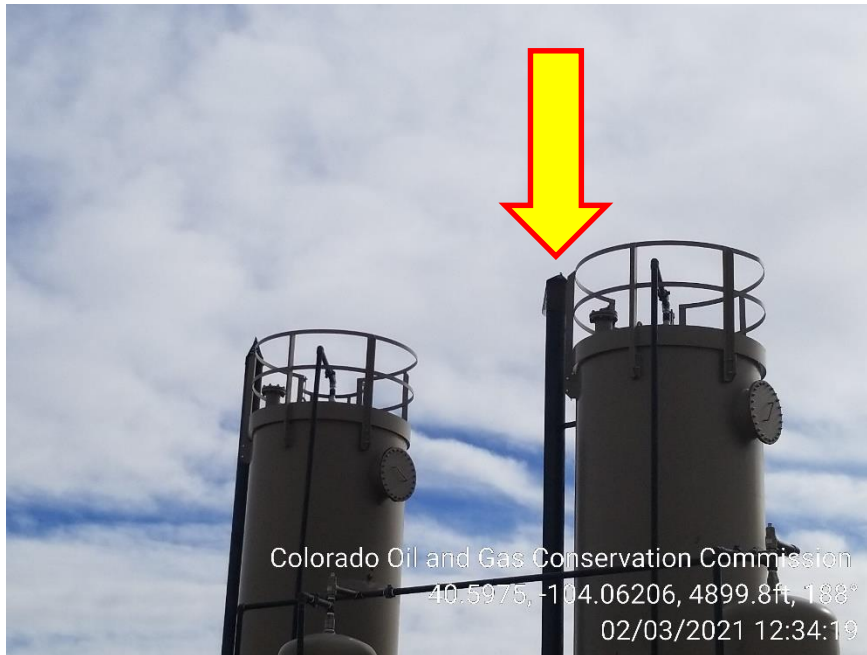
**Photo 19 – West Treater has Bird Protector Installed**

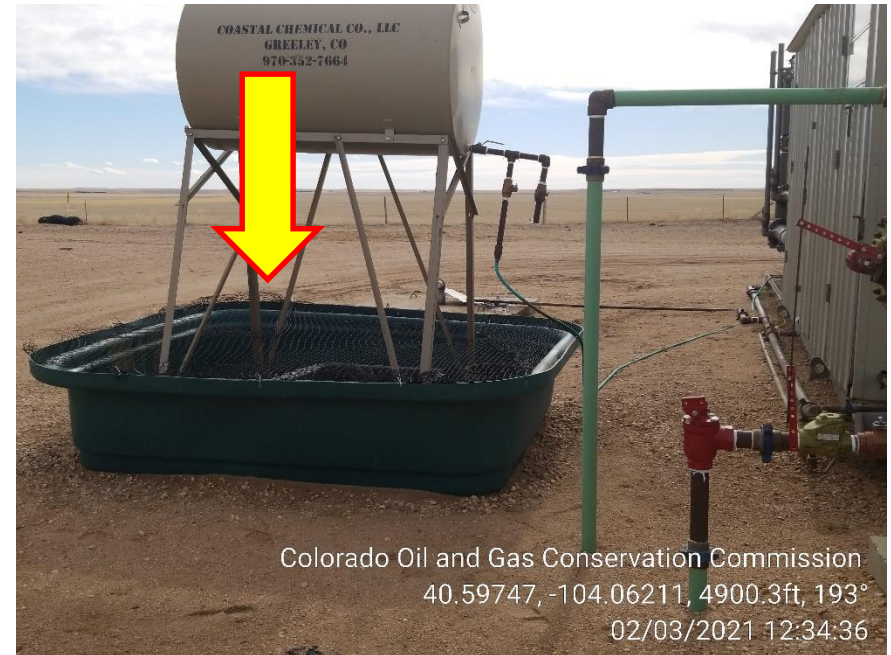
**Photo 20 – Day Tank now has Wildlife Netting Installed**

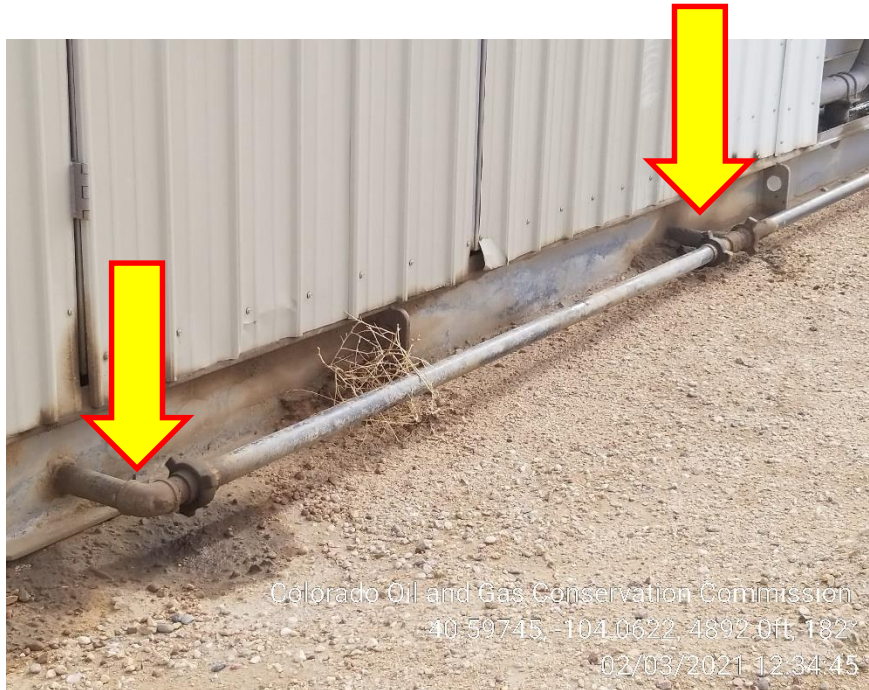
**Photo 21 – Stained Soil at Compressor Drain Line**

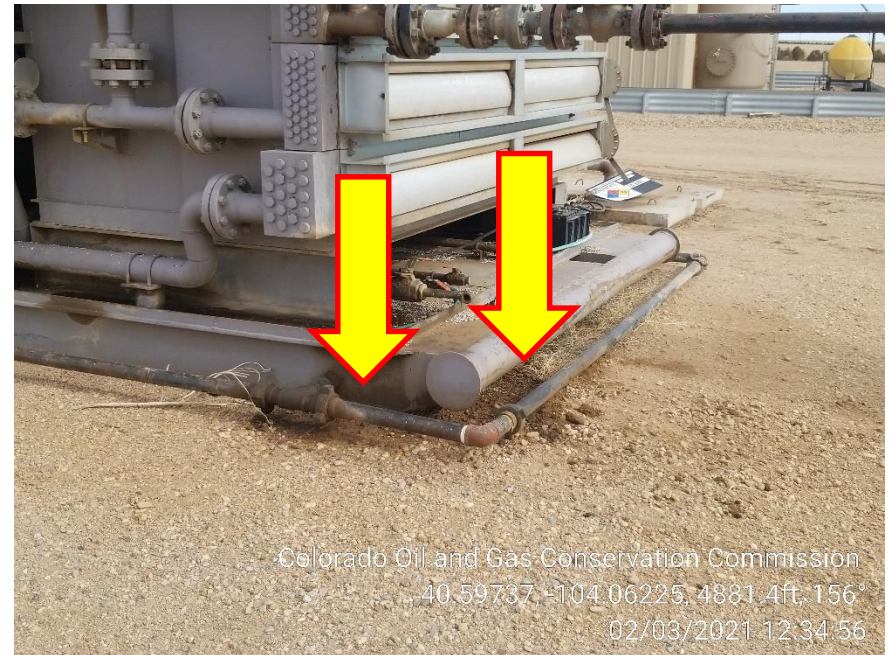
**Photo 22 – Stained Soil at Compressor Drain Line**

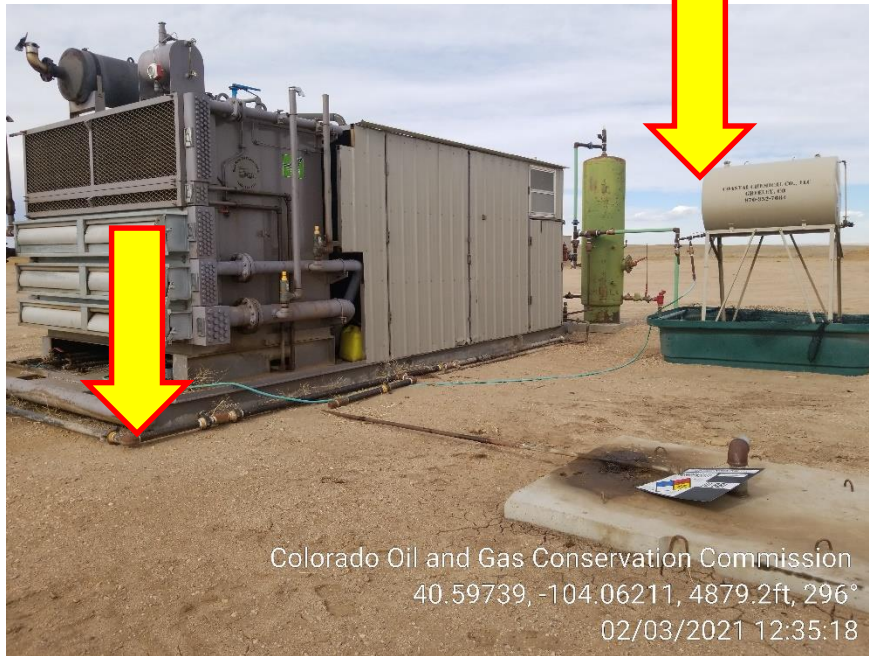
**Photo 23 – Compressor. Concrete Vault now has Signage**

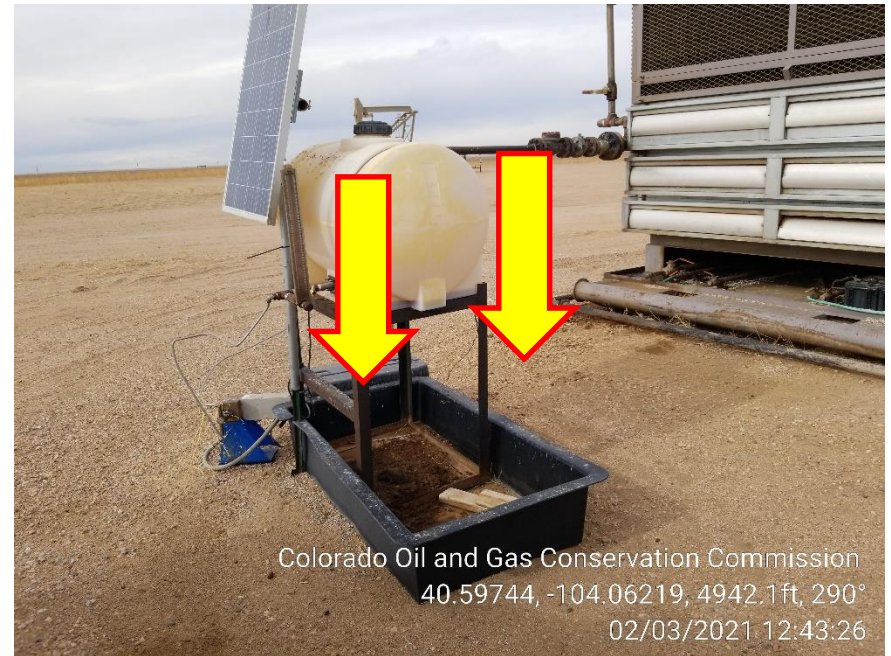
**Photo 24 – Chemical Tank at Compressor missing Wildlife netting**

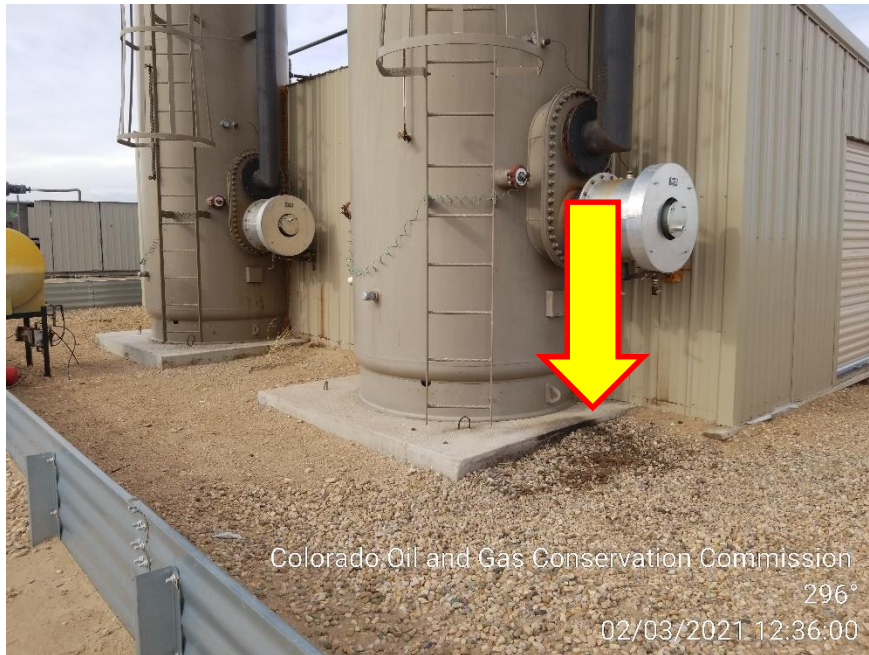
**Photo 25 – Heater Treater – Stained Soil**

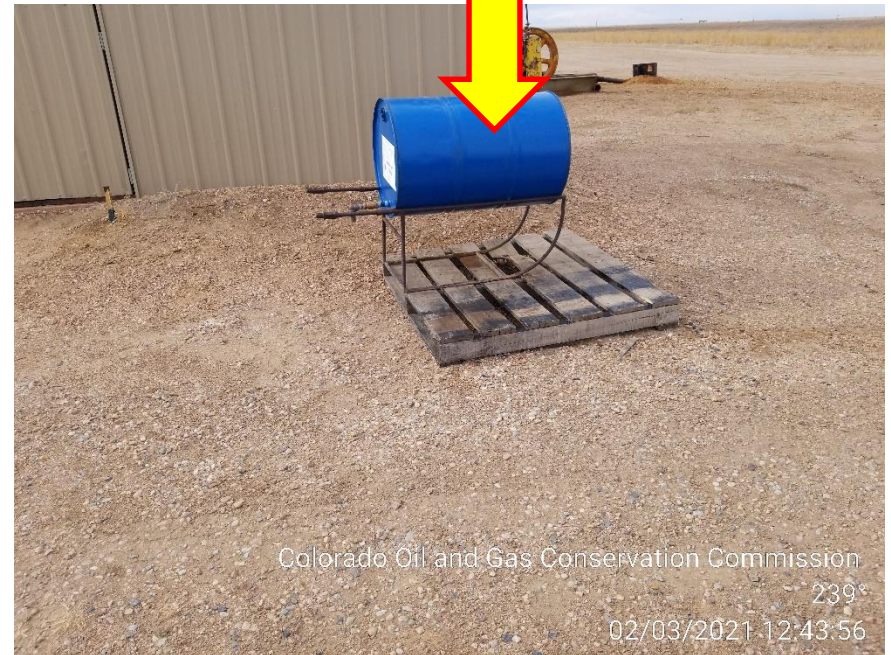
**Photo 26 – Chemical Tank at Gas Lift Meter house missing  
Secondary Containment with Wildlife netting**
