Inspection Photos

Location Name: CAERUS PICEANCE LLC M. DUTTON-68S95W /7SWSW

Location ID: 334127

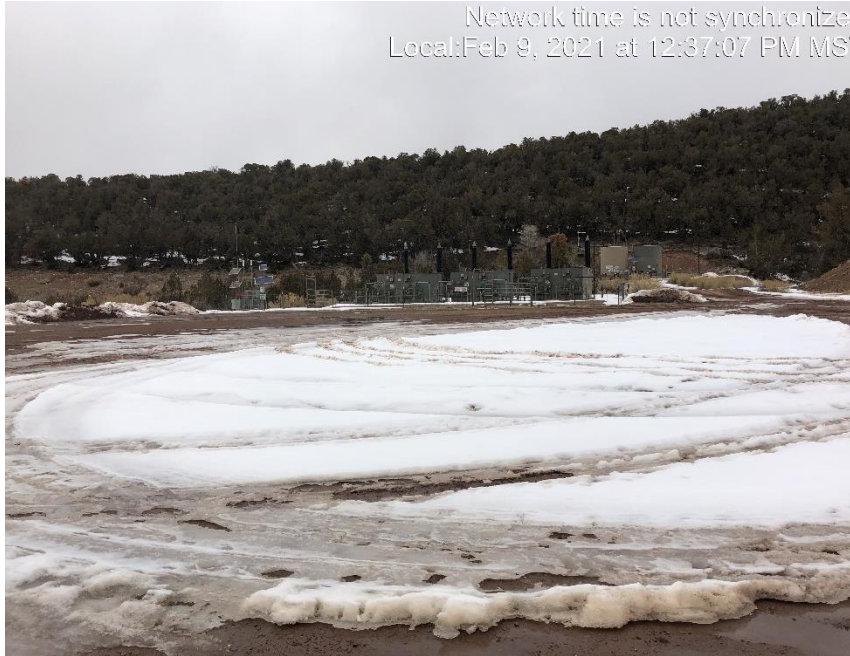
Photo #2852 from entrance to location.

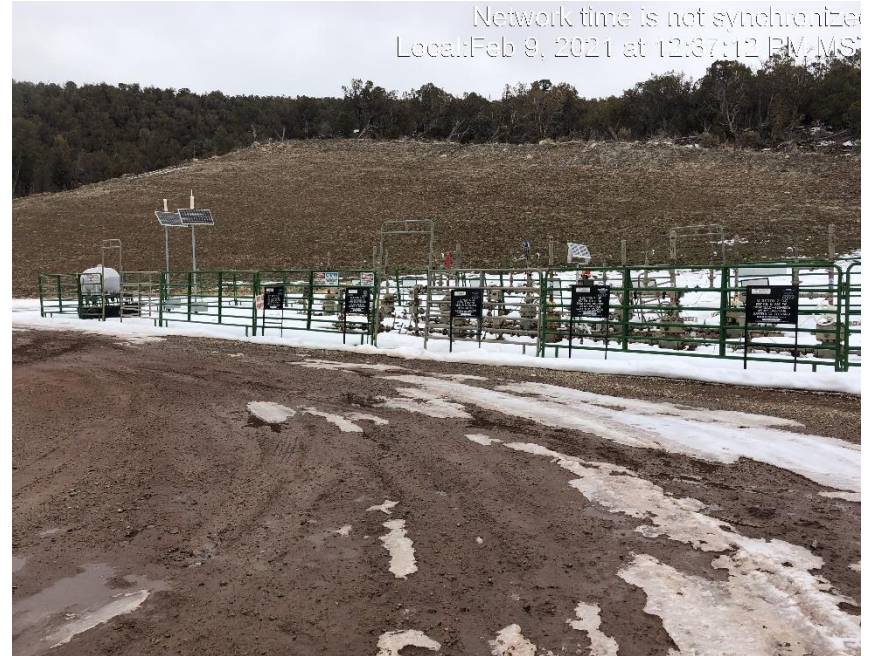
Photo #2853 from entrance to location.

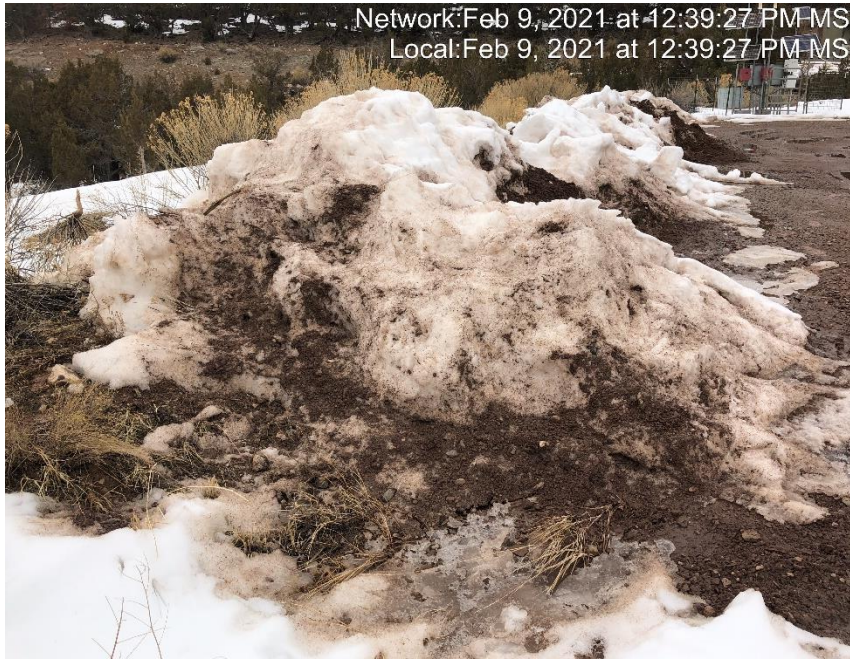
Photo #2854 Sediment has been transported off location due to plowing.

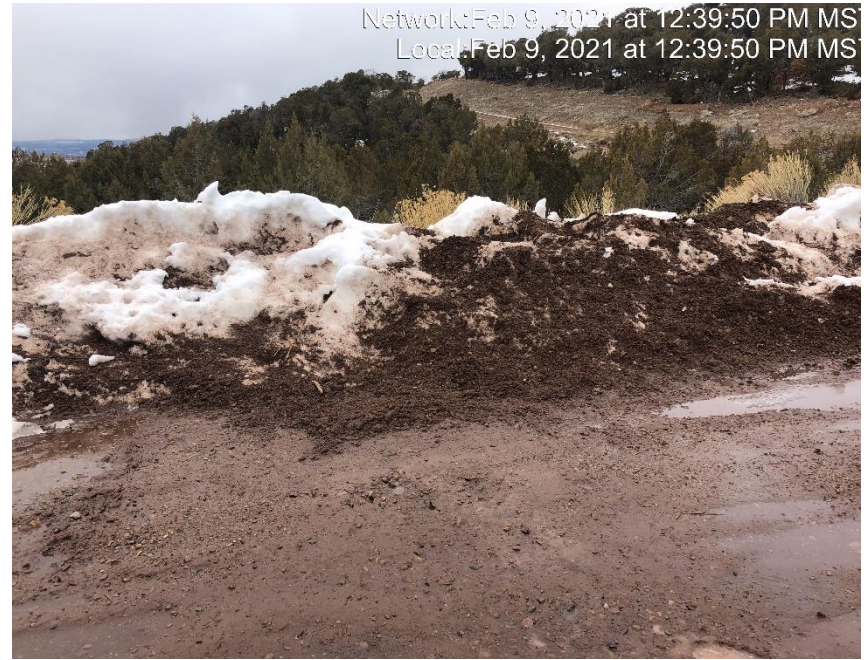
Photo #2855 Sediment has been transported off location due to plowing.

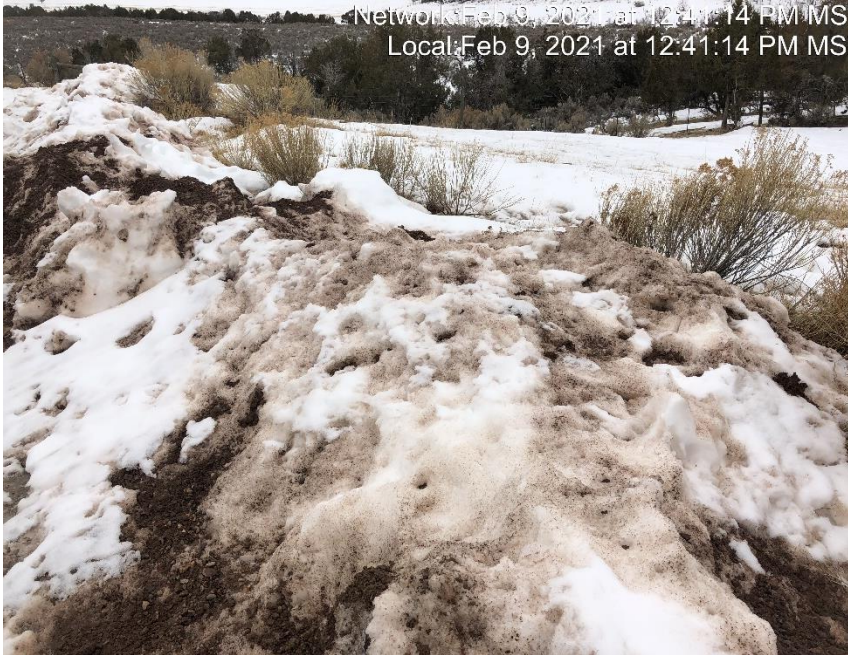
Photo #2856 Sediment has been plowed into berm and vegetation.

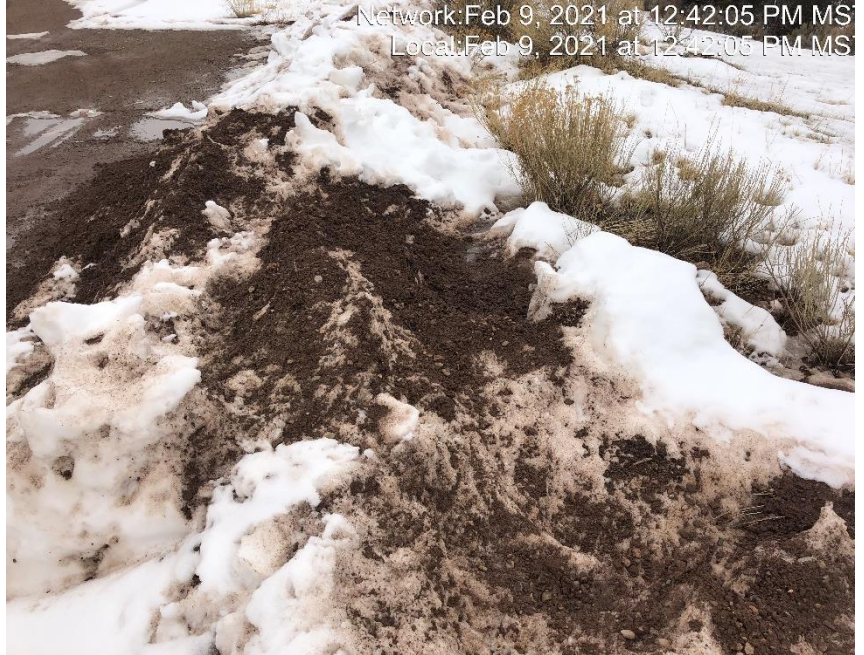
Photo #2857 Sediment has been plowed into berm and vegetation.

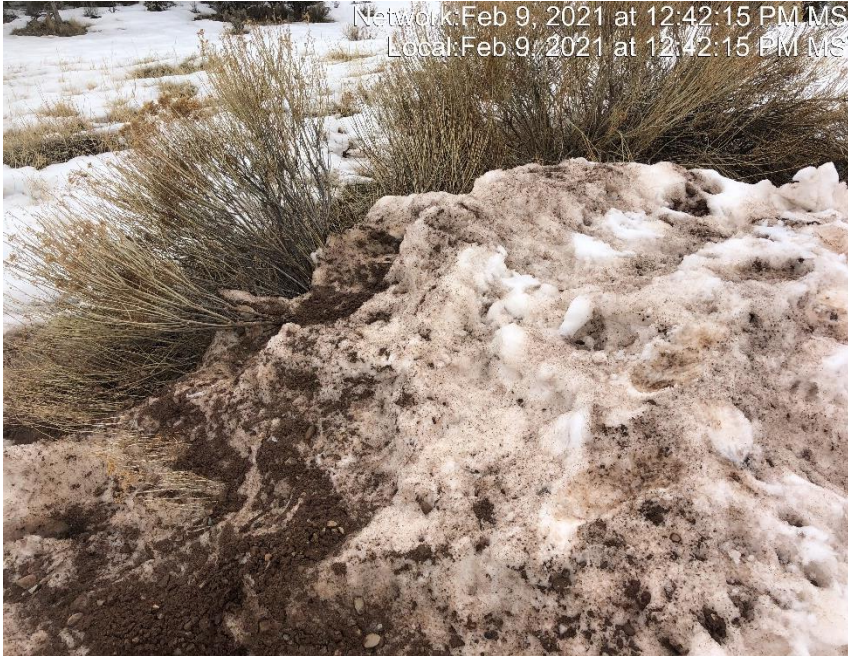
Photo #2858 Sediment has been plowed into berm and vegetation.
