**TEP ROCKY MOUNTAIN LLC
AMERICAN SODA-67S96W 2SWSE
Location ID: 334932**

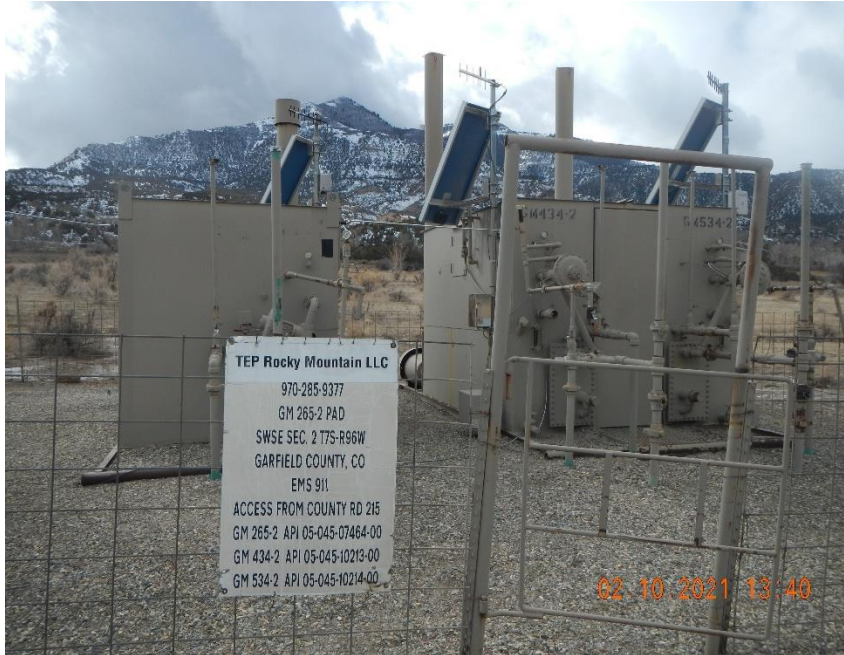
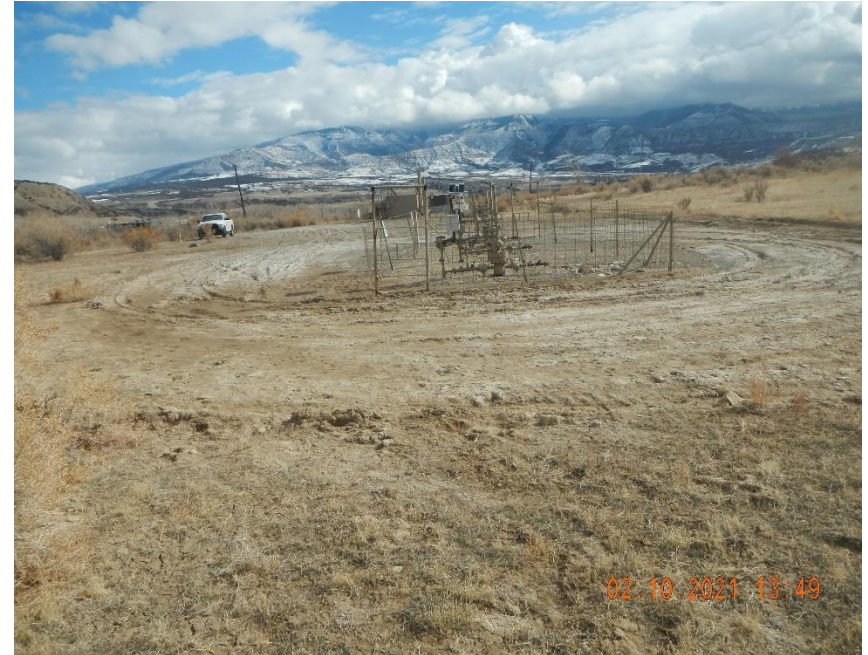
**Location shows signs of lack of stabilization
BMP's in some areas (rutting is present).**

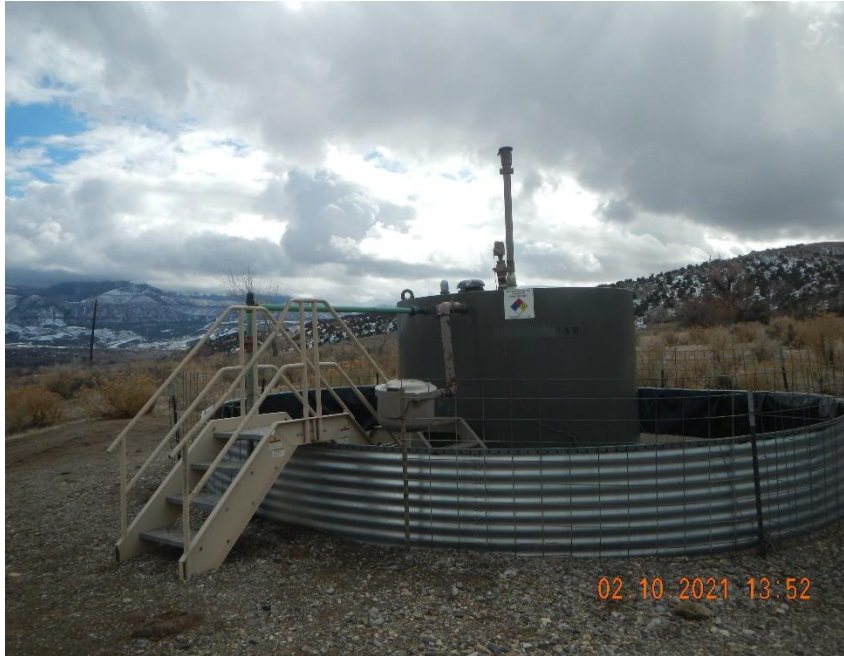
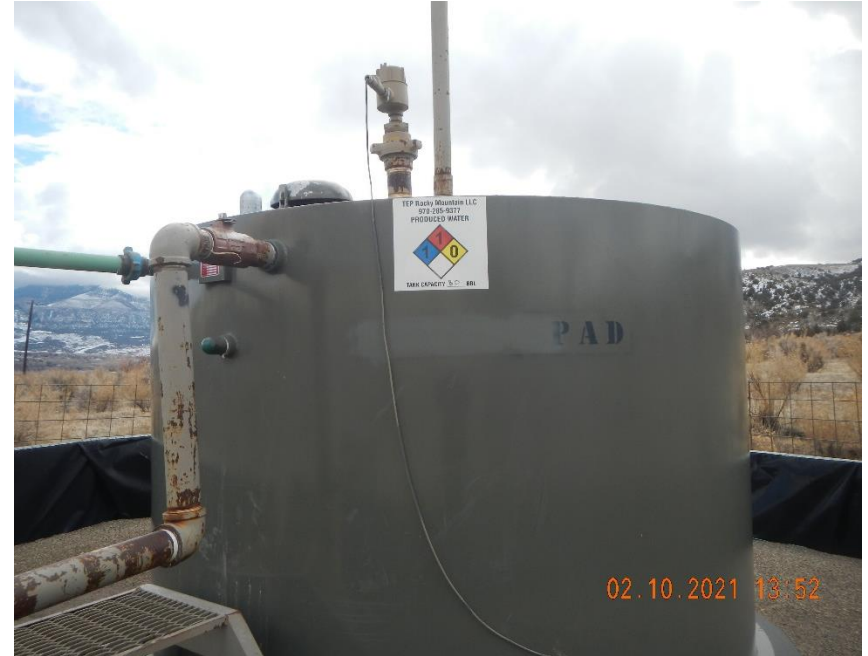
Capacity fill in on tank label.

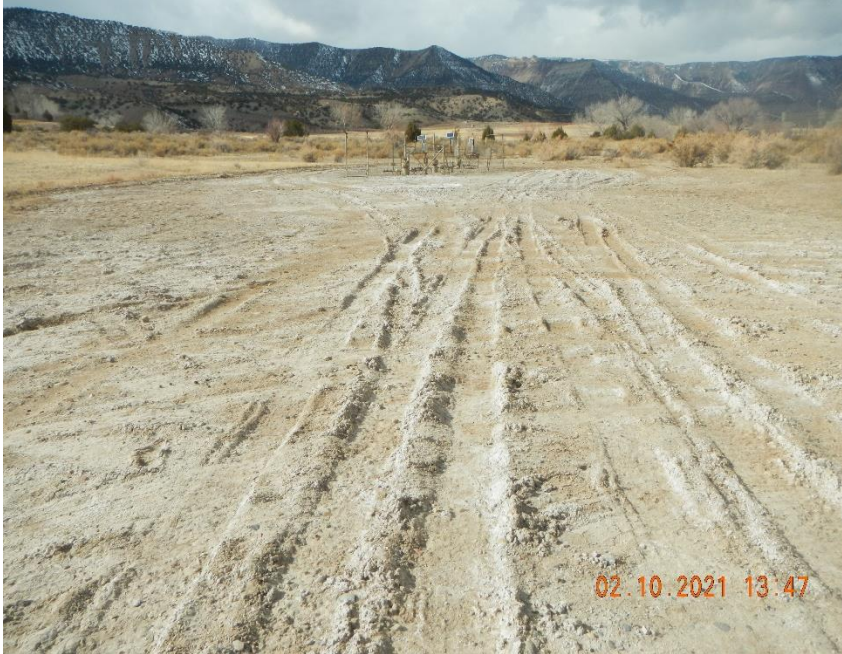
**Location shows signs of lack of stabilization
BMP's in some areas (rutting is present).**

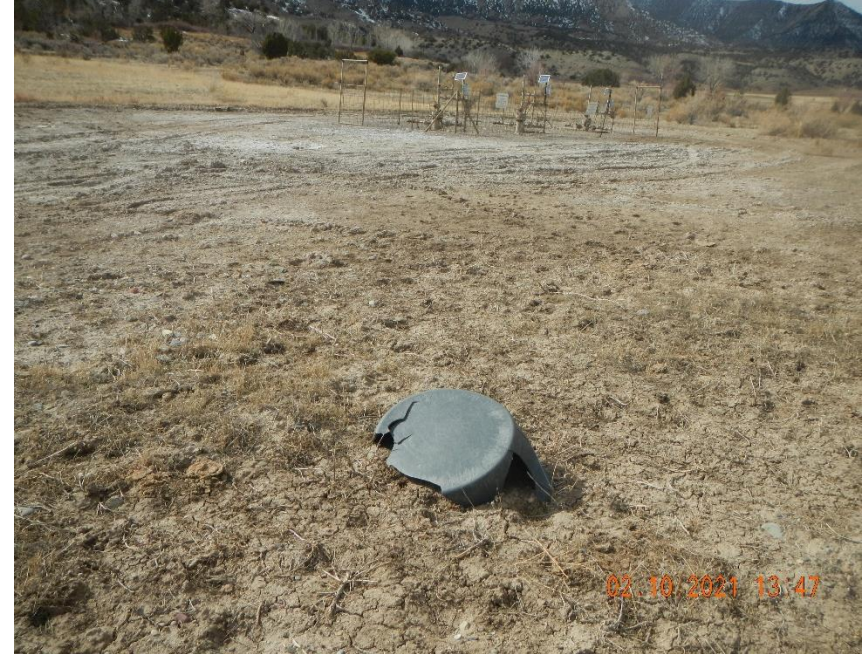
Debris on location

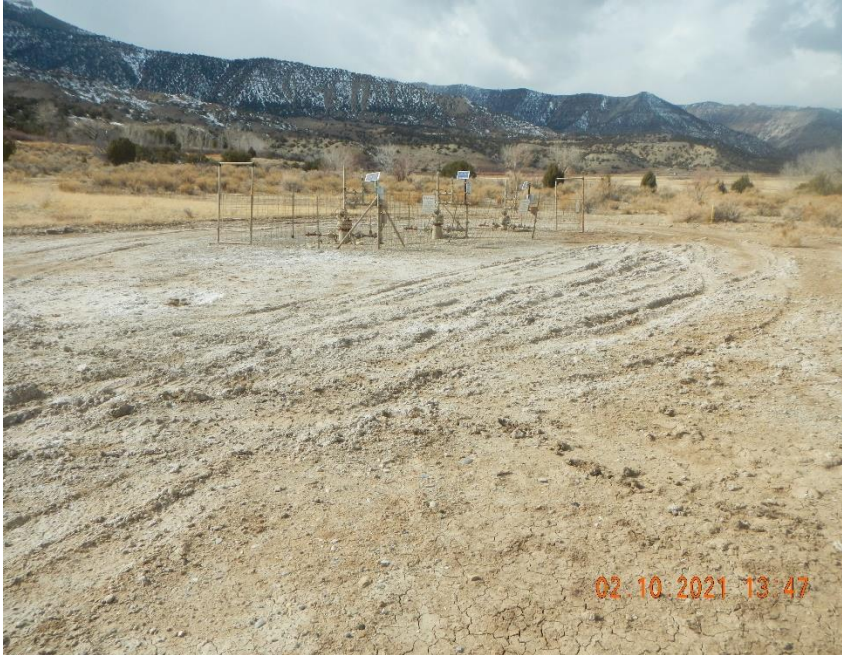
**Location shows signs of lack of stabilization
BMP's in some areas (rutting is present).**

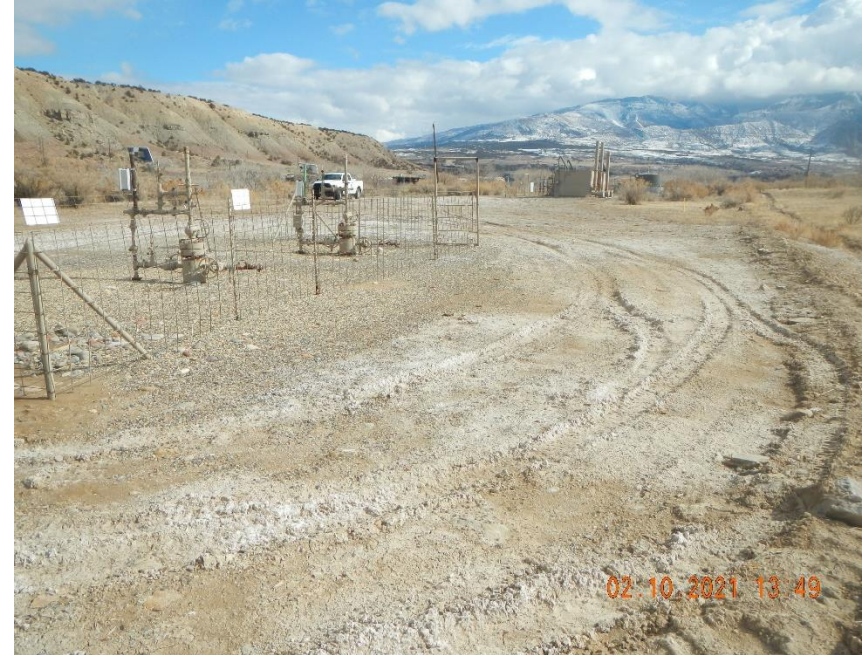
**Location shows signs of lack of stabilization
BMP's in some areas (rutting is present).**

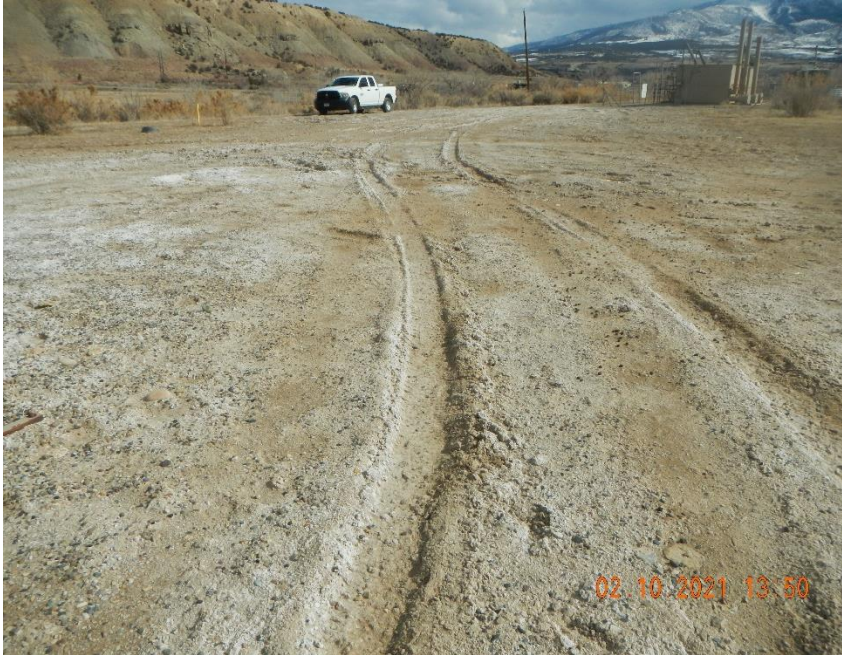
**Location shows signs of lack of stabilization
BMP's in some areas (rutting is present).**

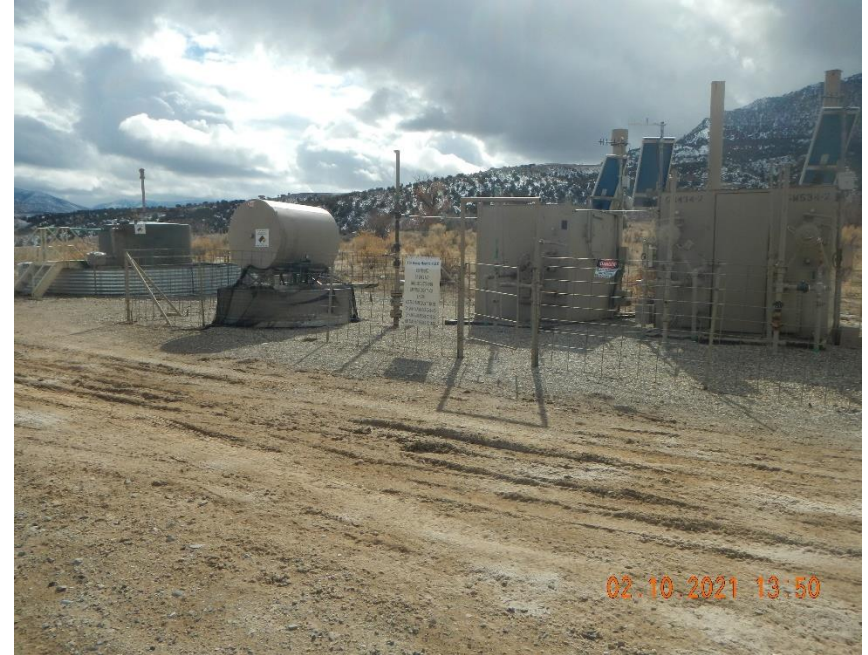
**Location shows signs of lack of stabilization
BMP's in some areas (rutting is present).**

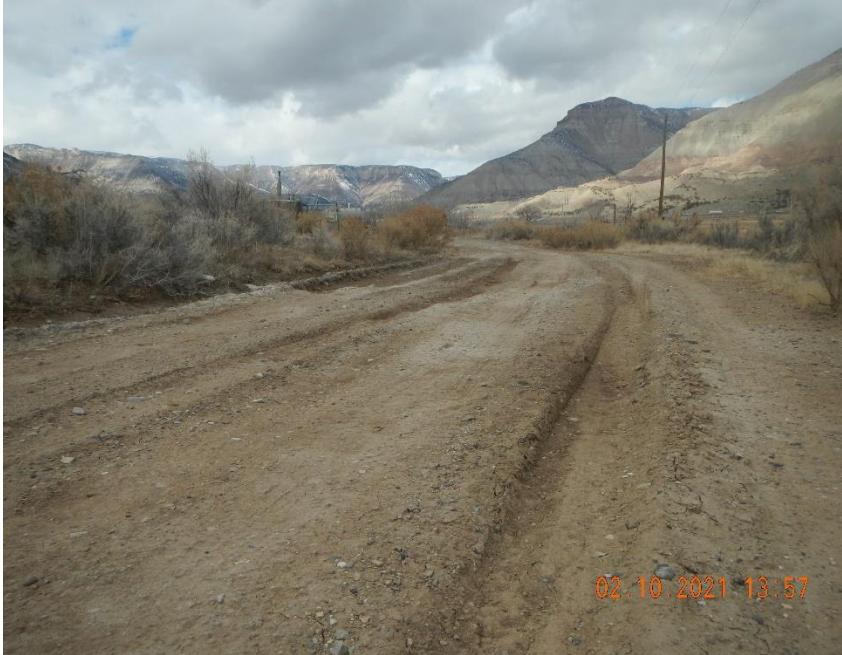
**Access road shows signs of lack of stabilization
BMP's in some areas (rutting is present).**

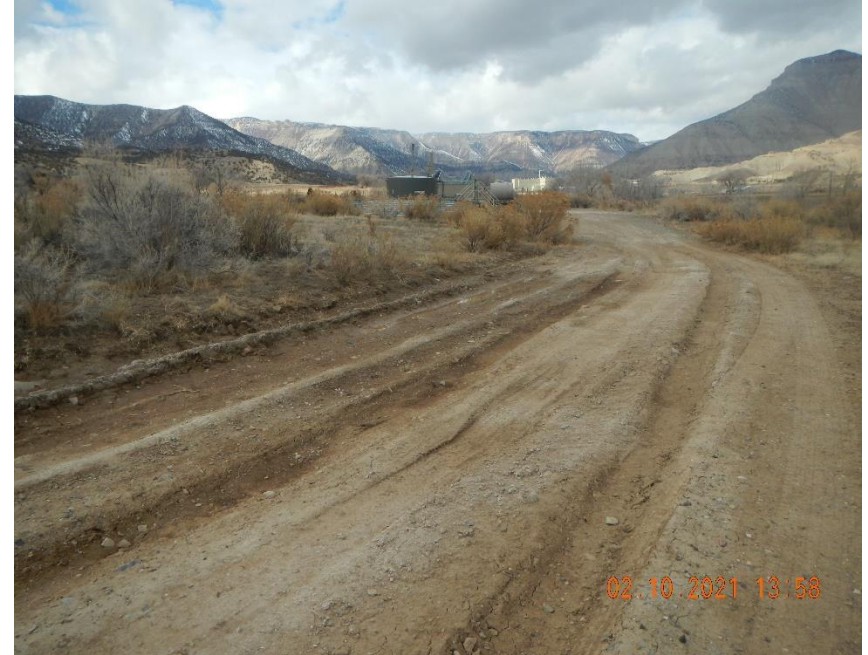
**Access road shows signs of lack of stabilization
BMP's in some areas (rutting is present).**
