**Api # : 007-06246**

**Inspection Photos**  
**Location Name: Conley 7**  
**API #: 007-06246**

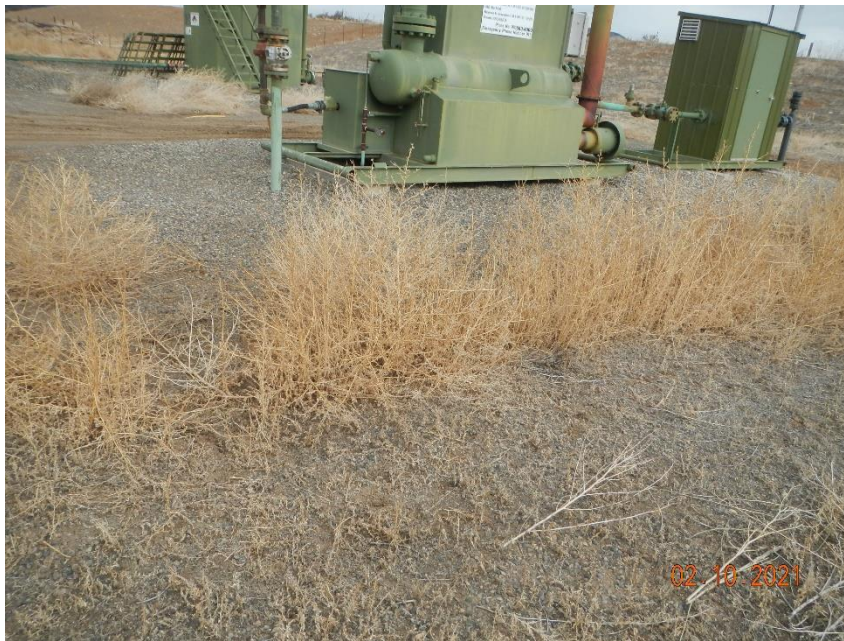
**Combustible material (dead/dry weeds) within 25 feet of fired equipment**

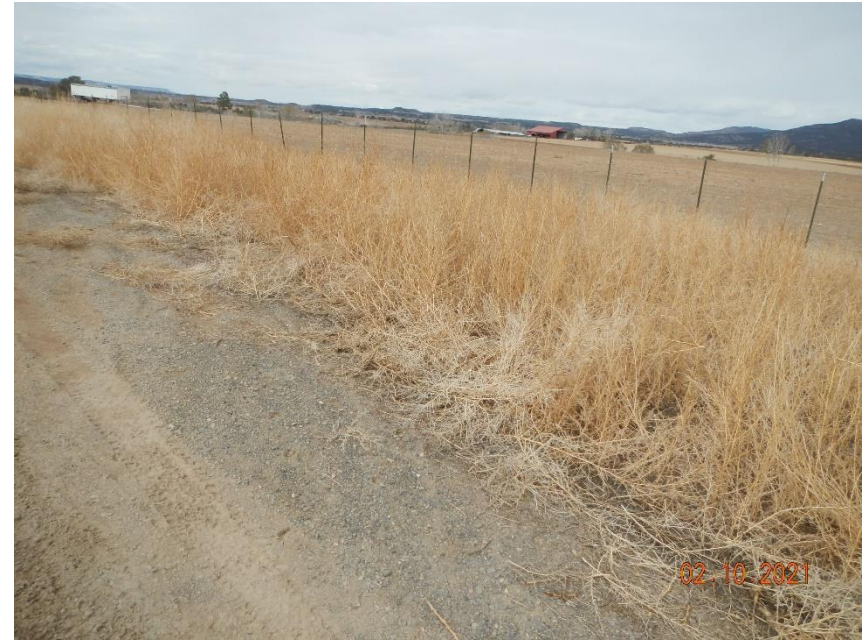
**Reclamation area appears to predominantly weeds and undesirable vegetation**

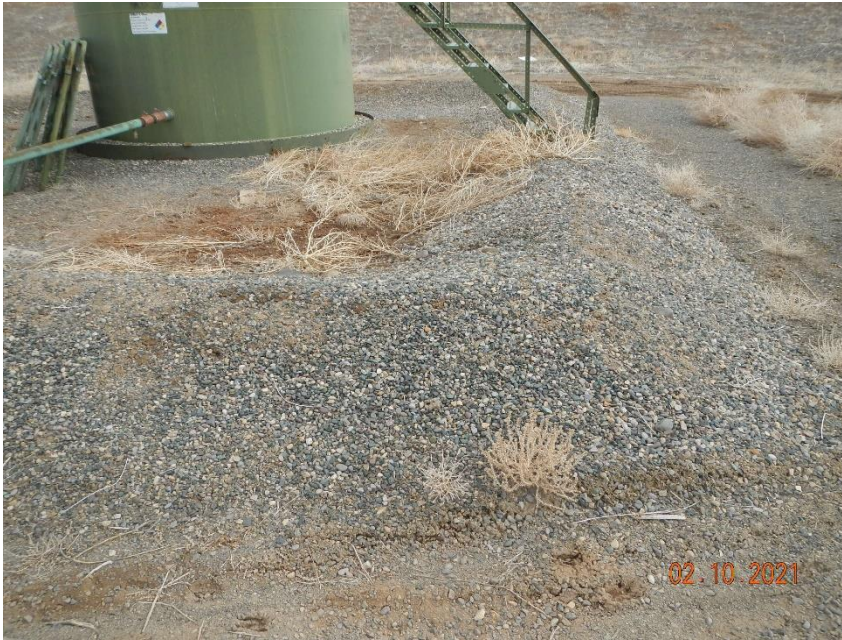
**Weeds inside secondary containment**

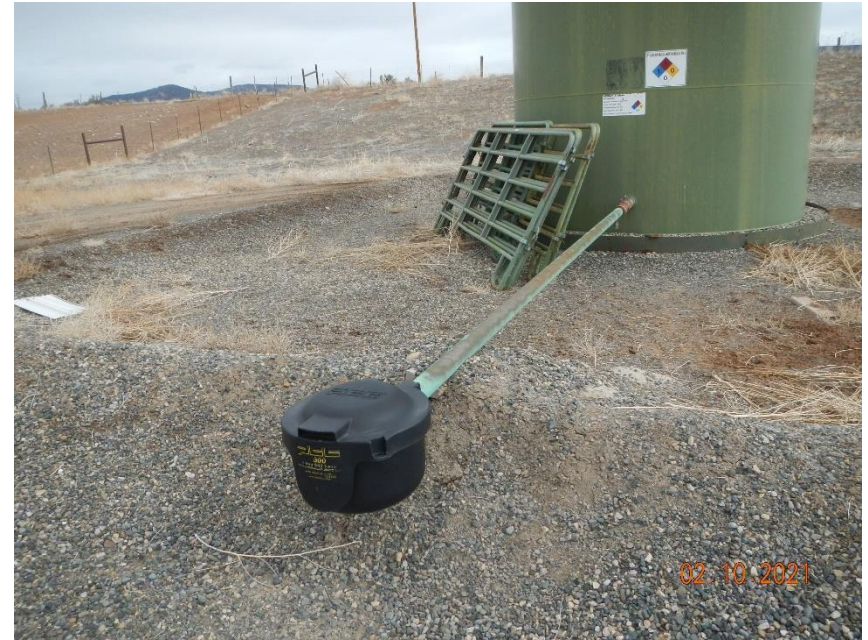
**Storage of materials inside secondary containment, trash**

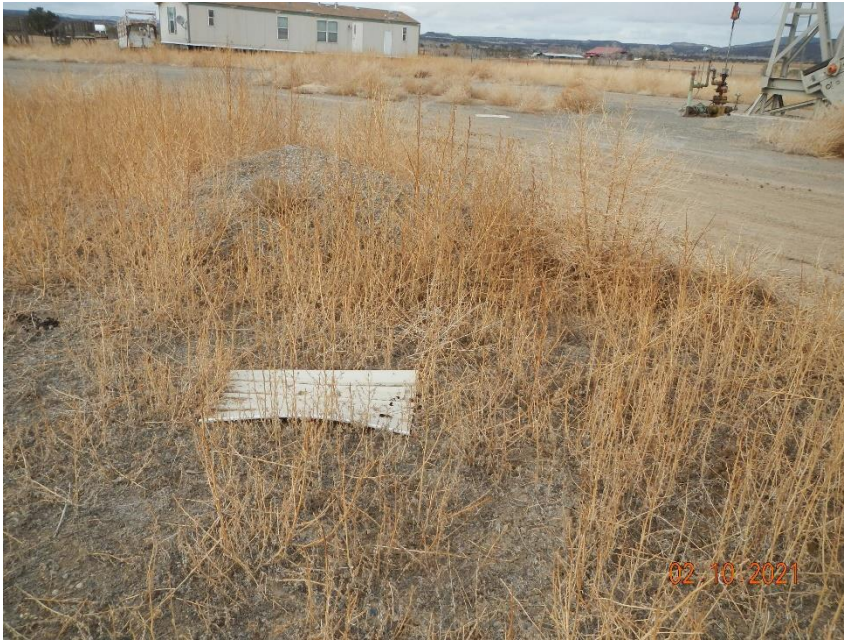
**Weed/undesirable vegetation in reclamation area and trash/debris**

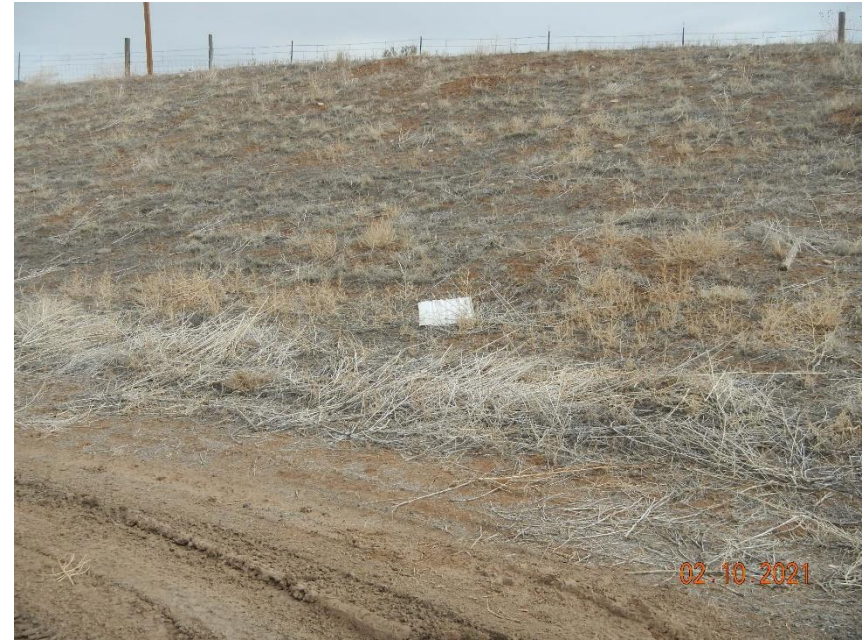
**Trash/debris**

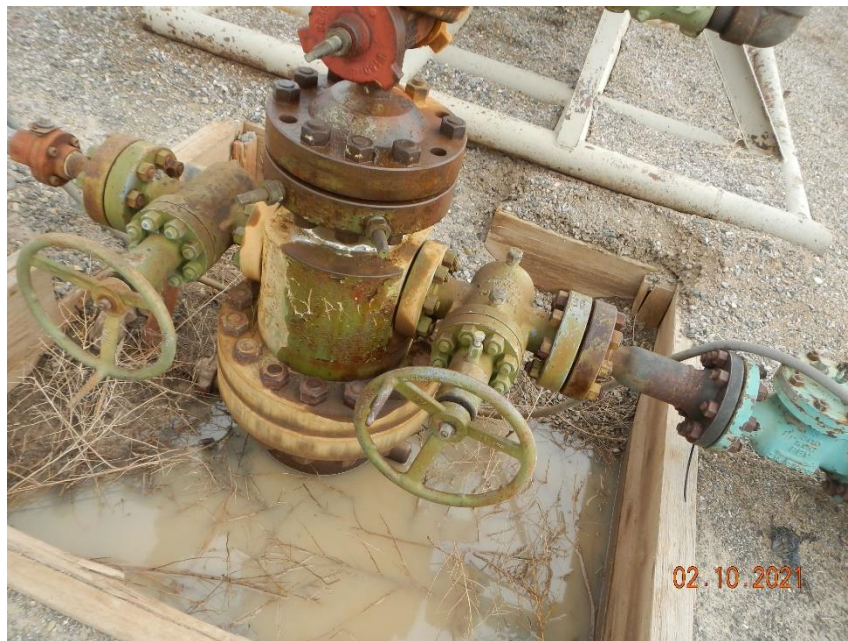
**Stuffing box leak and over oiling rod oiler**

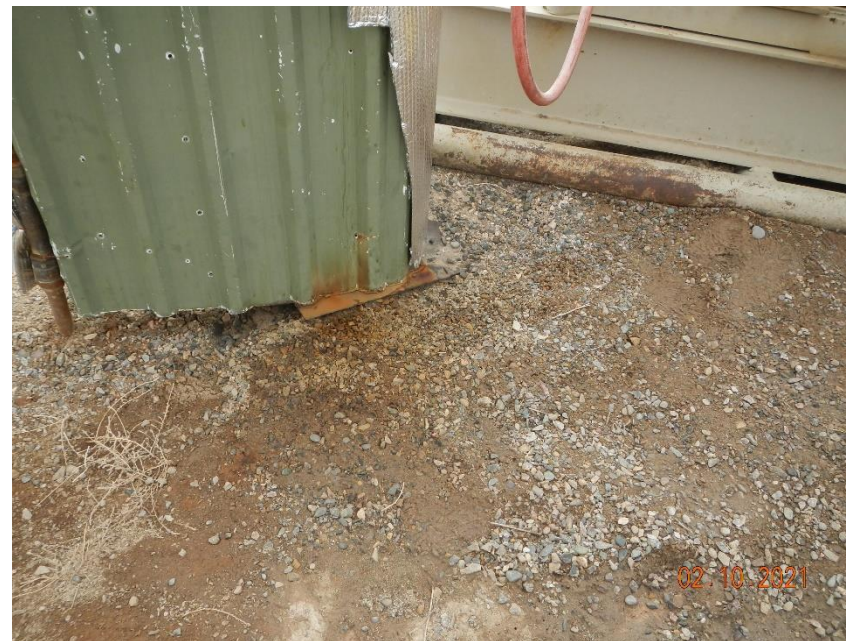
**Oil leak/exhaust staining**
