Grizzly Operating Miller 5-36 Location # 334962

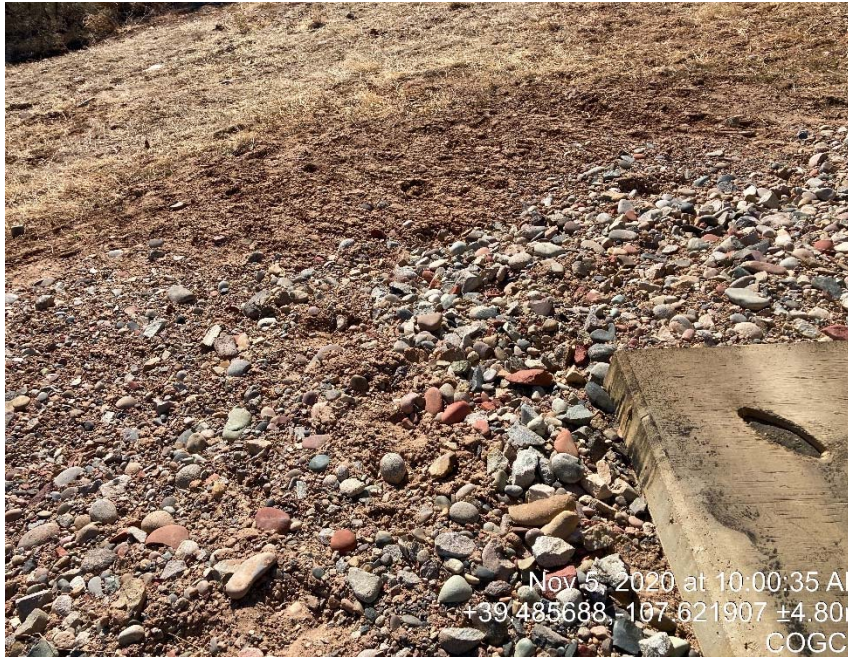
**Sediment migration/erosion under combustor
(photo from previous inspection)**

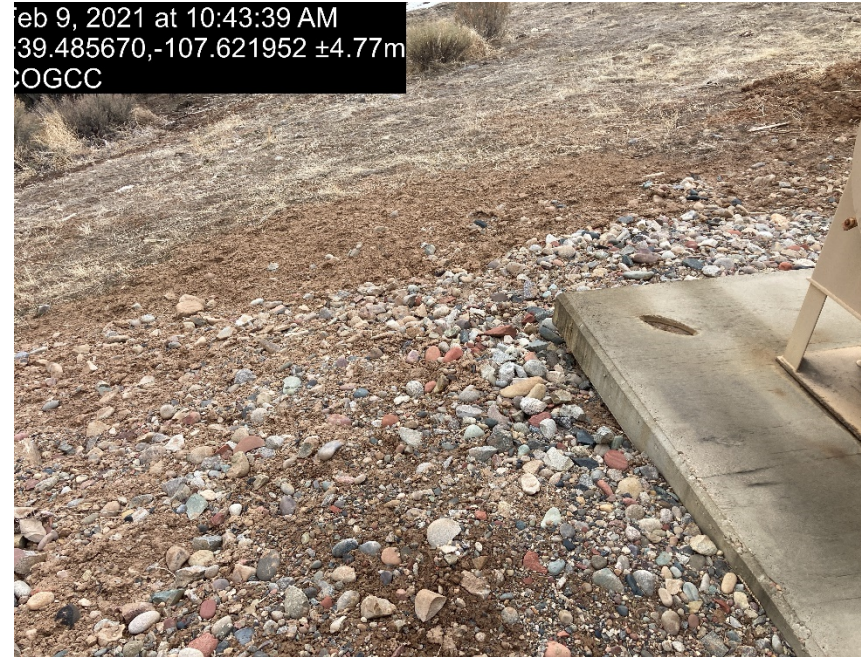
**Sediment migration/erosion under combustor
(photo from follow up inspection)**

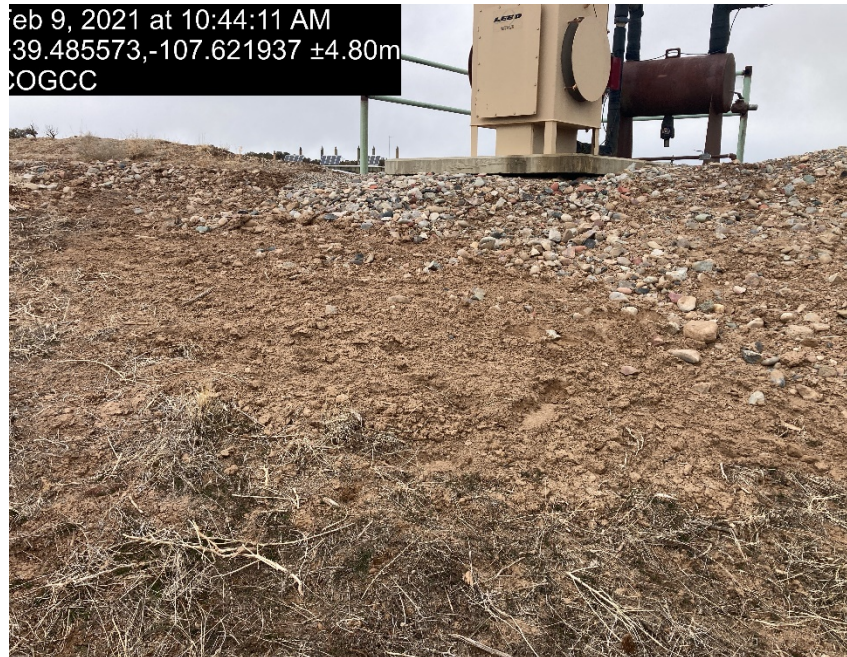
**Sediment migration/erosion under combustor
(photo from follow up inspection)**

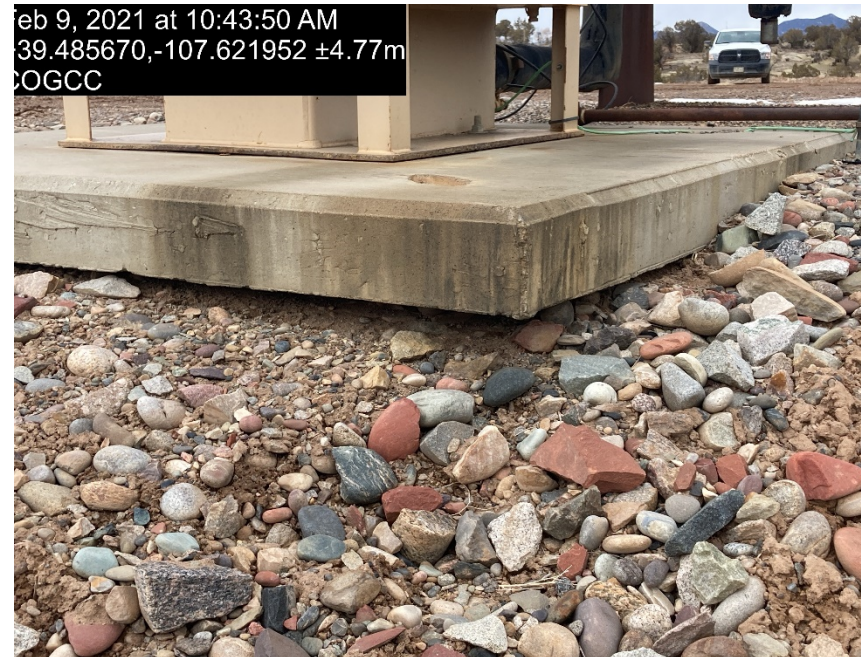
**Sediment migration/erosion under combustor
(photo from follow up inspection)**

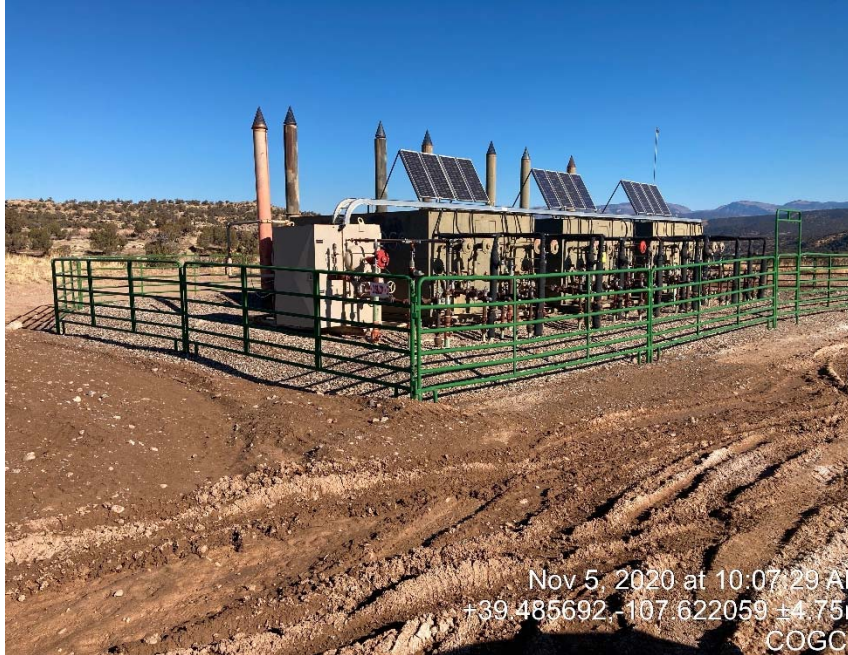
Location/ Lack of stabilization

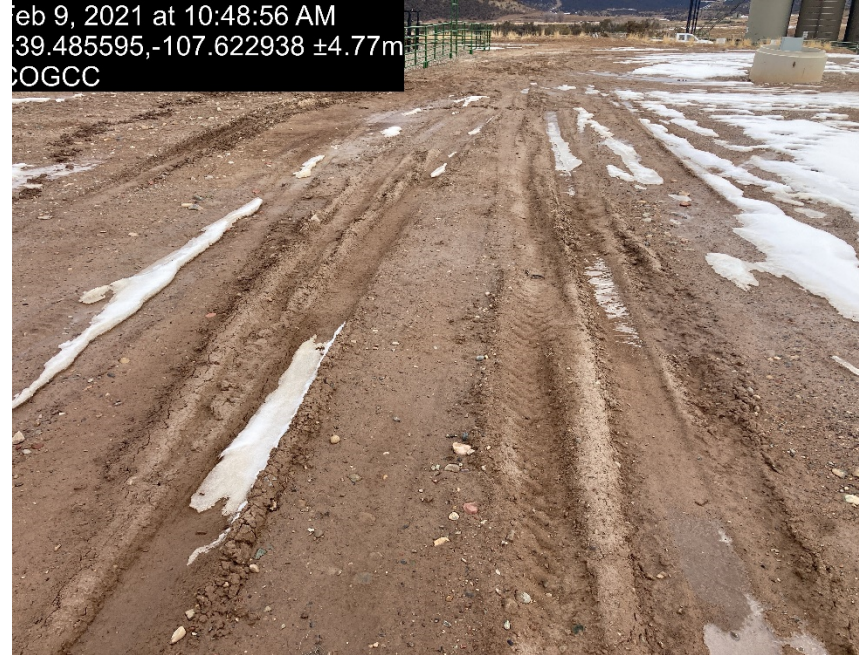
Lack of stabilization

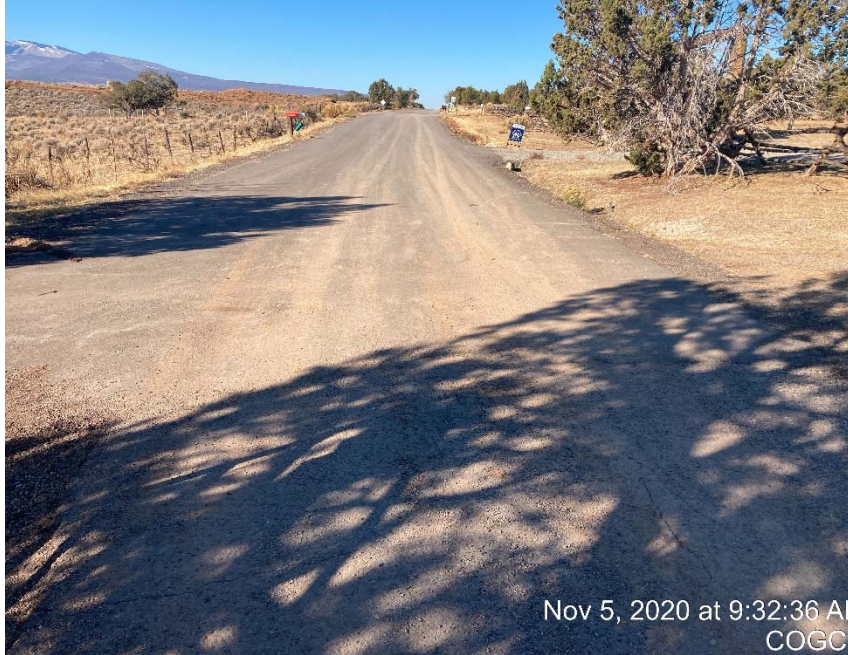
Photo from previous inspection of tracking

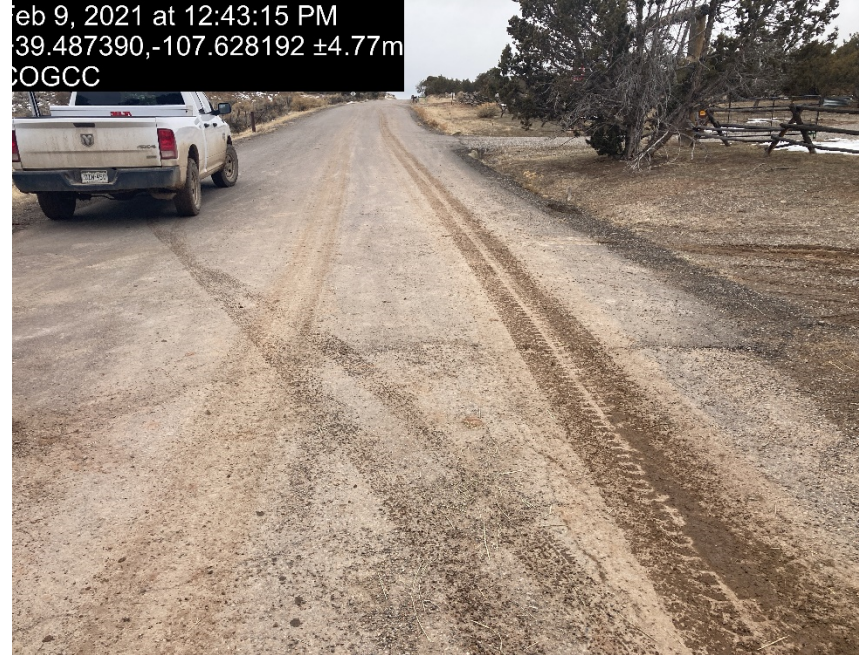
Photo from follow up inspection of tracking (chemical truck had just left access road before myself)
