**COLORADO**  
Oil & Gas Conservation  
Commission  
Department of Natural Resources

**C&K 1-6      API: 05-103-07880**  
**Inspection: 700405353**

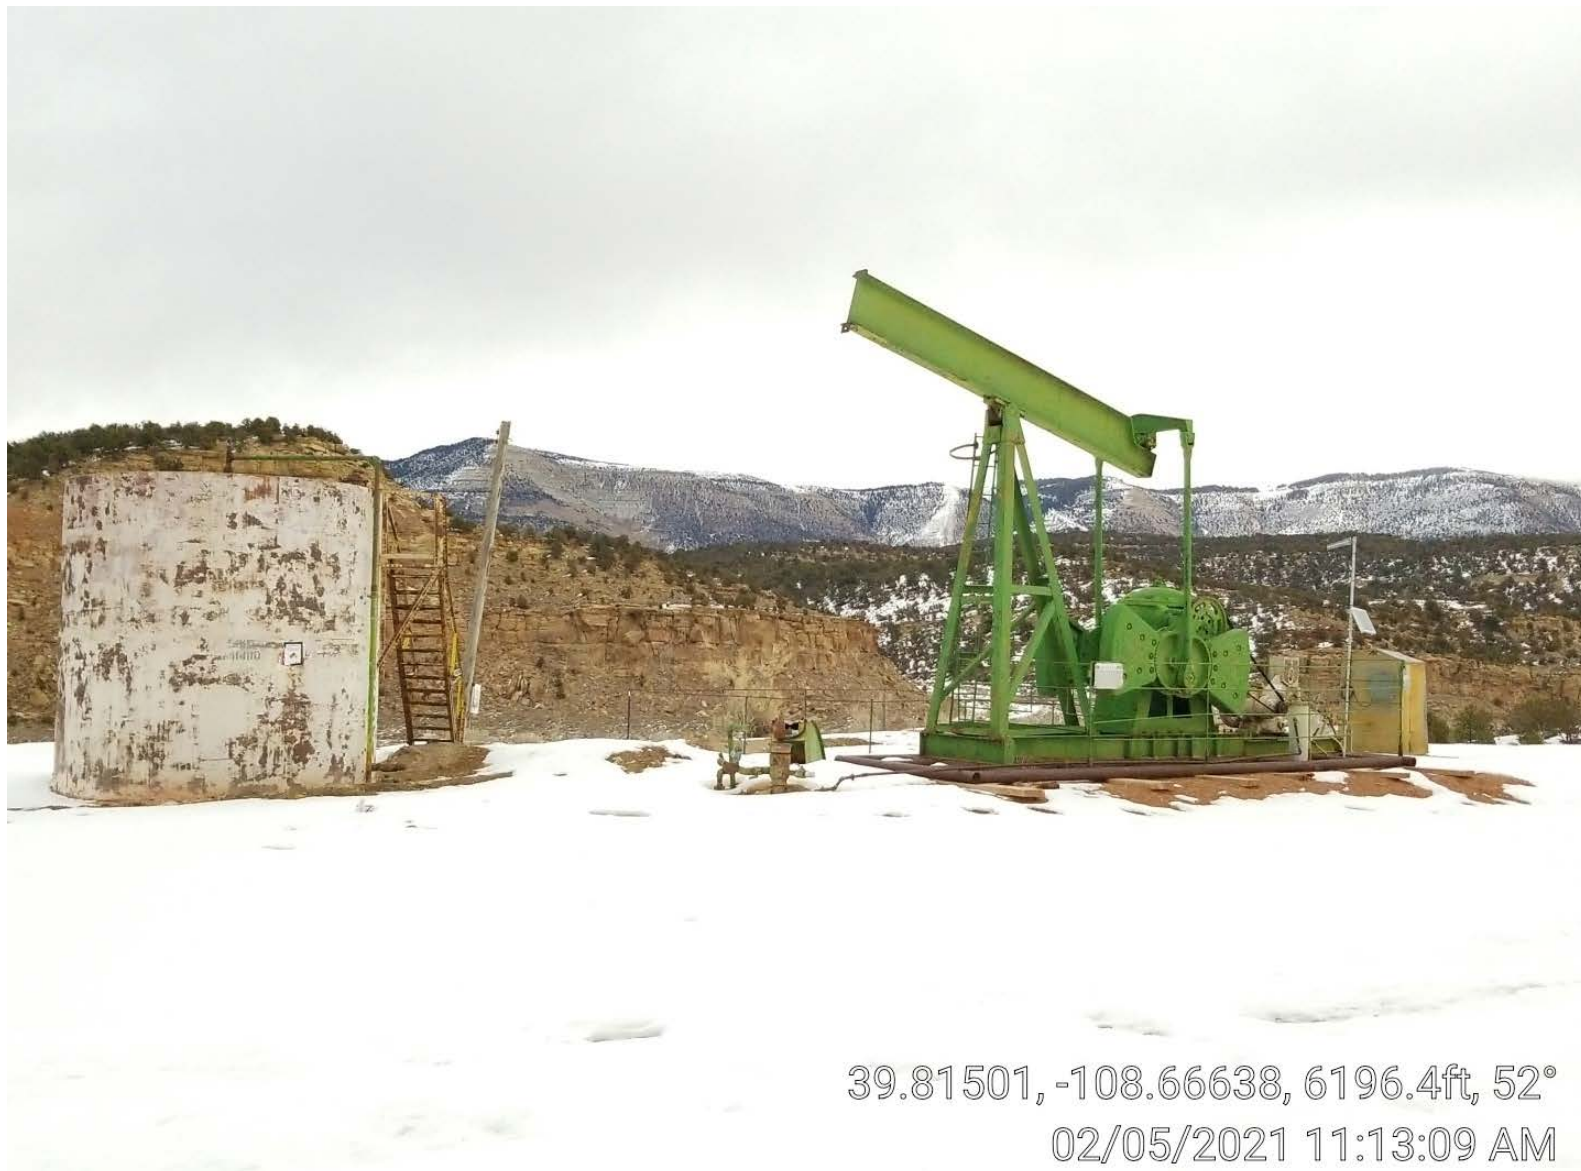
**Photo 1. Location.**

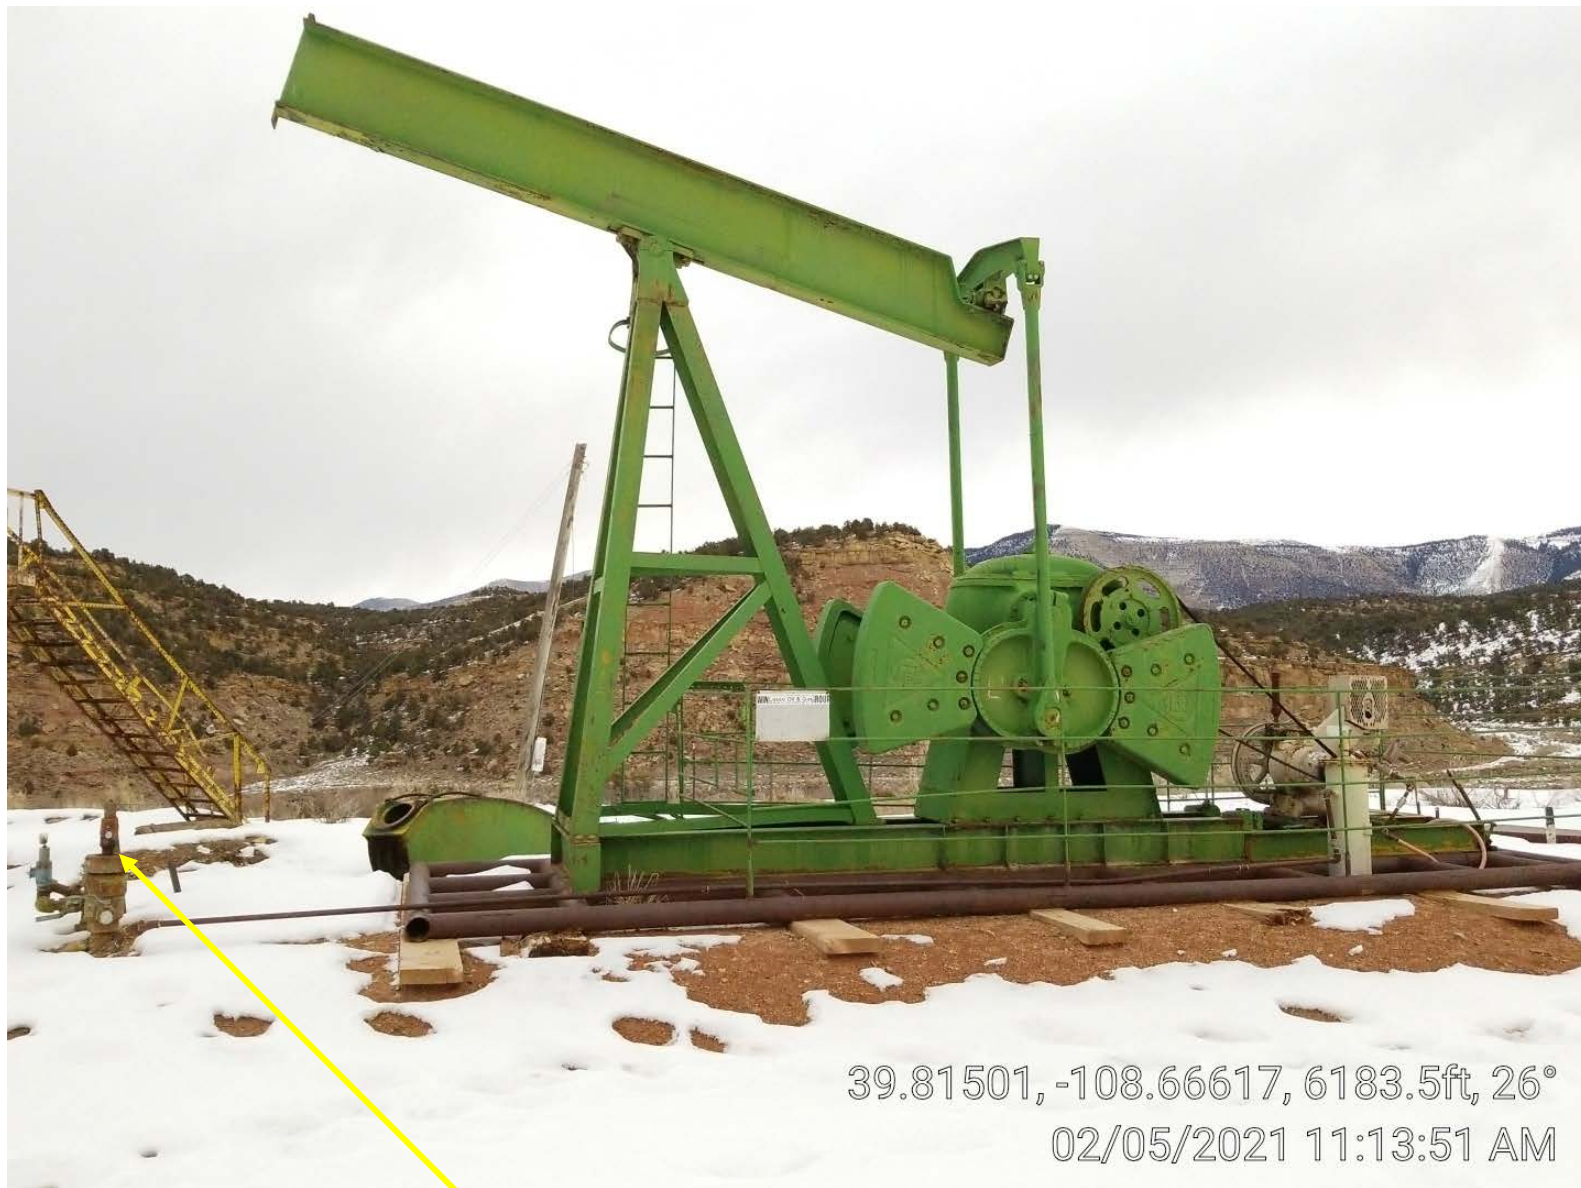
**Photo 2. Pump jack gas leak.**

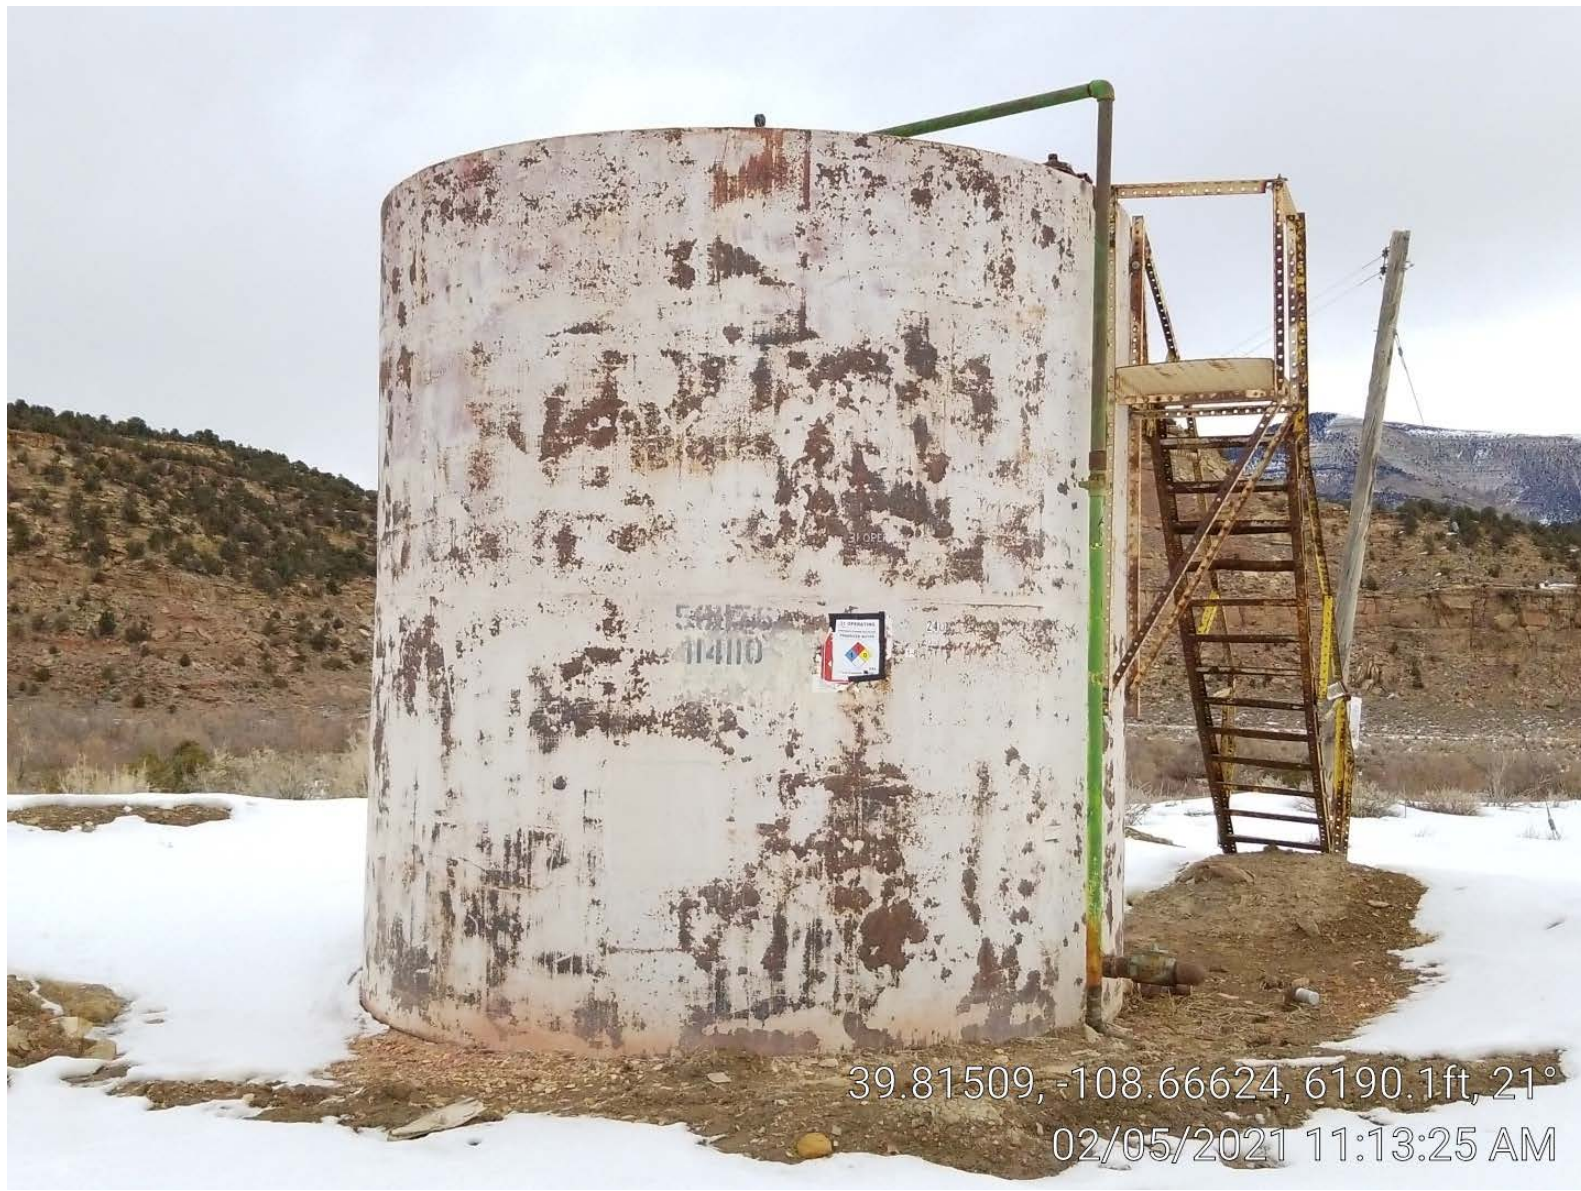
**Photo 4. Tank.**

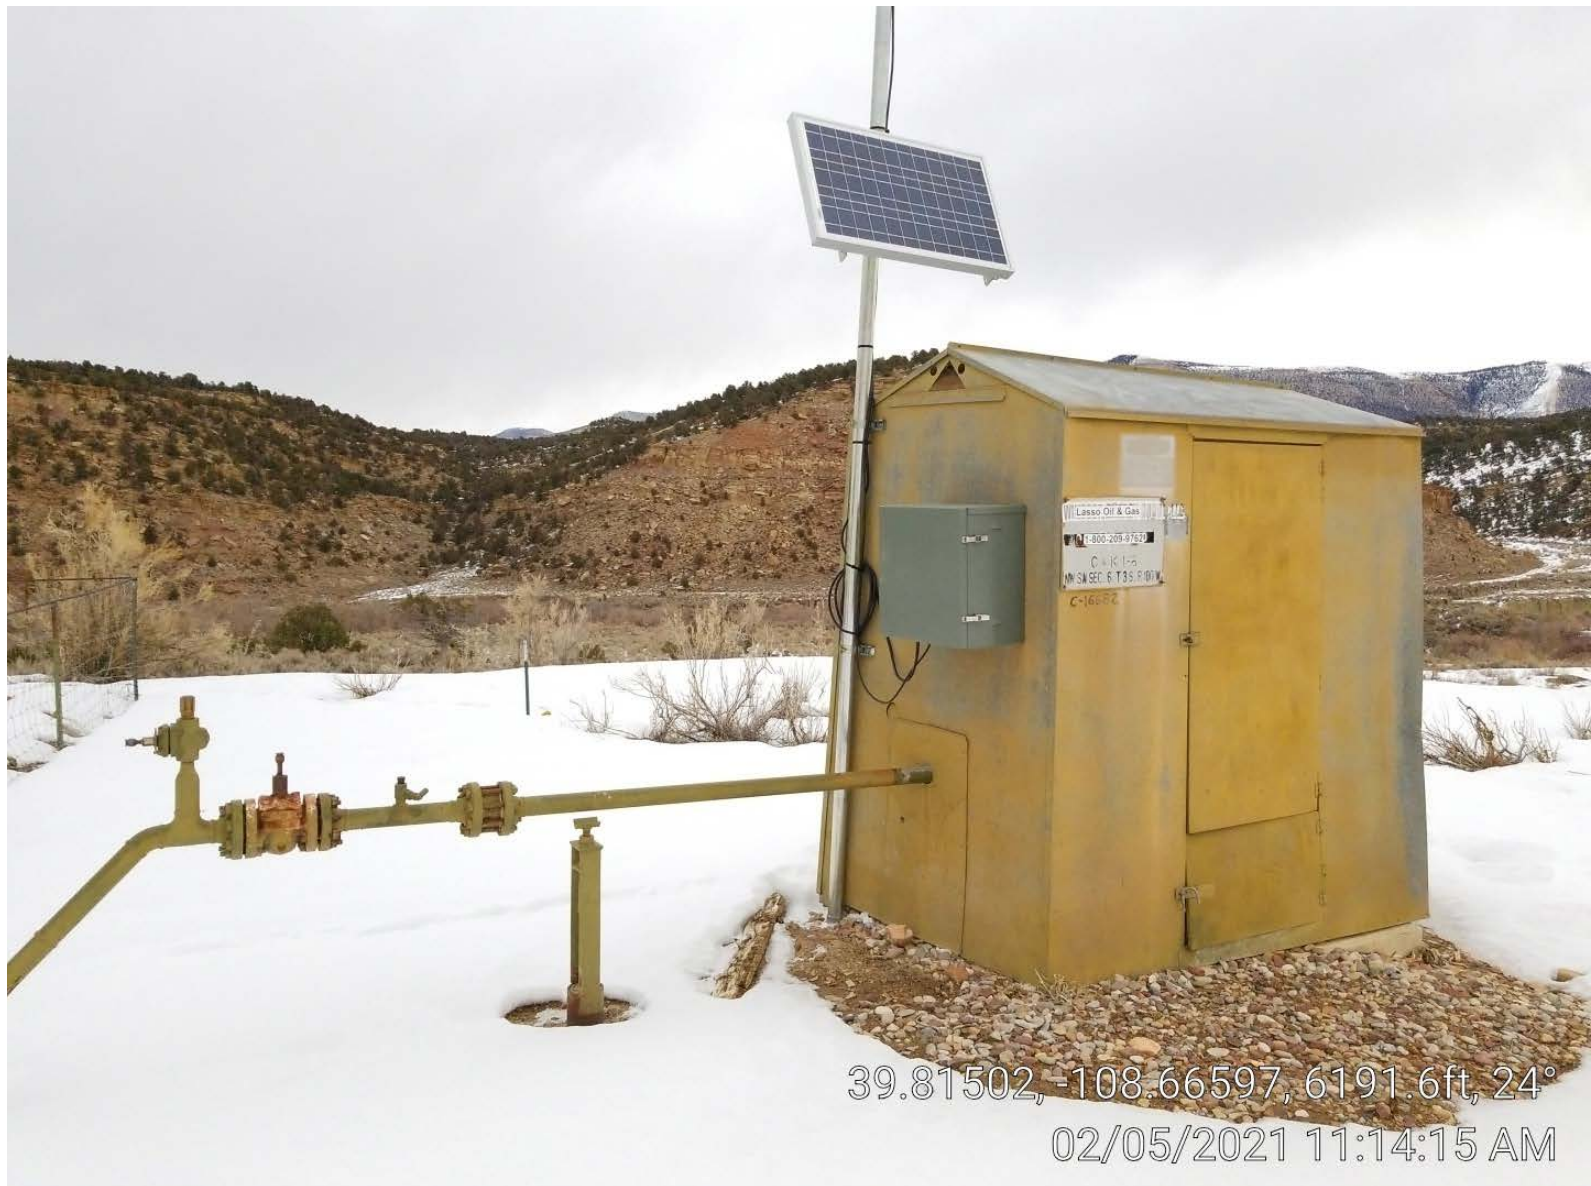
**Photo 5. Meter building & pit.**
