Inspection Photos

Operator: Rim Operating
API: 067-06515
Date: 2/8/2021

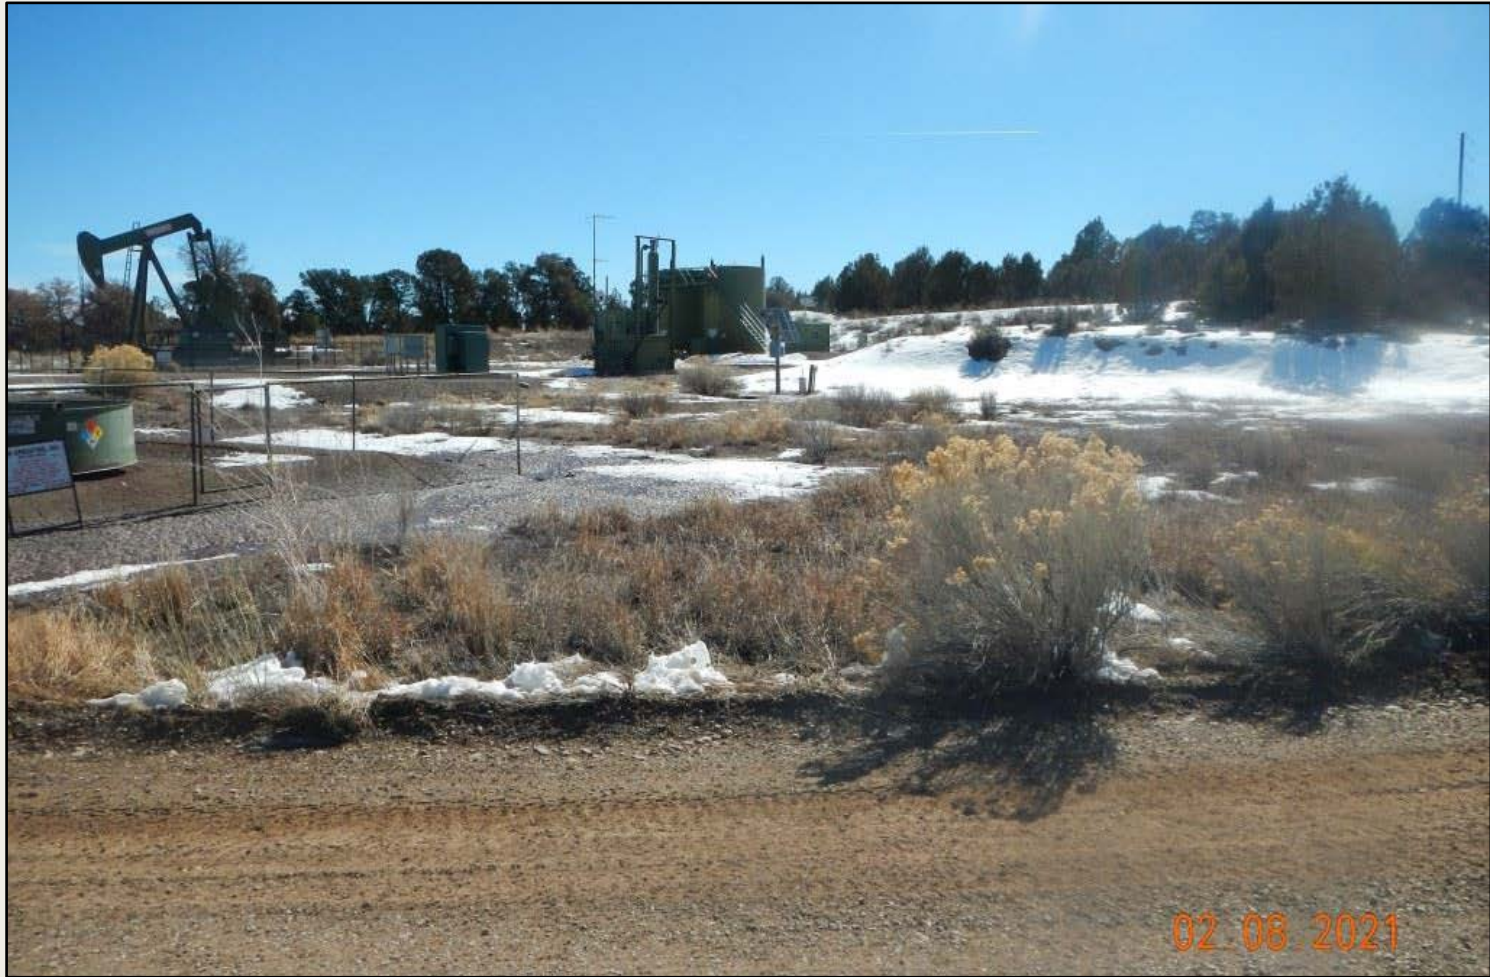
Photo 1. View of the project area from the northern edge facing center.

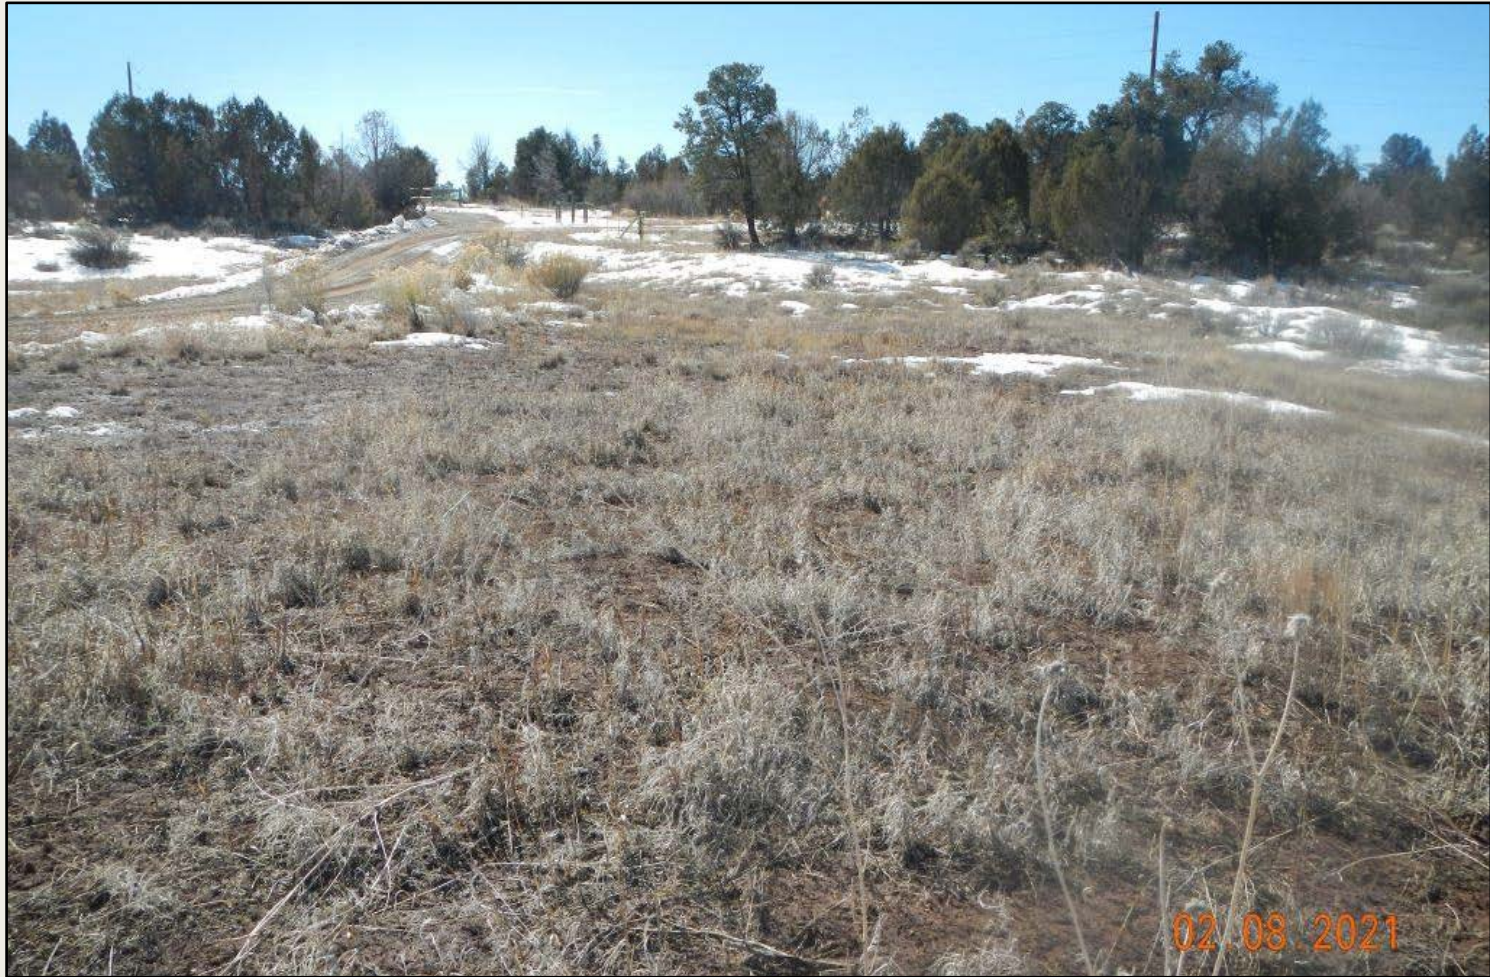
Photo 2. View of the western project from the northwestern corner facing southward. Revegetation is progressing with mixed grasses such as smooth brome and western wheatgrass.

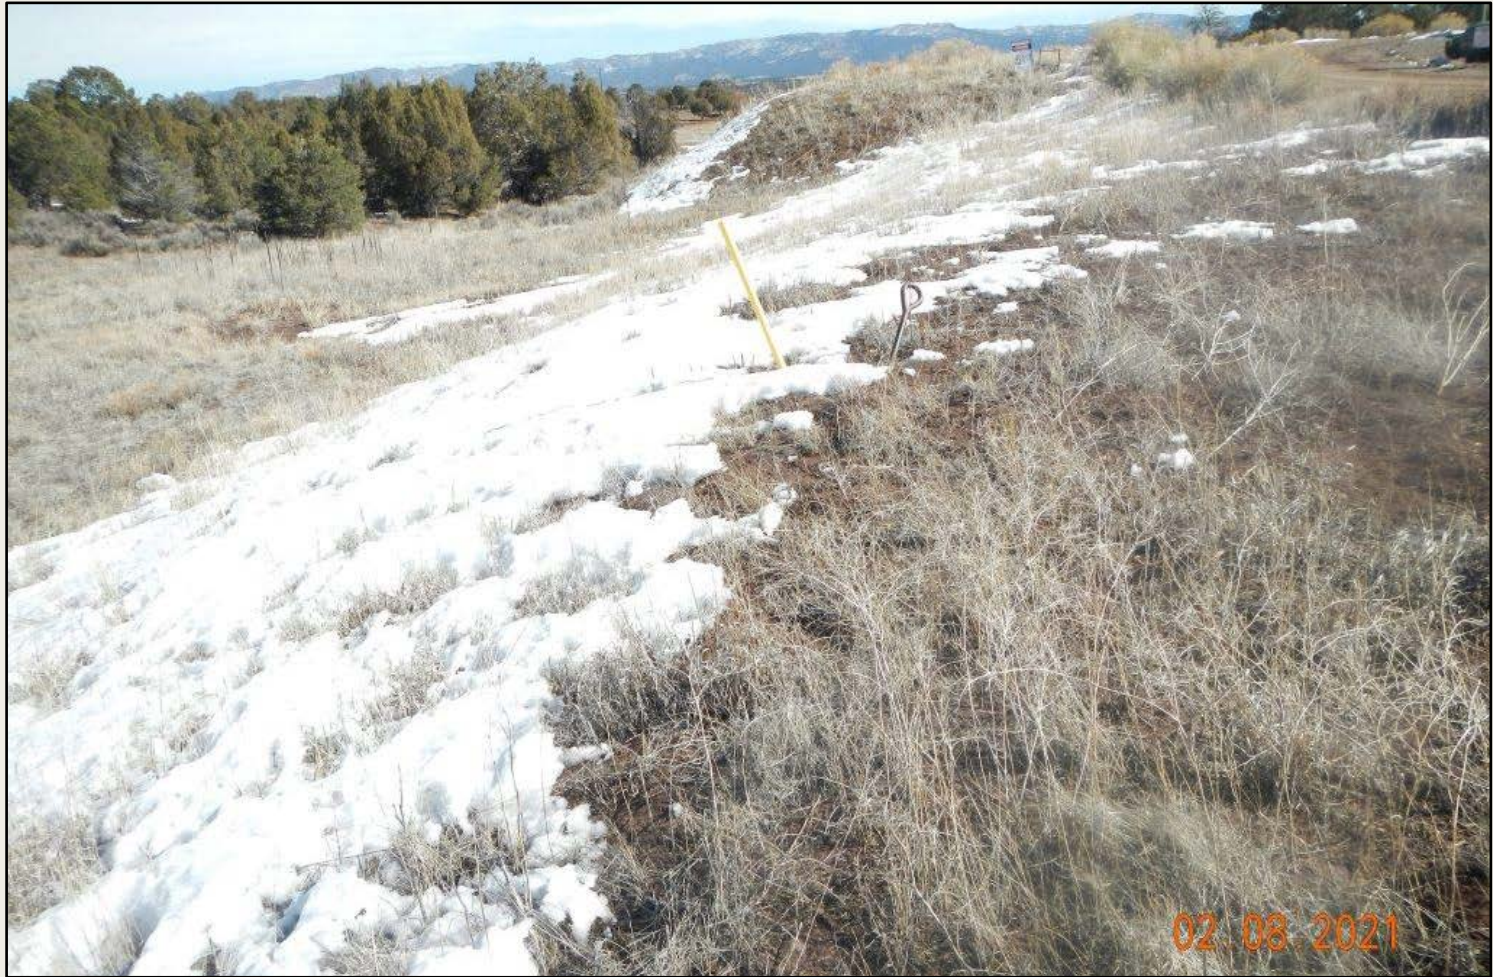
Photo 3. View of the northern fill slope from the northwestern corner facing eastward.

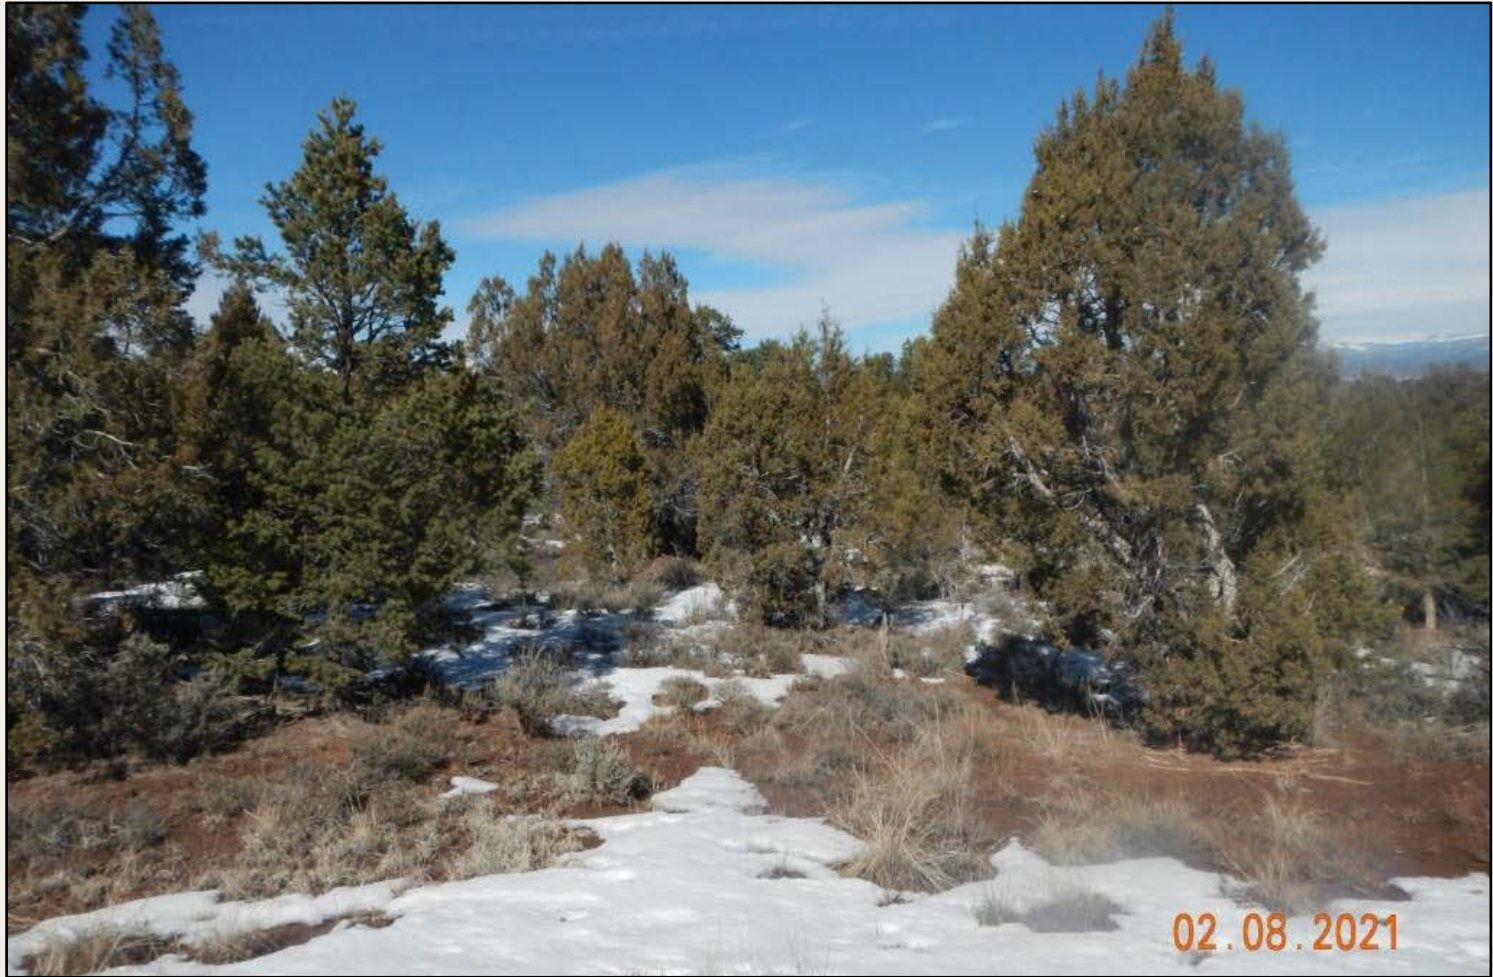
Photo 4. View of the reference area comprised of pinyon and juniper woodland, with understory of sagebrush, snakeweed, and James galleta.
