Inspection Photos
Operator: Catamount
API: 067-05412
Date: 2/8/2021

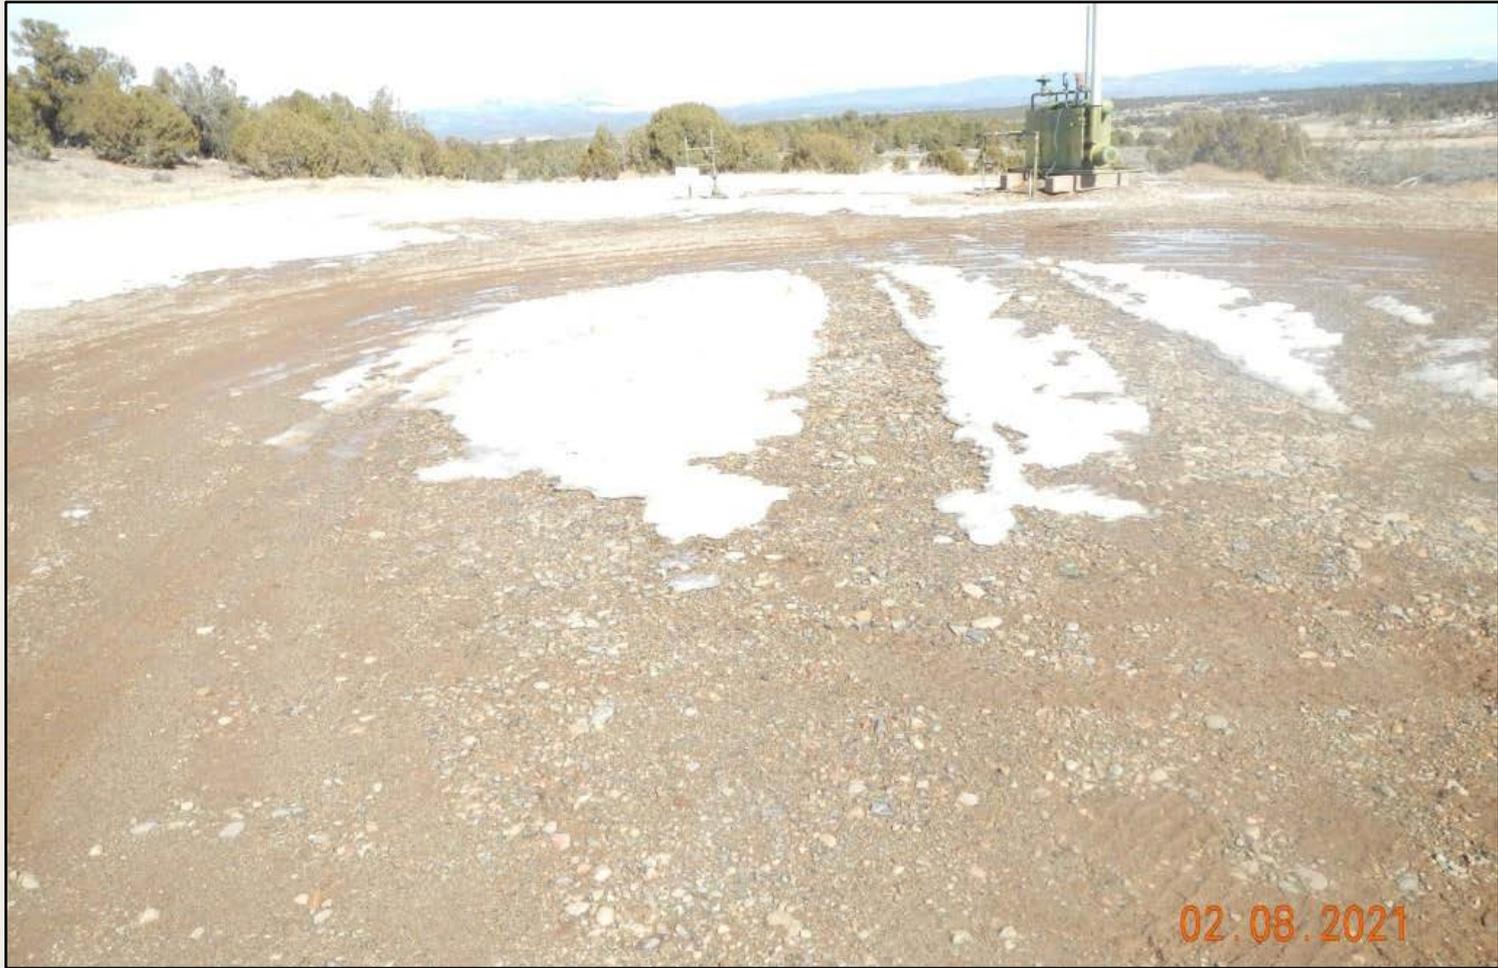
Photo 1. View of the project area from the well pad entrance facing center.

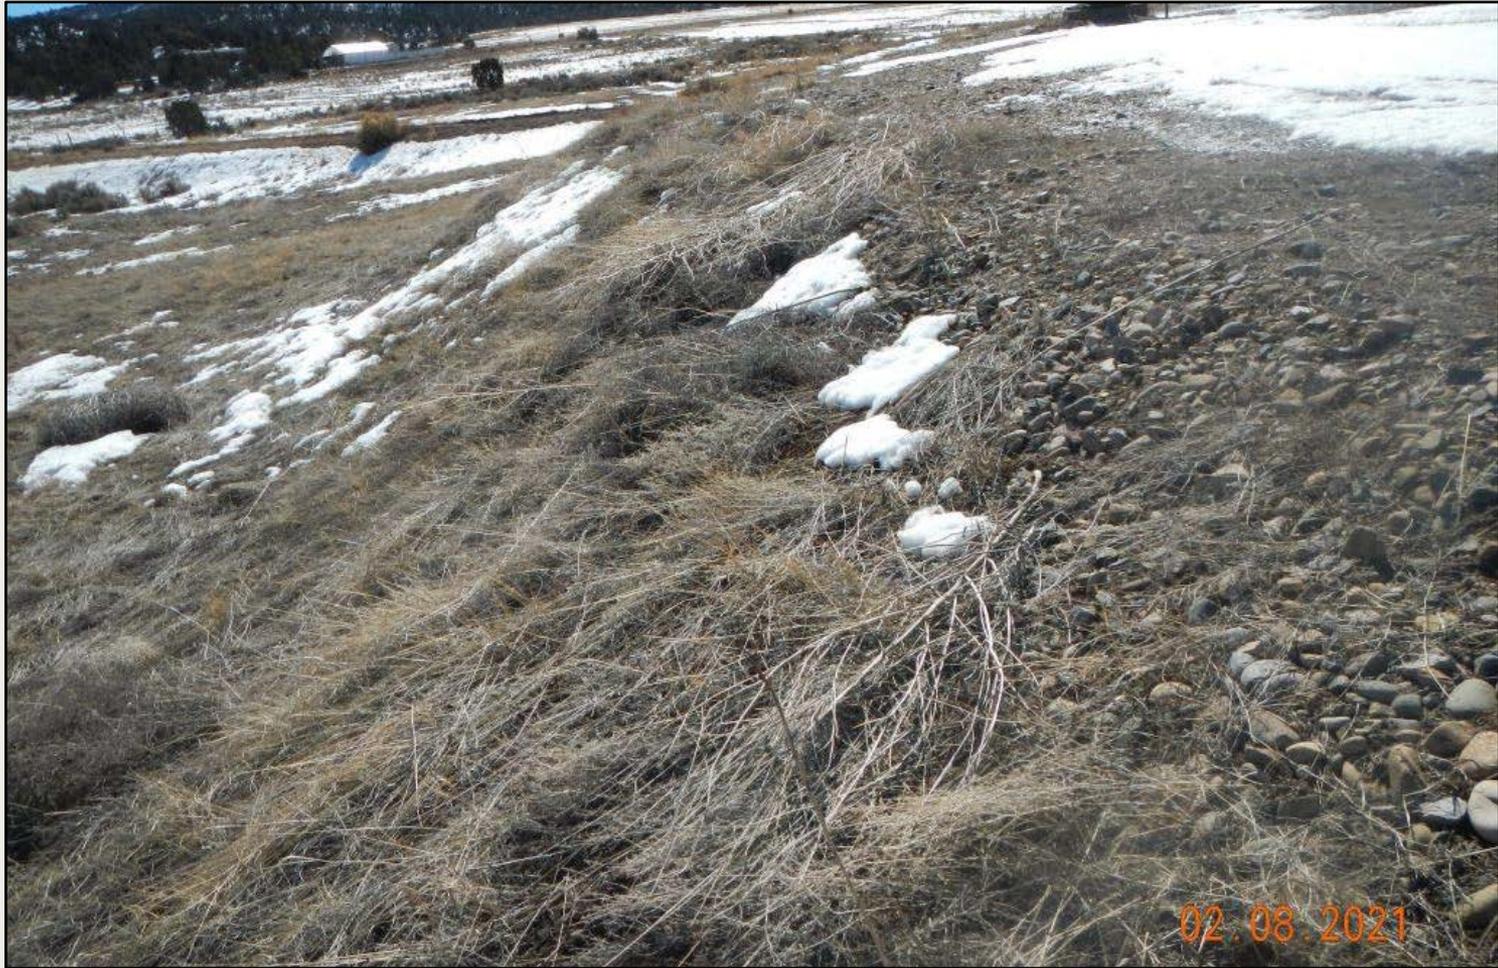
Photo 2. View of the eastern project from the northeastern corner facing southward. Revegetation is progressing in portions with mixed grasses such as western wheatgrass in a dormant vegetative condition.

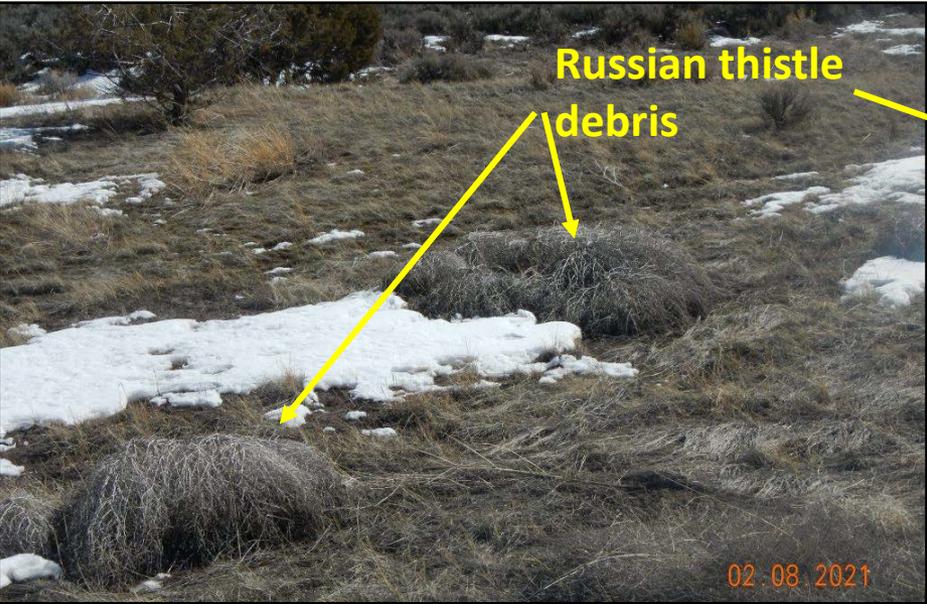
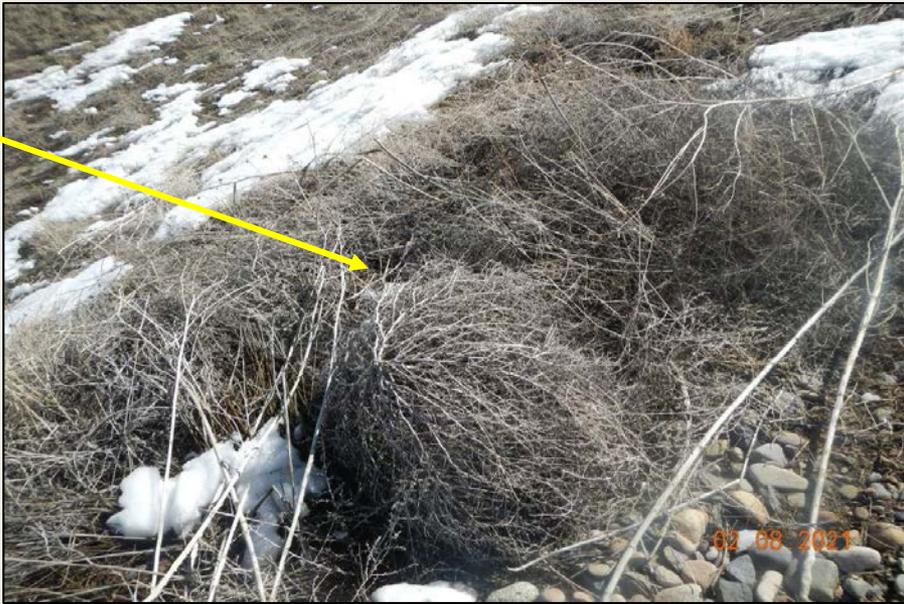
Photos 3/4. View of Russian thistles blown off of the western project area, and other Russian thistle debris within the project area.

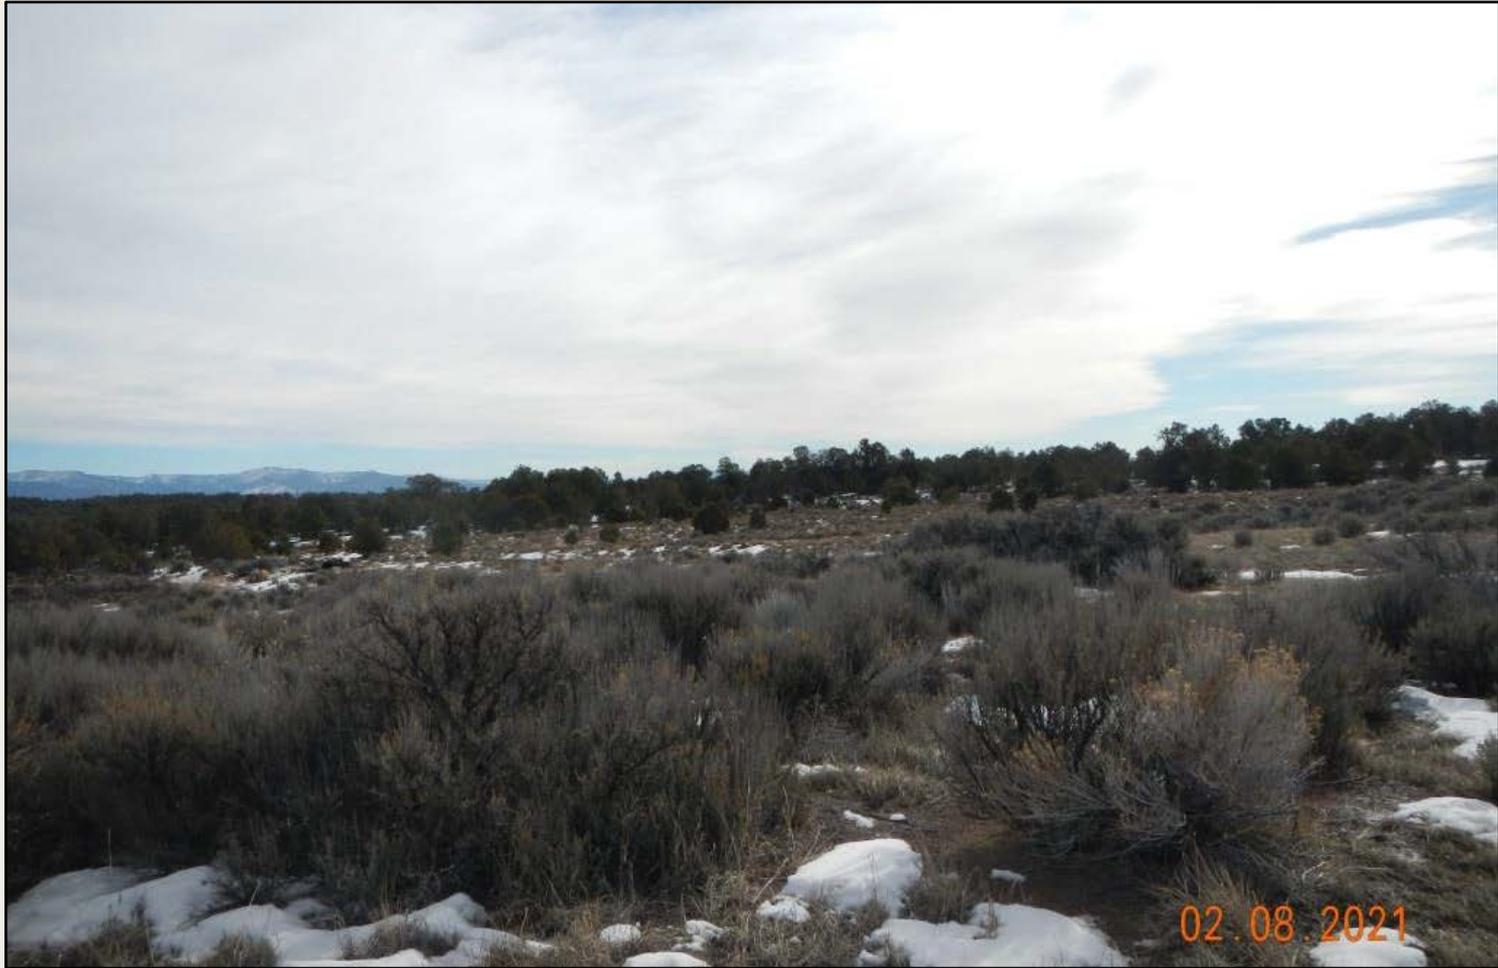
Photo 4. View of the reference area comprised of sagebrush shrubland with understory of grasses and forbs such as western wheatgrass, sand dropped, and James galleta.
