**BERRY PETROLEUM COMPANY LLC**  
**CHEVRON L04 696**  
**Location # 335597**

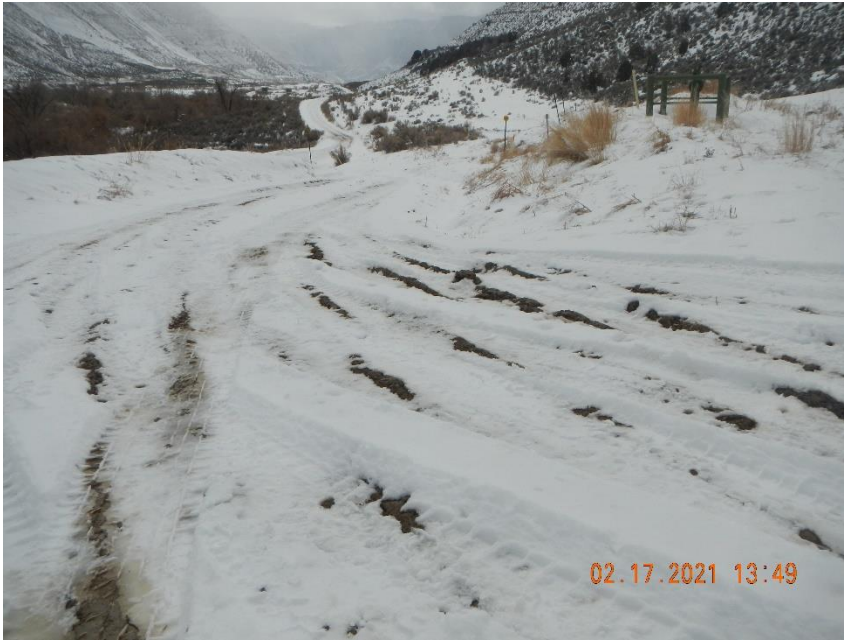
**Access road shows signs of lack of stabilization  
BMP's in some areas (rutting is present).**

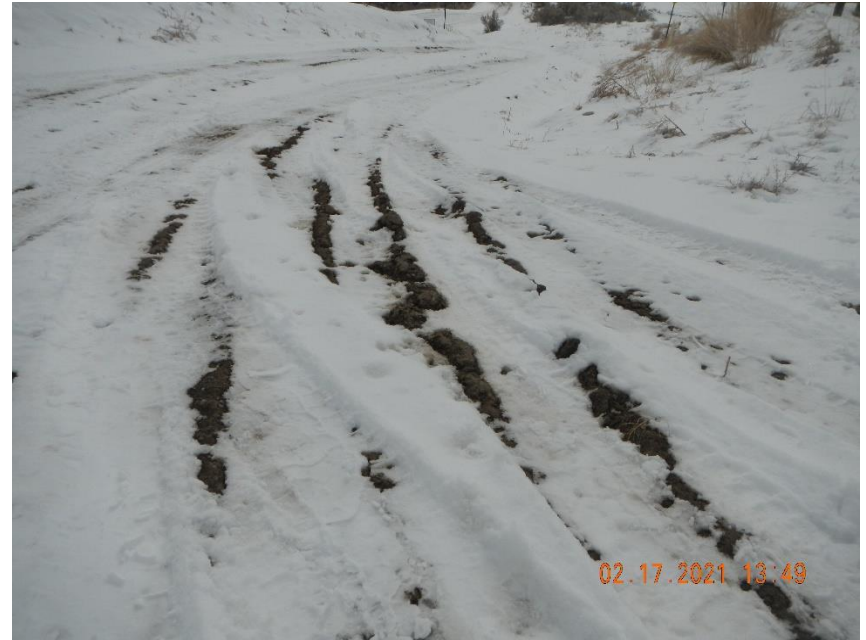
**Access road shows signs of lack of stabilization  
BMP's in some areas (rutting is present).**

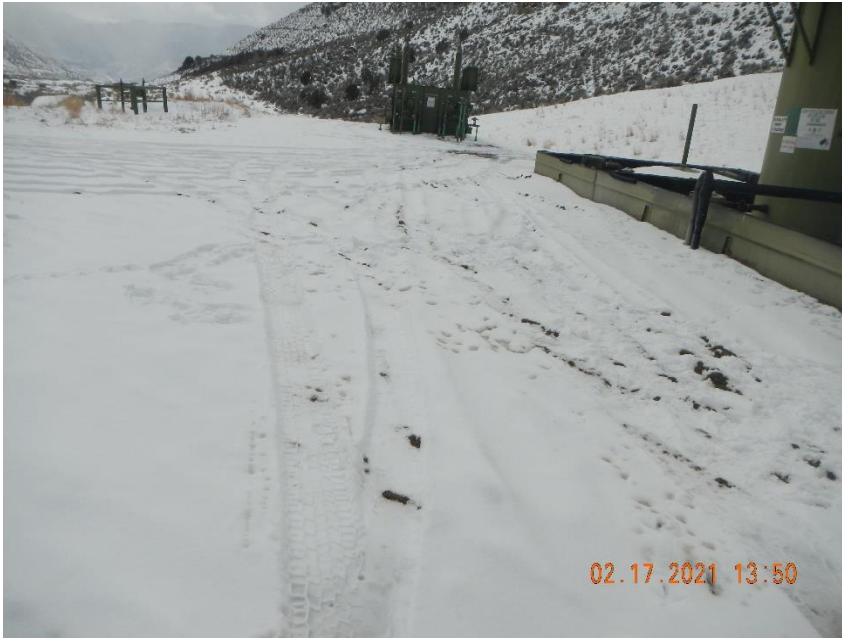
**Location shows signs of lack of stabilization  
BMP's in some areas (rutting is present).**

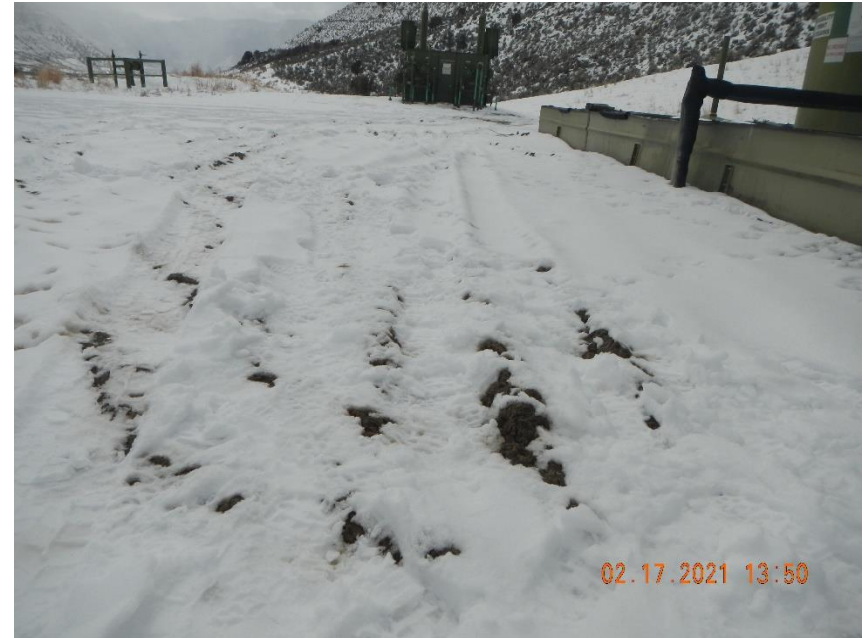
**Location shows signs of lack of stabilization  
BMP's in some areas (rutting is present).**

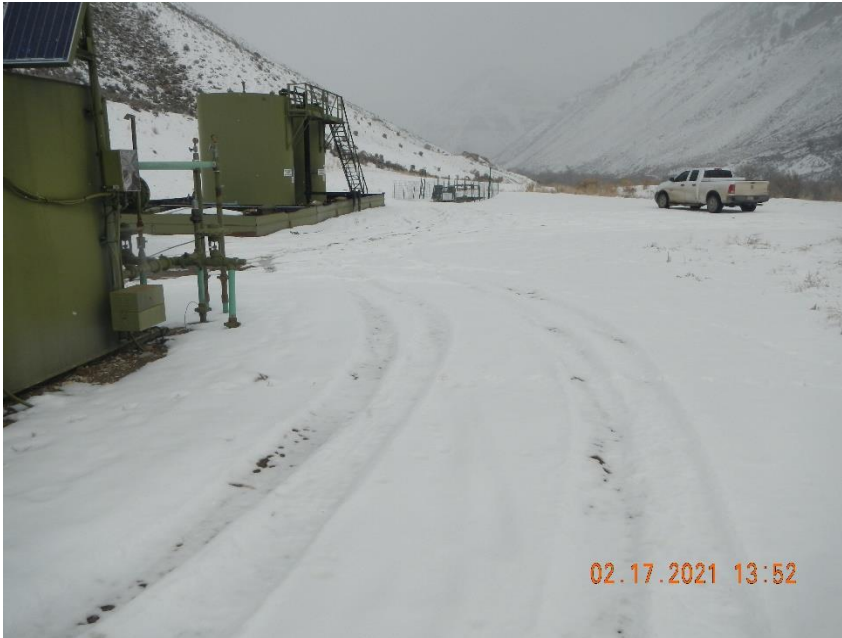
**Location shows signs of lack of stabilization  
BMP's in some areas (rutting is present).**

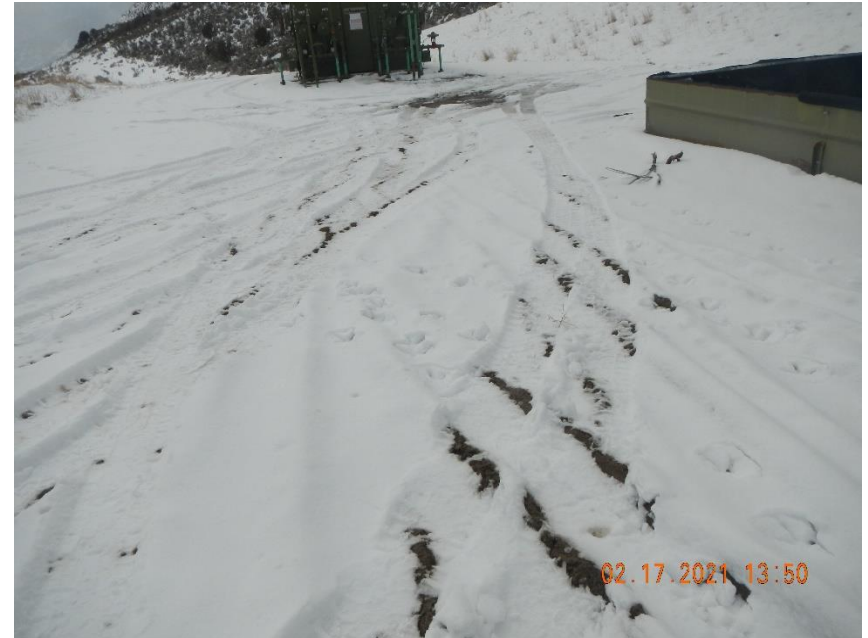
**Location shows signs of lack of stabilization  
BMP's in some areas (rutting is present).**

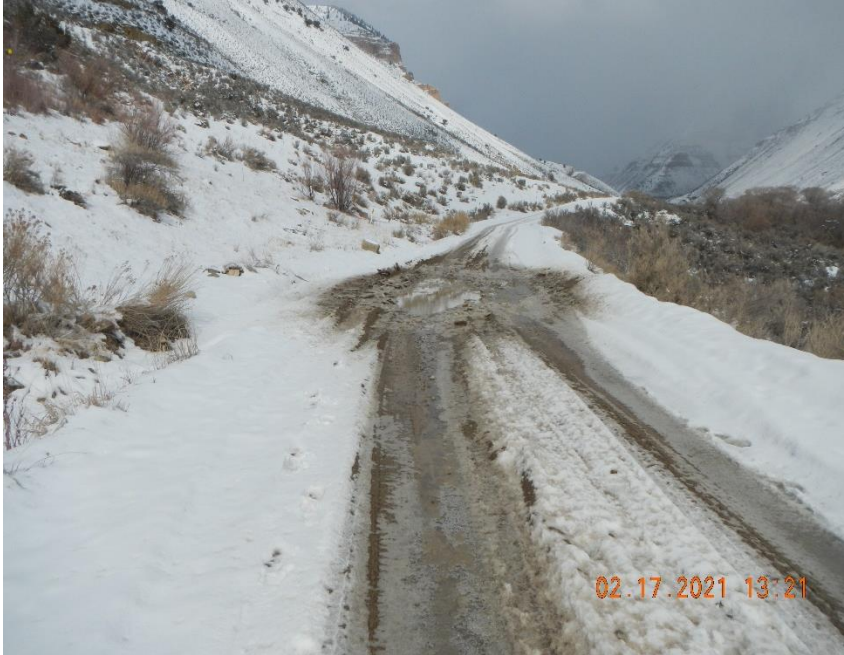
**N39.55096 W108.12064**

**Water not draining off road into culvert or ditch.**

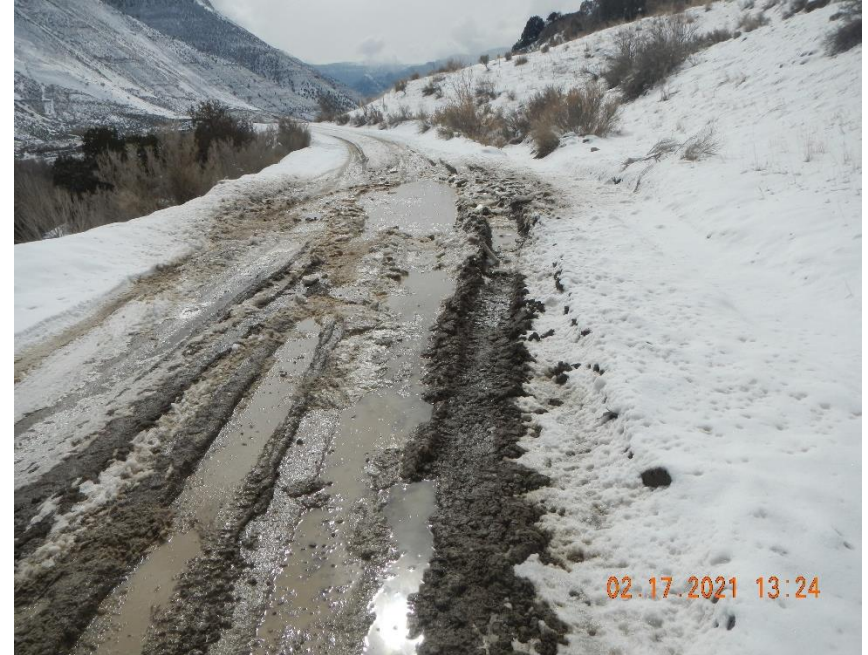
**Access road shows signs of lack of stabilization  
BMP's in some areas (rutting is present).**

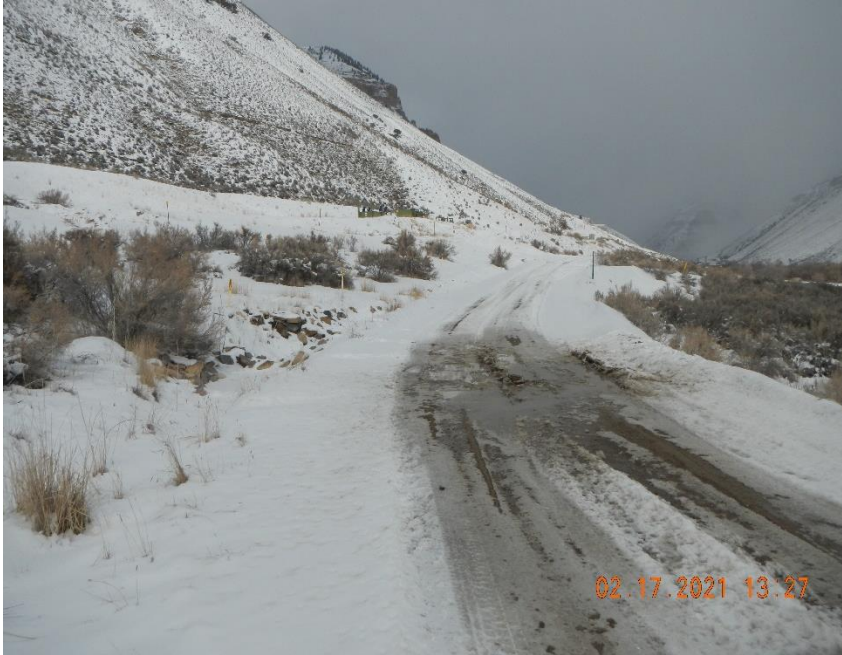
**N39.55334 W108.11990**

**Erosion damage from culvert outlet. Access road shows signs of lack of stabilization BMP's in some areas (rutting is present).**

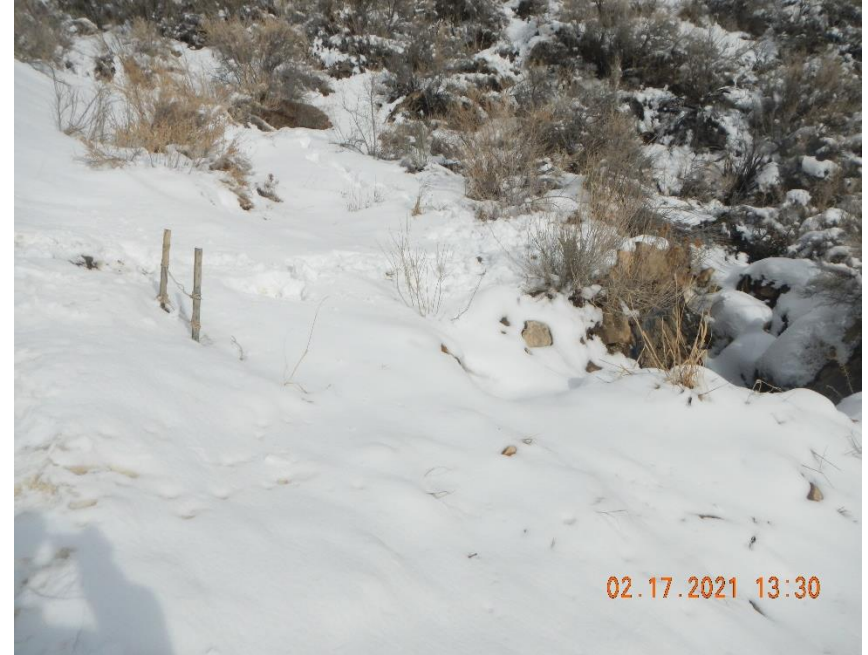
**N39.55334 W108.11990**

**Erosion damage from culvert outlet.**

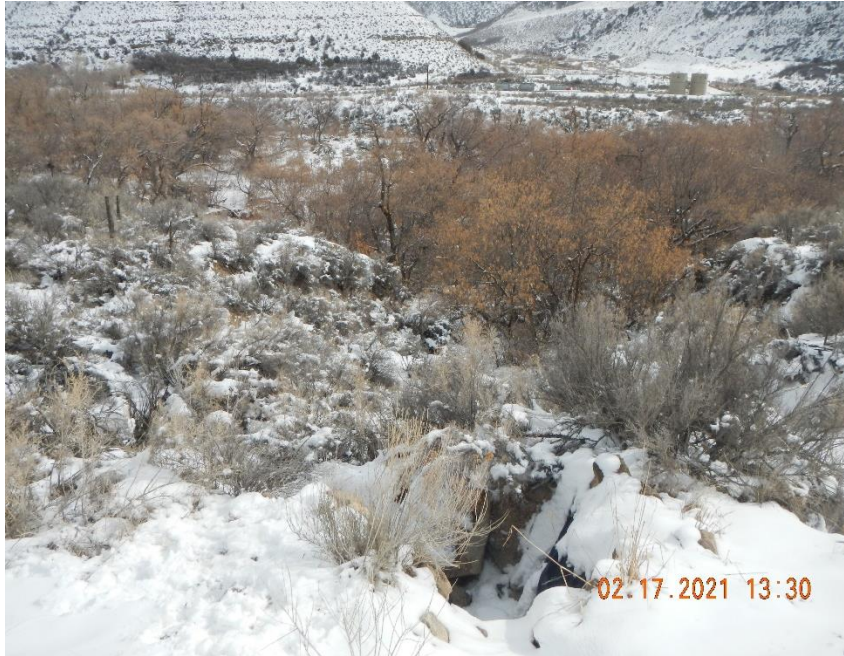
**Erosion damage from culvert outlet.**

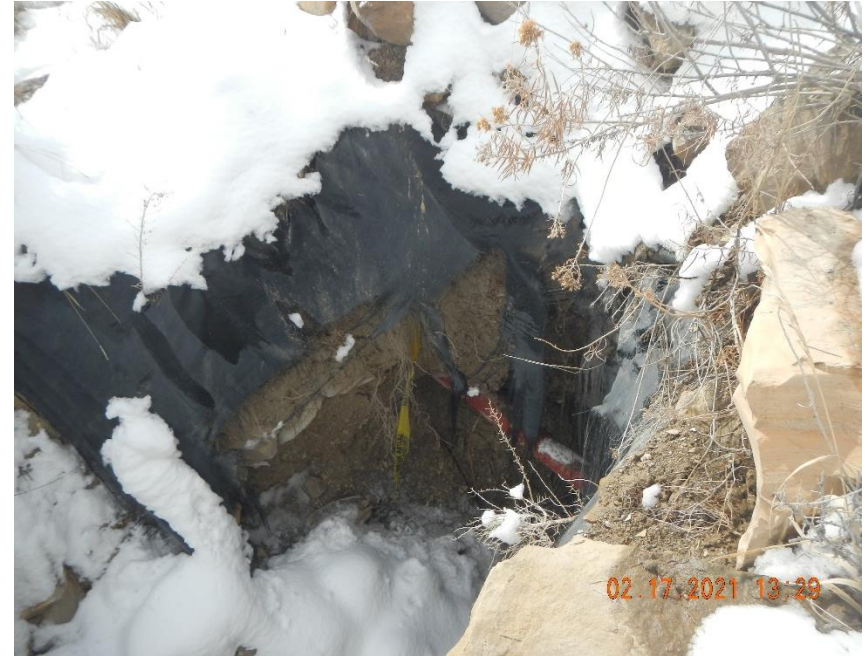
**Erosion has exposed pipe line.**
