Pit Status Evaluation Form

Pit Name: GRANT 1-4	Facility ID: 103574
Current Status: Unknown	Status Date: 9/23/1999
Current Operator: KP KAUFFMAN COMPANY INC / 46290	
Updated Operator:	
Form 15 Pit Permit Doc #: 712445	Permit Date: 7/29/1983
Related Facilities: GRANT #4 (API 123-09309; Facility ID 241520; Loc ID 311319); Grant Tank Battery Facility ID 446608, Loc ID 446484

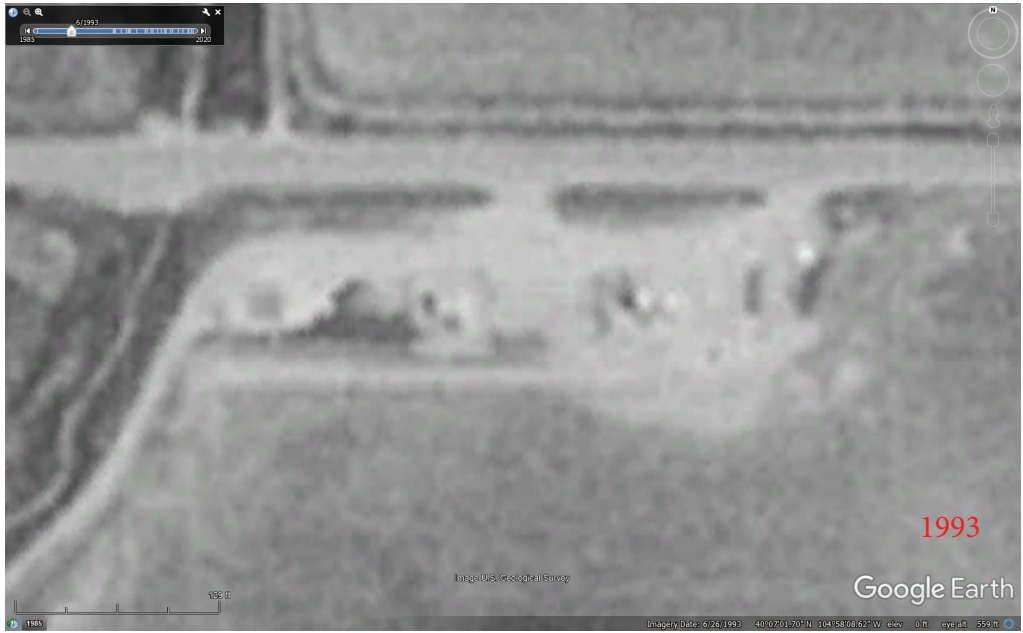
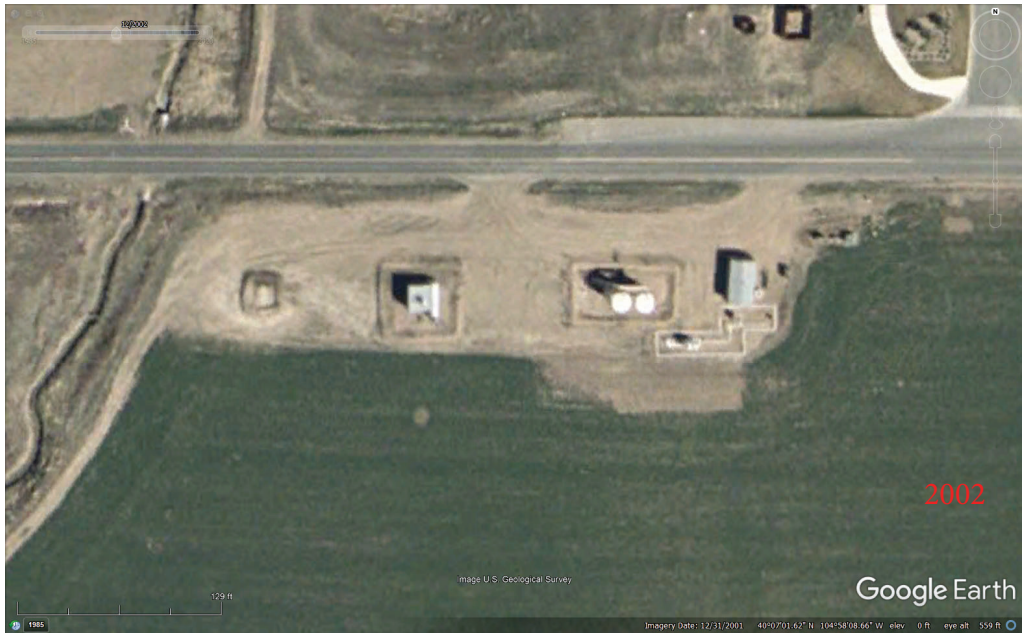
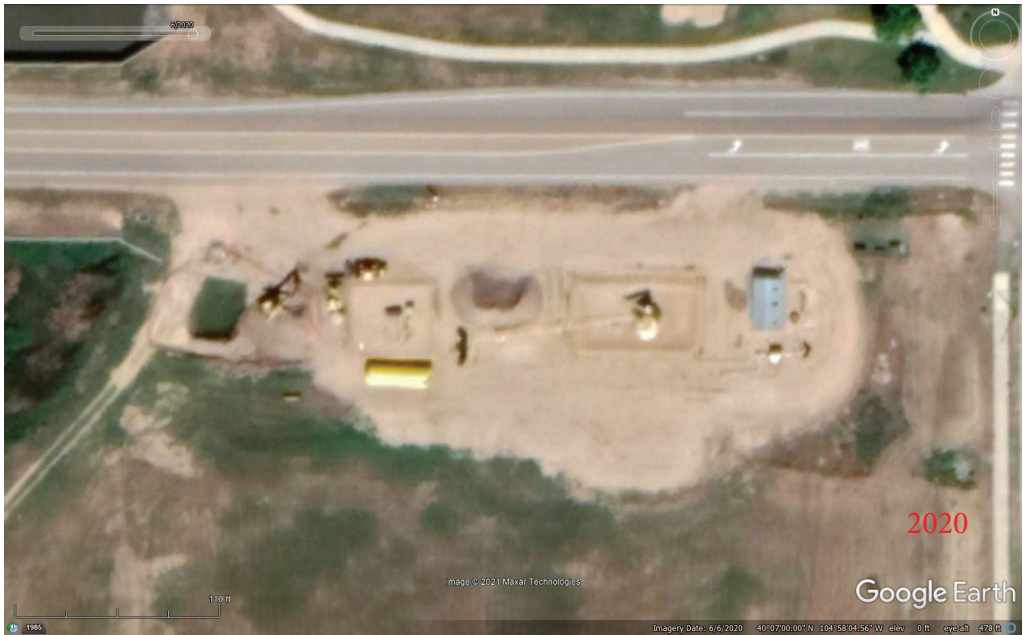
| <input checked="" type="checkbox"/> Aerial Photo Verification (photos attached) | |

Shared battery with Grant 1-4 (duplicate pits 118284, 118789, 103574). 1998 pit inventory documents an earthen pit on location. Based on inspection reports and aerial imagery it appears that the pit was replaced with a fiberglass produced water tank at the same location. Impacts surrounding the produced water tank/pit area remediated under Remediation Project No. 12158. Pit Status has been changed to closed.
