Inspection Photos  
Operator: Hilcorp Energy  
API: 067-06266  
Date: 2/11/2021

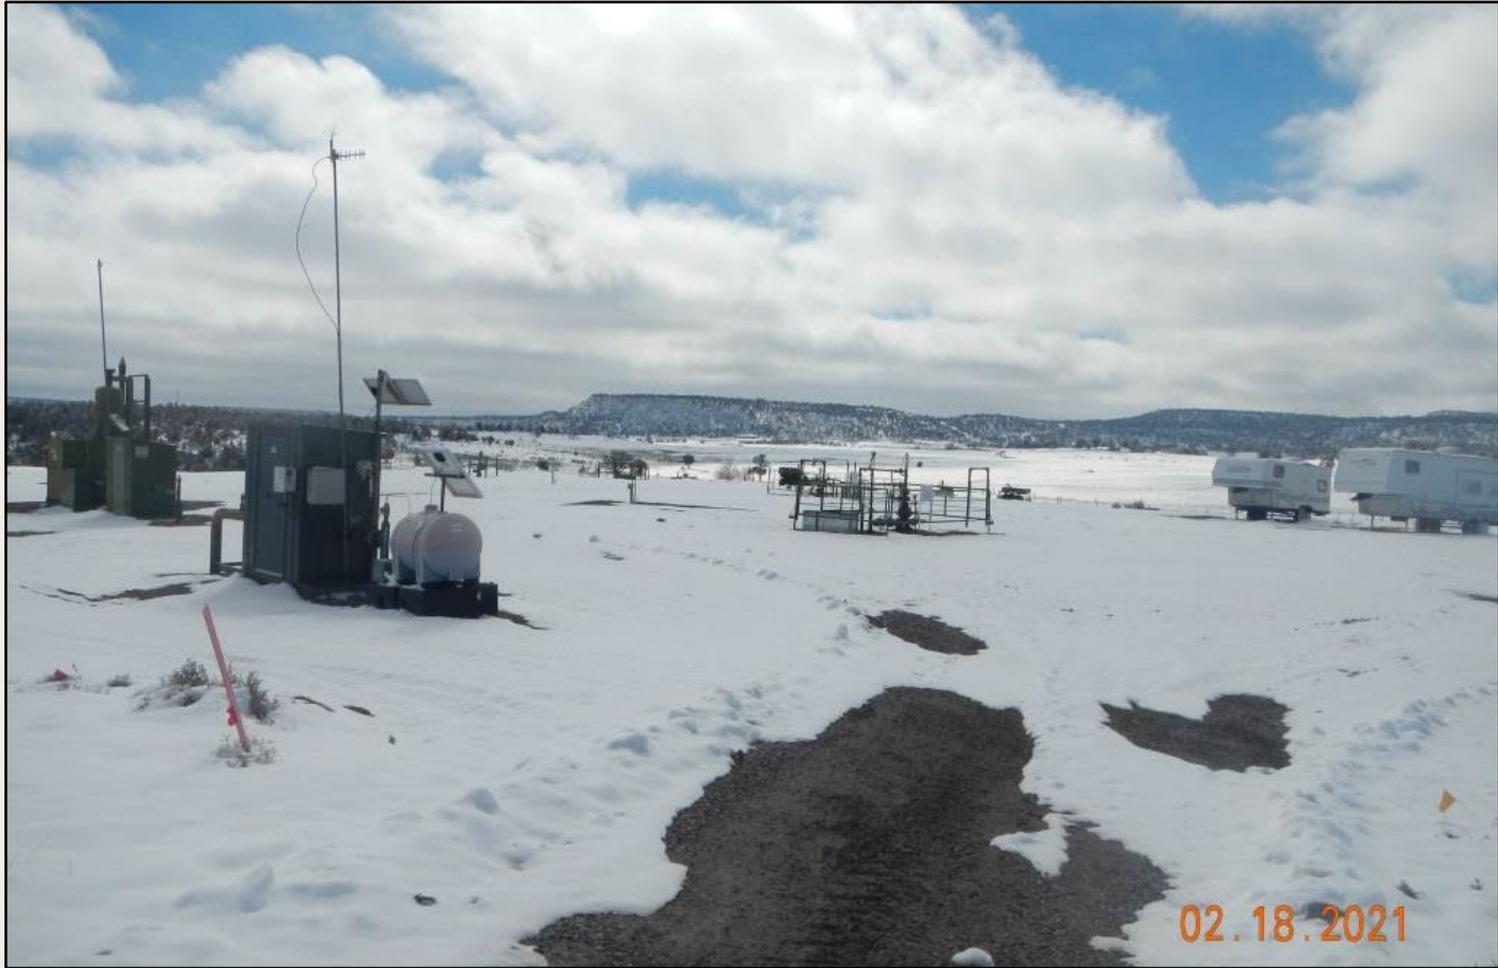
Photo 1. View of the project area from the well pad entrance facing center.

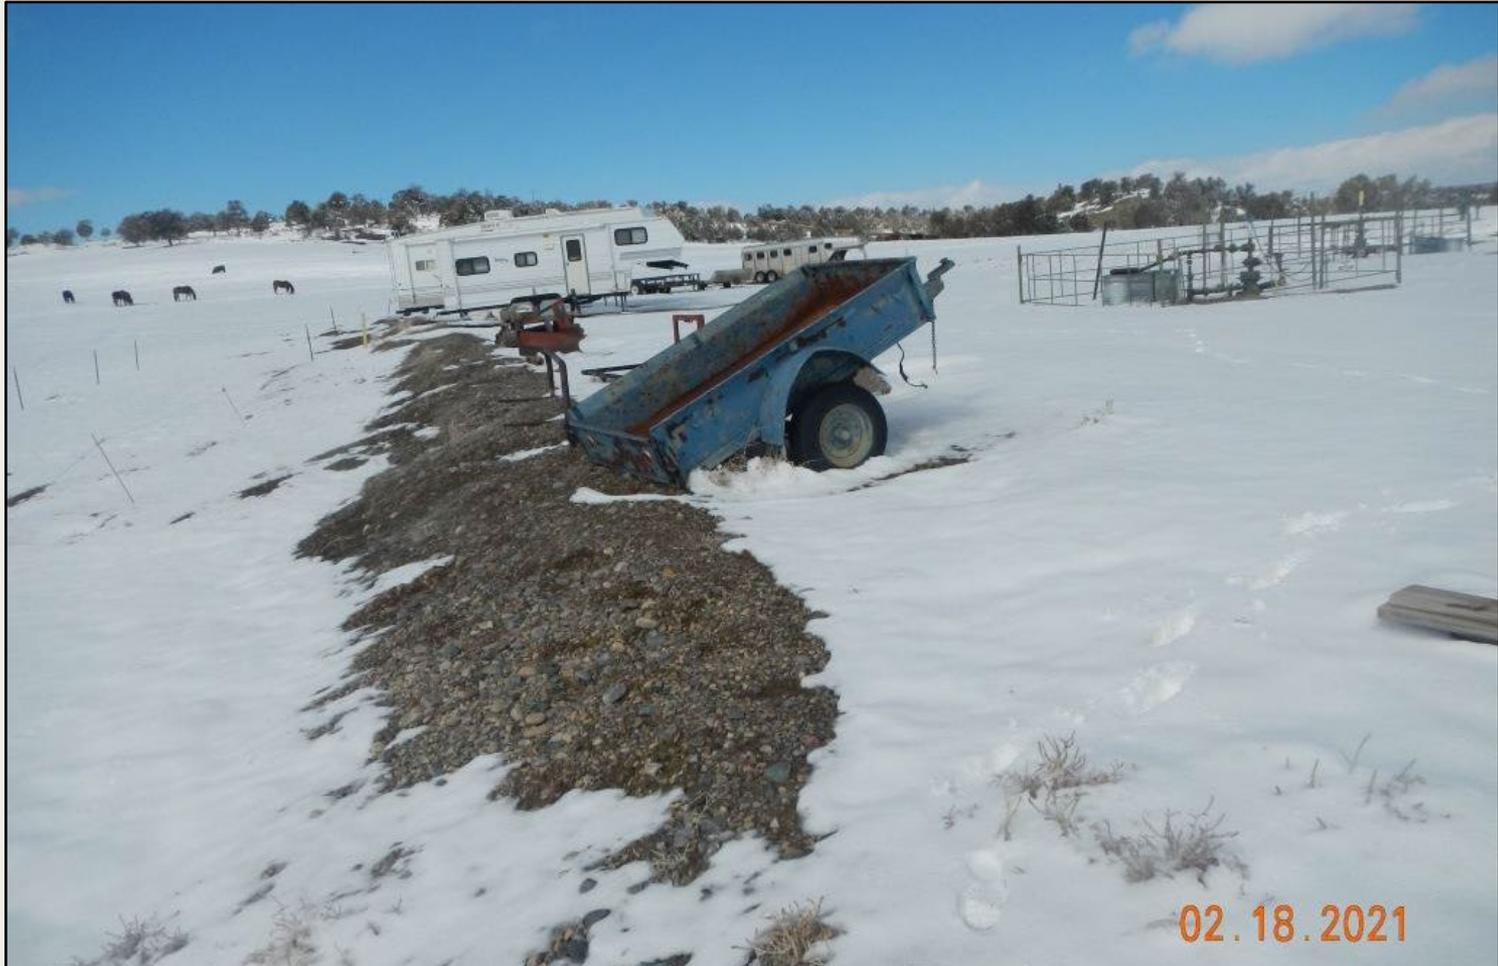
Photo 2. View of the western fill slope facing northward. Trailers, wood piles, fencing materials, etc. remain stored on the western and northwestern portions of the project area.

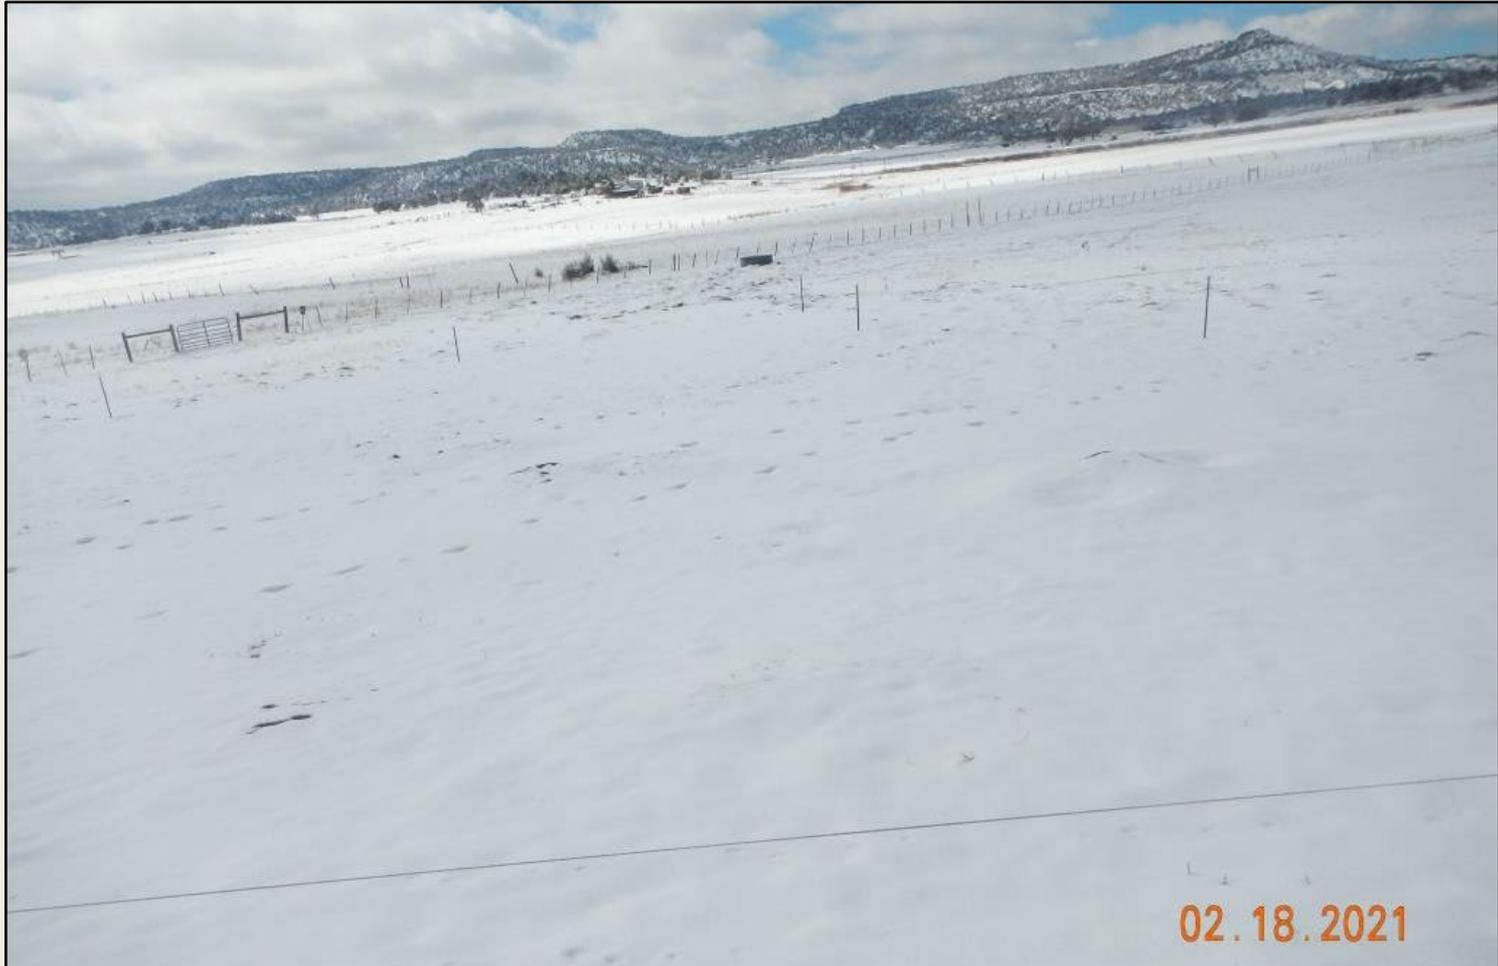
Photo 3. View of the reference area comprised of irrigated grass fields and sagebrush/pinyon/juniper mosaic.

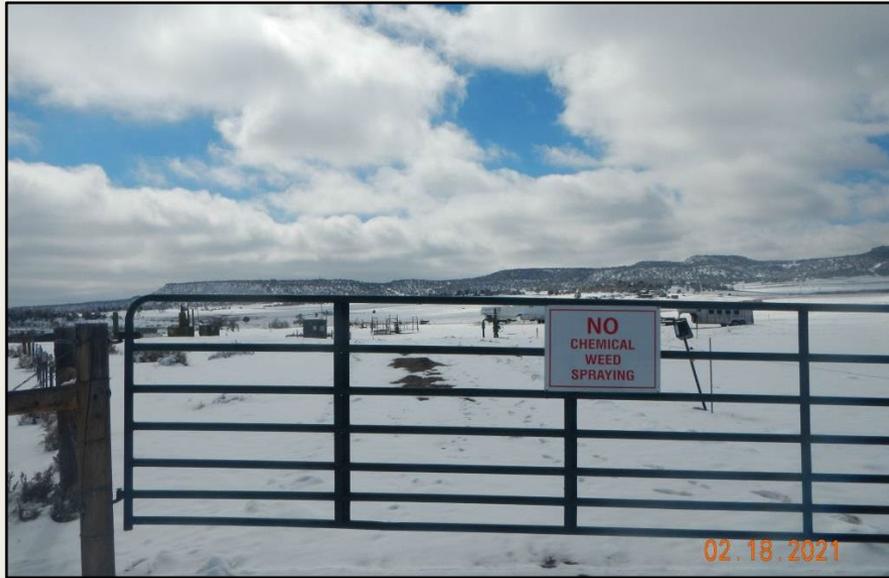
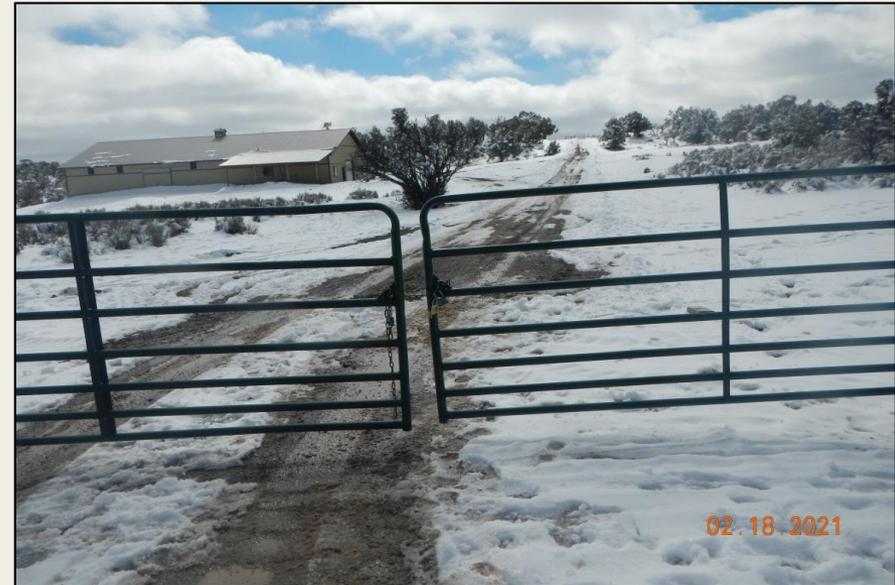
Photos 4/5. View of closed gates after leaving location.
