Inspection Photos

2/17/2021

Operator: TEP ROCKY MOUNTAIN LLC - 96850

Location ID: 430567

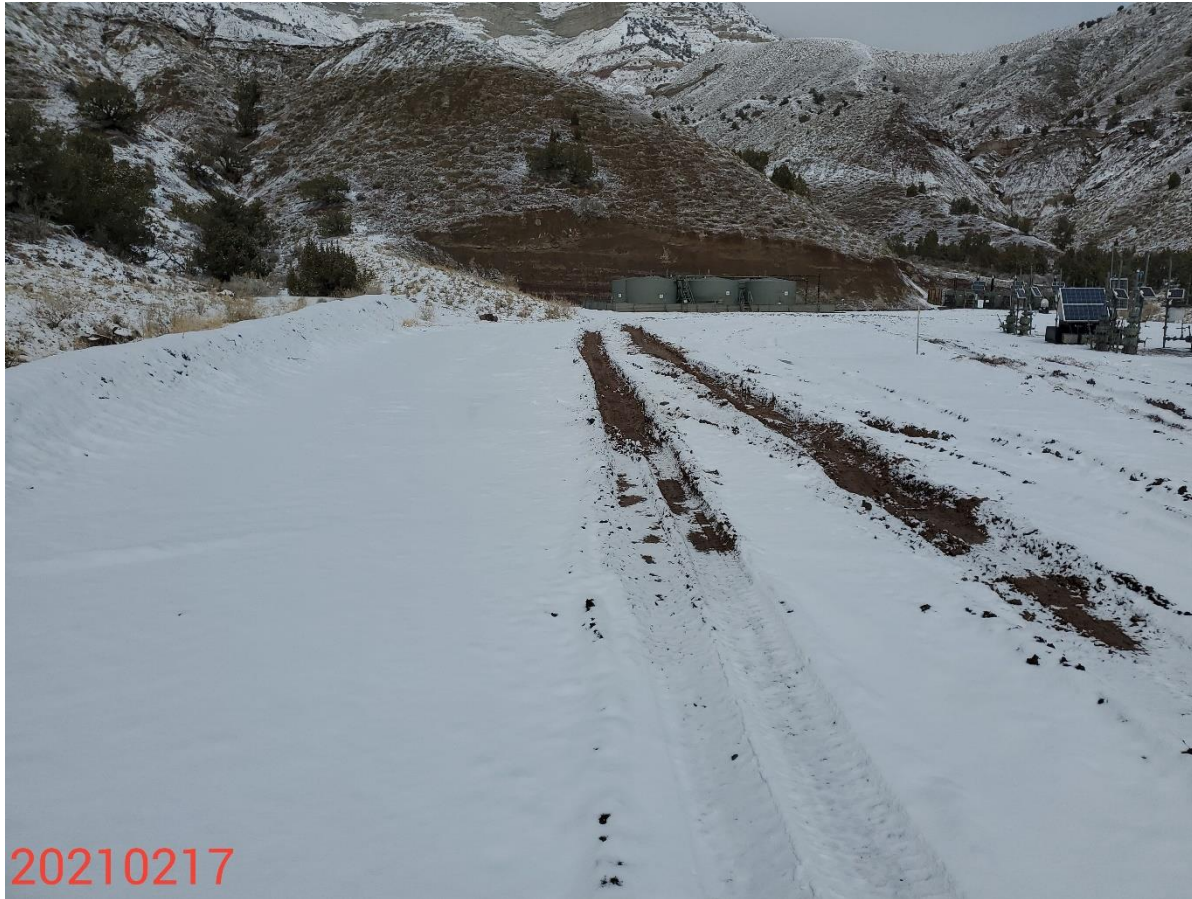
Photo 1: Photo taken from the south end of the Location, facing north. Photo provides an overview of the Location. Photo also show vehicle tracking/rutting issues observed on the Location.

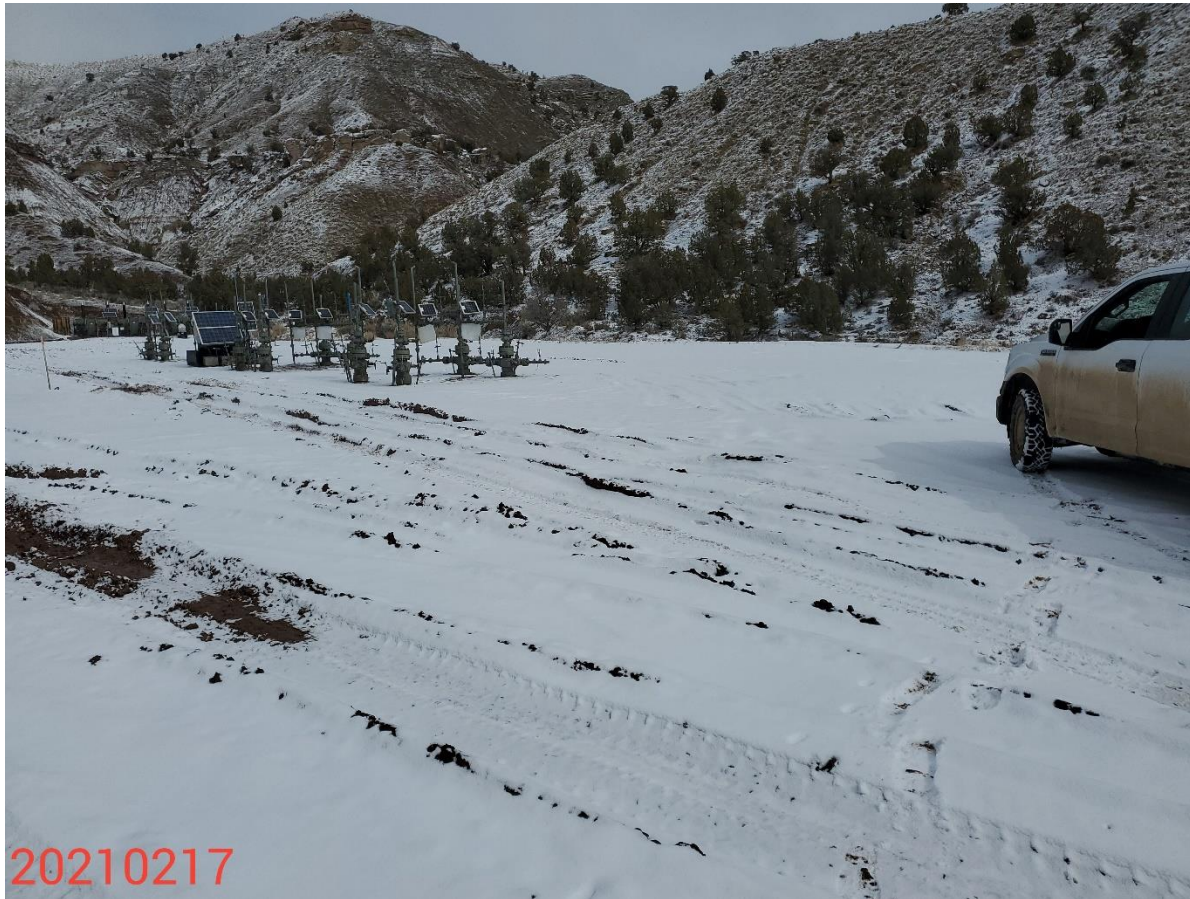
Photo 2: Photo taken from the south end of the Location, facing northeast. Photo provides an overview of the Location

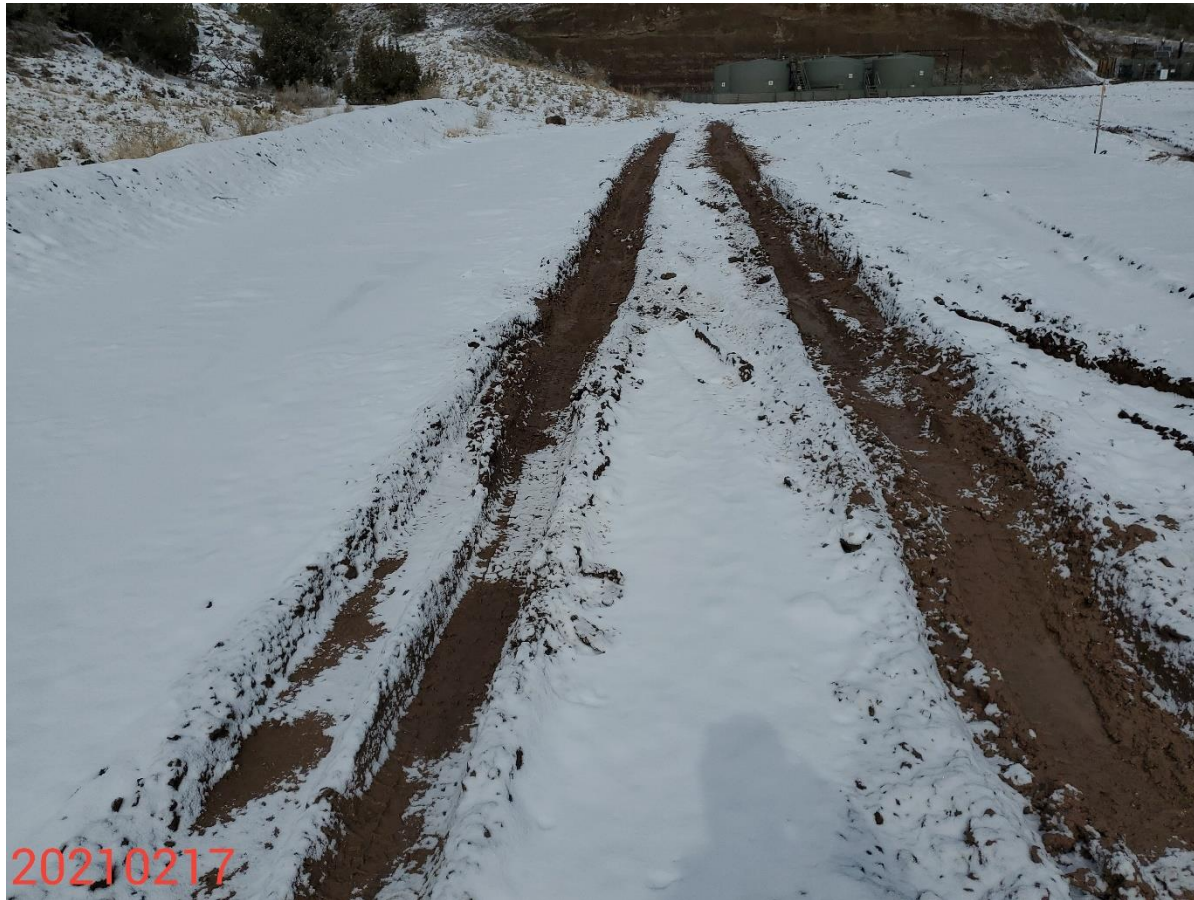
Photo 3: Photo taken from the west end of the Locaiton, facing north. Photo shows tracking/rutting on the location; BMPs to stabilize pad missing or insufficient.

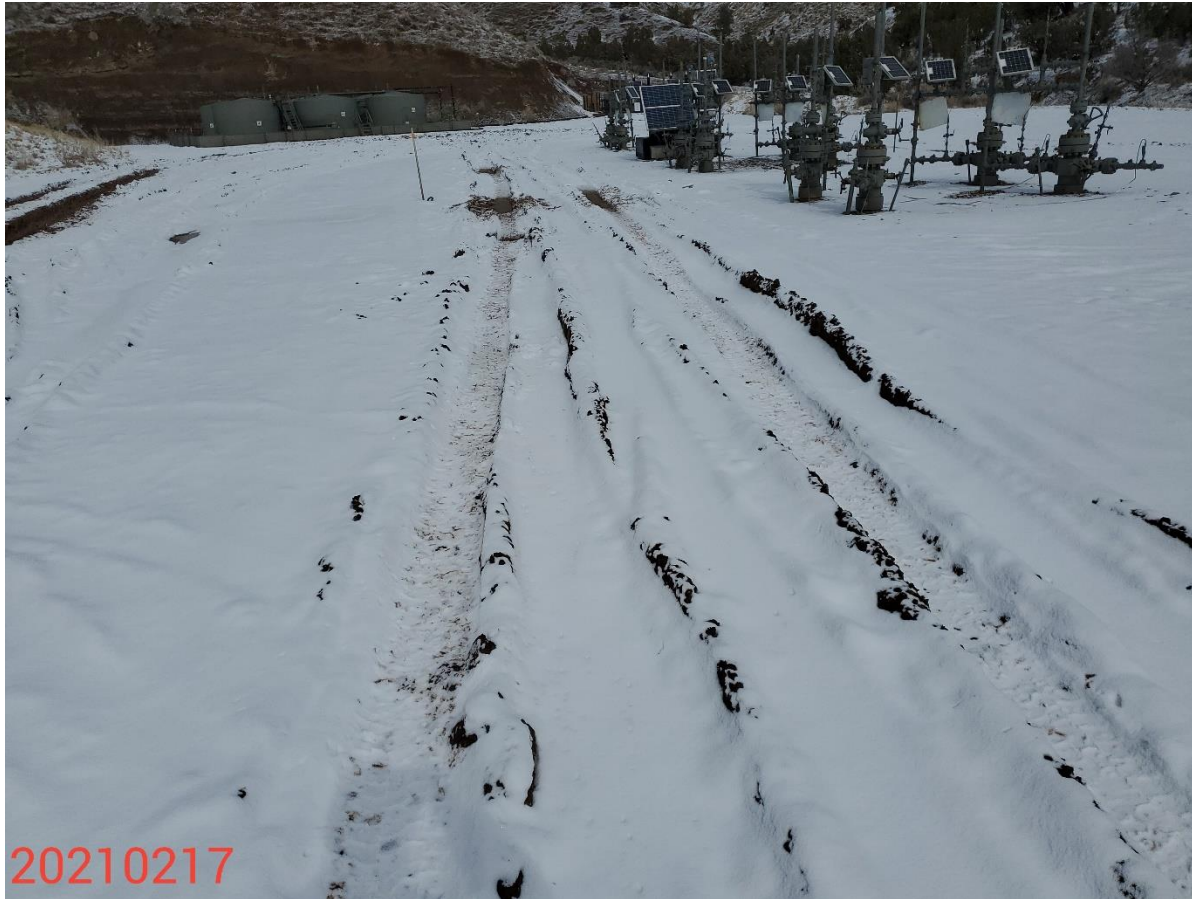
Photo 4: See comments under photo 3.

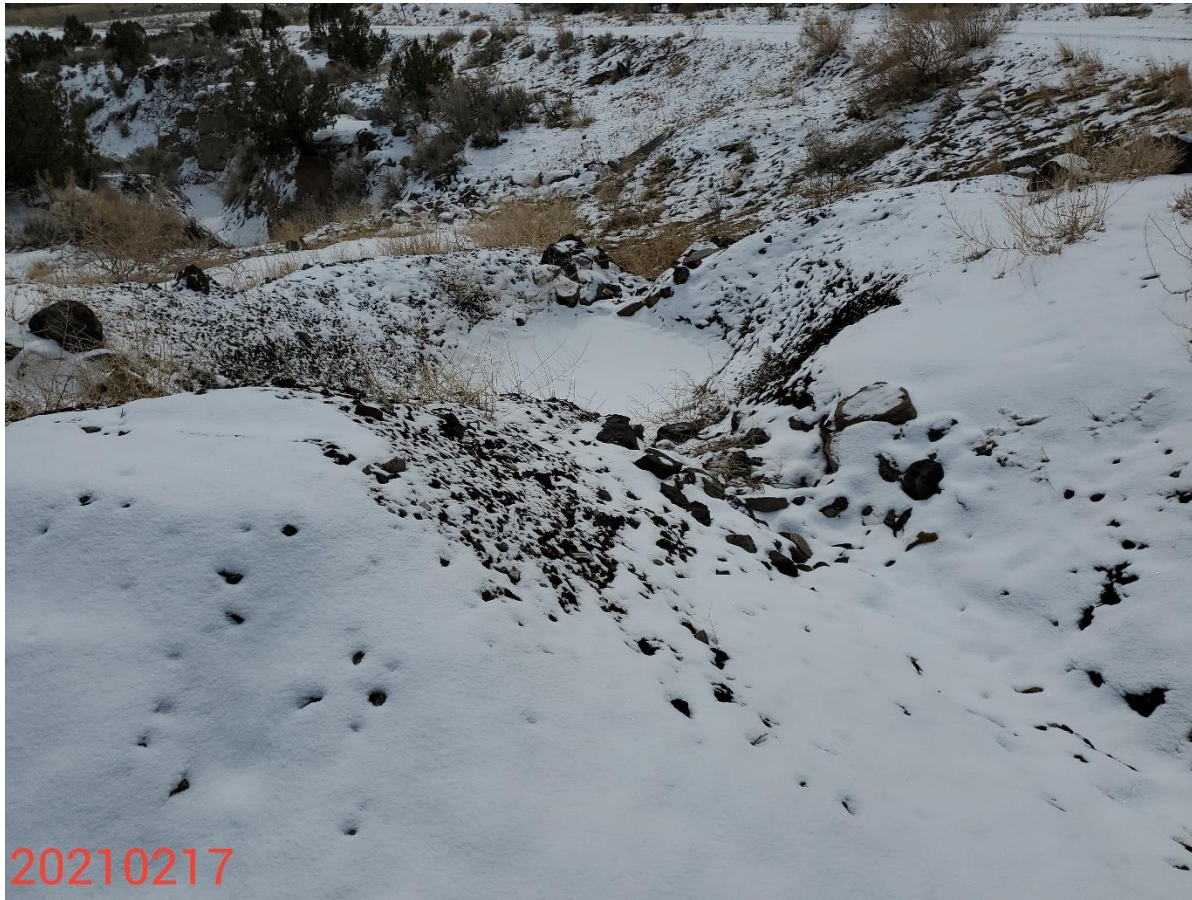
Photo 5: Photo taken from the south end of the Location, facing south. Photo of sediment trap.

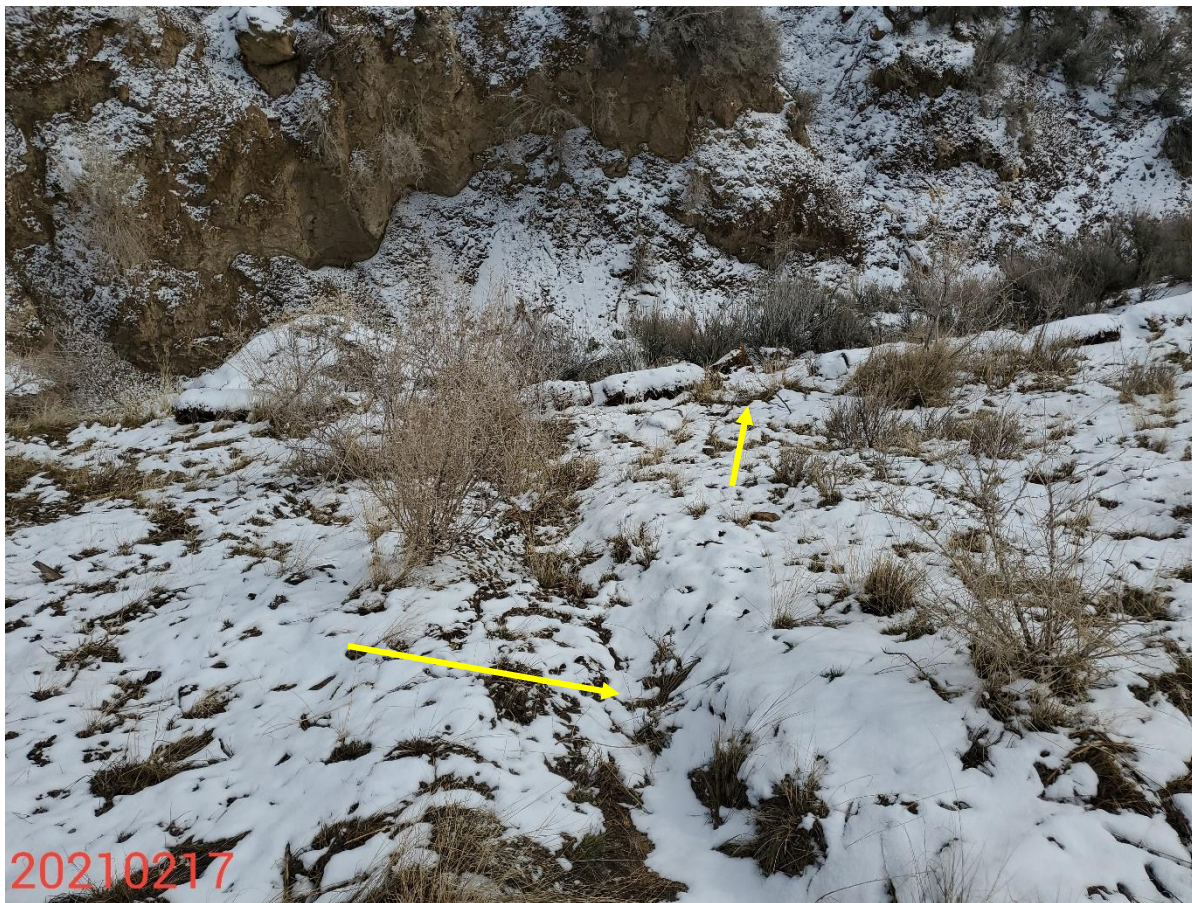
Photo 6: Photo taken from the east end of the Location, facing east. Photo shows areas of the slope where erosion degradation is evident. Photo also shows the hay bale control measure on the perimeter of the Location is in disrepair. Location adjacent to an intermittent drainage along the eastern perimeter.

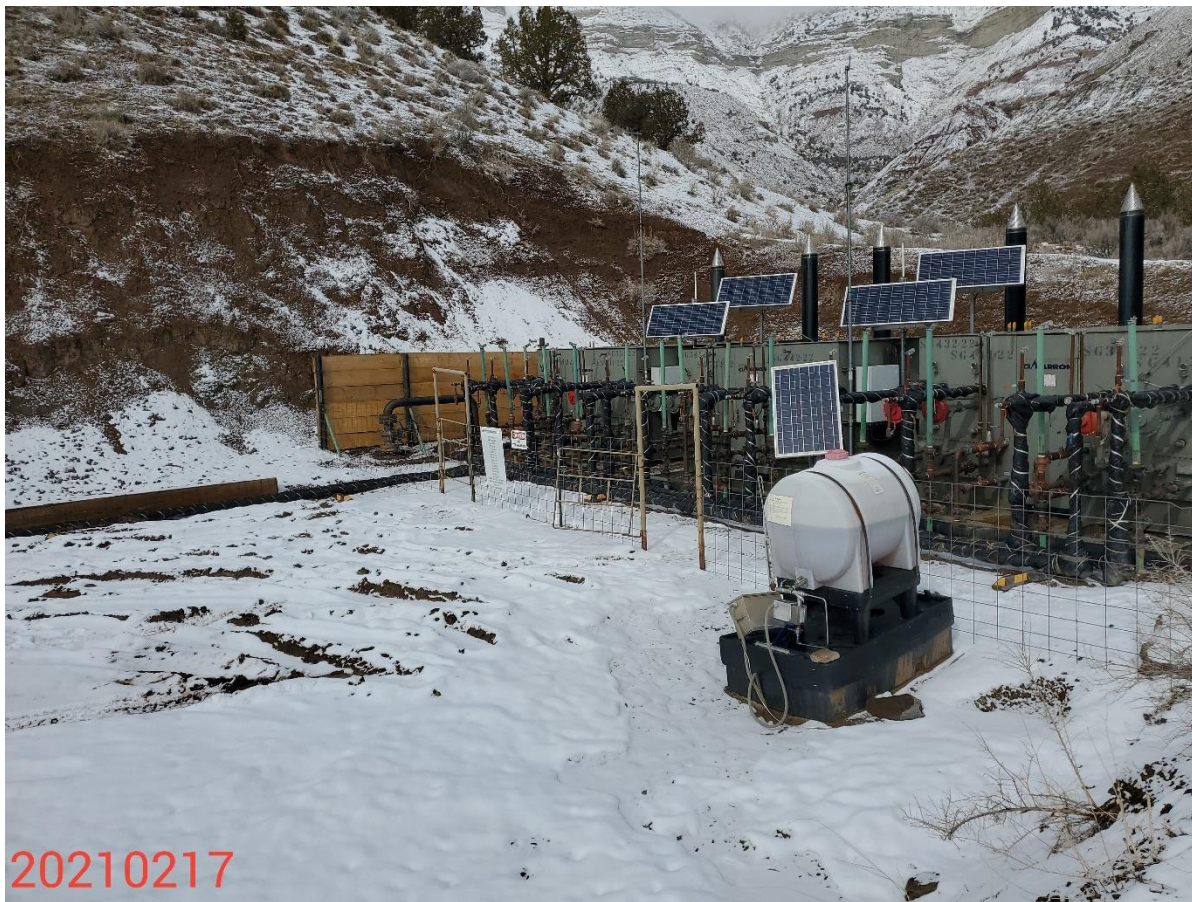
Photo 7: Photo taken from the northeast end of the Location, facing north. Photo shows separator equipment and cut slopes. BMPs missing or insufficient to manage run-on, and stabilize/protect the cut slope; sediment observed falling from cut slopes during inspection.

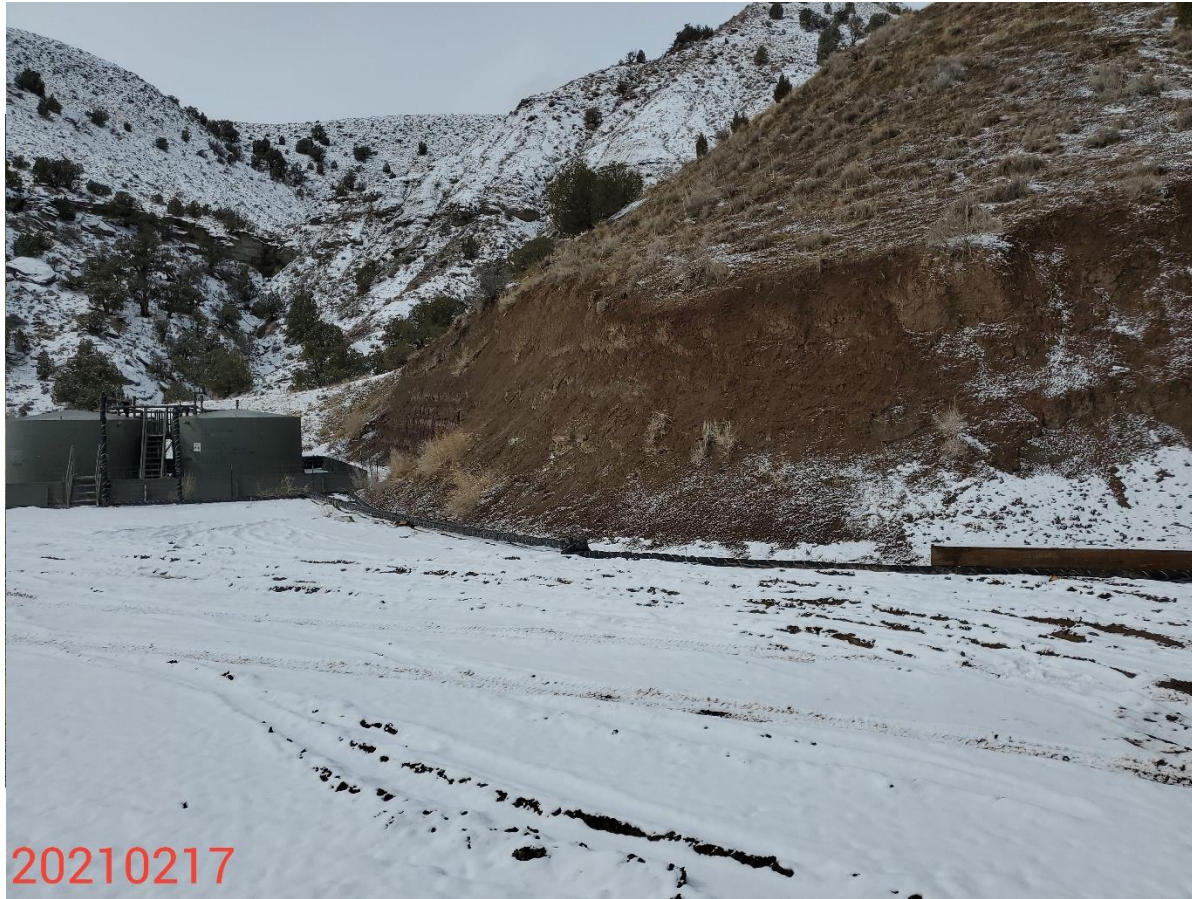
Photo 8: Photo taken from the north end of the Location, facing west. Photo shows cut slope has been constructed with a steep slope and that BMPs to manage run-on, and to stabilize/protect the cut slope are missing or insufficient.

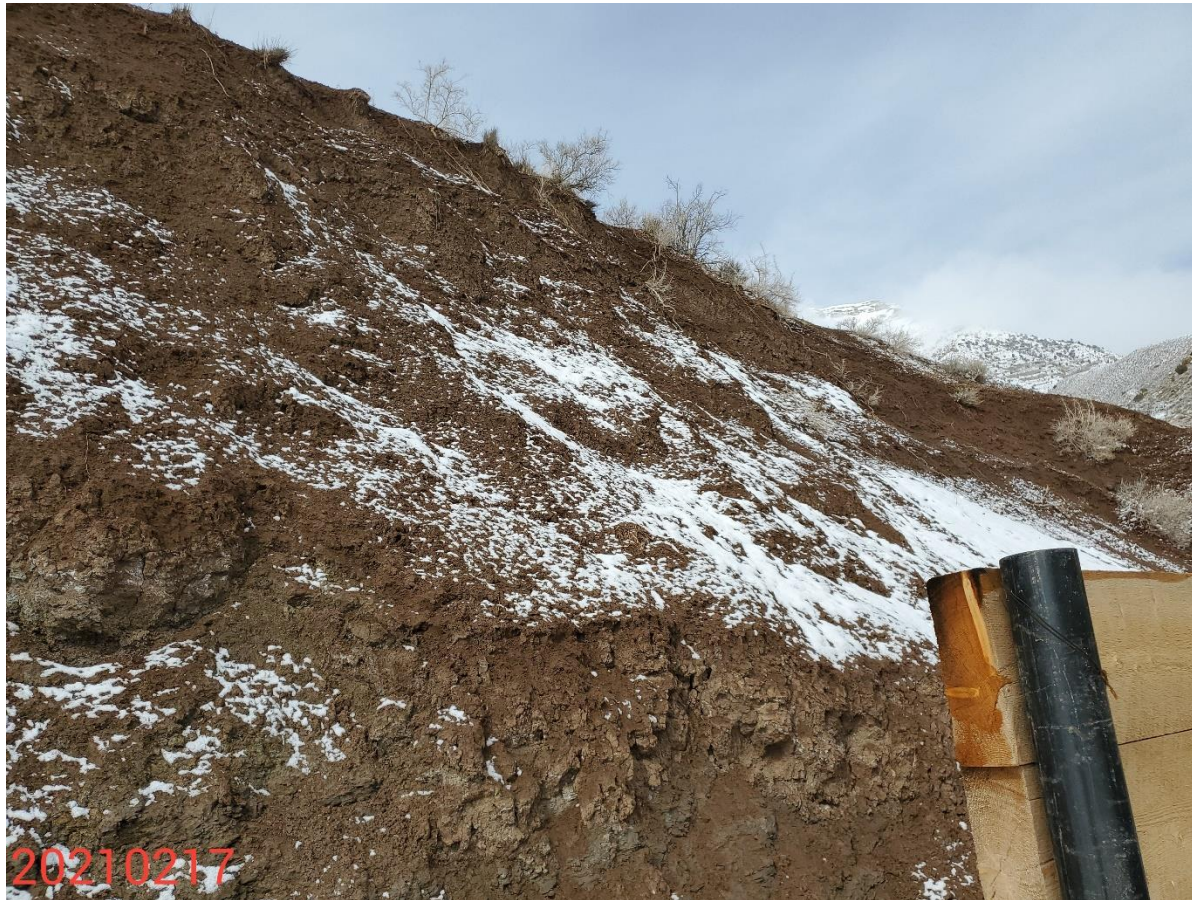
Photo 9: Photo of the cut slope. See comments under photo 7

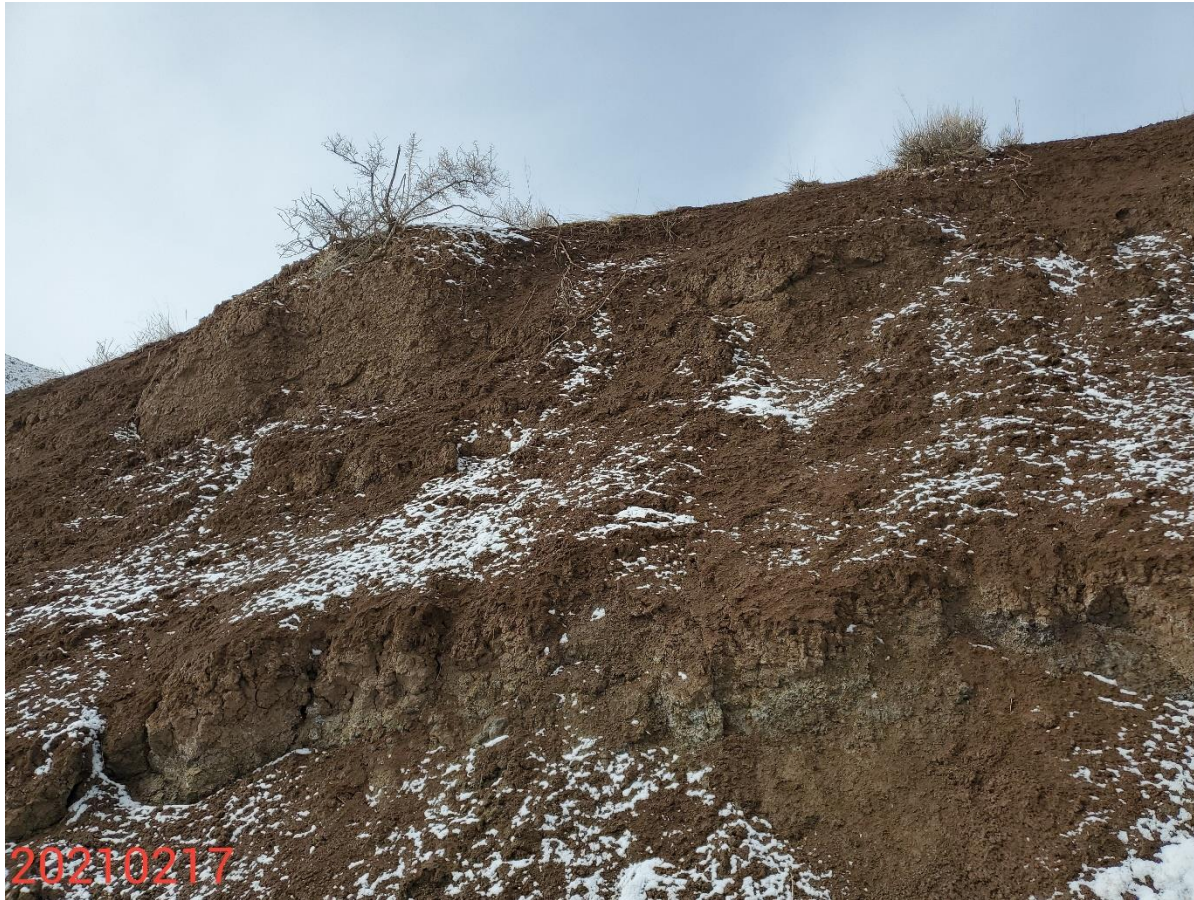
Photo 10: Photo of the cut slope. See comments under photo 7

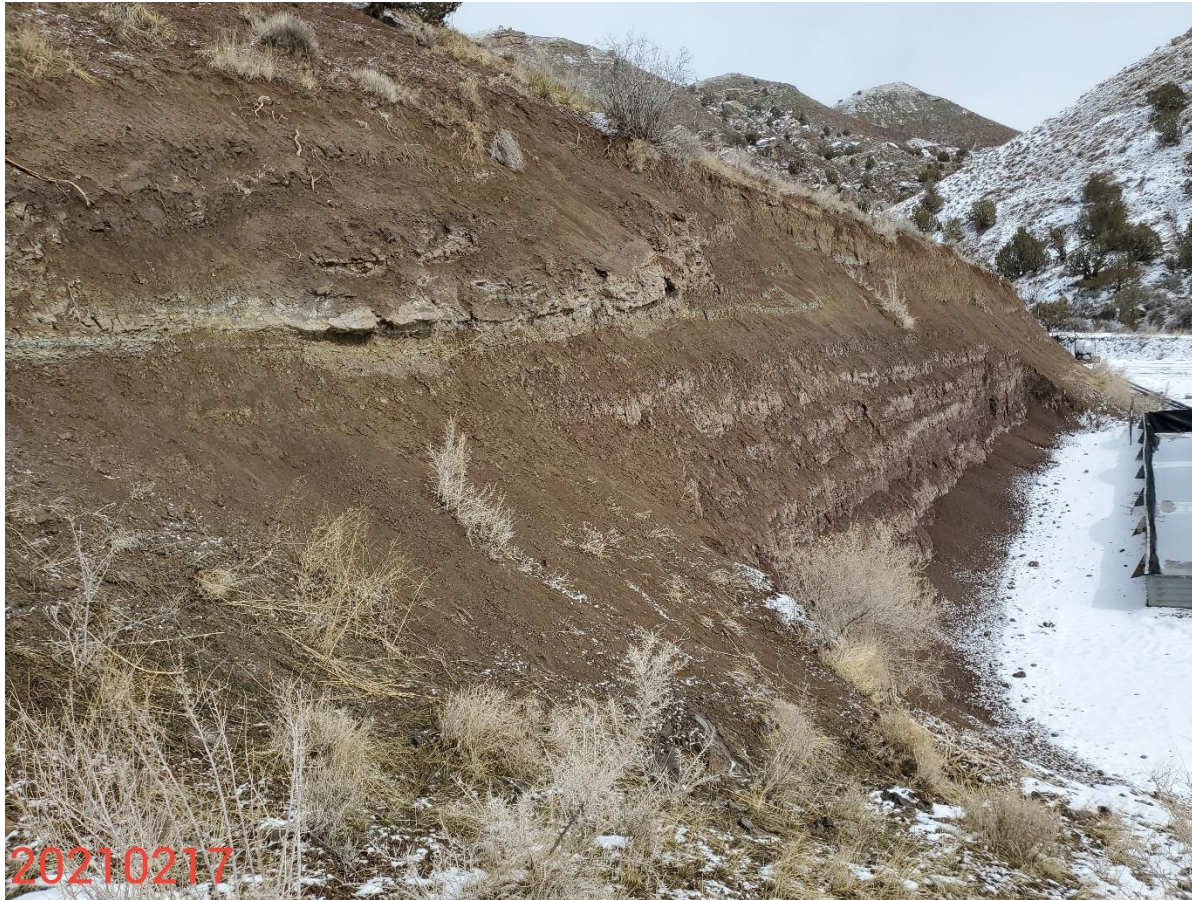
Photo 11: Photo taken from the northwest corner of the Location, facing east. Photo shows cut slope has been constructed with a steep slope and that BMPs to manage run-on, and to stabilize/protect the cut slope are missing or insufficient.

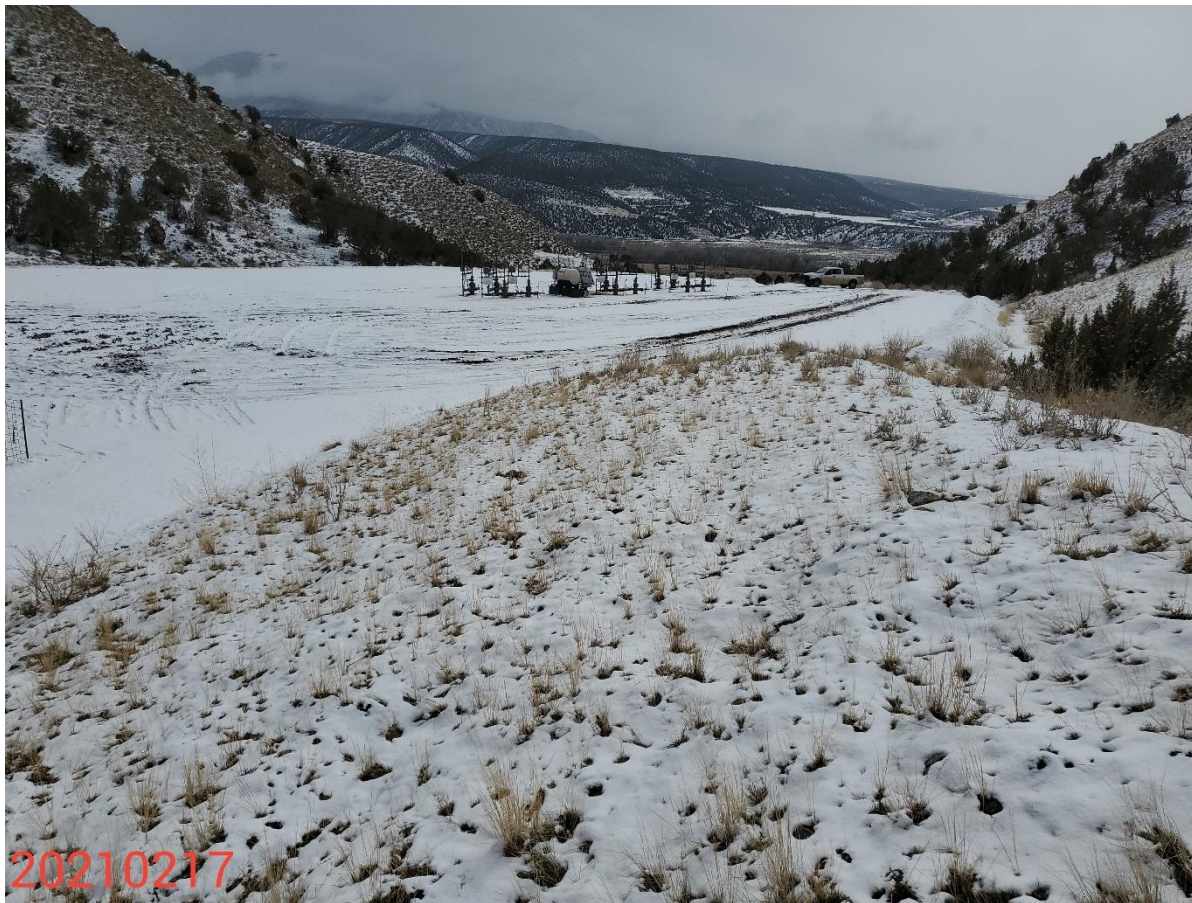
Photo 12: Photo taken from the northwest corner of the Location, facing south. Photo provides an overview of the production area, and interim areas. Visible vegetation predominantly desirable perennial plant species.

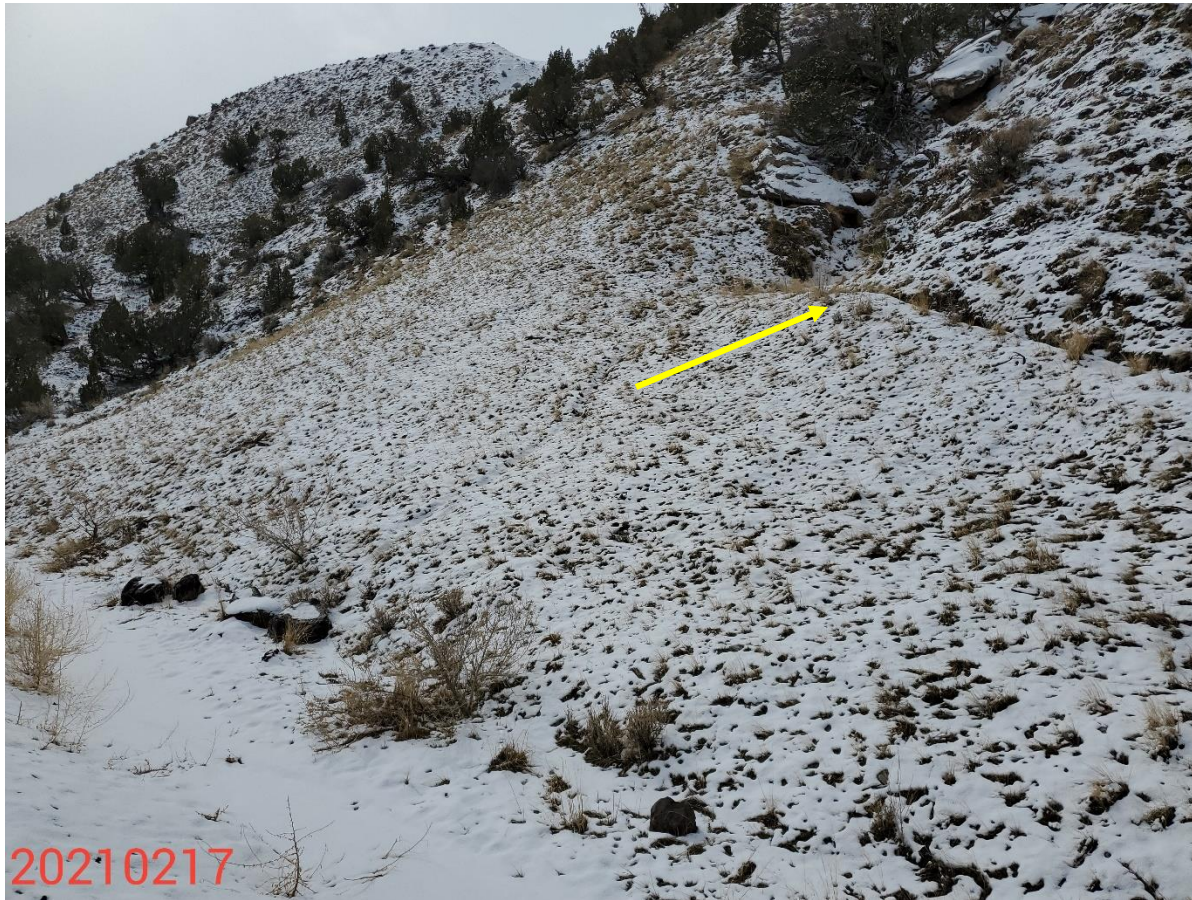
Photo 13: Photo taken from the west end of the Location, facing southwest. Photo shows interim areas and ditch along the west end of the Location/slope.

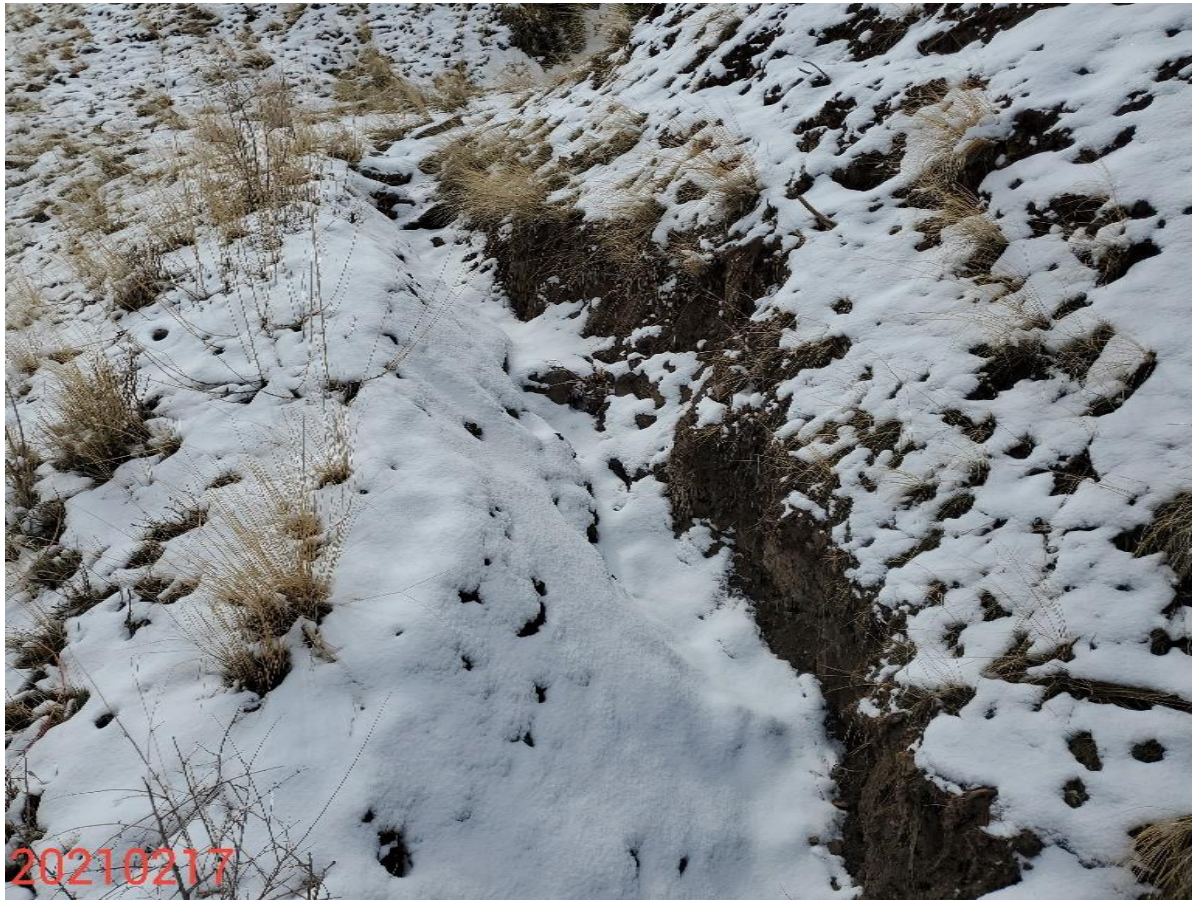
Photo 14: Continued from photo 13. Photo shows ditch has not been constructed in accordance with good engineering practices; stormwater incision within the ditch evident.
