**CAERUS PICEANCE LLC
CHEVRON-66S96W 4SWNW
Location # 335578**

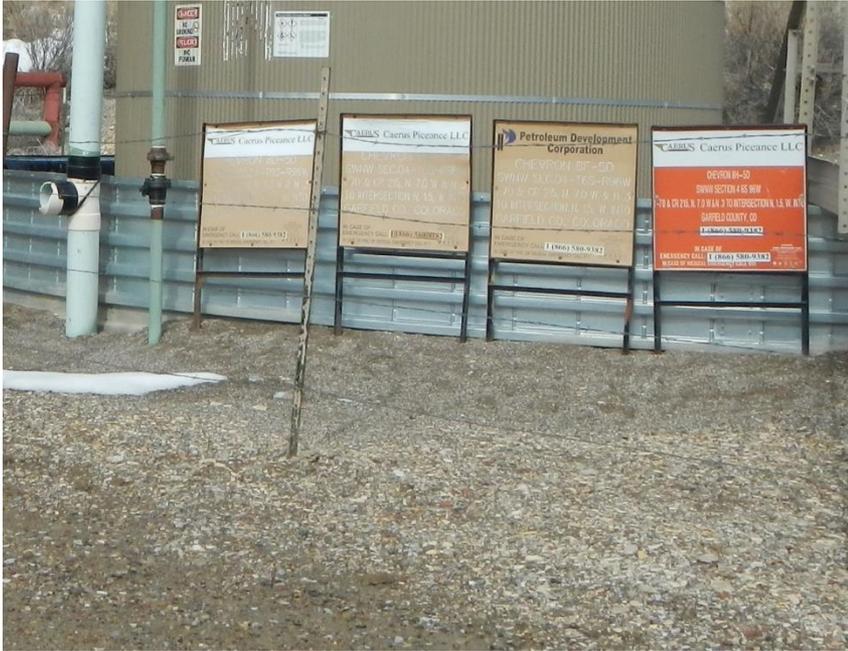
Battery sign missing Operator name.

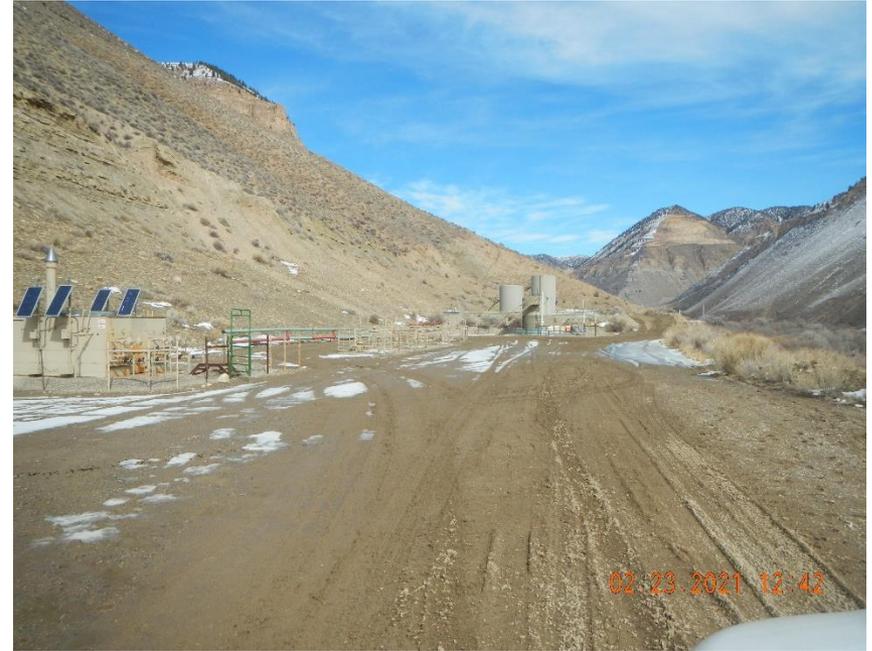
Location shows signs of lack of stabilization BMP's in some areas (rutting is present).

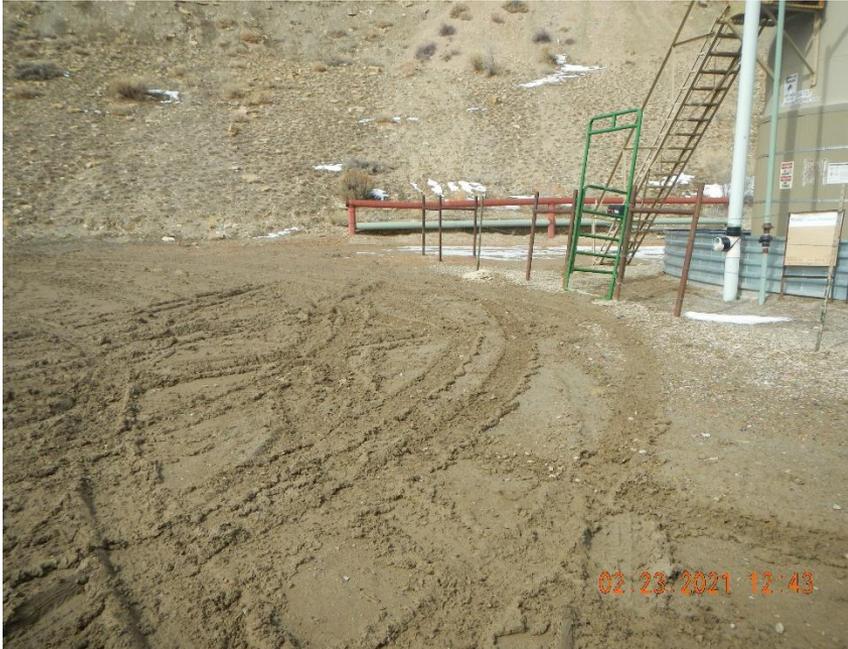
**Location shows signs of lack of stabilization BMP's
in some areas (rutting is present).**

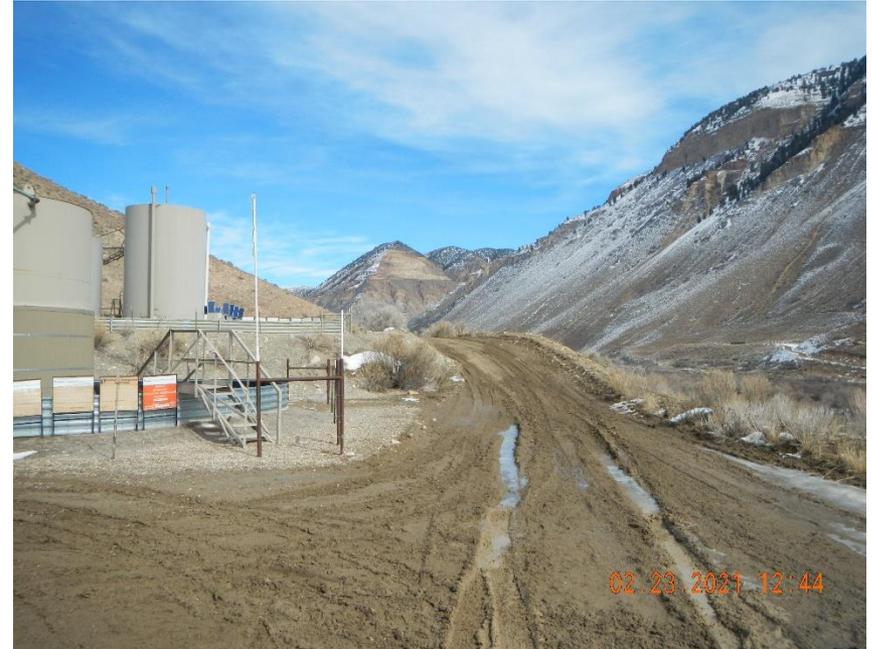
**Location shows signs of lack of stabilization BMP's
in some areas (rutting is present).**

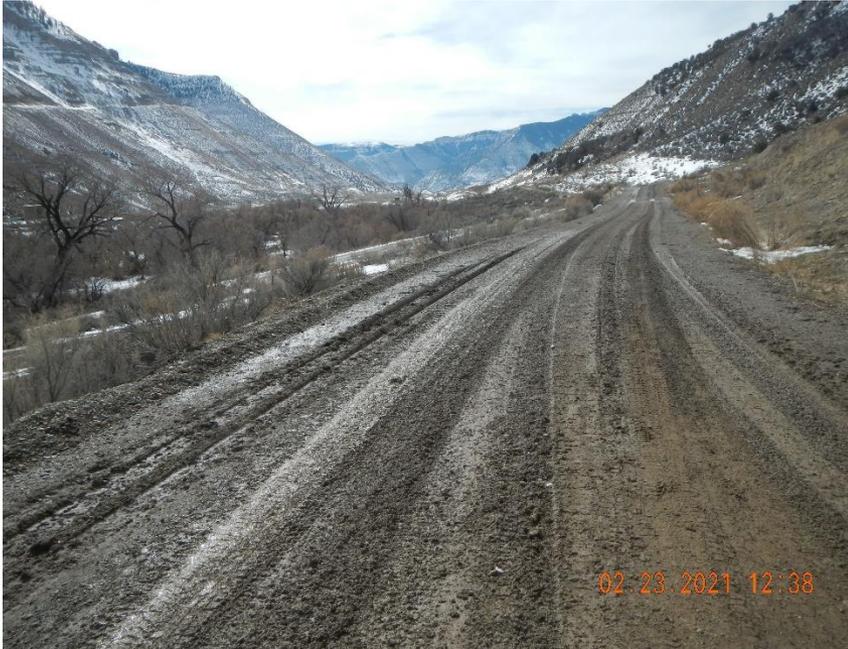
**Access road shows signs of lack of stabilization
BMP's in some areas (rutting is present).**

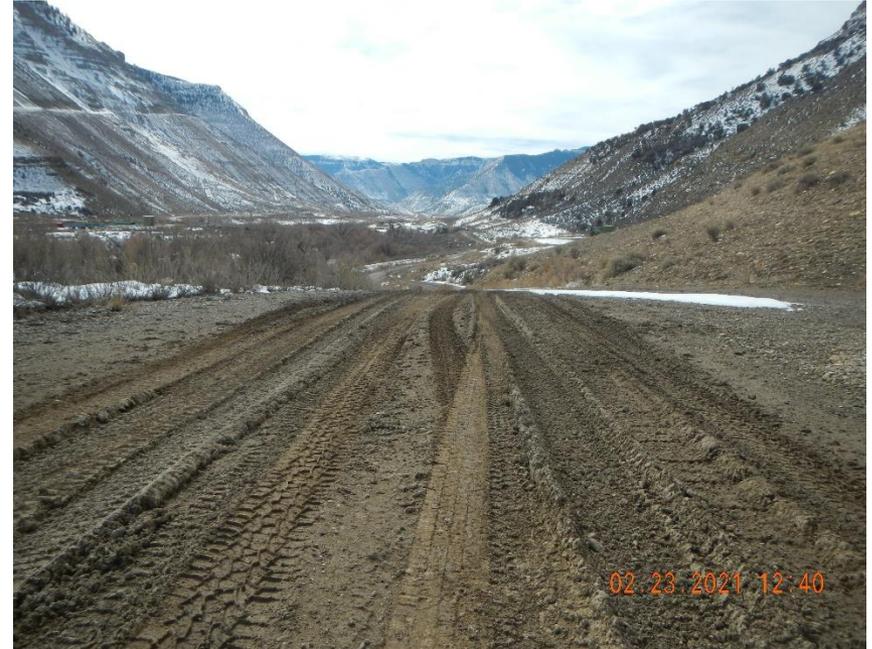
**Access road shows signs of lack of stabilization
BMP's in some areas (rutting is present).**

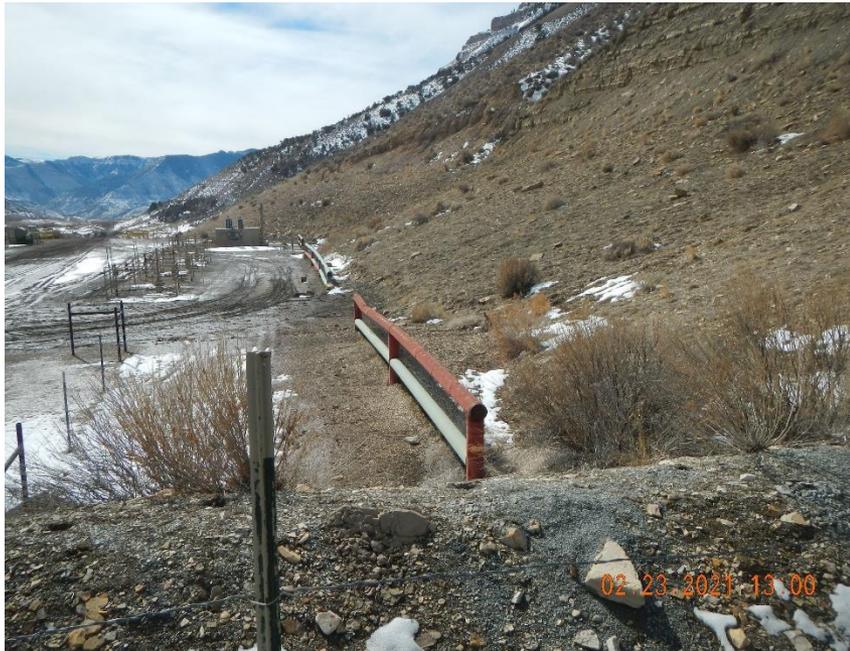
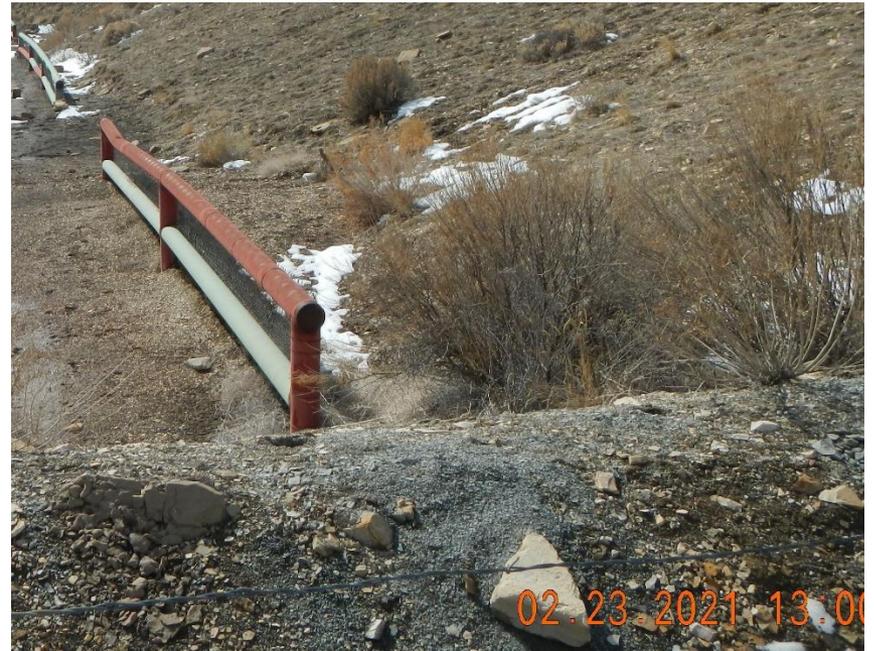
Sediment build up behind falling rock guard rails.

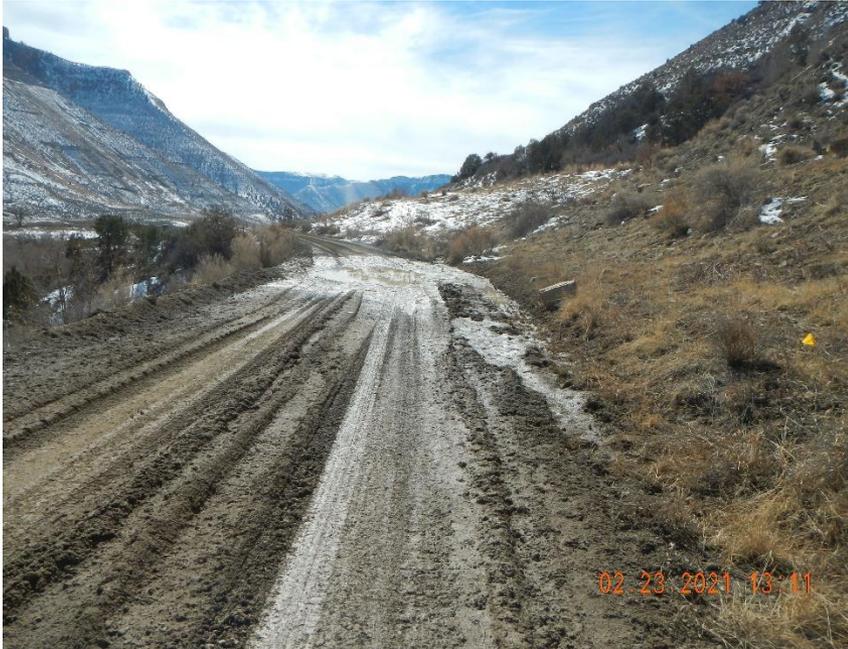
**N39.55096 W108.12064 Rut damage in ditch.
Water not draining off road into culvert or ditch.**

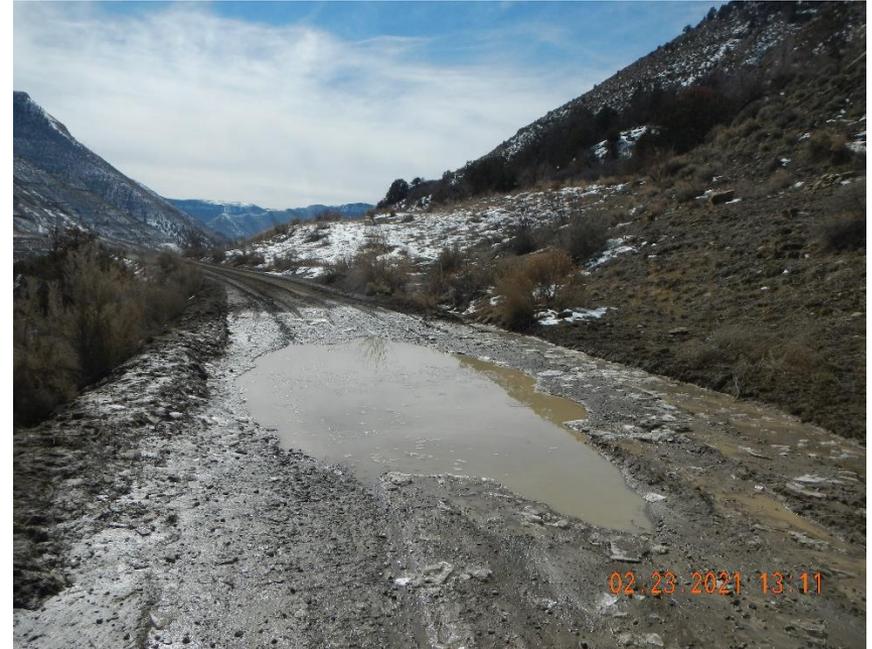
**Access road shows signs of lack of stabilization
BMP's in some areas (rutting is present).**

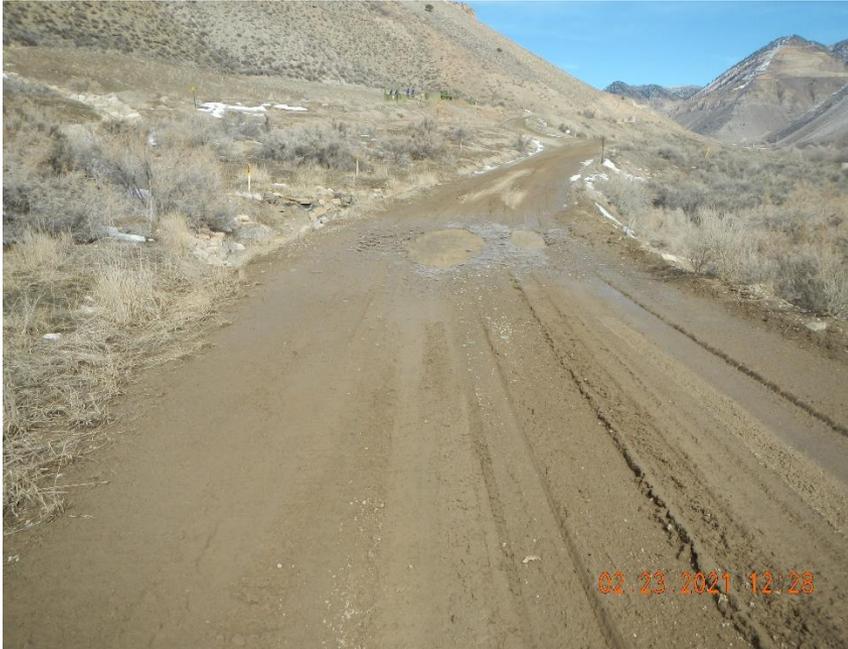
**Access road shows signs of lack of stabilization
BMP's in some areas (rutting is present).**

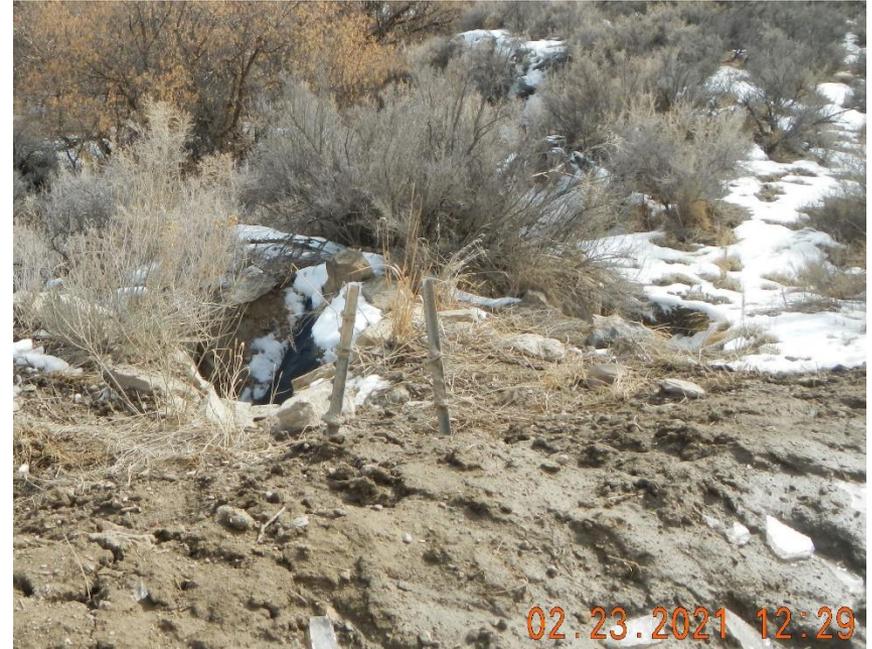
**N39.55348 W-108.11985 Erosion damage
from culvert outlet.**

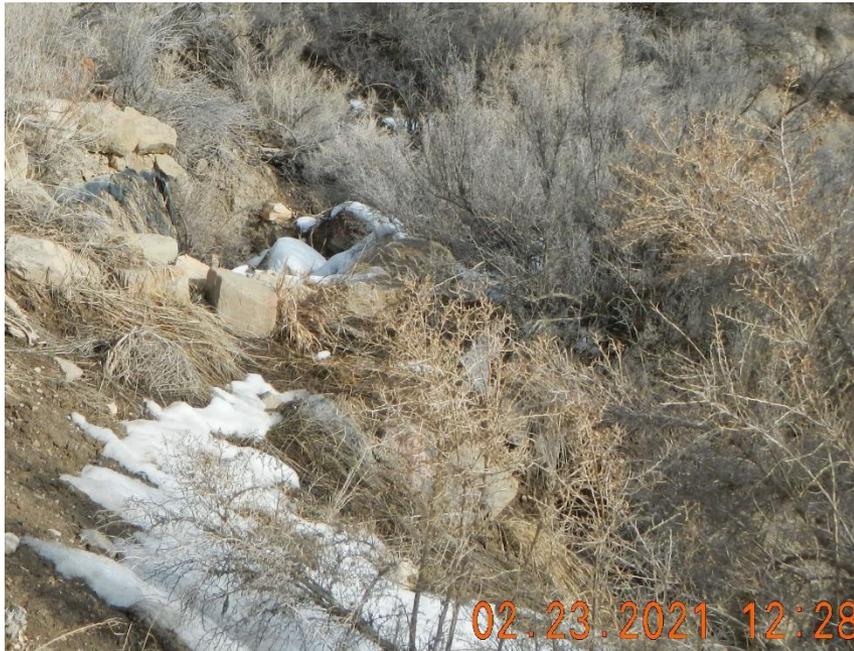
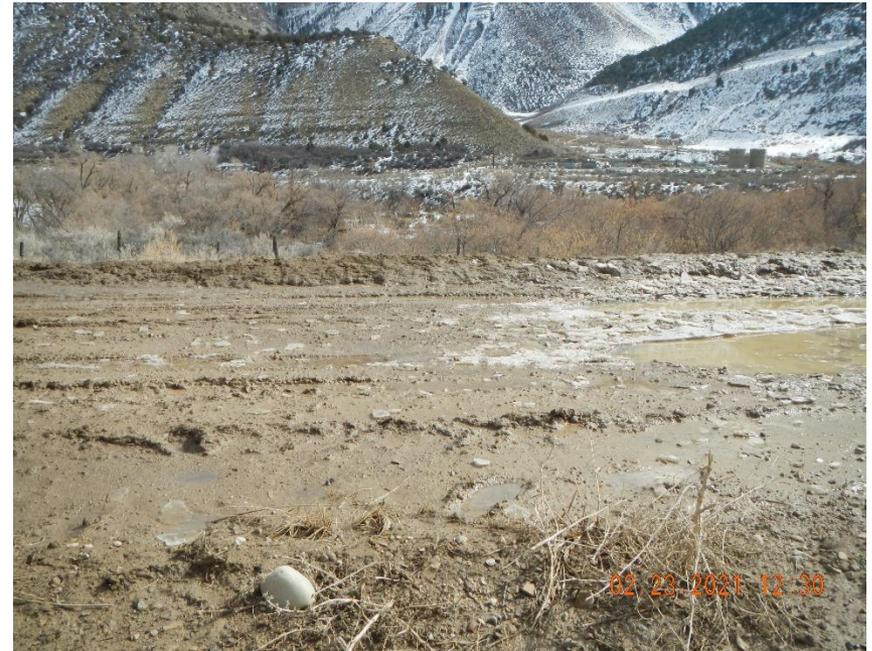
**N39.55348 W-108.11985 Erosion damage
from culvert outlet.**
