**Inspection Photos**  
**Location Name: Cosslet A 9 Flowline**  
**Spill ID: 478542**

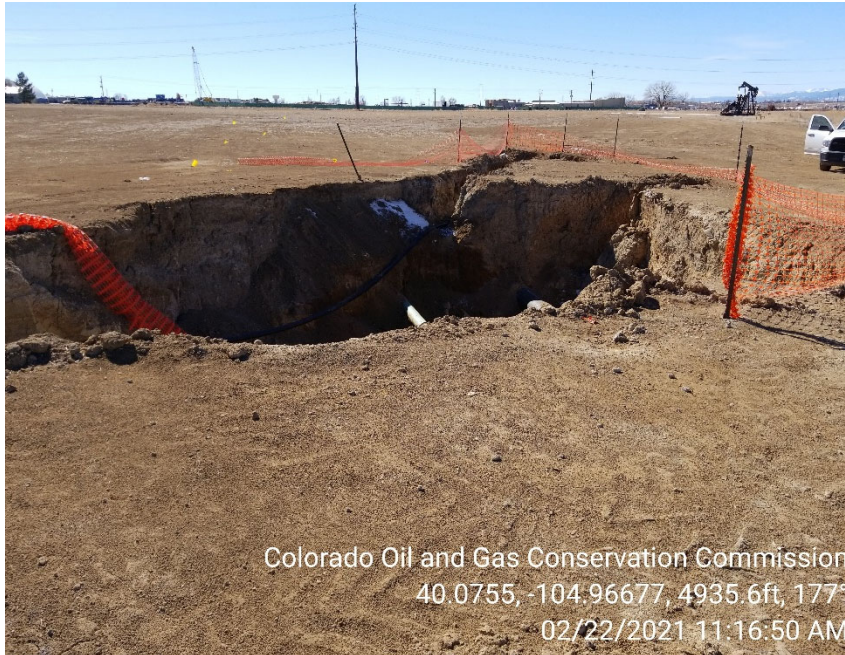
**Photo 1 – Spill excavation area. Fencing is down around open excavation.**

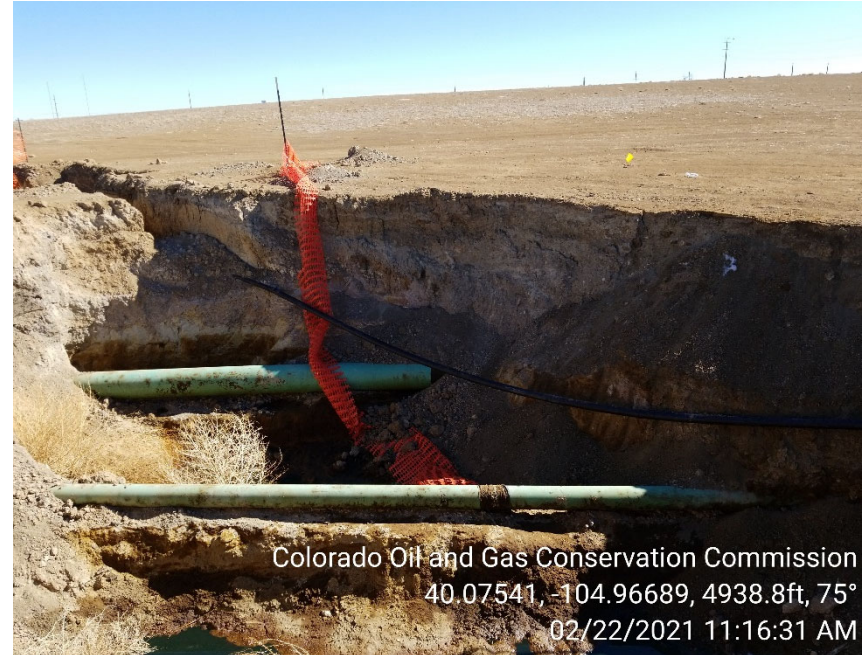
**Photo 2 – 3<sup>rd</sup> party lines running through open excavation.**

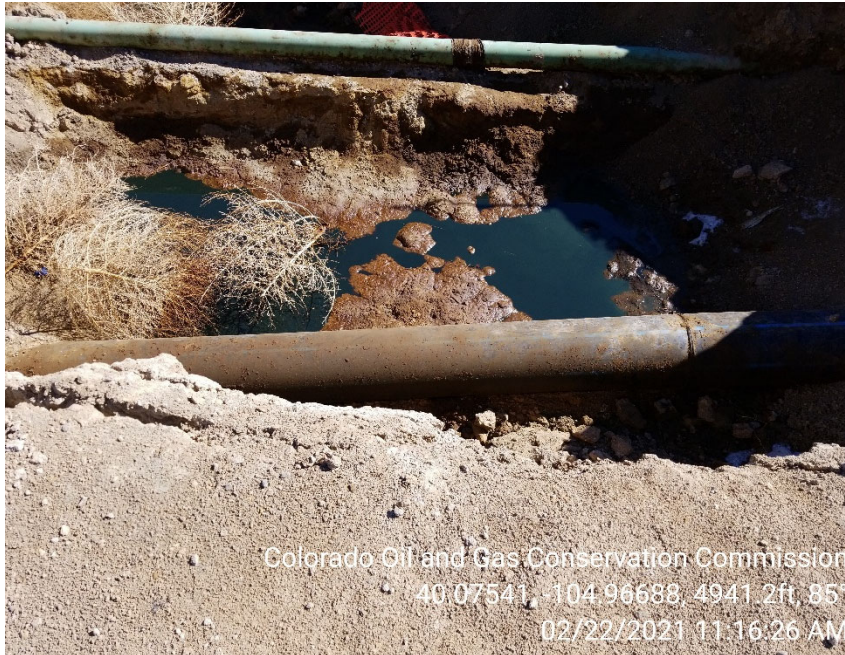
**Photo 3 – Free product present in open excavation.**

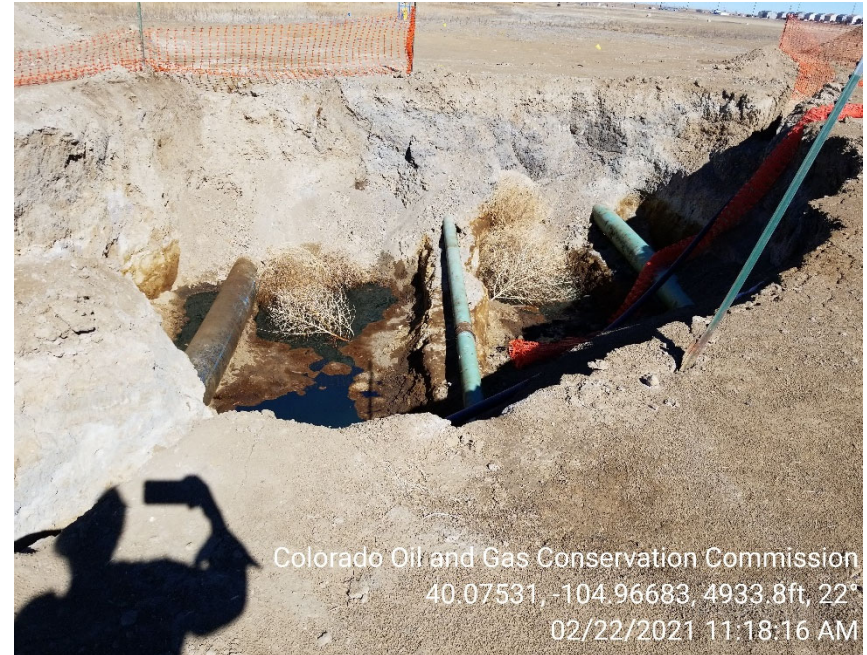
**Photo 4 – Free product present in open excavation.**

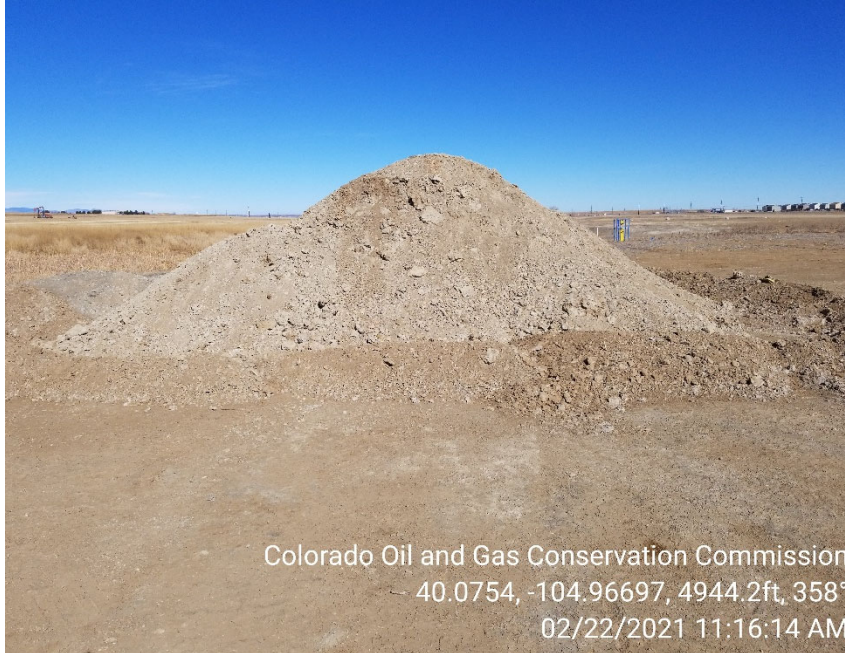
**Photo 5 – Soils stored on site.**

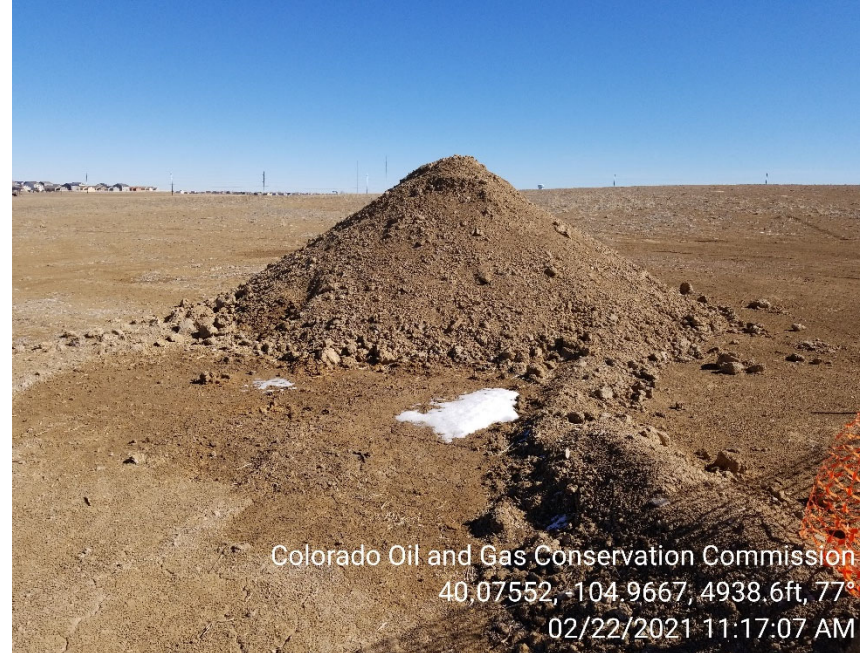
**Photo 6 – Soils stored on site.**

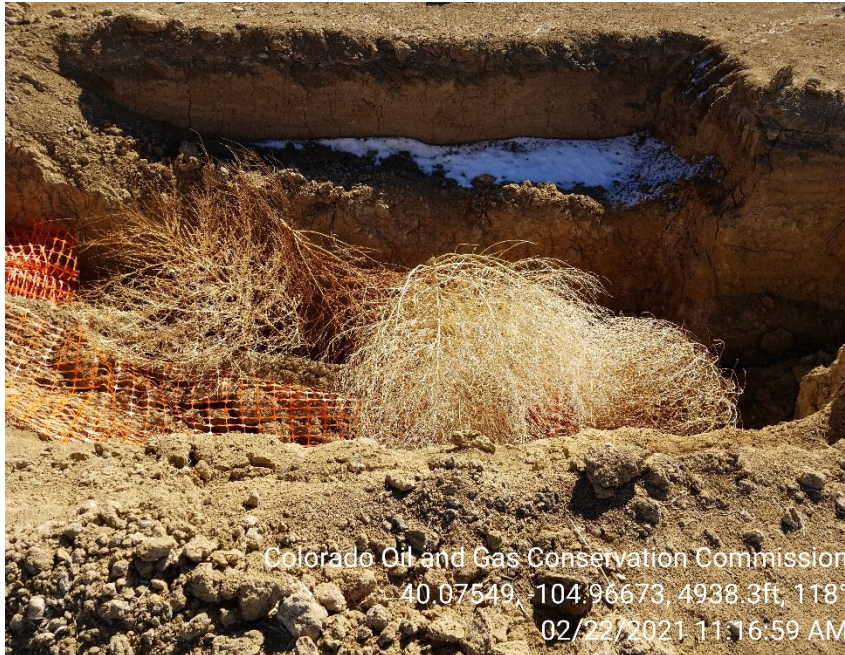
**Photo 7 – Weeds/debris in open excavation**

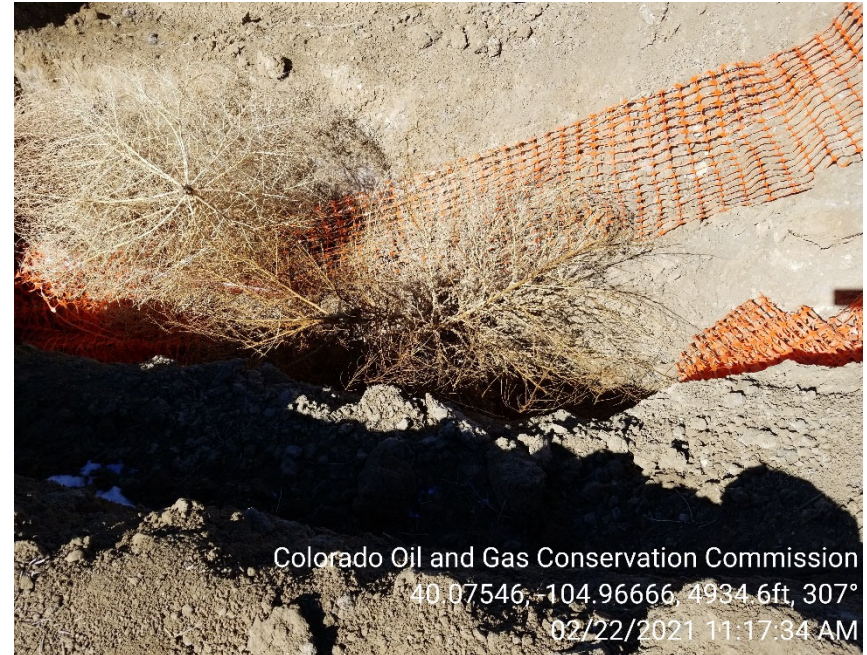
**Photo 8 – Weeds/debris in open excavation**
