Inspection Photos

Location Name: CAERUS PICEANCE LLC ENCANA-67S95W /21NWNW

Location ID: 335047

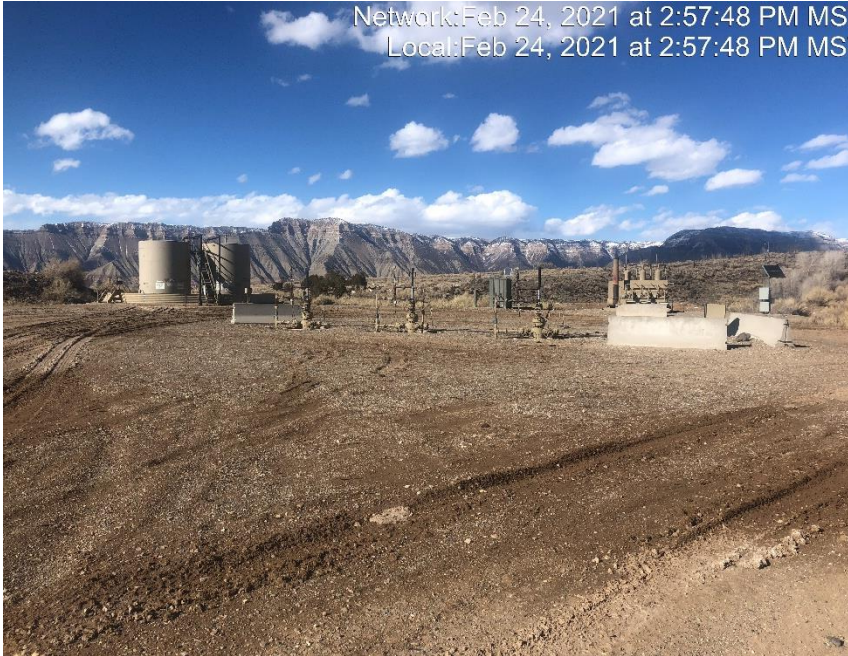
Photo #2974 from entrance to location.

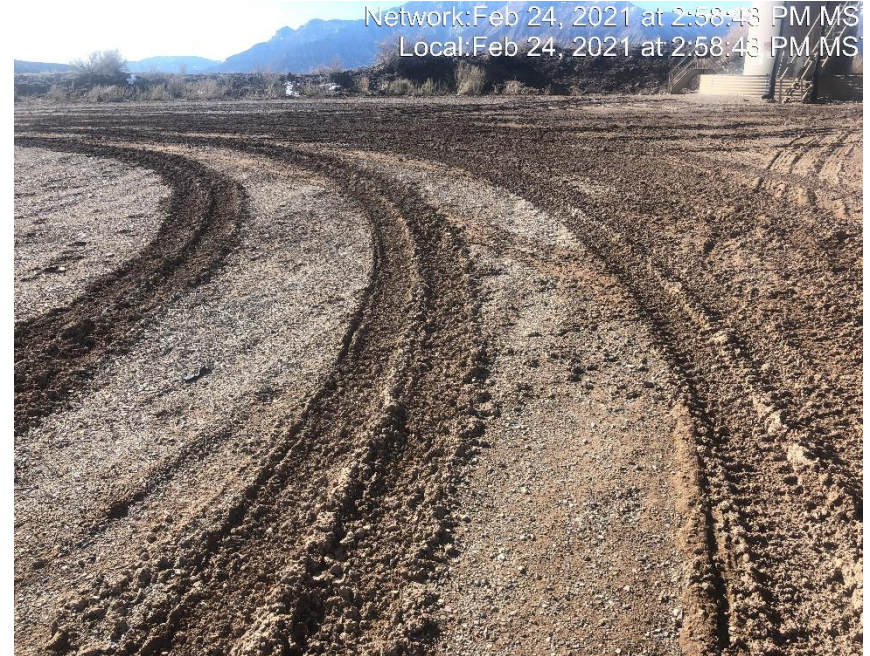
Photo #2975 Rutting present on location due to lack of stabilization.

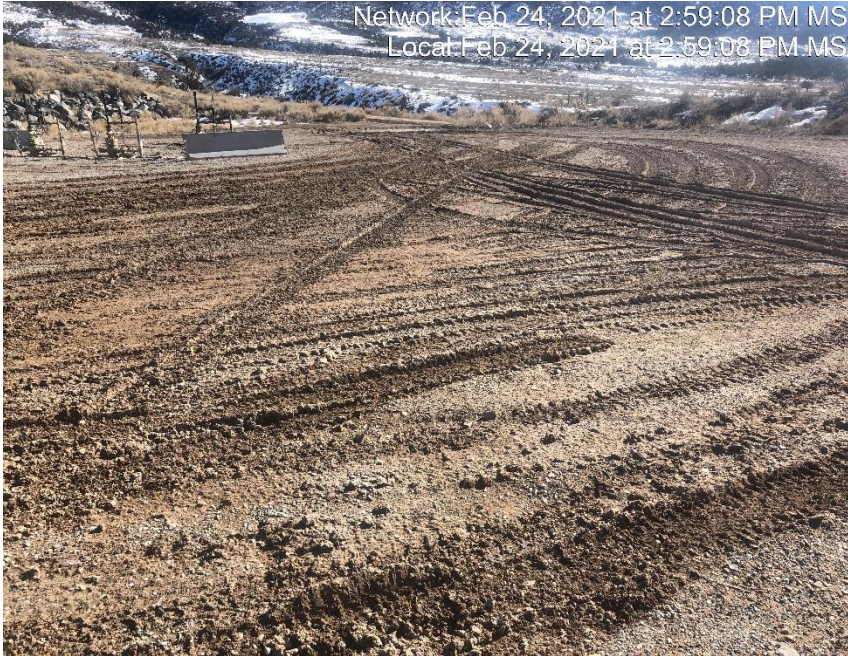
Photo #2976 Rutting present on location due to lack of stabilization.

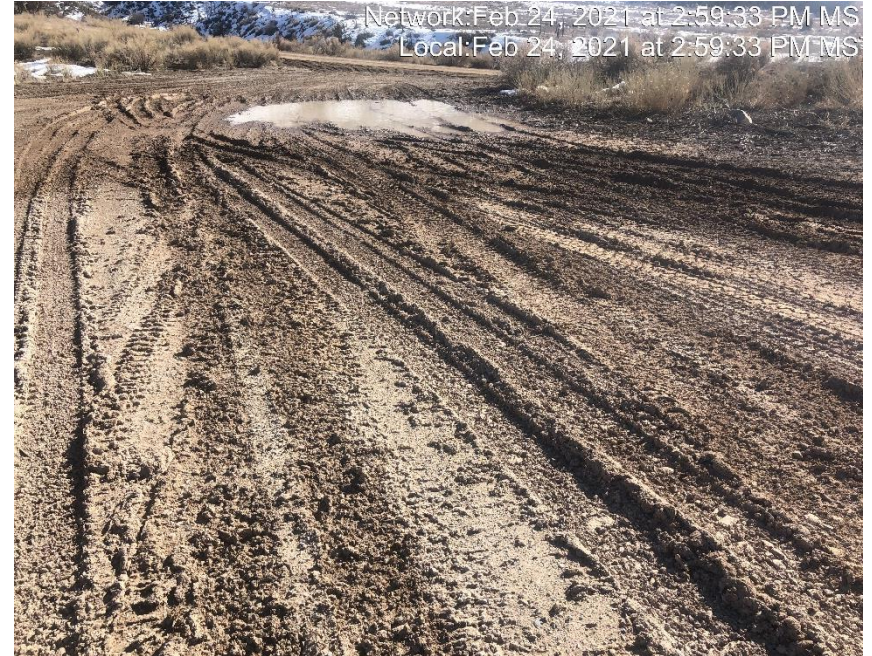
Photo #2977 Rutting present on location due to lack of stabilization.

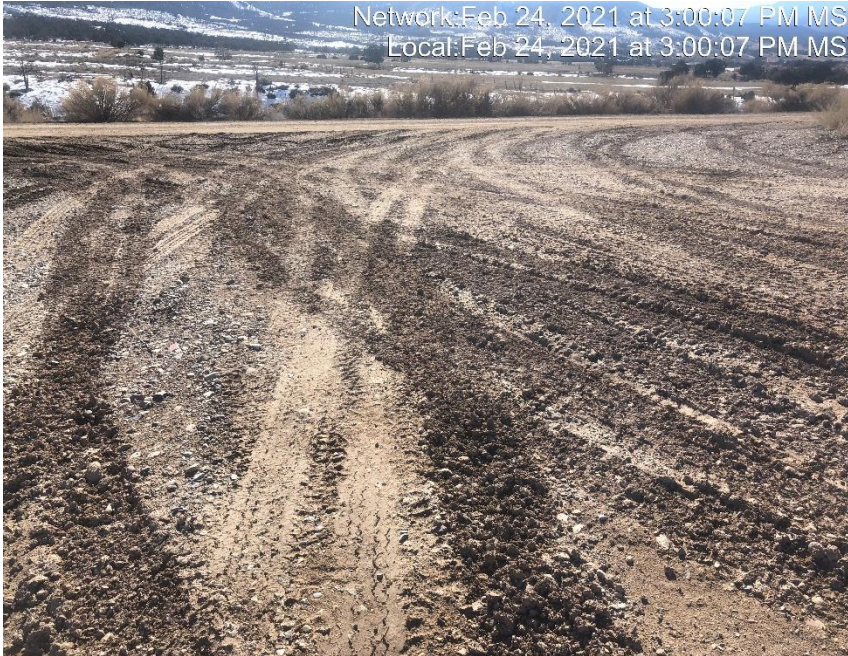
Photo #2978 No form of tracking control at the entrance to location.

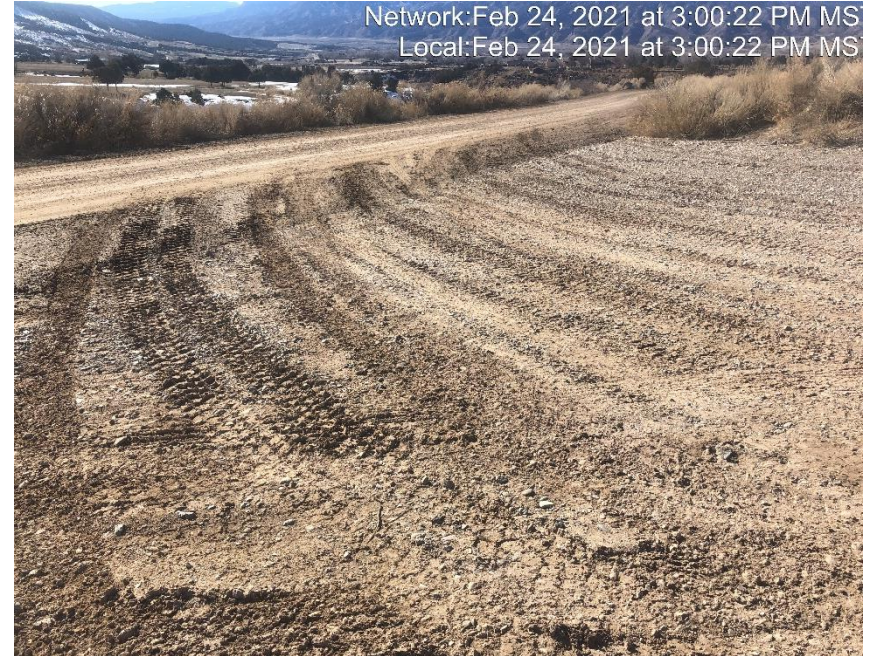
Photo #2979 No form of tracking control at the entrance to location.

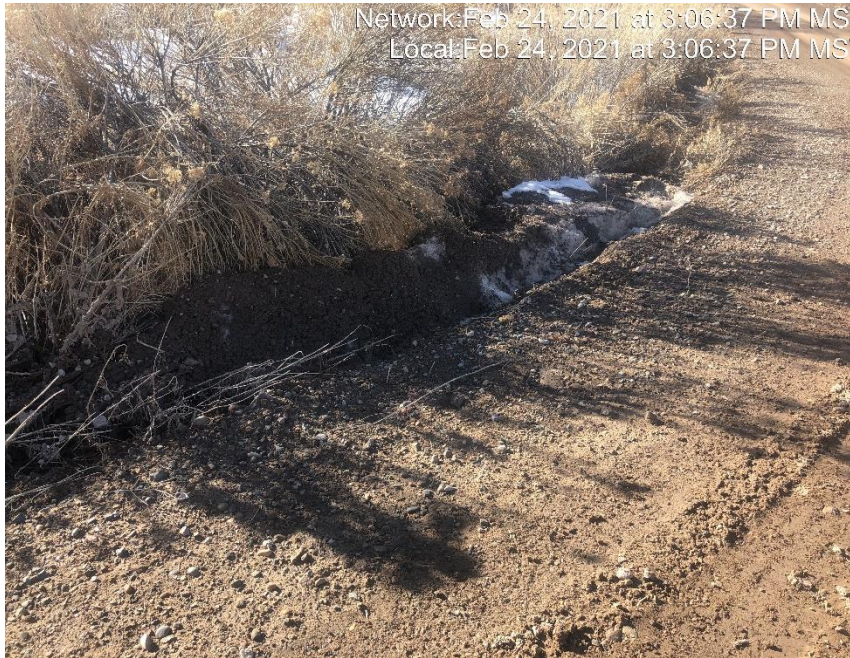
Photo #2980 Sediment has been plowed into ditch and is choking off vegetation.

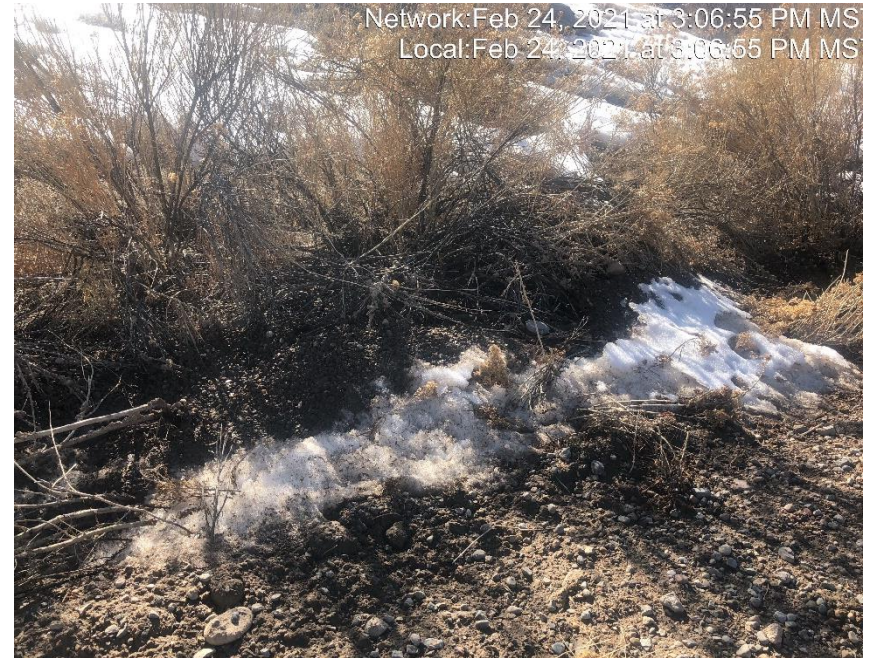
Photo #2981 Sediment has been plowed into ditch and is choking off vegetation.

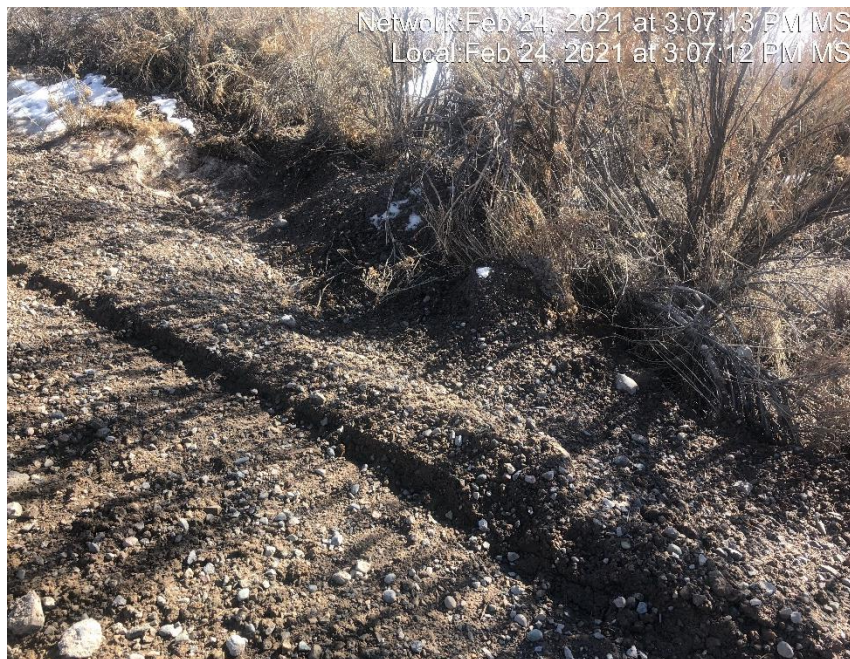
Photo #2982 Sediment has been plowed into ditch and is choking off vegetation.

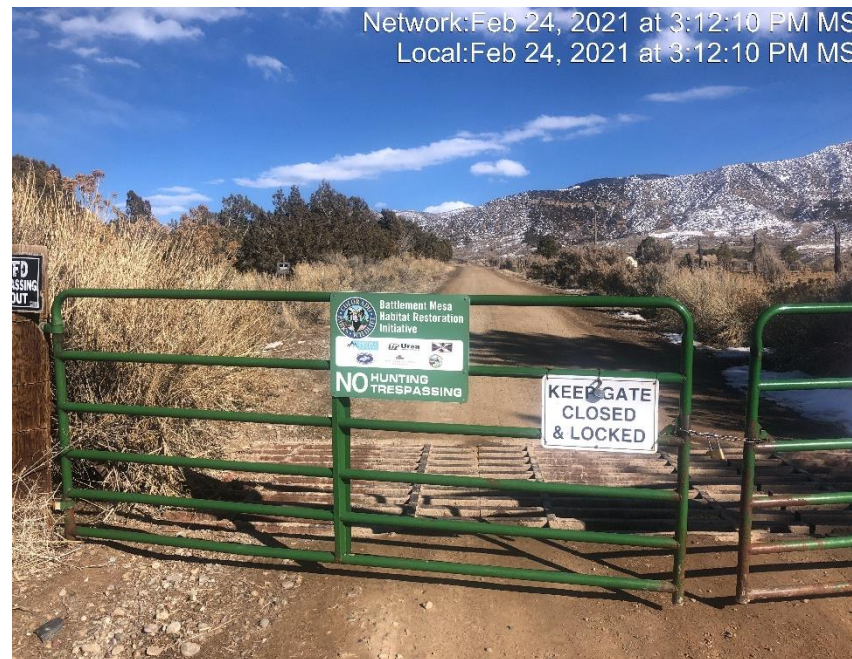
Photo #2983 Battlement habitat restoration area.
