# Inspection Photos

Operator: Hilcorp Energy  
API: 067-09409  
Date: 2/24/2021

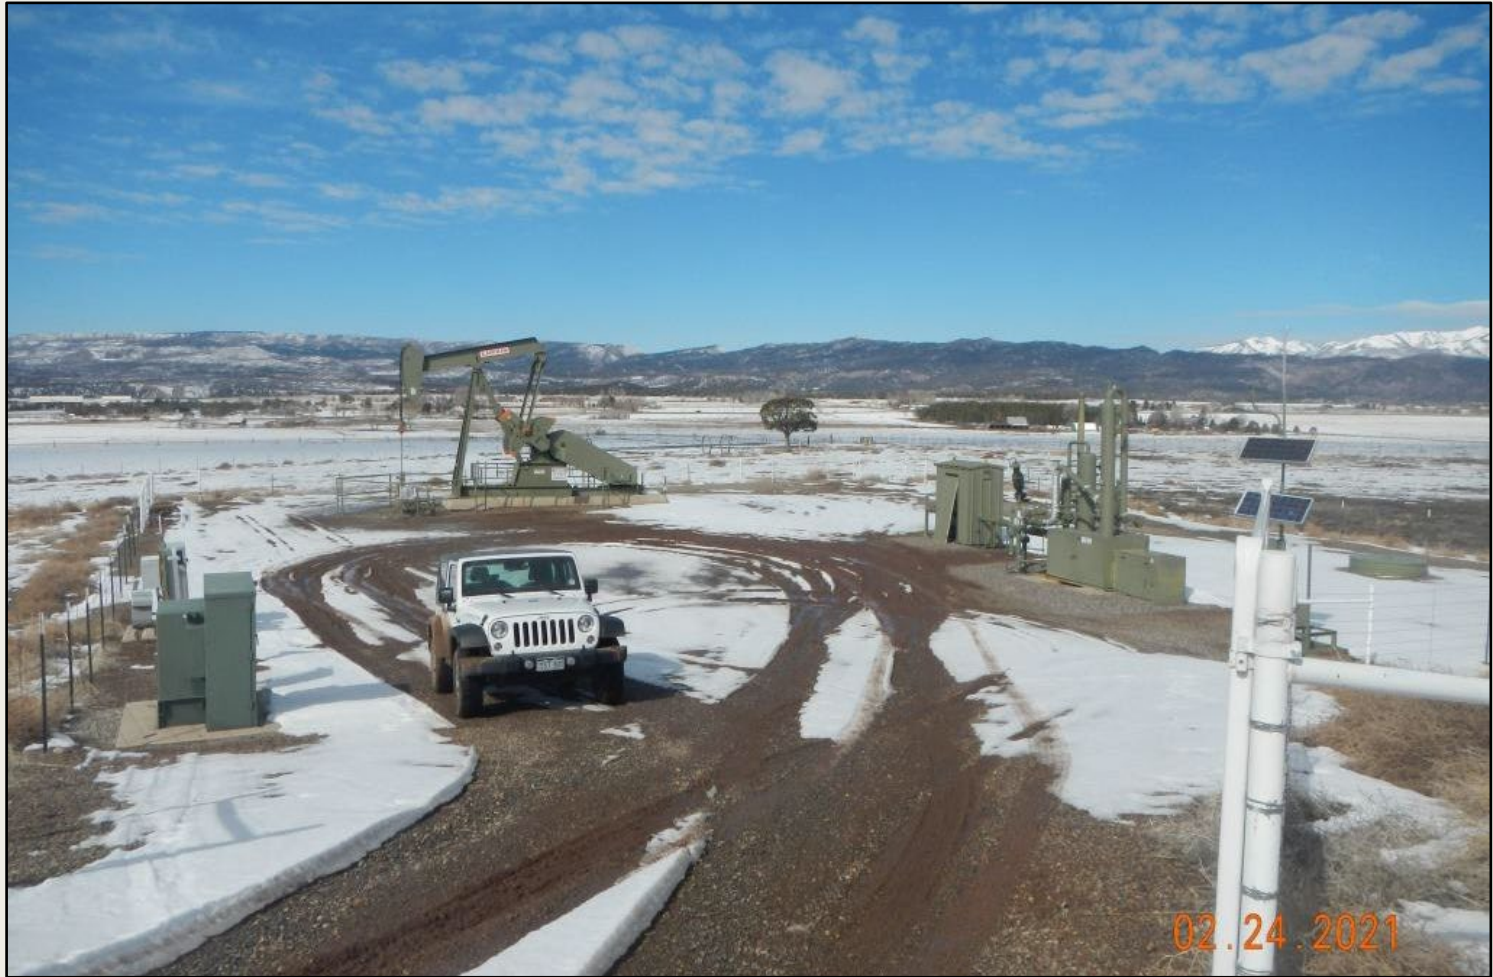
Photo 1. View of the well pad entrance facing center.

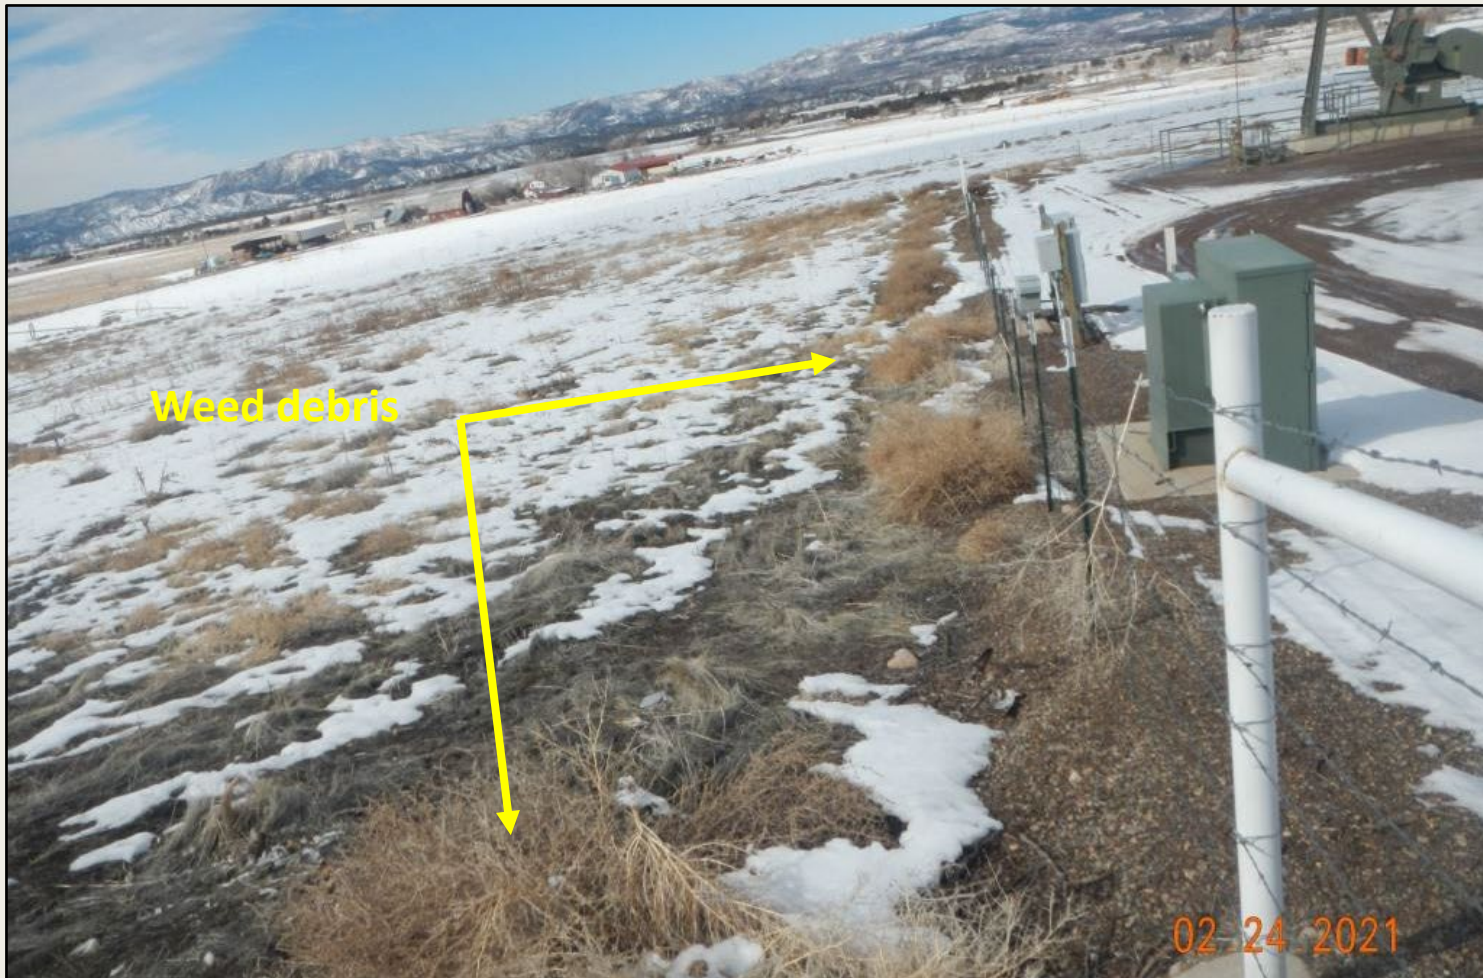
Photo 2. View of the southern project area facing westward. Dense weed debris observed along the fenceline of the working area.

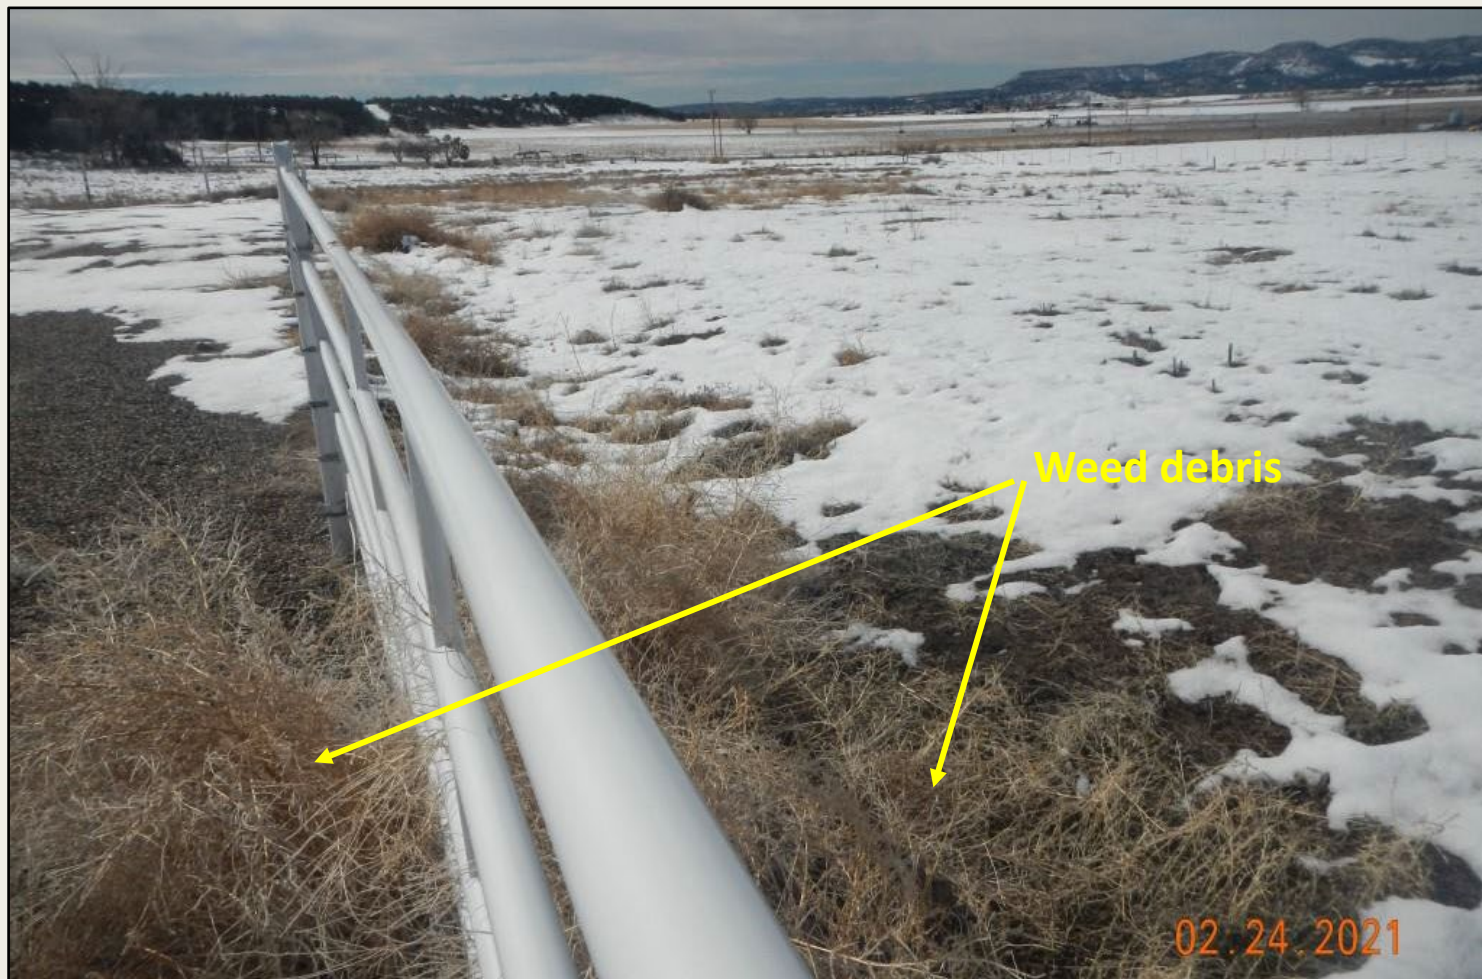
Photo 3. View of the western project area facing southward. Dense weed debris observed along the fencelines.
