Inspection Photos

API: 099-06354

Operator: BERRY* WALTER V DBA BERRY
ENERGY INC

Inspection Date: 2/23/2021

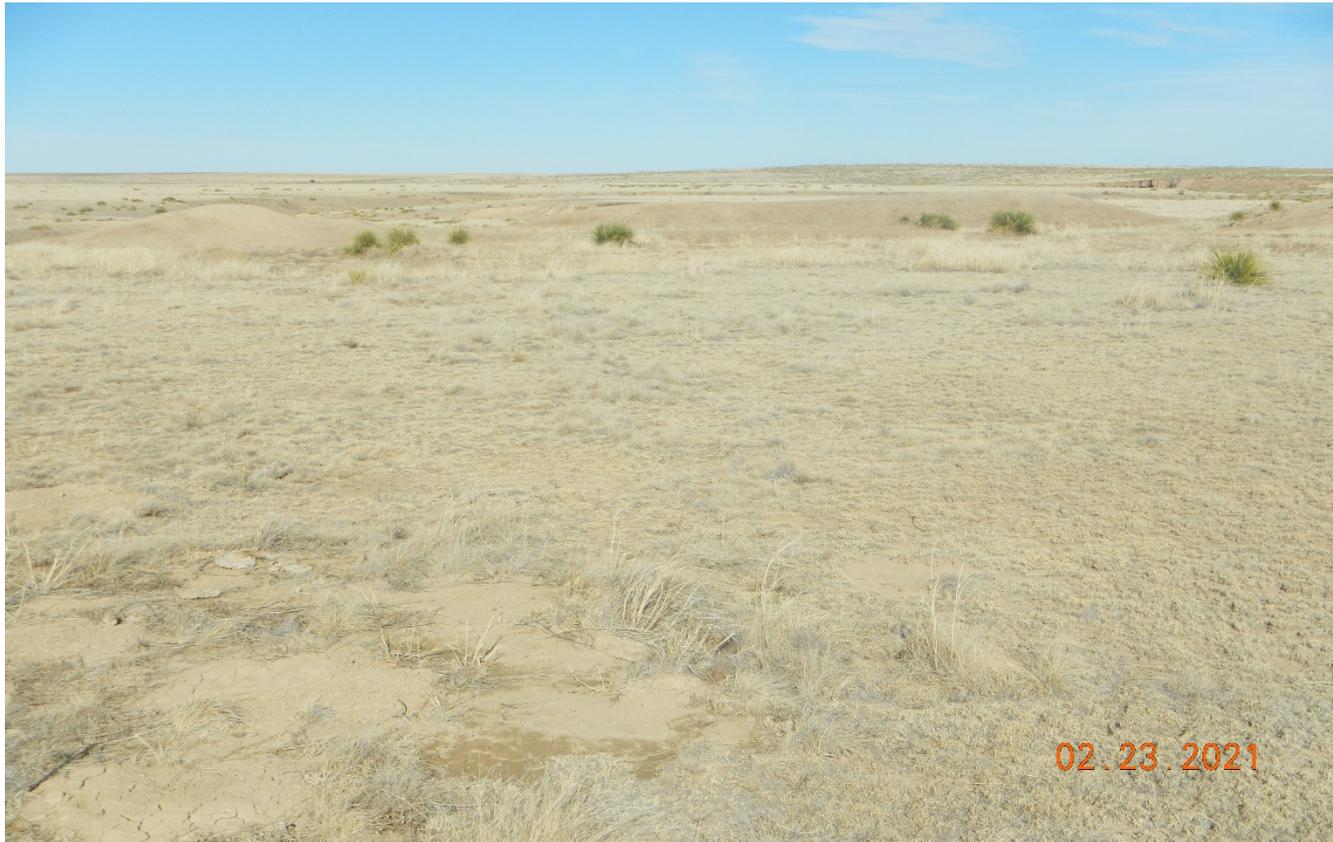
Photo 1. Facing northeast toward the location. There are soil pile that remain from the pits at the northeast side of the location.

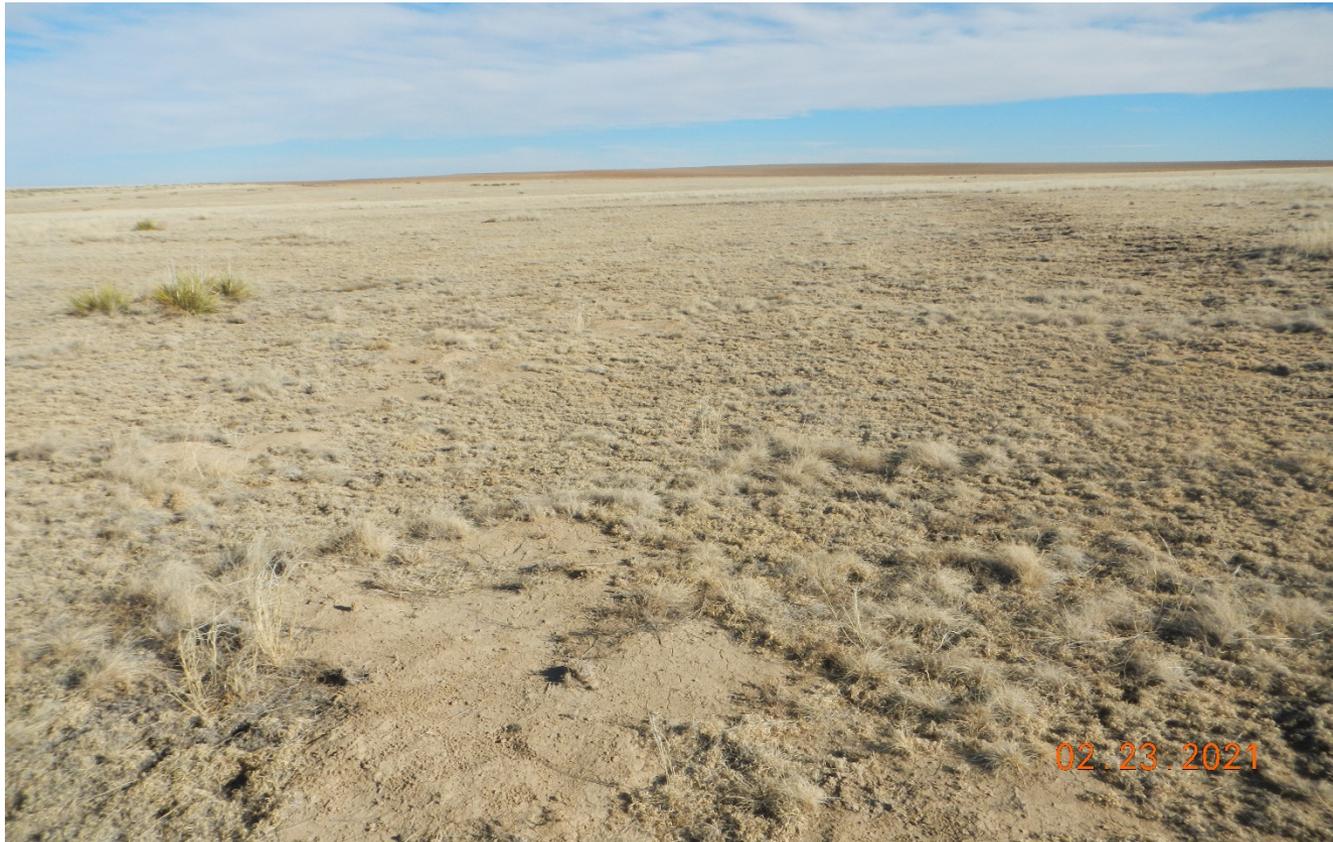
Photo 2. Facing southeast at the location. Vegetation has re-established. An outline of the location remains where it was graded.

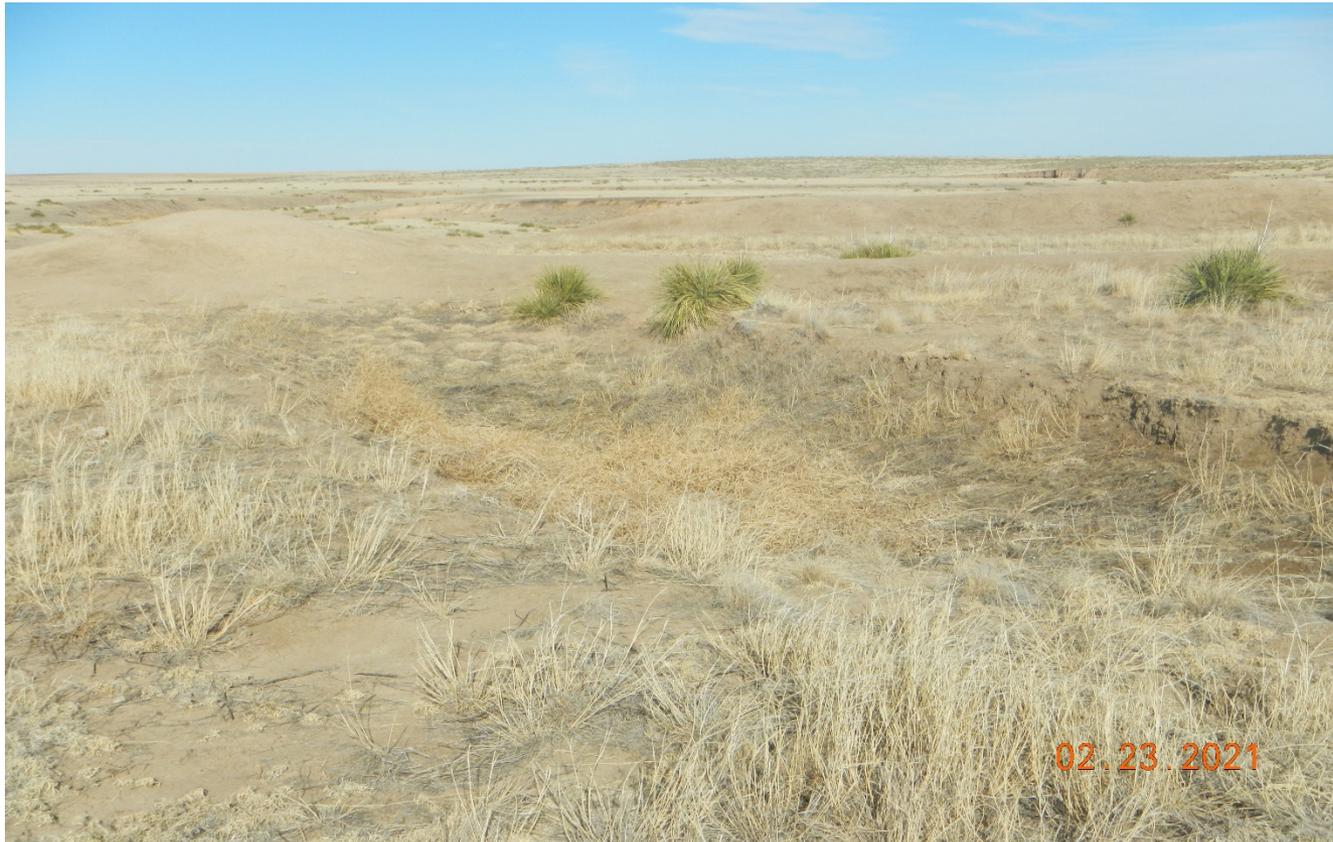
Photo 3. Facing east at the location. The pits have not been backfilled and reclaimed.

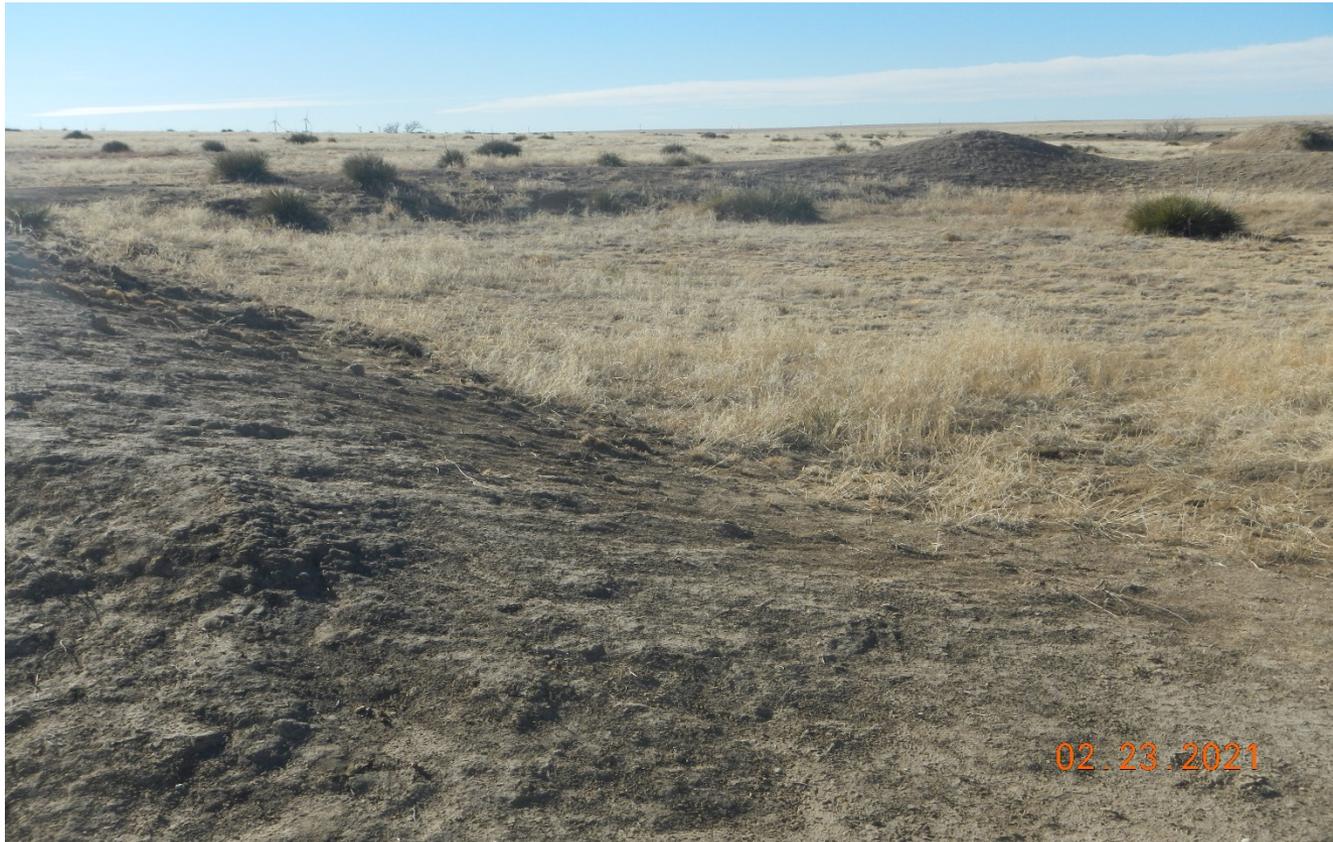
Photo 4. Facing west at the opposite side of the pit.

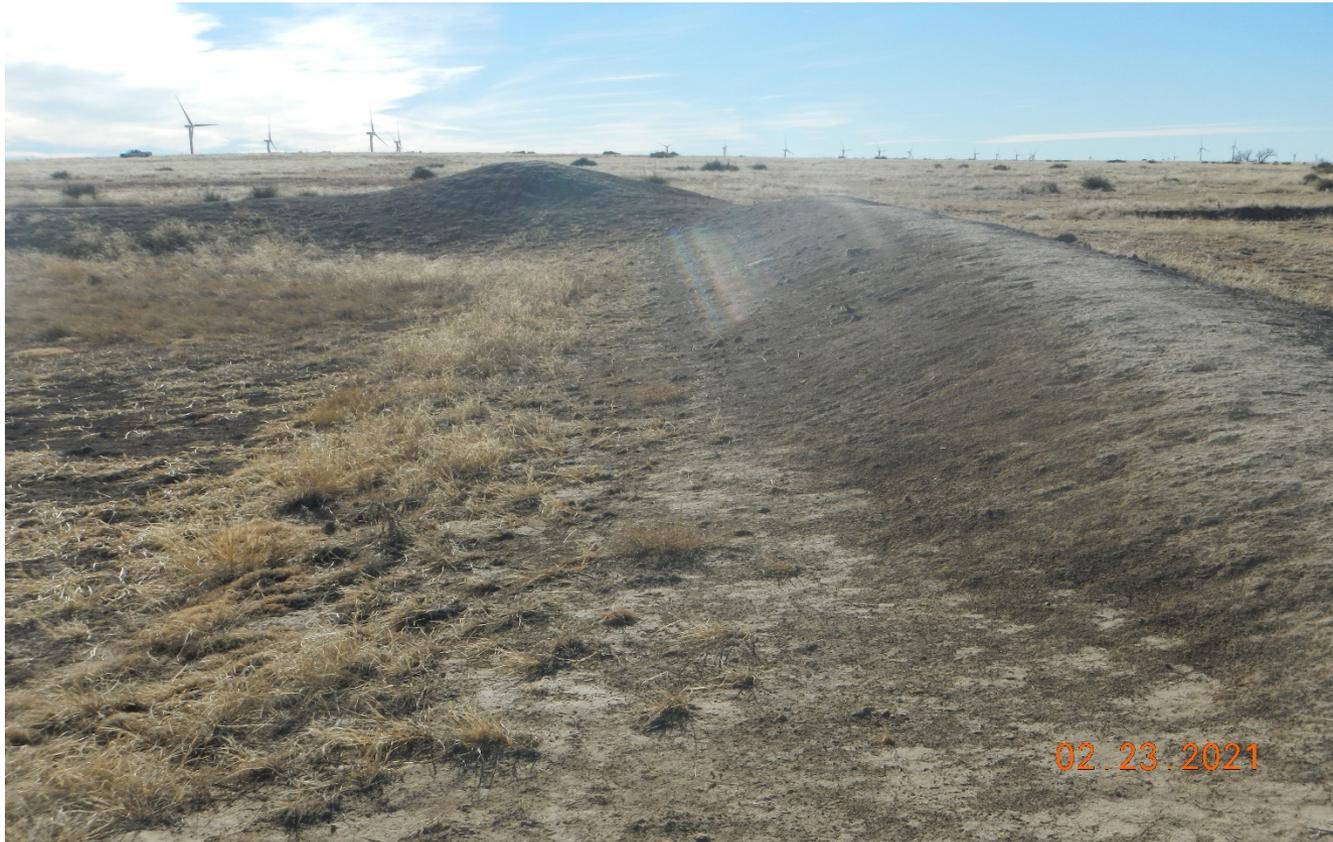
Photo 5. Facing southwest toward the pit berm.

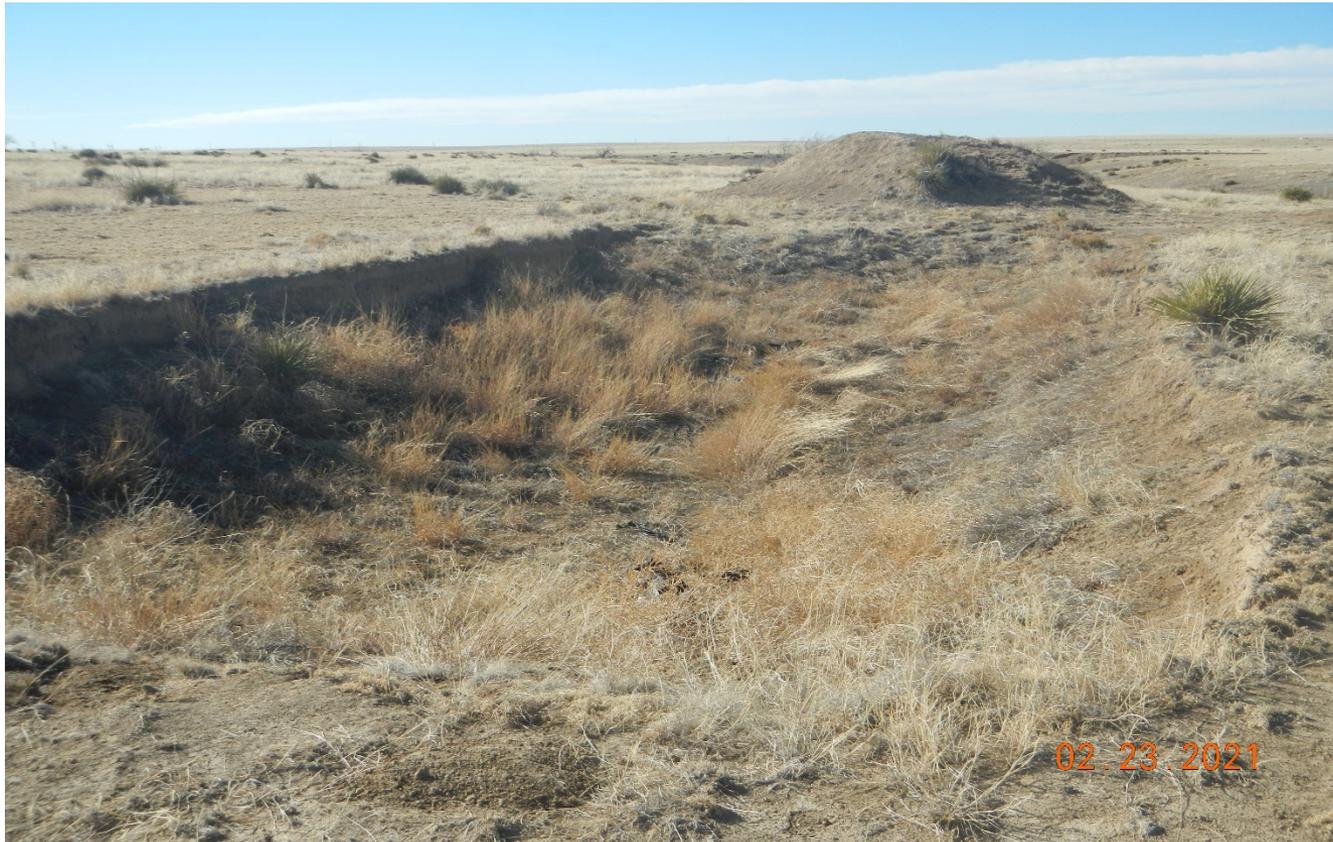
Photo 6. This pit remains at the north side of the location. Pit liner debris remains in the pit.

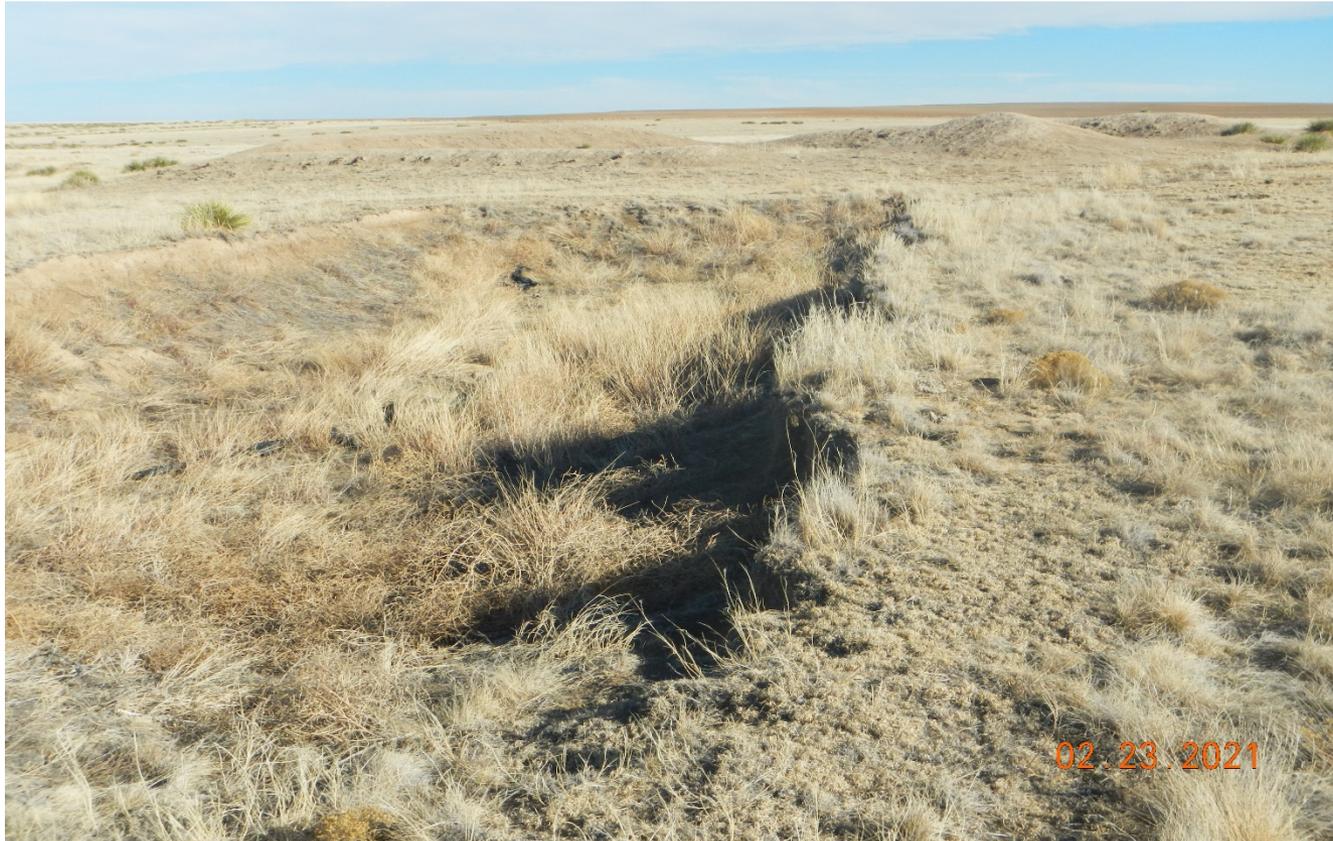
Photo 7. Facing southwest toward the two open pits that remain at the location.
