Inspection Photos
Operator: Simcoe
API: 067-06959
Date: 3/1/2021

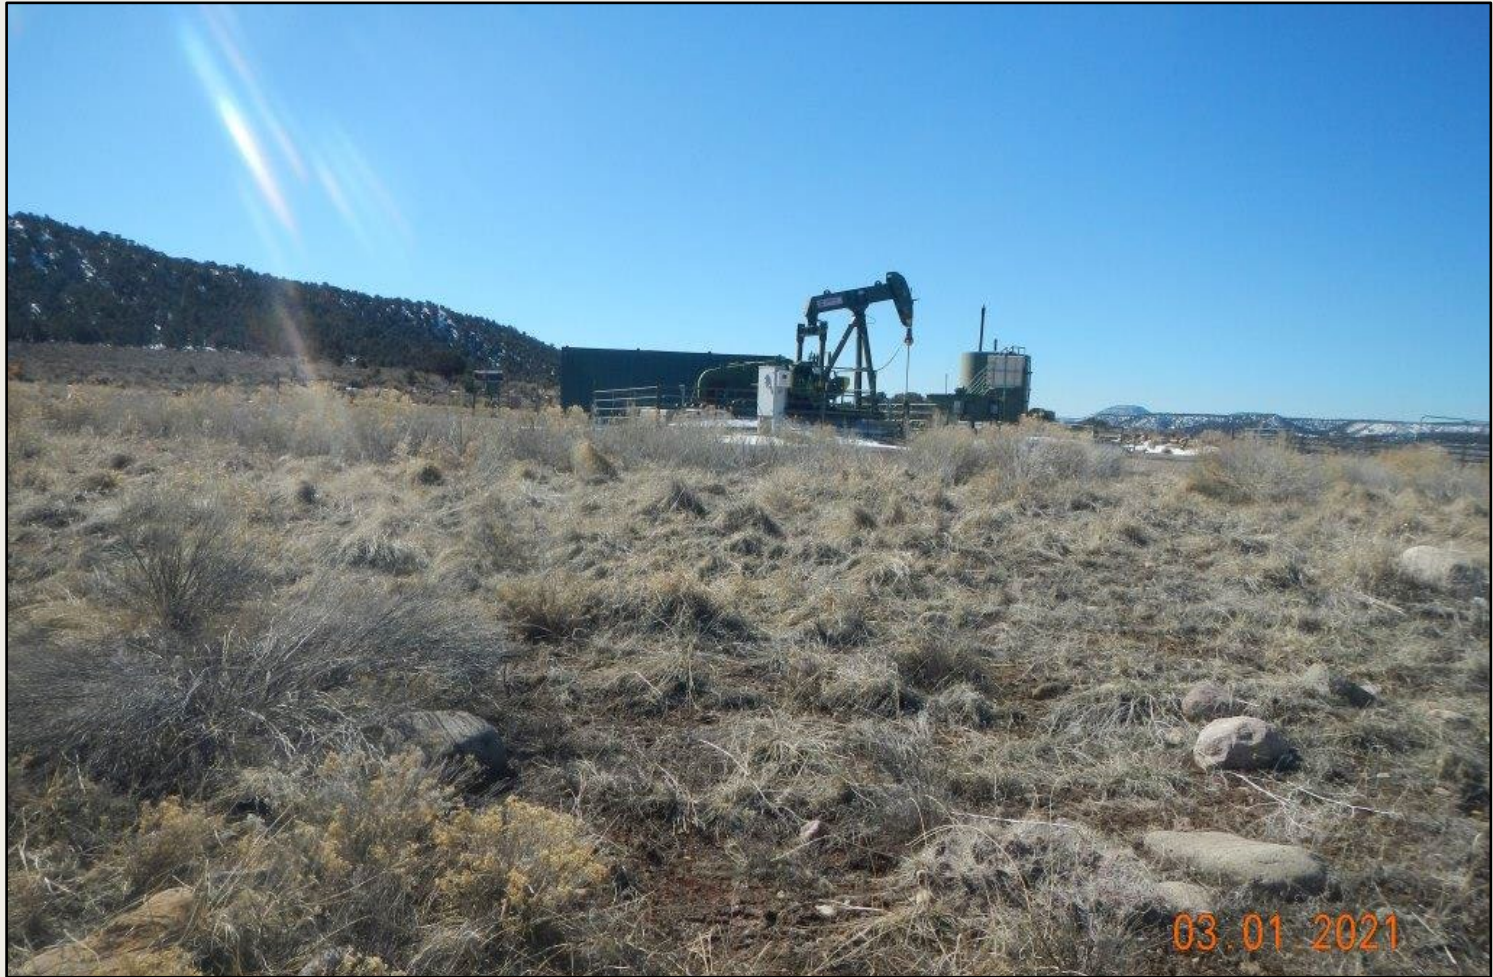
Photo 1. View of the project area from the northwestern corner facing center.

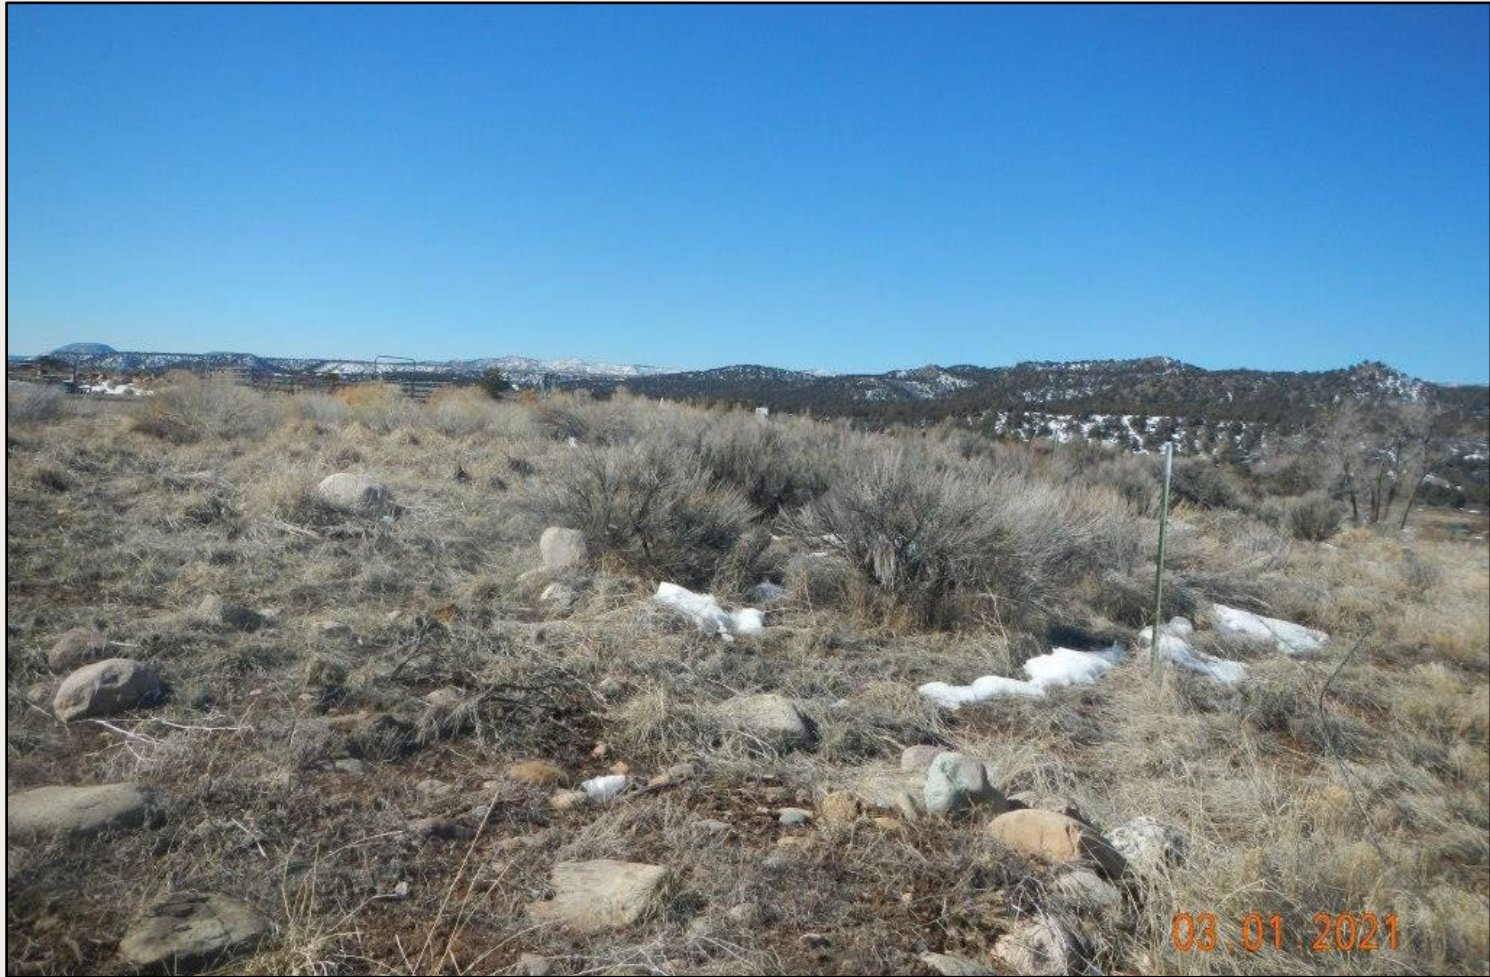
Photo 2. View of the western fill slope from the northwestern corner facing southward. Revegetation is progressing with native and non-native grasses such as western wheatgrass, crested wheatgrass, and smooth brome, as well as shrubby rubber rabbitbrush.

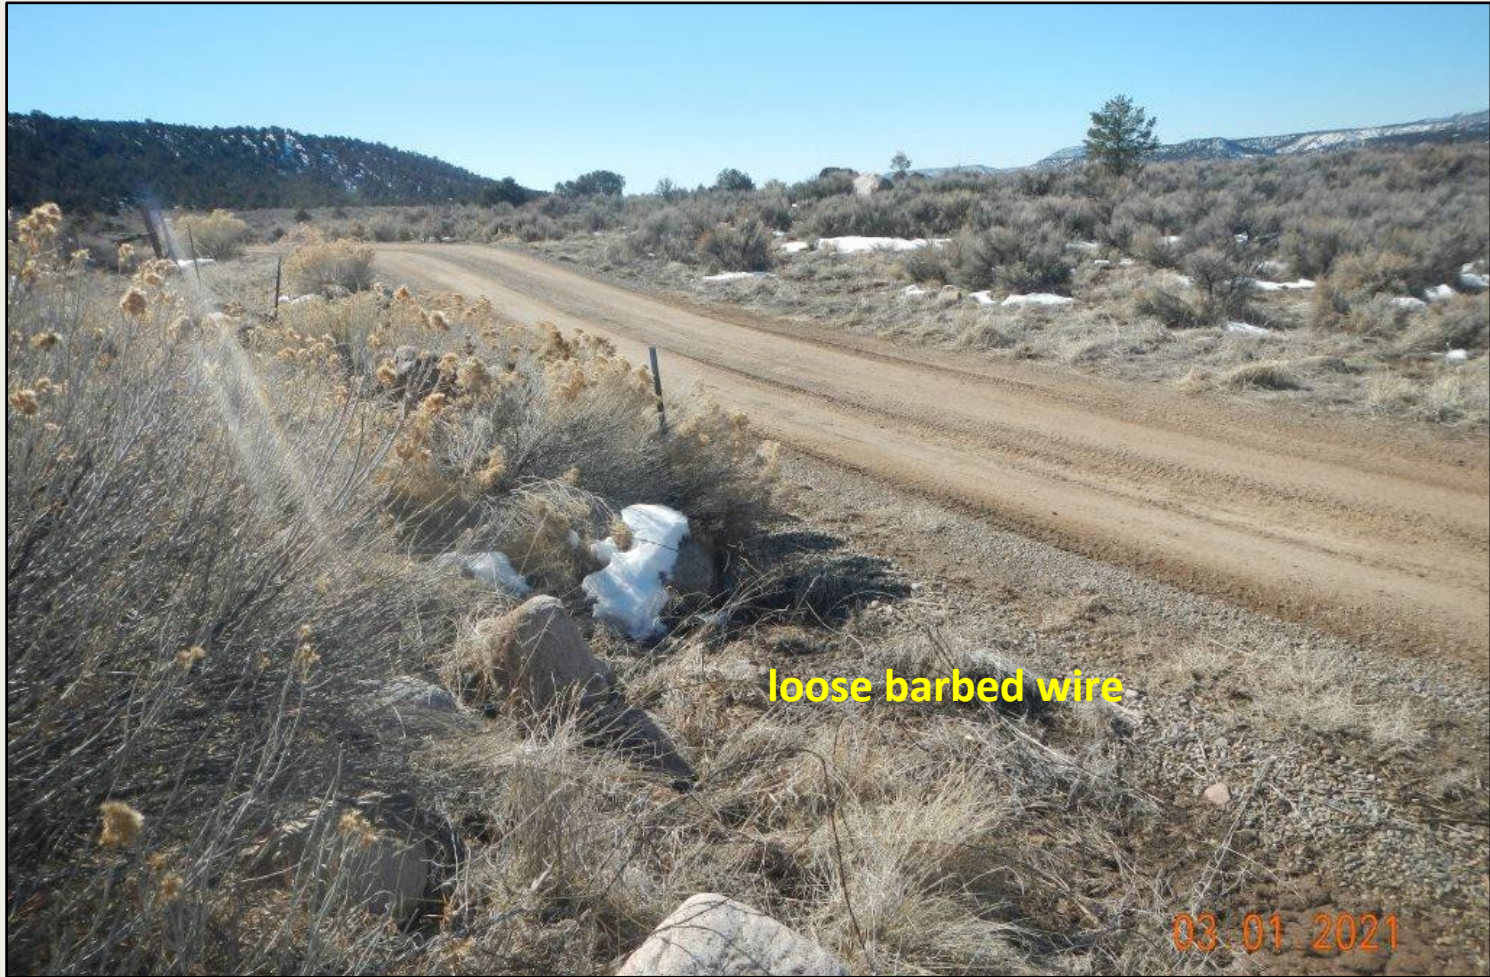
Photo 3. View of the southern project area facing eastward. Fencing is damaged and no longer functioning in many places, needing repair. Loose strands of barbed wire can be entrap wildlife.

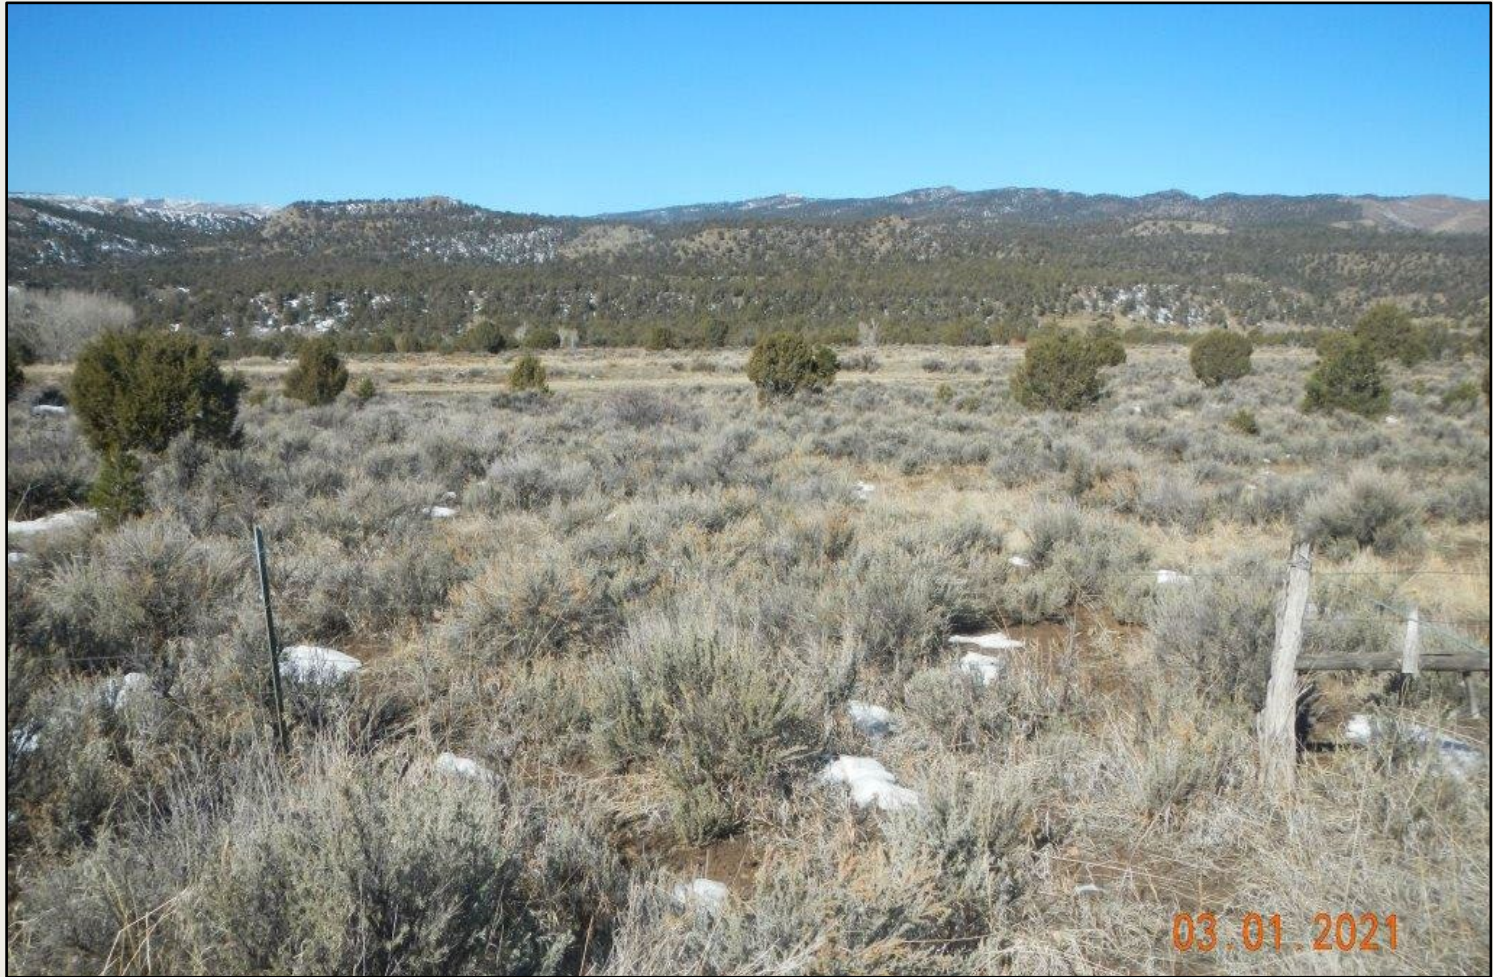
Photo 4. View of the reference area comprised of sagebrush shrubland with understory of grasses and forbs such as purple three awn, western wheatgrass, and mat penstemon.
