Inspection Photos

3/1/2021

Operator: CAERUS PICEANCE LLC - 10456

Location ID: 324199

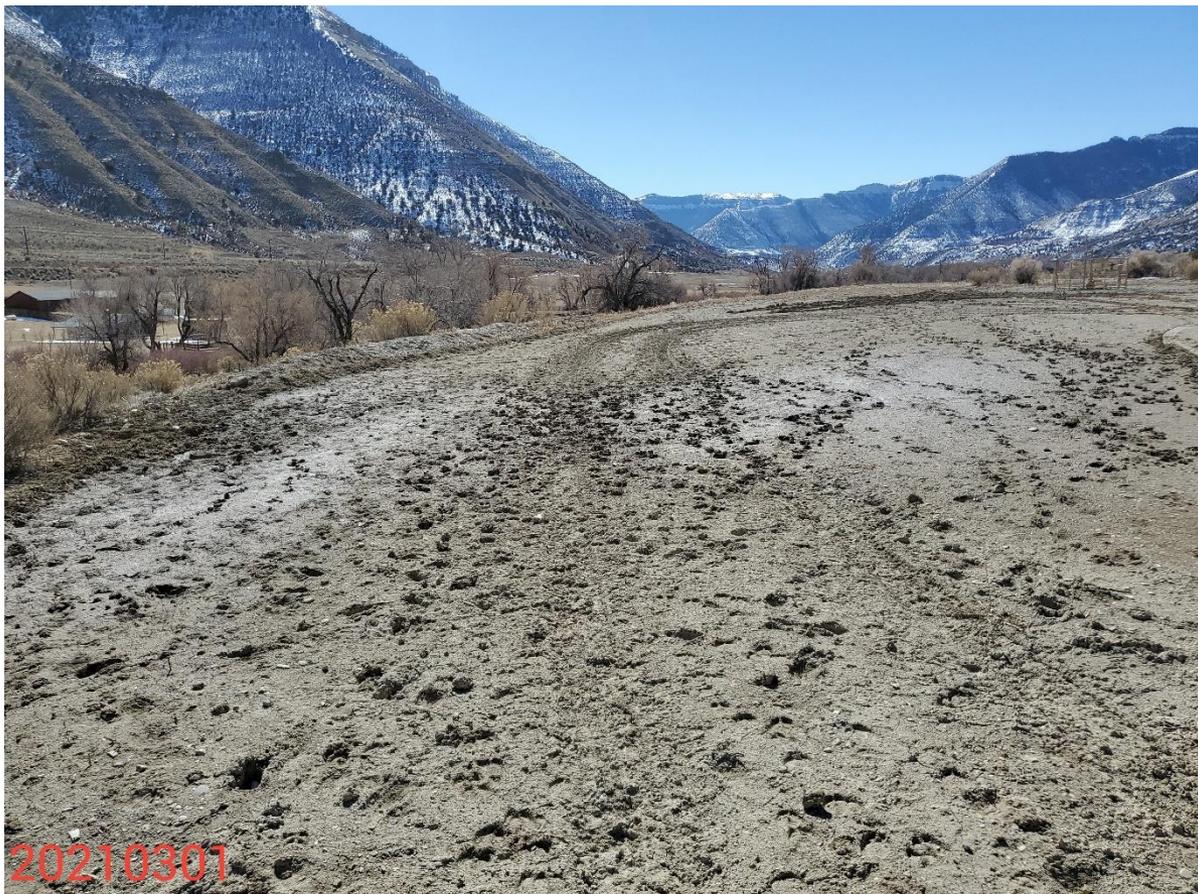
Photo 1: Photo taken from the north end of the Location, facing southeast. Photo provides an overview of the Location. Photo also shows rutting and tracking issues observed on the Location; pad not sufficiently stabilized.

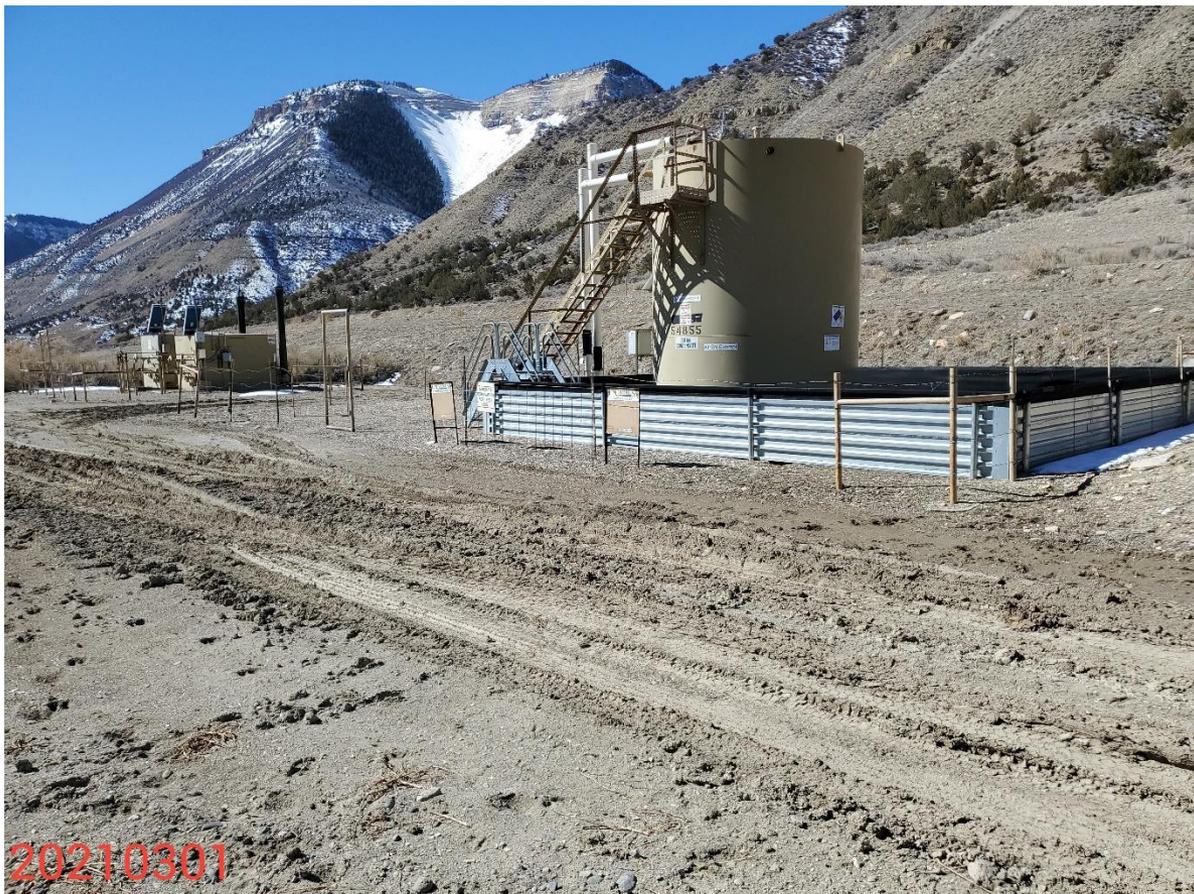
Photo 2: Photo taken from the north end of the Location, facing southwest. Photo provides an overview of the Location. Photo also shows rutting and tracking issues observed on the Location; pad not sufficiently stabilized.

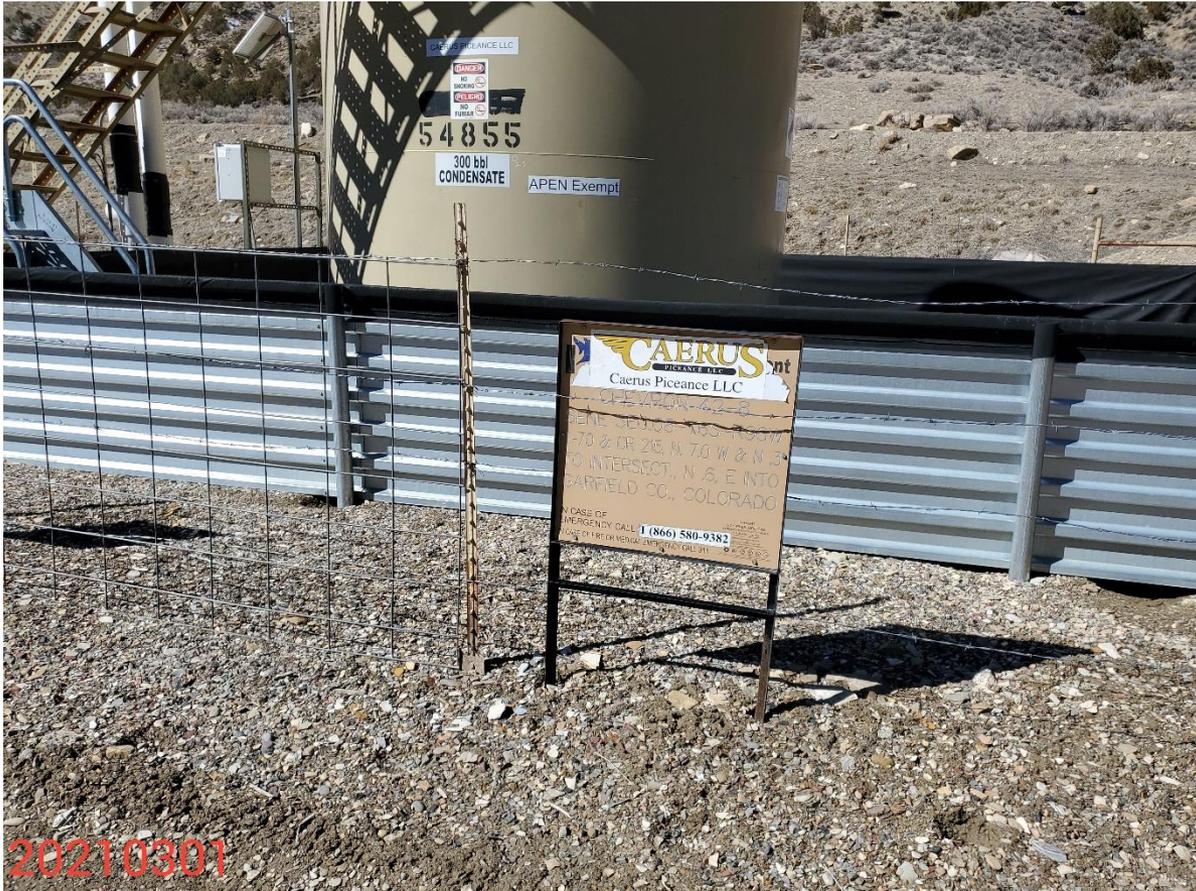
Photo 3: Photo of sign at battery

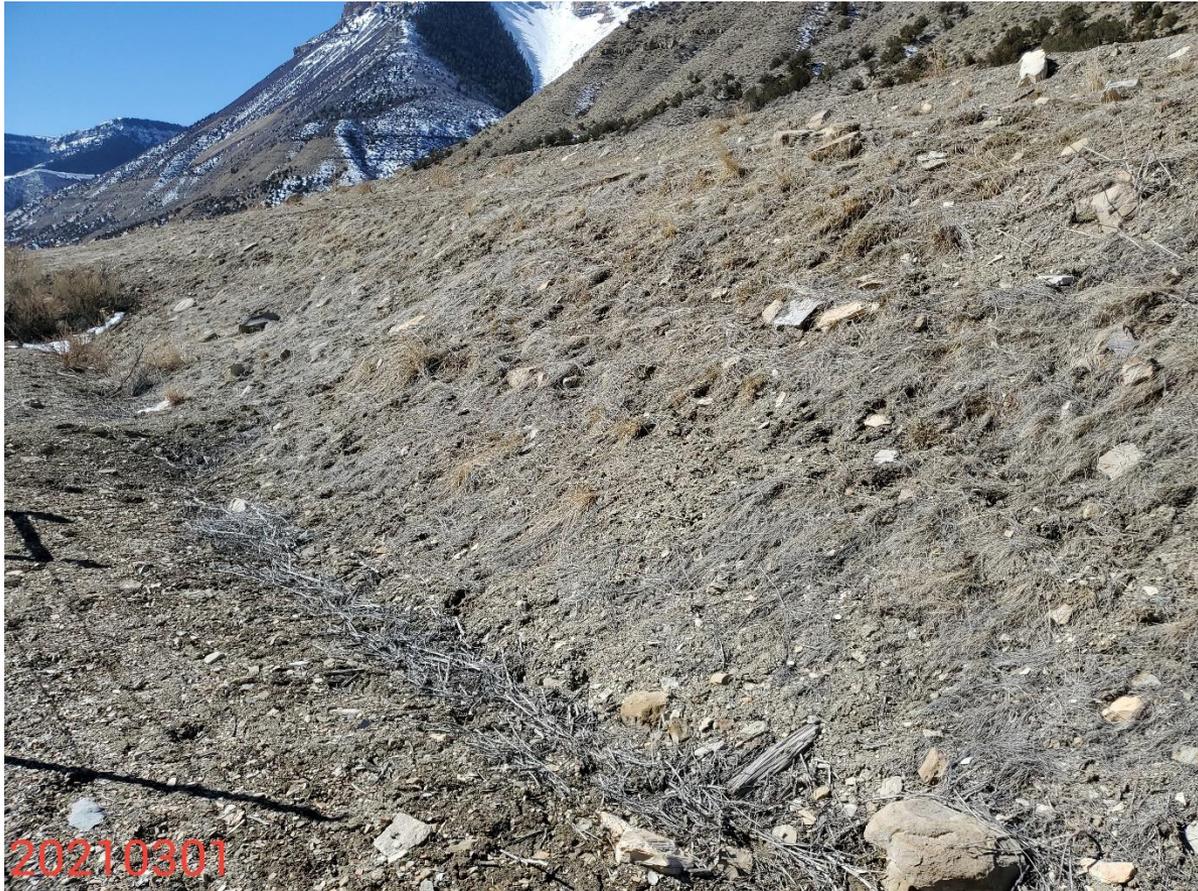
Photo 4: Photo taken from the west end of the Location, facing southwest. Desirable perennial vegetative establishment observed on cut slopes.

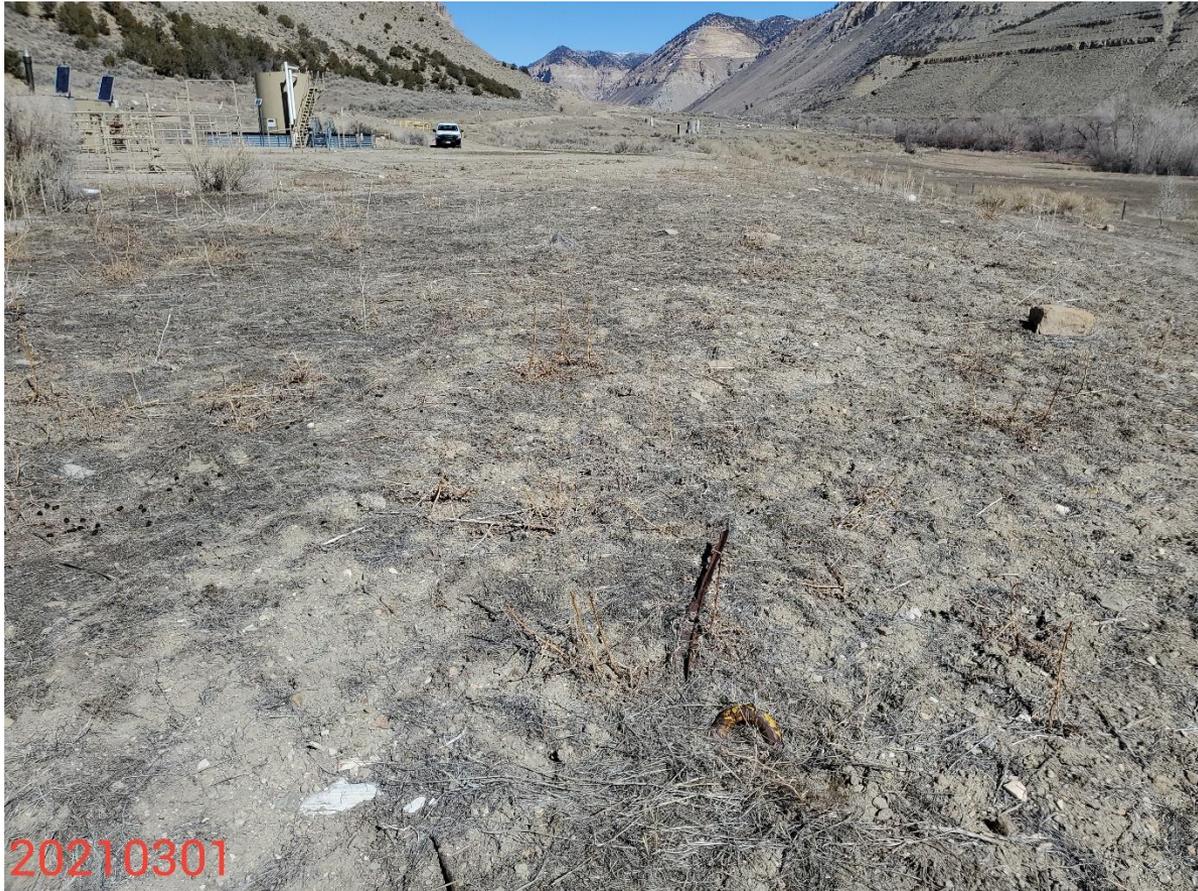
Photo 5: Photo shows anchor on the southeast end of the Location. Anchor(s) not marked in accordance with Rule 1003.a and 603.j

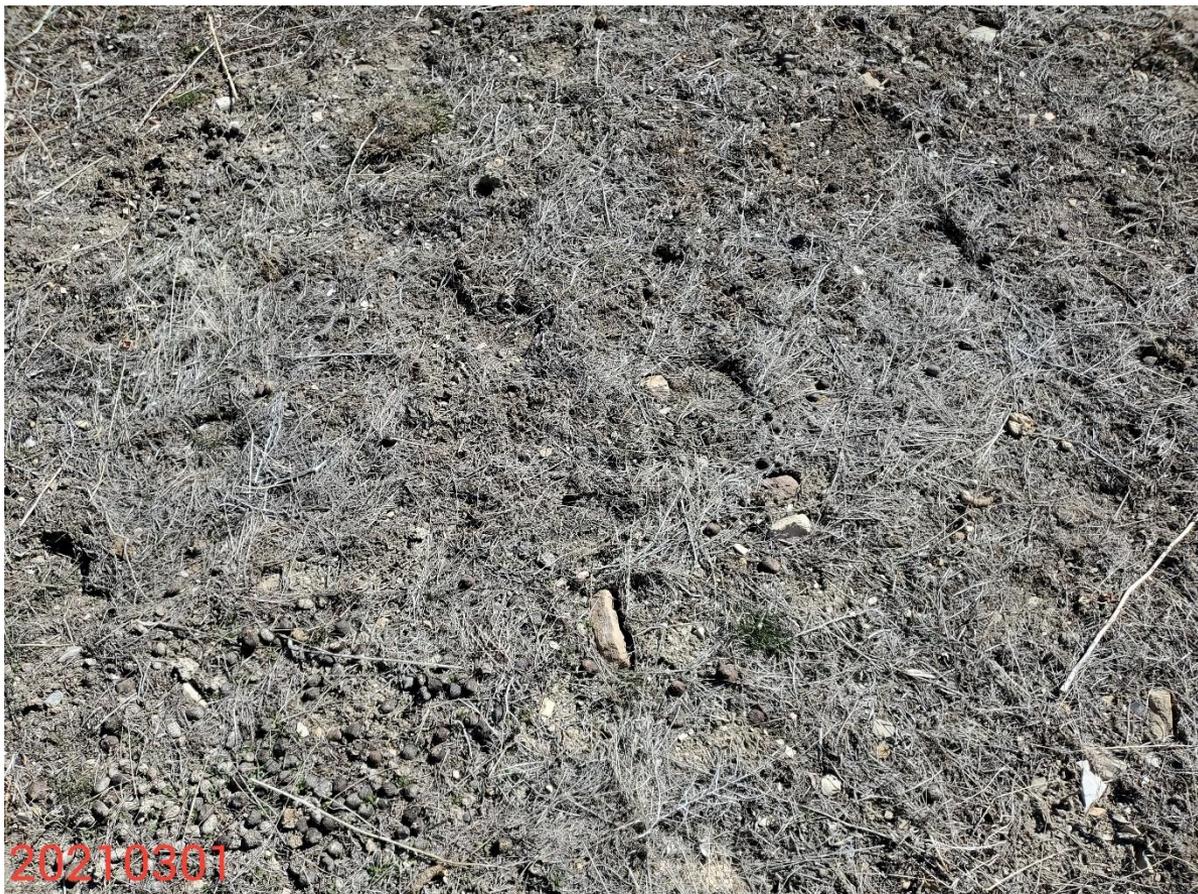
Photo 6: Photo taken from the interim areas. Photo shows vegetation from previous years growing season is predominantly undesirable weedy plant species such as cheat grass.

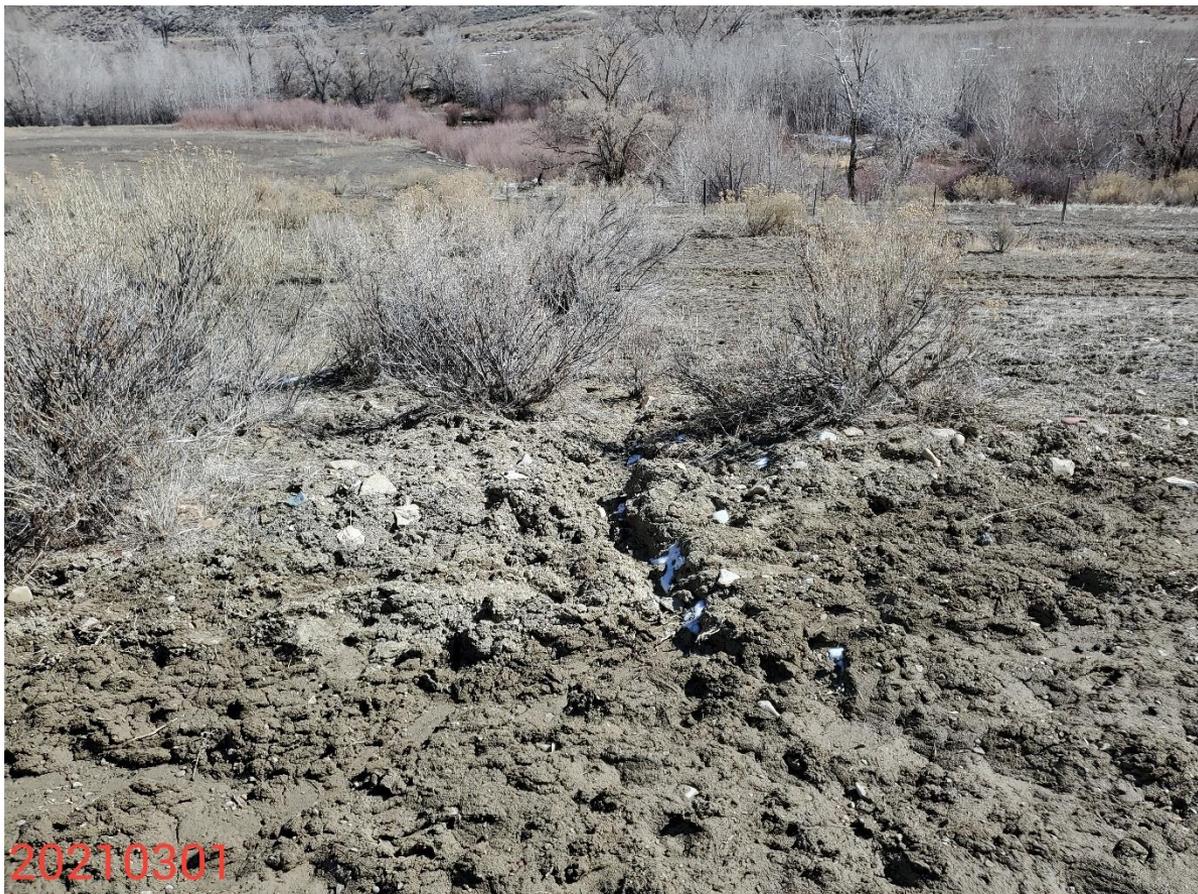
Photo 7: Photo taken from the west end of the Location, facing east. Photo shows erosion degradation due to stormwater runoff from the Location. Stormwater and erosion control measure missing or insufficient.

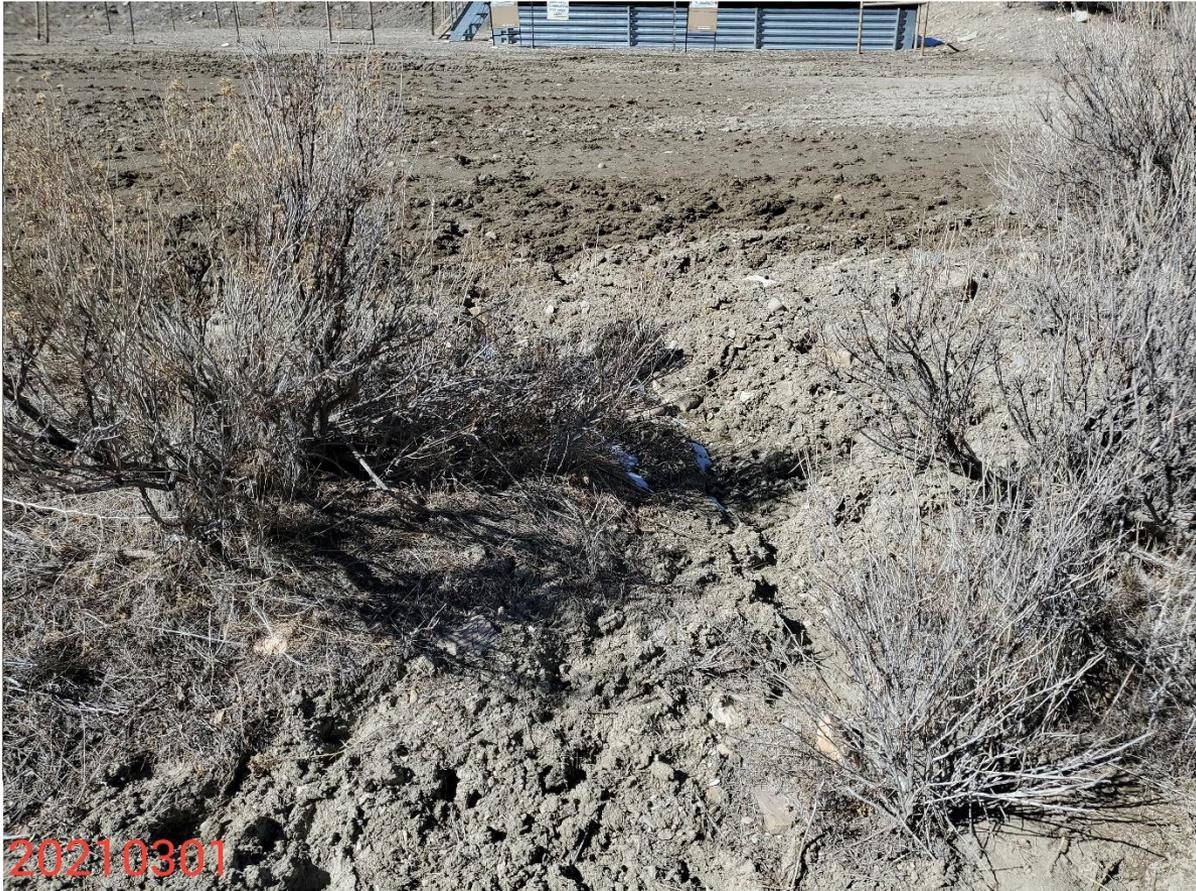
Photo 8: Photo taken from the west end of the Location, facing west. Photo shows erosion degradation due to stormwater runoff from the Location. Stormwater and erosion control measure missing or insufficient.
