# Inspection Photos

Operator: BERRY PETROLEUM COMPANY LLC

Location ID: 335597

Garfield County, CO

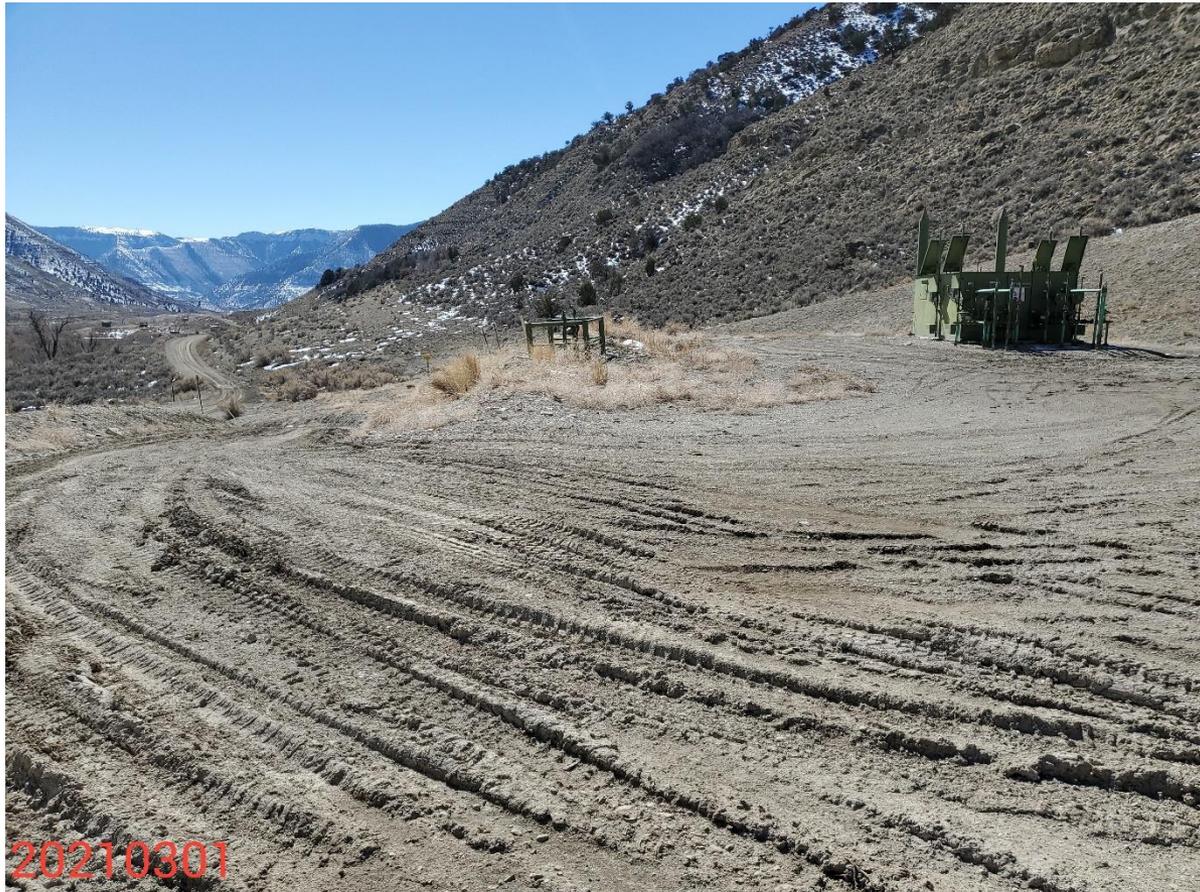
**Photo 1:** Photo taken from the east end of the Location, facing south. Photos 1-4 provide an overview of the Location from south, southwest, northwest to north.

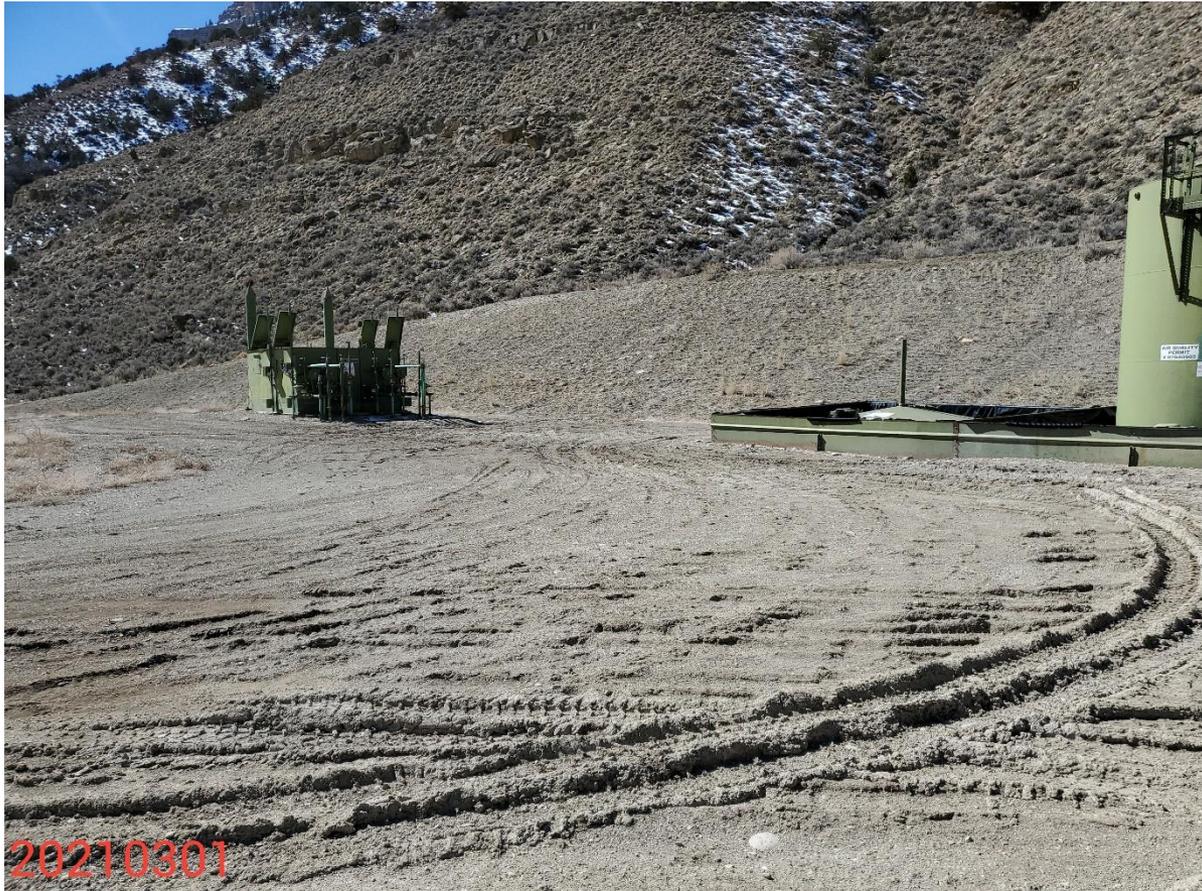
**Photo 2:** See comments under photo 1.

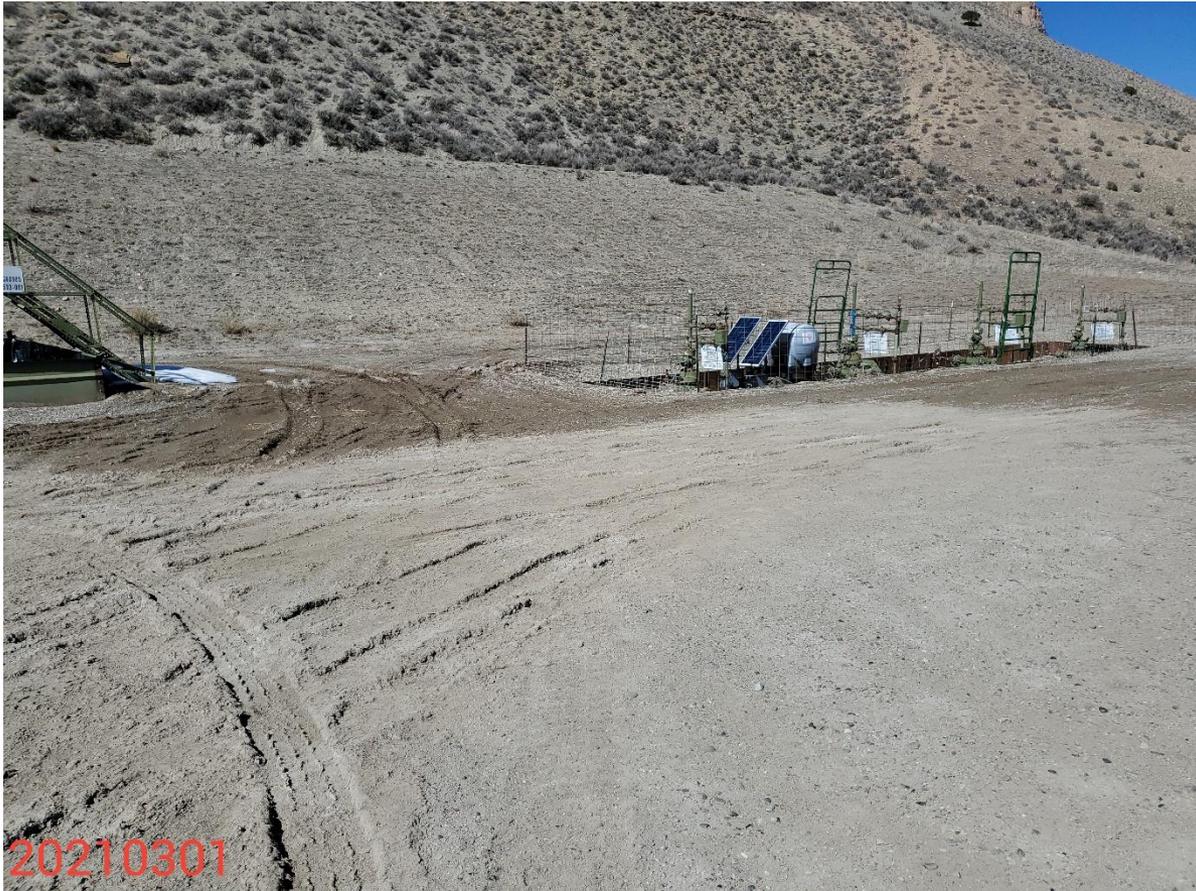
**Photo 3:** See comments under photo 1.

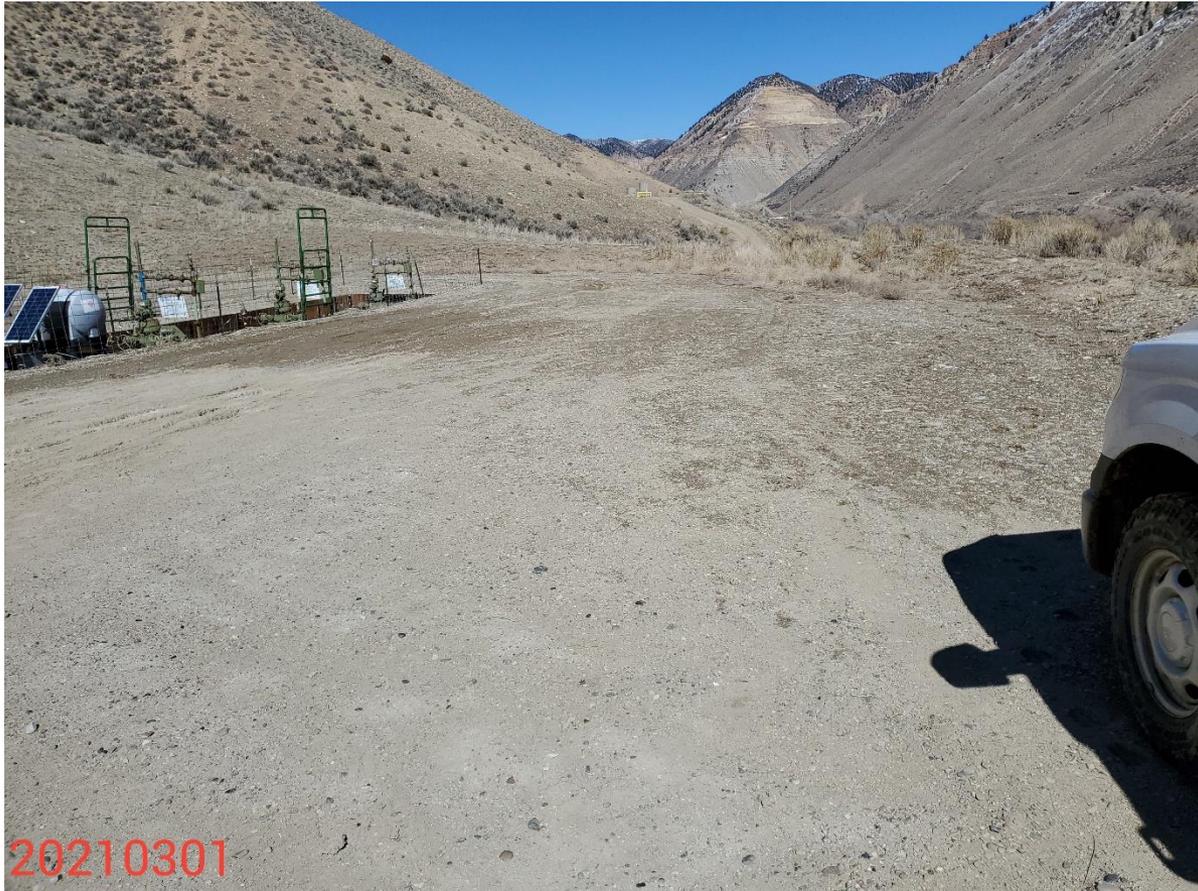
**Photo 4:** See comments under photo 1.

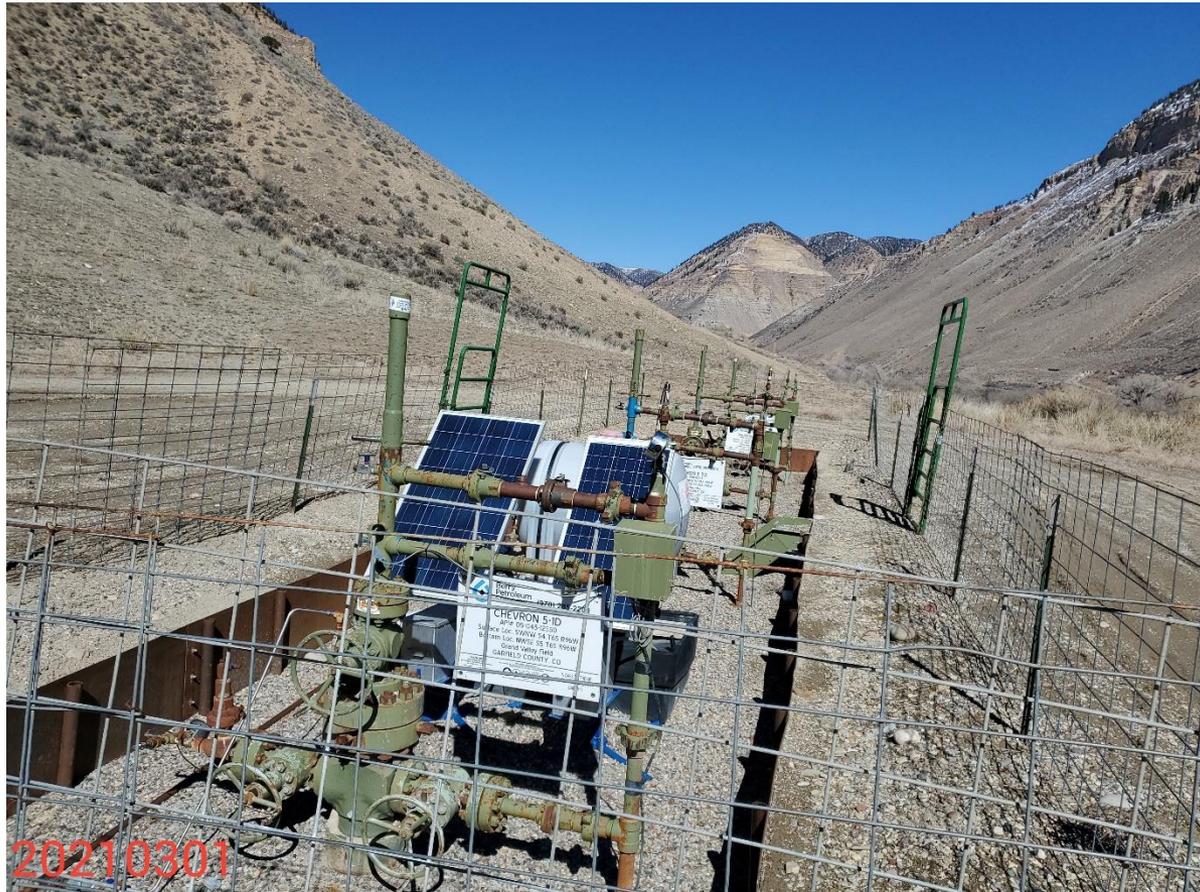
Photo 5: Photo shows wells on Location. .

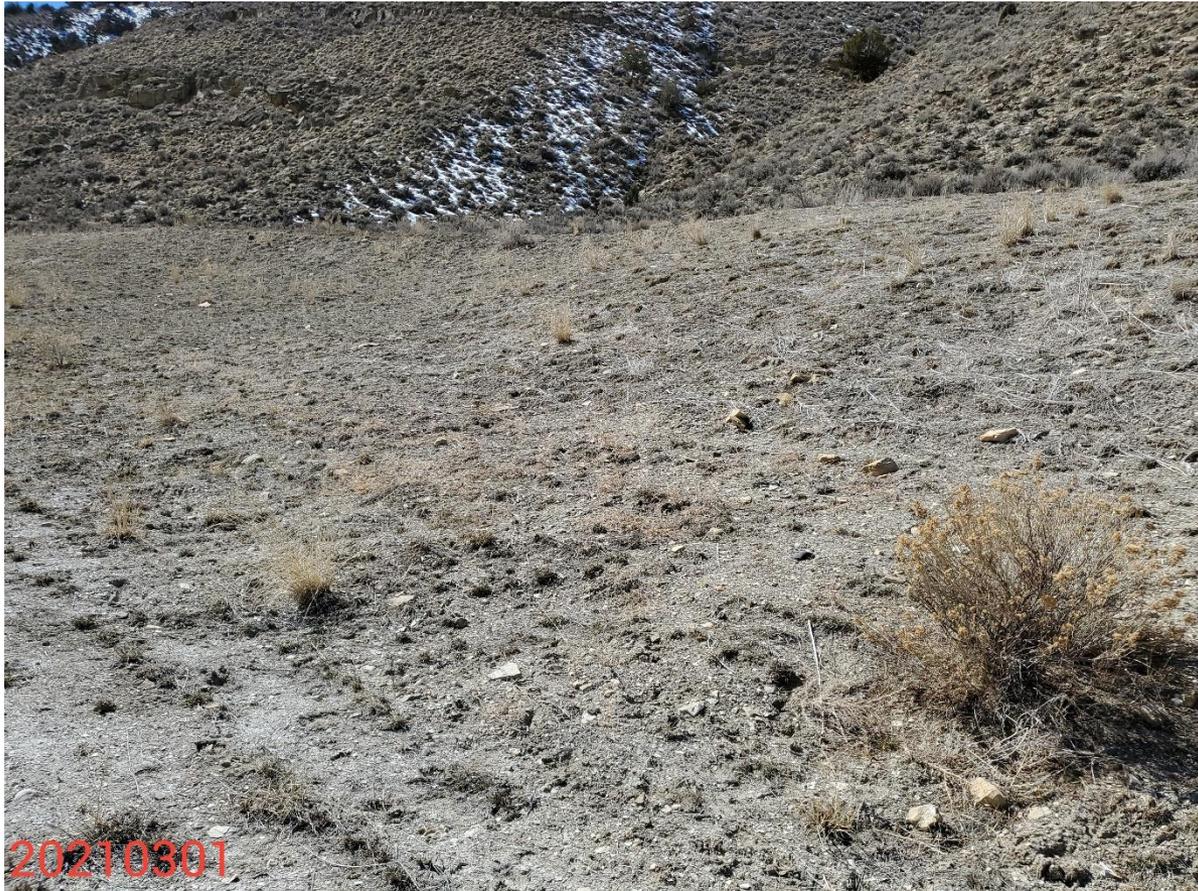
**Photo 6:** Photo taken from the west end of the Location, facing southwest. Photo shows interim areas. IR was due 1/29/2008; at least 12 growing seasons have passed; vegetative establishment on western interim areas does not appear to be progressing towards 1003 standards.

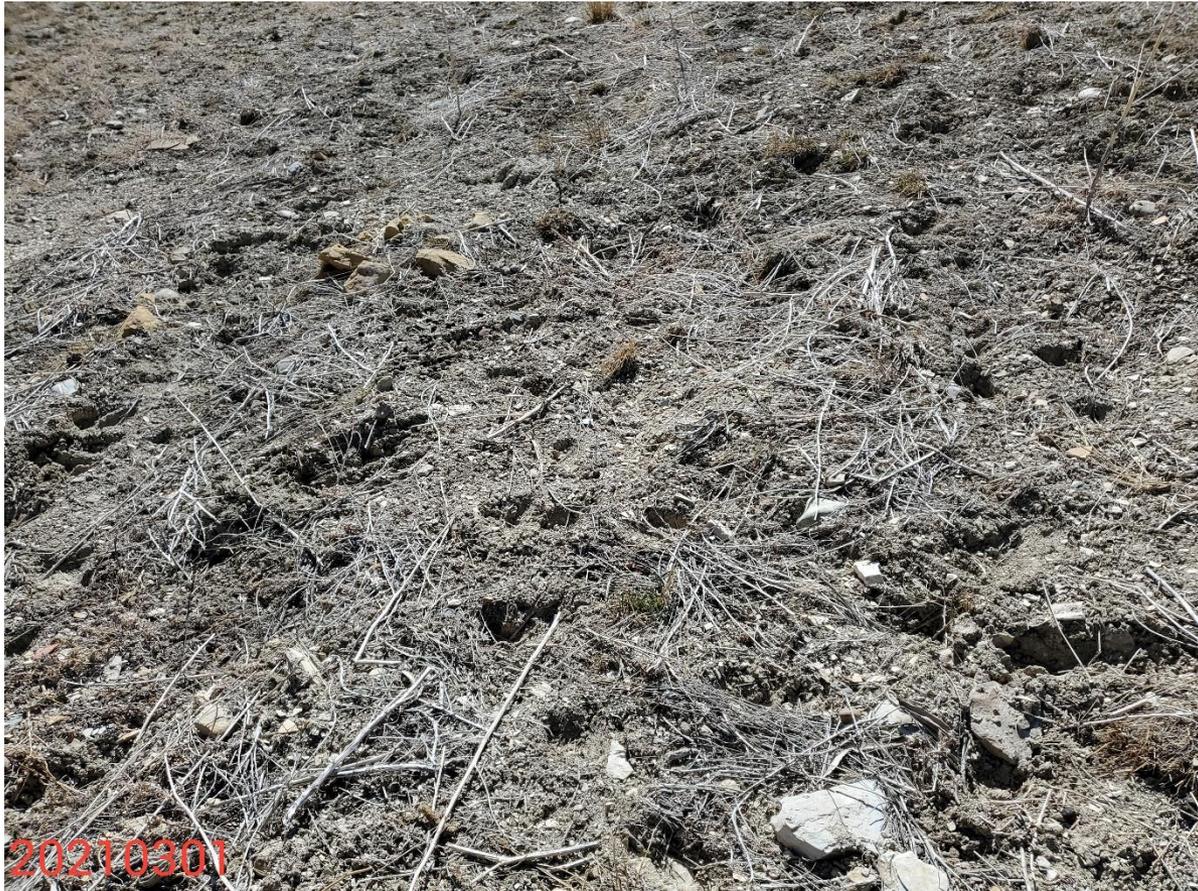
**Photo 7:** Photo taken from the western interim areas. See comments under photo 6. Vegetation observed in photo predominantly weed debris.

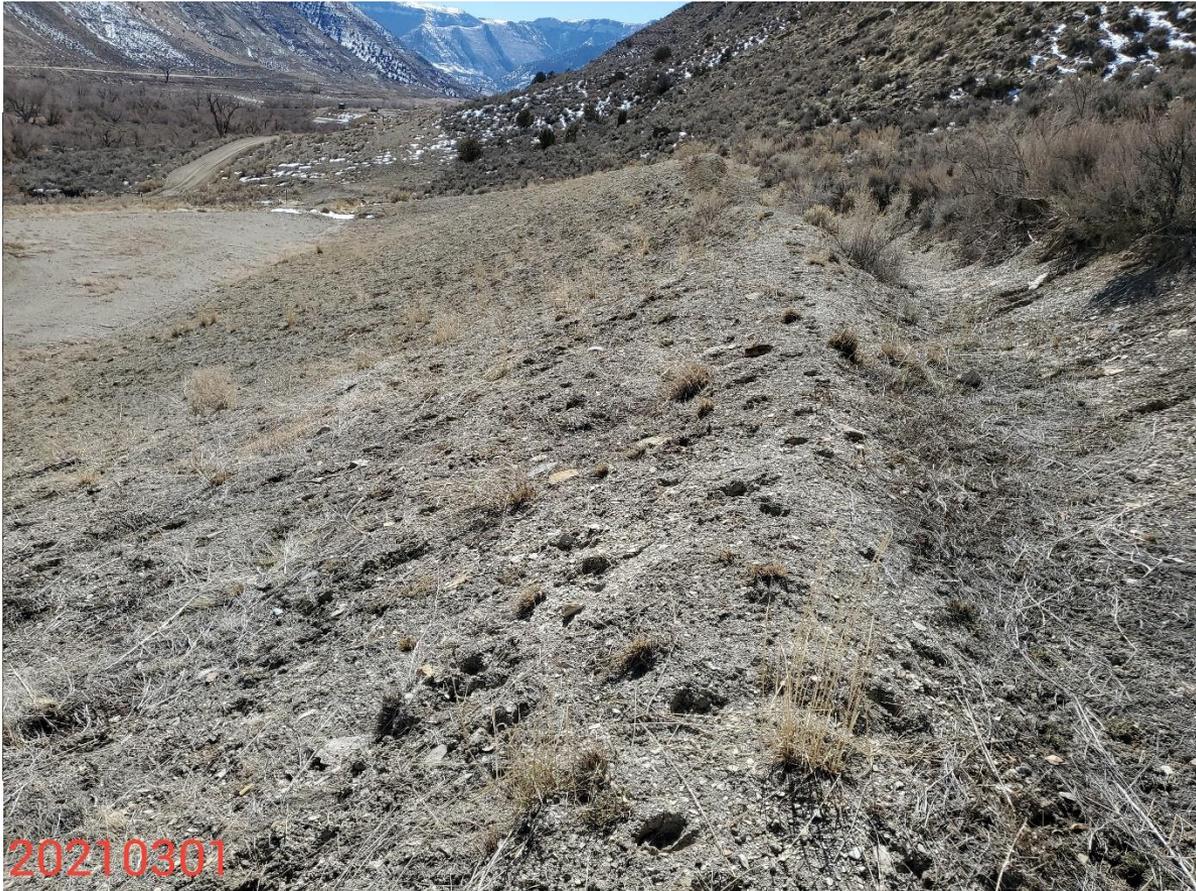
**Photo 8:** Photo taken from the western interim areas of the Location, facing south. See comments under photo 6. Photo also shows differences between vegetation on interim areas and adjacent reference areas; at least 12 growing seasons have passed, interim areas are not reflective of the reference.

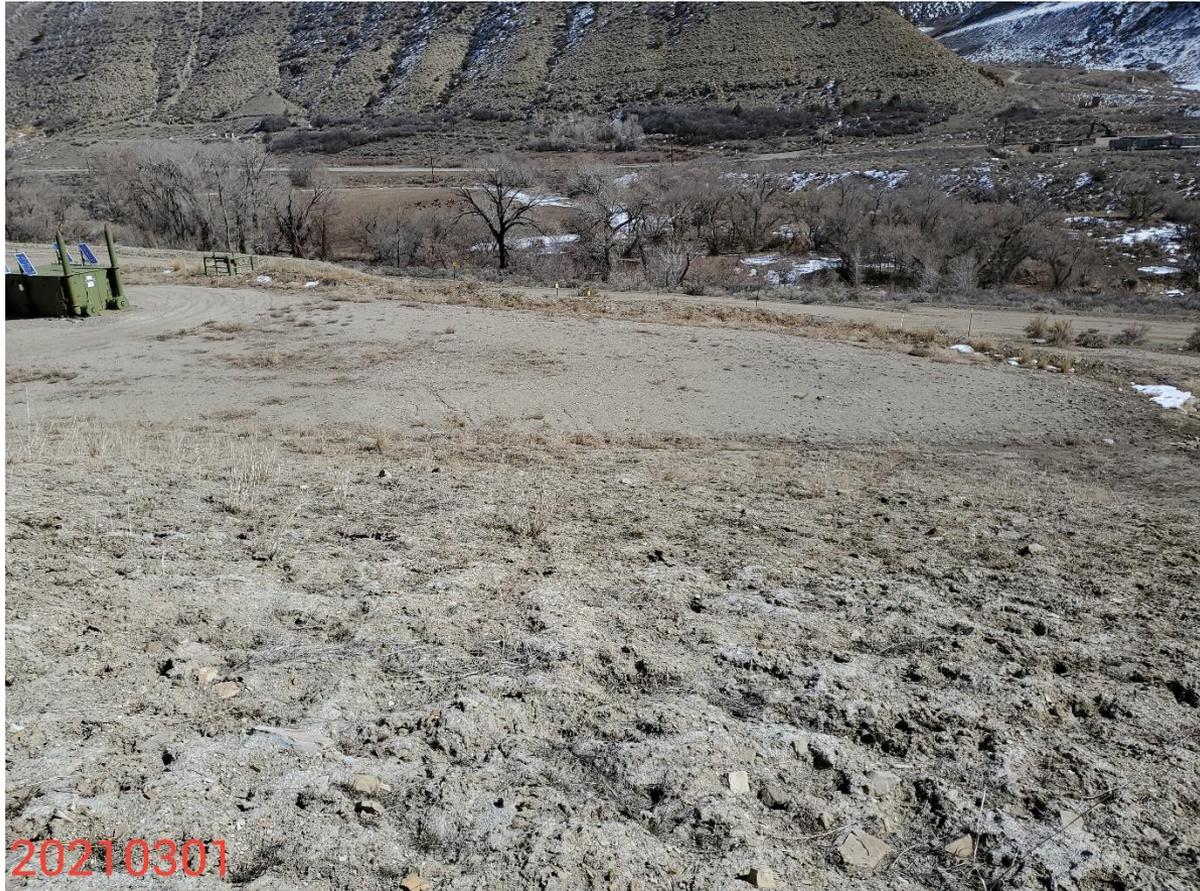
**Photo 9:** Photo taken from the southwest of the Location, facing east. Photo shows large areas on the south end of the Location that are not needed for production that have not been reclaimed.

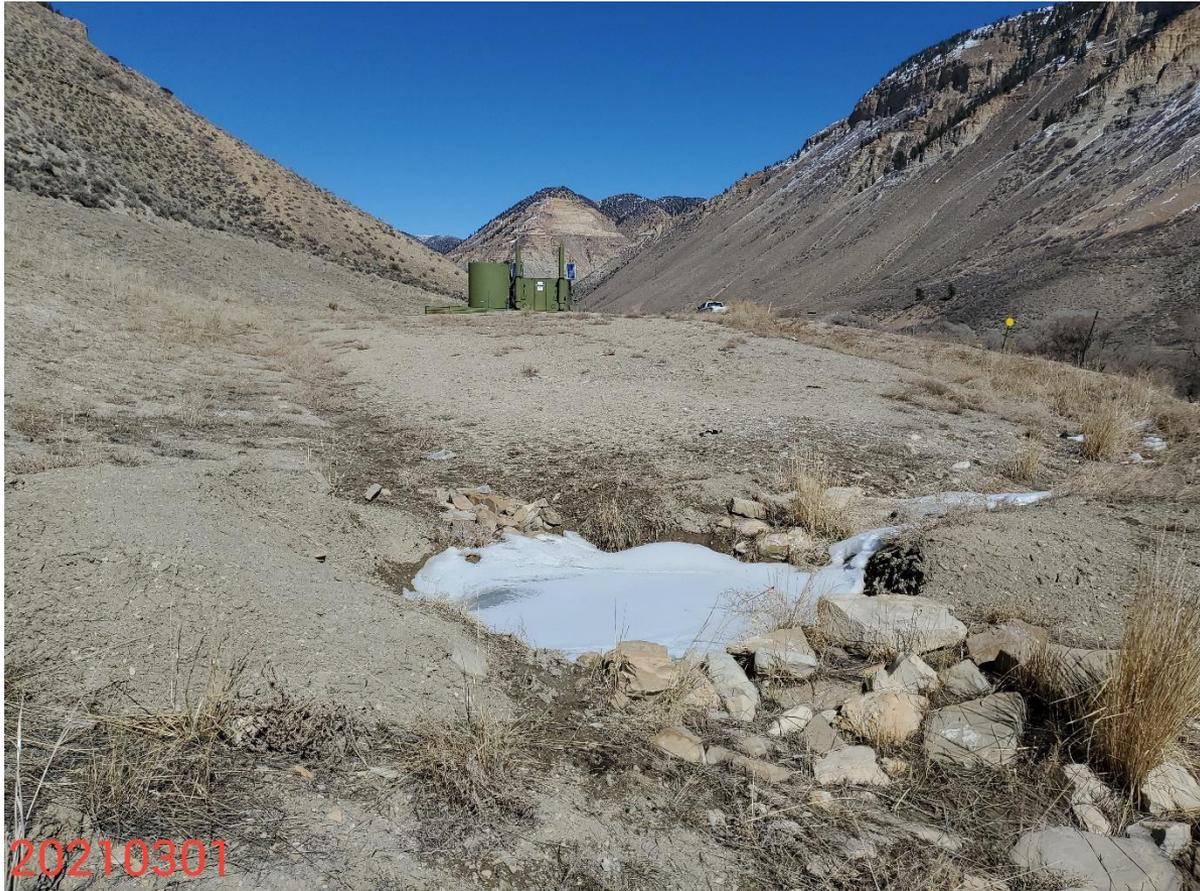
**Photo 10:** Photo taken from the south end of the Location, facing north. See comments under photo 9.

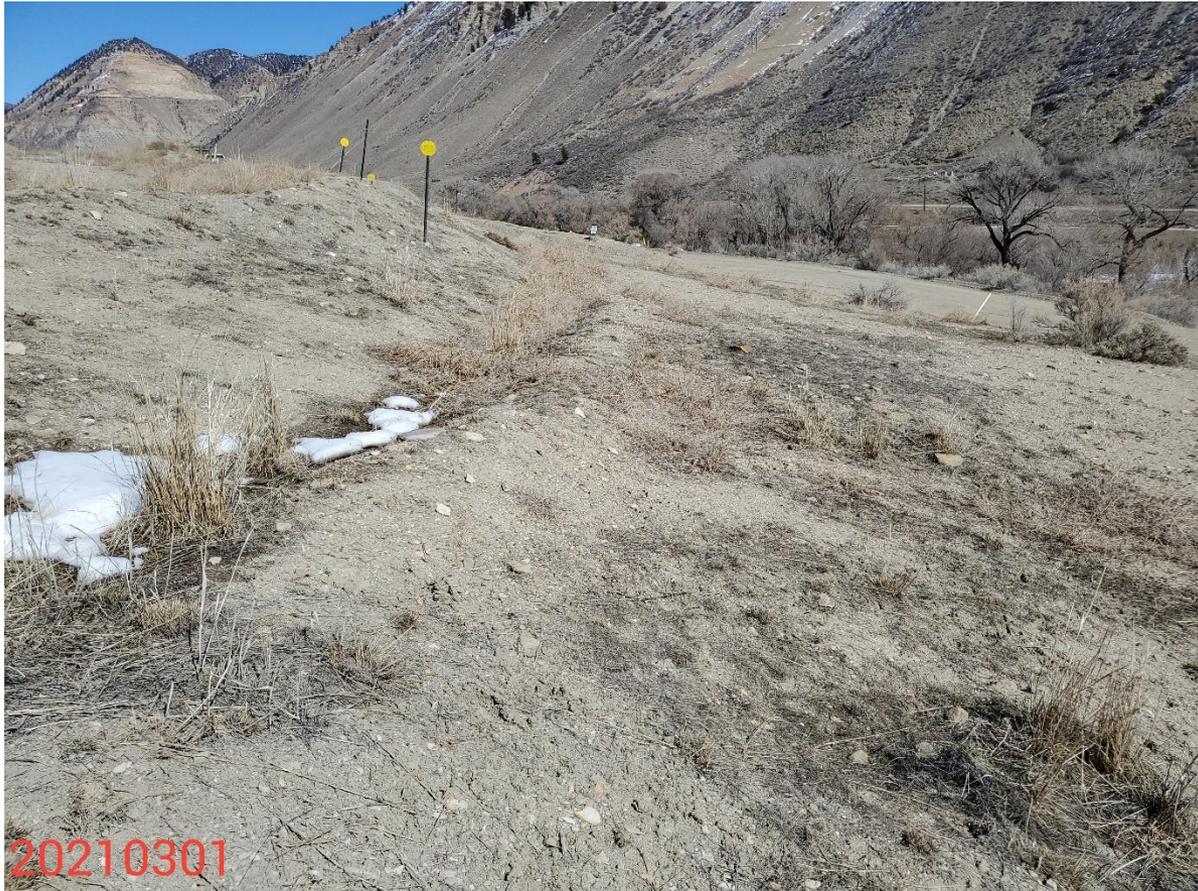
**Photo 11:** Photo taken from the eastern interim areas of the Location, facing northeast. Photo shows reclamation is not progressing towards COGCC 1003 standards; interim areas bare soil or vegetated by undesirable weedy plant species.

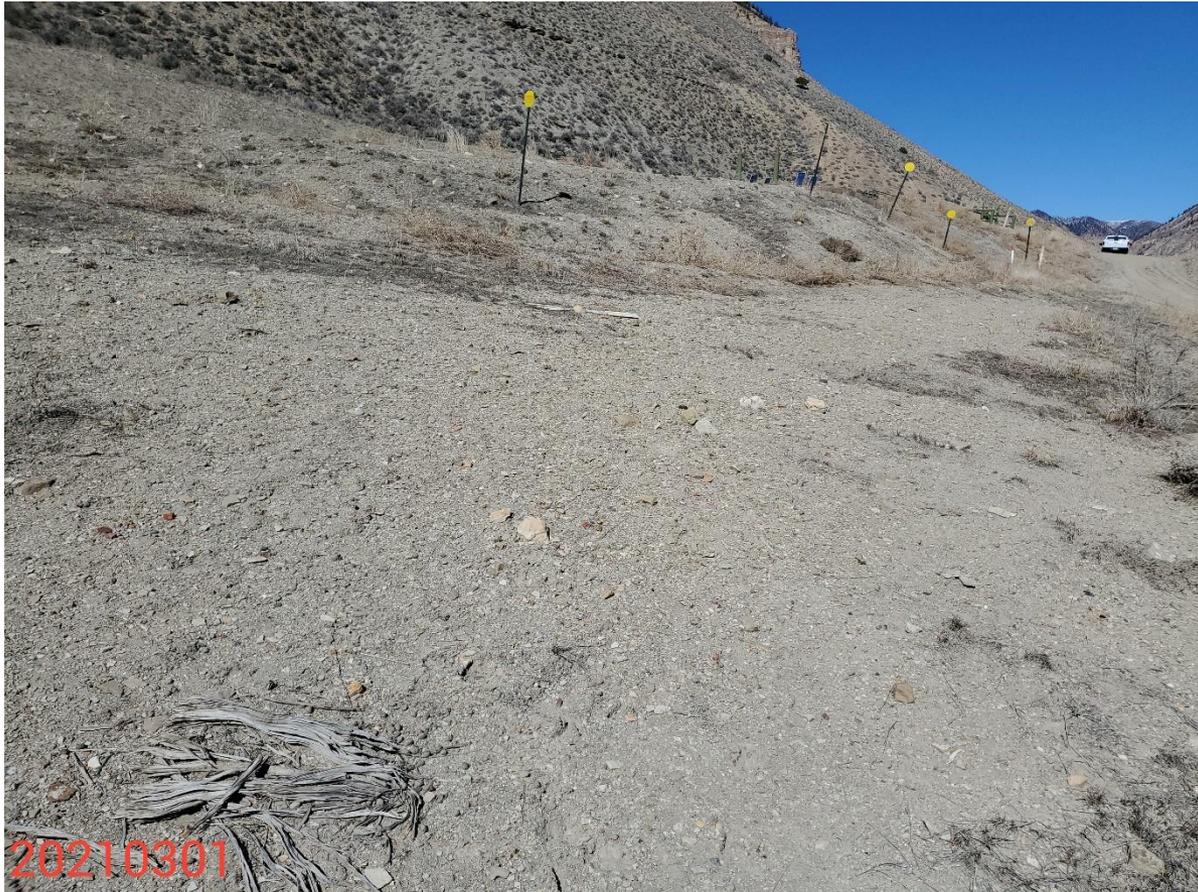
**Photo 12:** Photo taken from the eastern interim areas of the Location, facing northwest. Photo shows reclamation is not progressing towards COGCC 1003 standards; interim areas bare soil or vegetated by undesirable weedy plant species.

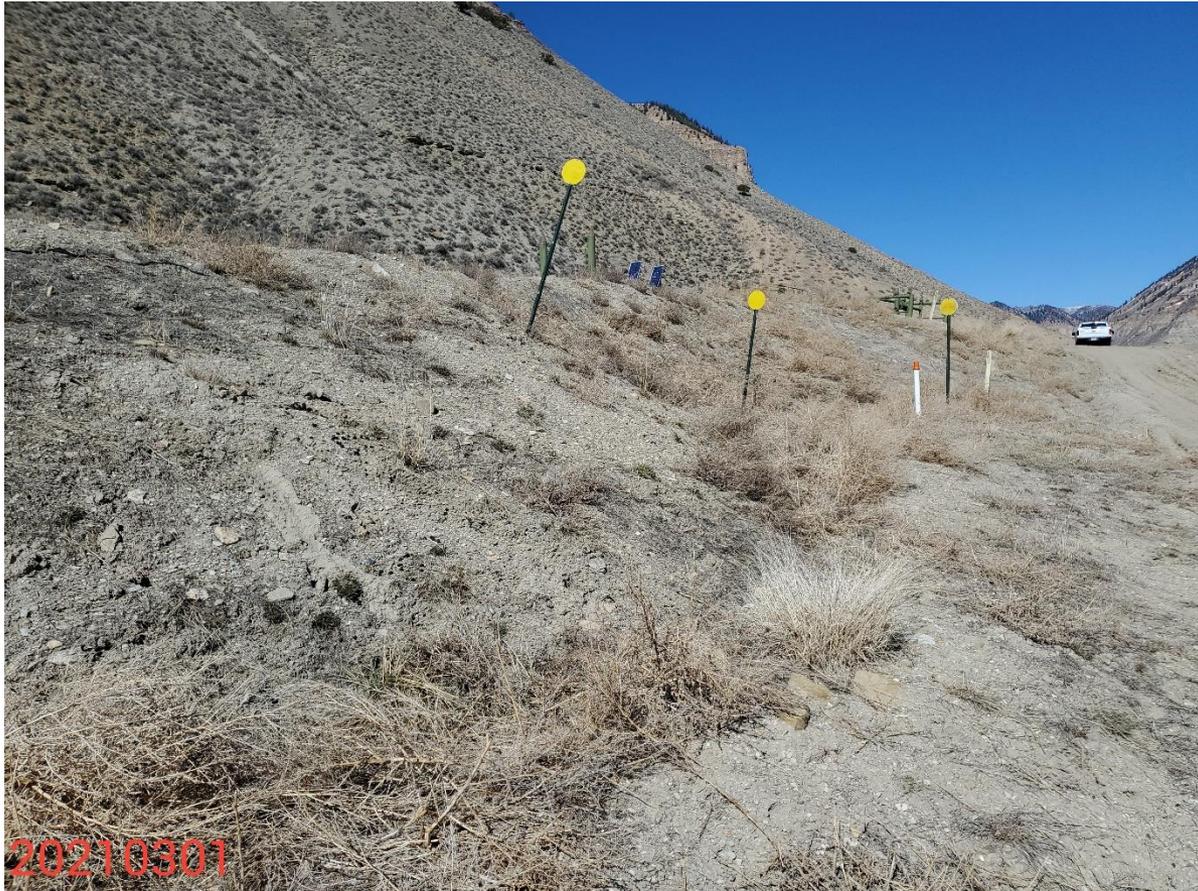
**Photo 13:** Photo taken from the eastern interim areas of the Location, facing northwest. Photo shows reclamation is not progressing towards COGCC 1003 standards; interim areas bare soil or vegetated by undesirable weedy plant species.

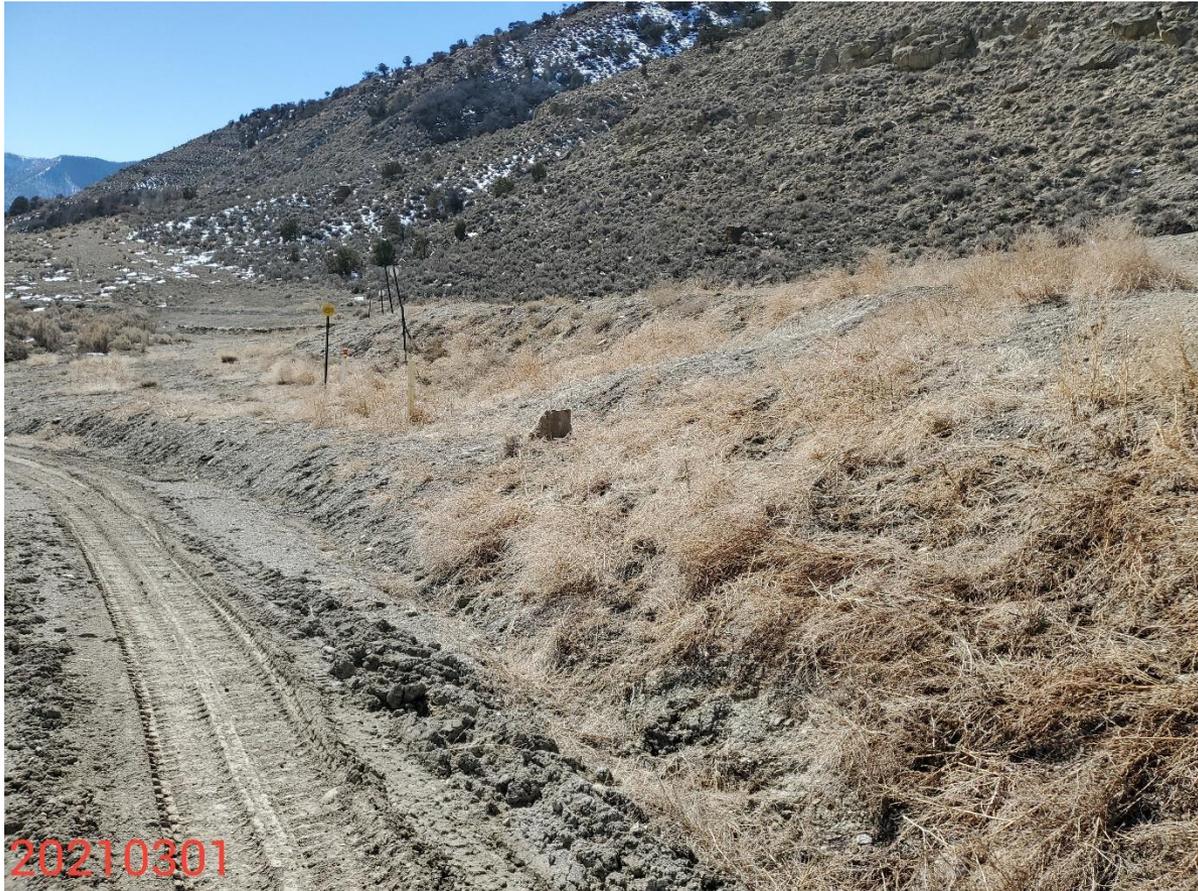
**Photo 14:** Photo taken from the eastern interim areas of the Location, facing southwest. Photo shows reclamation is not progressing towards COGCC 1003 standards; interim areas bare soil or vegetated by undesirable weedy plant species.

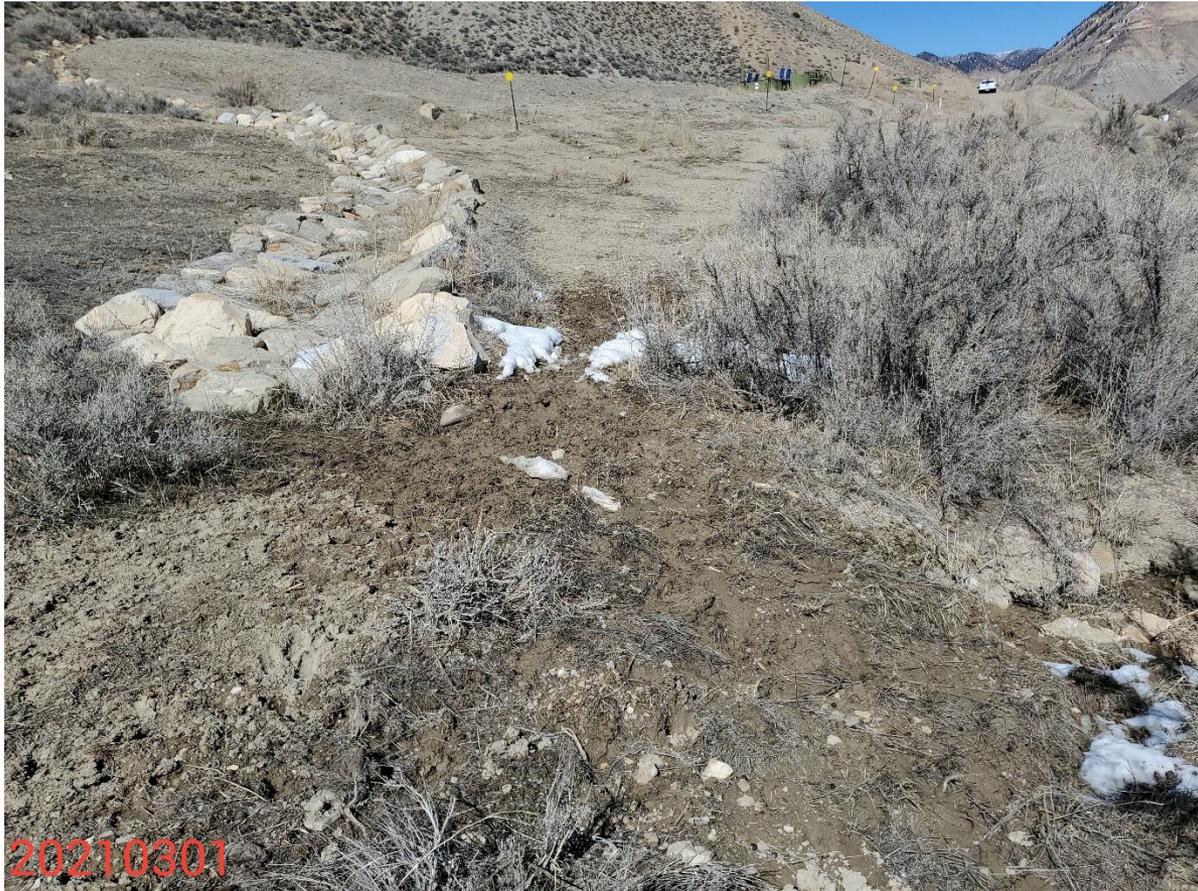
**Photo 15:** Photo taken from the southeastern interim areas, facing north. Photo shows areas below the sediment trap outlet where head cutting and gulley erosion degradation due to runoff is occurring.

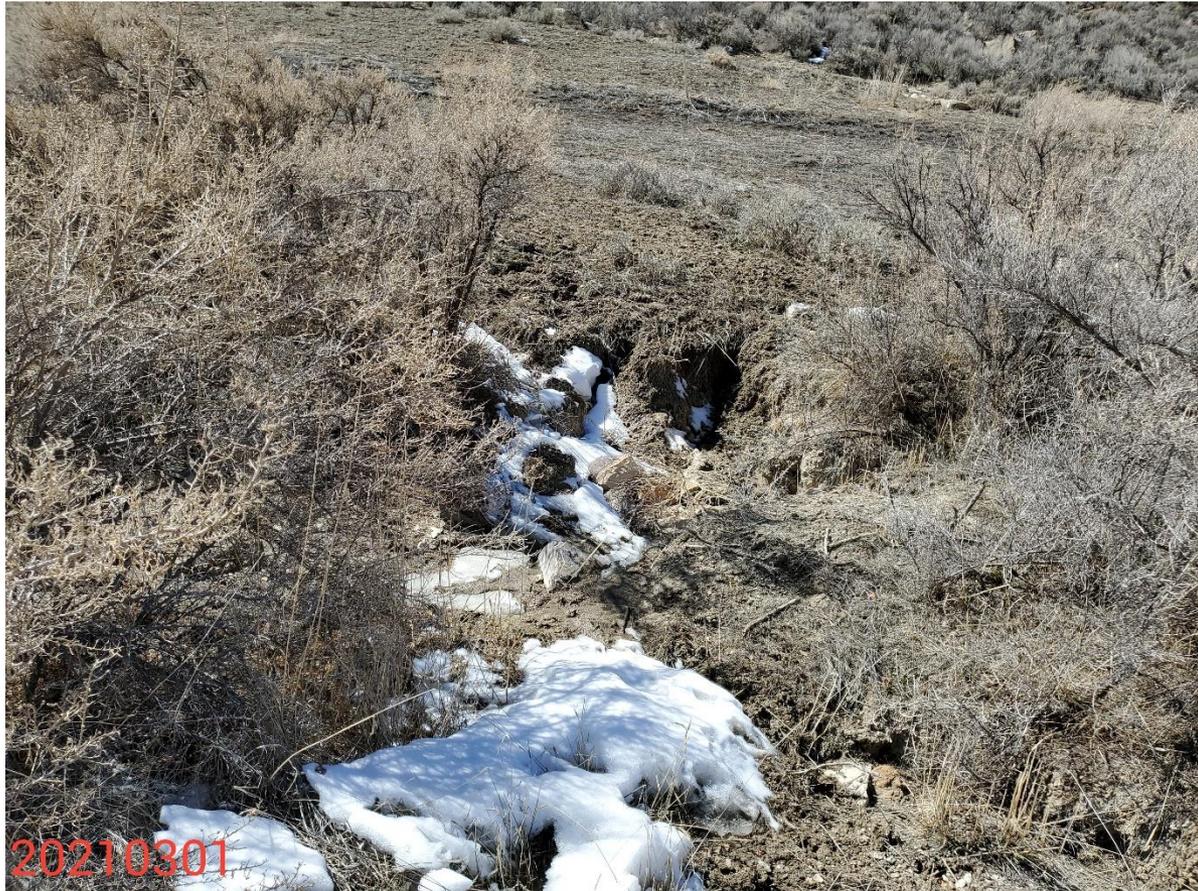
**Photo 16:** Photo taken from below the sediment trap outlet observed in photo 15. Photo shows areas below the sediment trap outlet where head cutting and gully erosion degradation due to runoff is occurring. Control measures missing or insufficient.

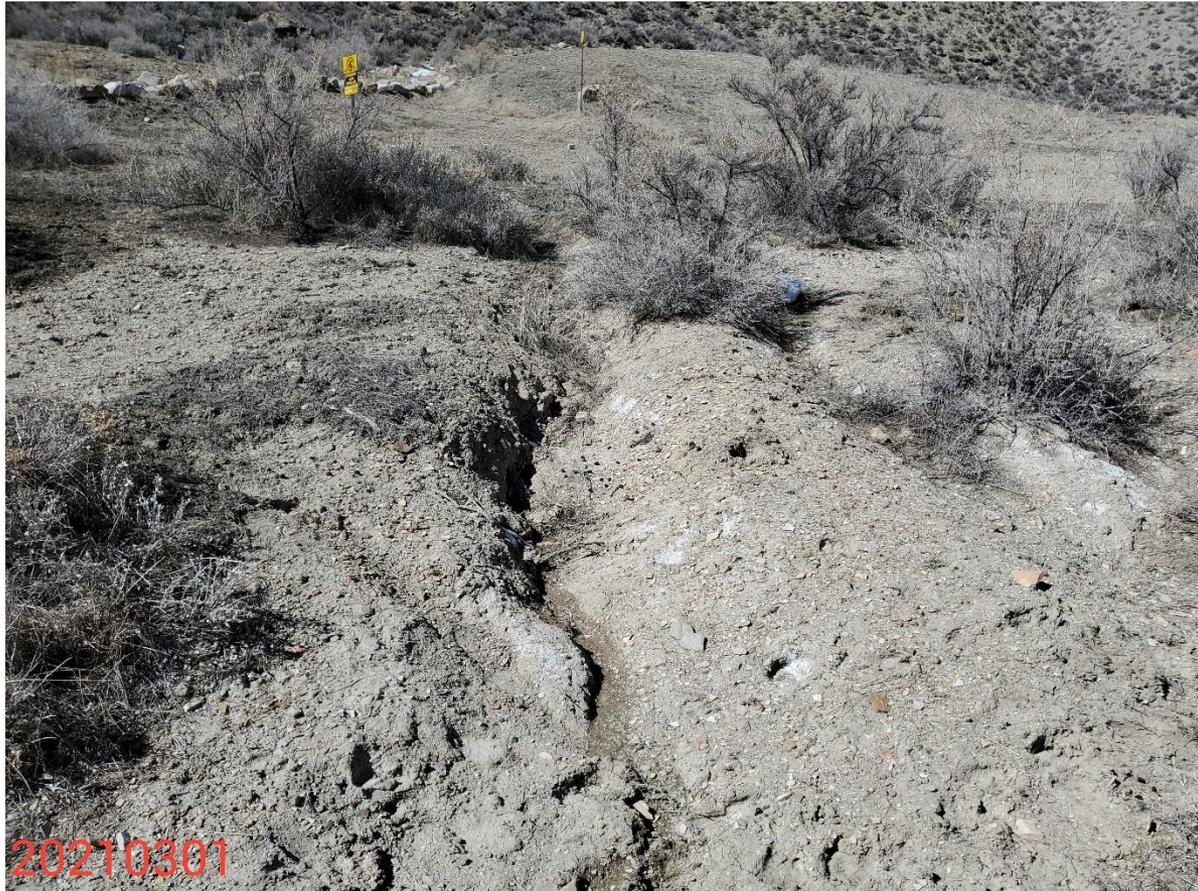
**Photo 17:** Photo taken from the eastern interim areas, adjacent to the access road, facing west. Photo shows gully erosion on the southern slopes of the Location. Control measures missing or insufficient.

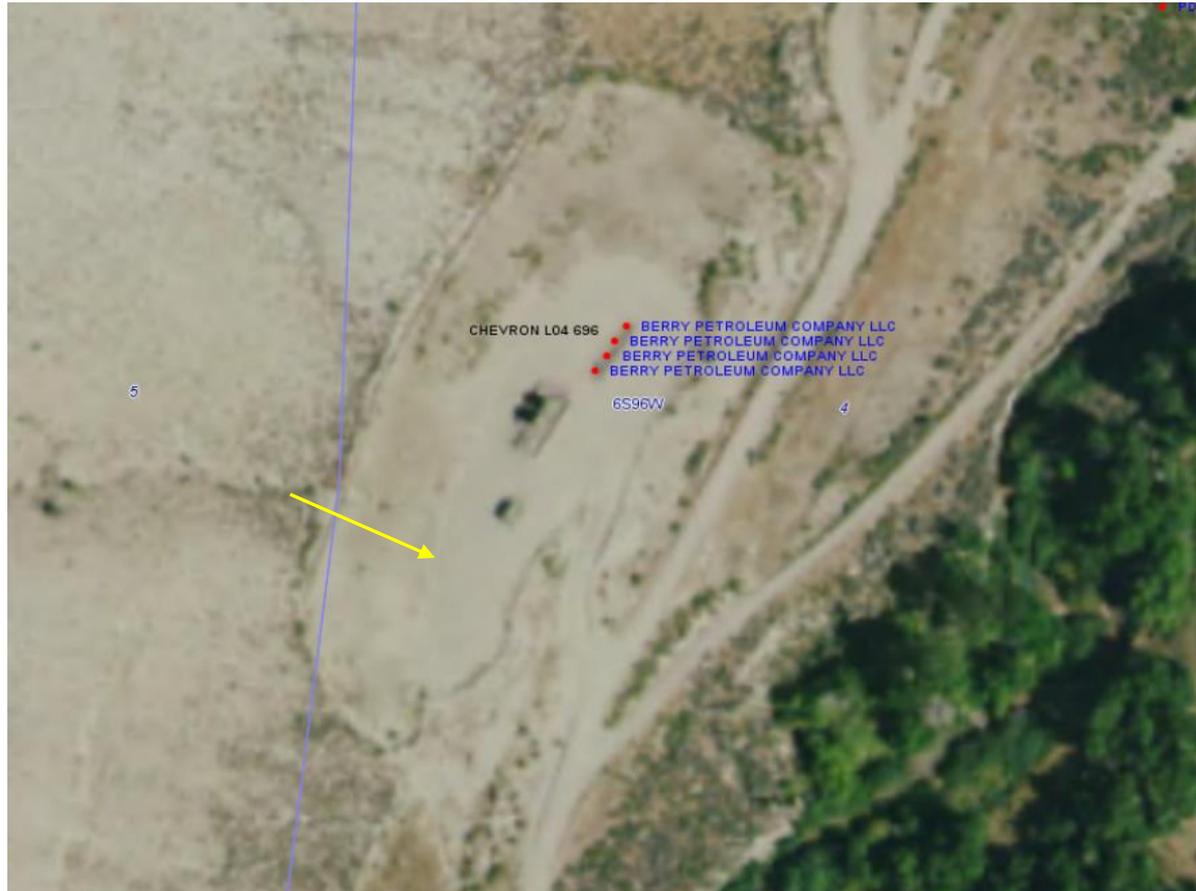
**Photo 18:** 2019 COGIS aerial imagery. Photo shows areas on the south end of the Location that are not needed for production and have not been reclaimed.
