Inspection Photos

API: 009-06453

Operator: INVESTMENT EQUIPMENT LLC

Inspection Date: 3/3/2021

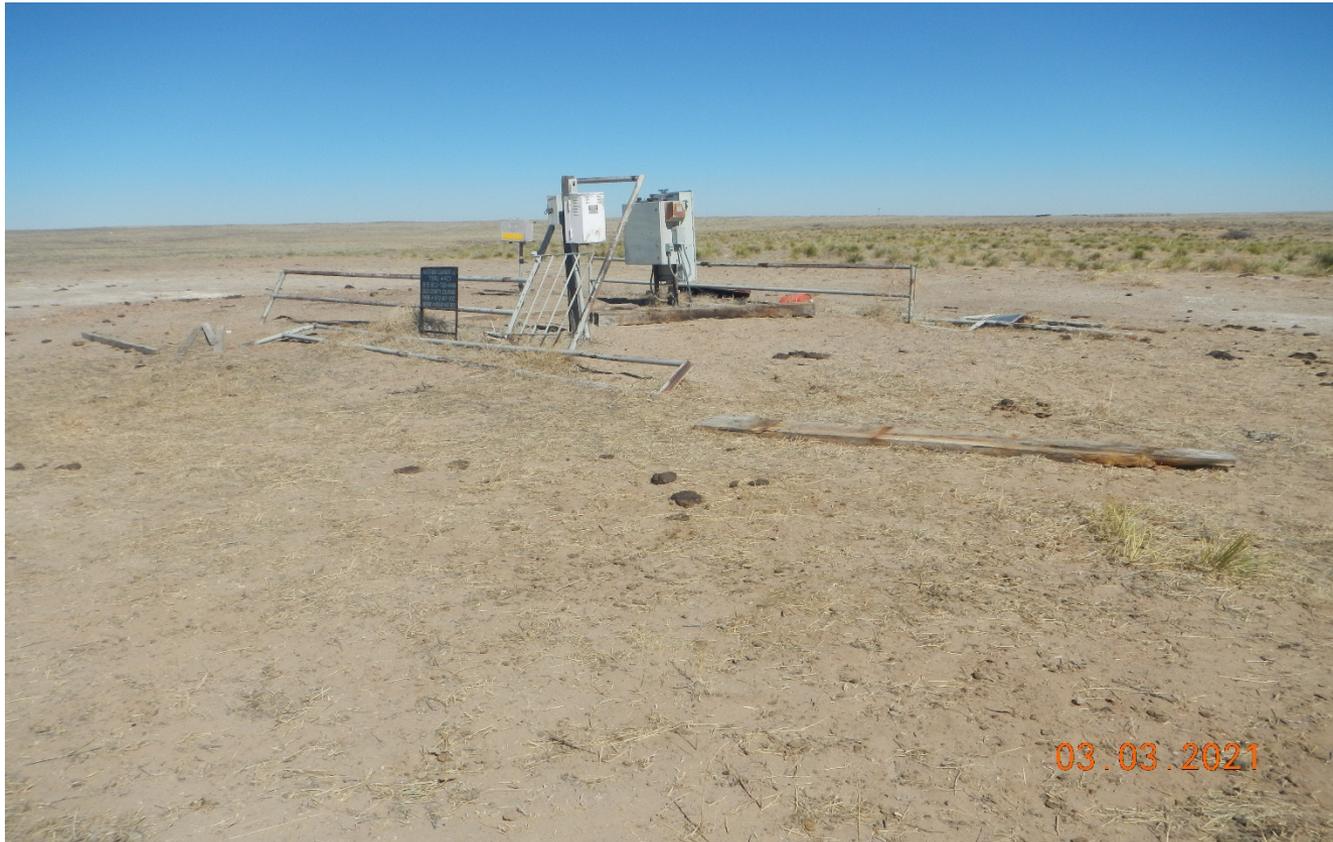
Photo 1. Facing northeast toward the well site. The location has not been reclaimed. Equipment and debris remains at the location. All equipment should have been removed within 3 months of abandoning the well.

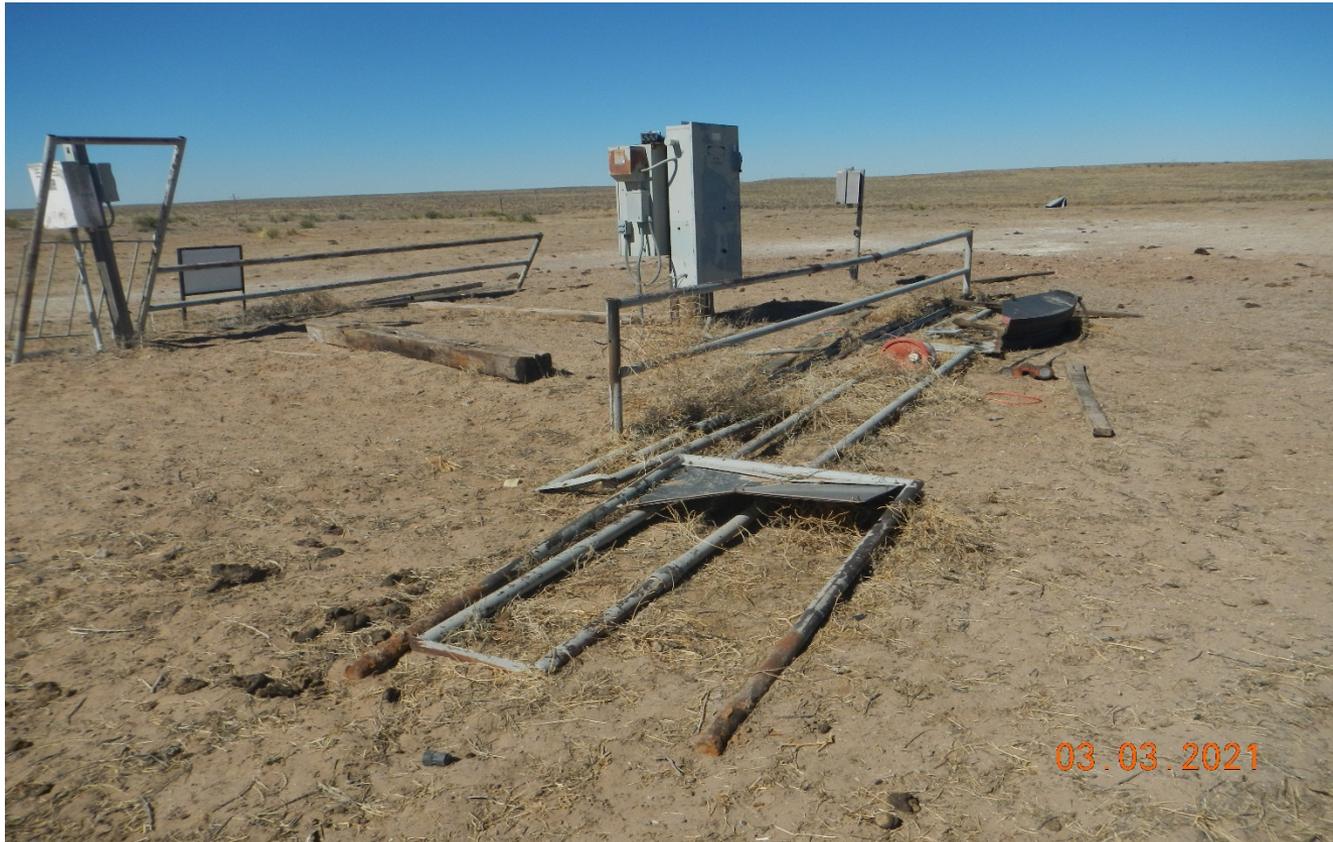
Photo 2. Equipment and debris remains at the location. All equipment should have been removed within 3 months of abandoning the well.

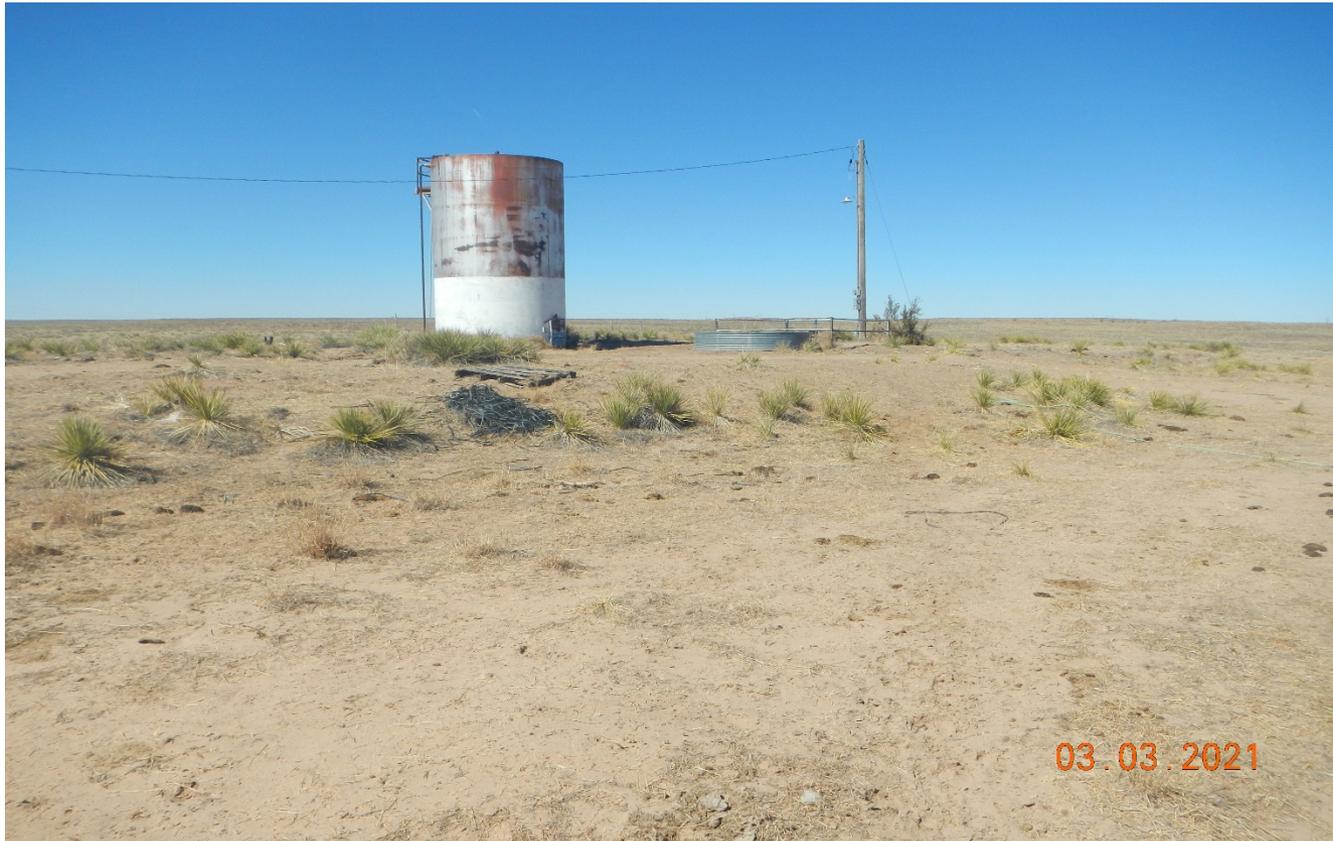
Photo 3. Facing northwest at the location. A tank battery remains at the northwest side of the location.

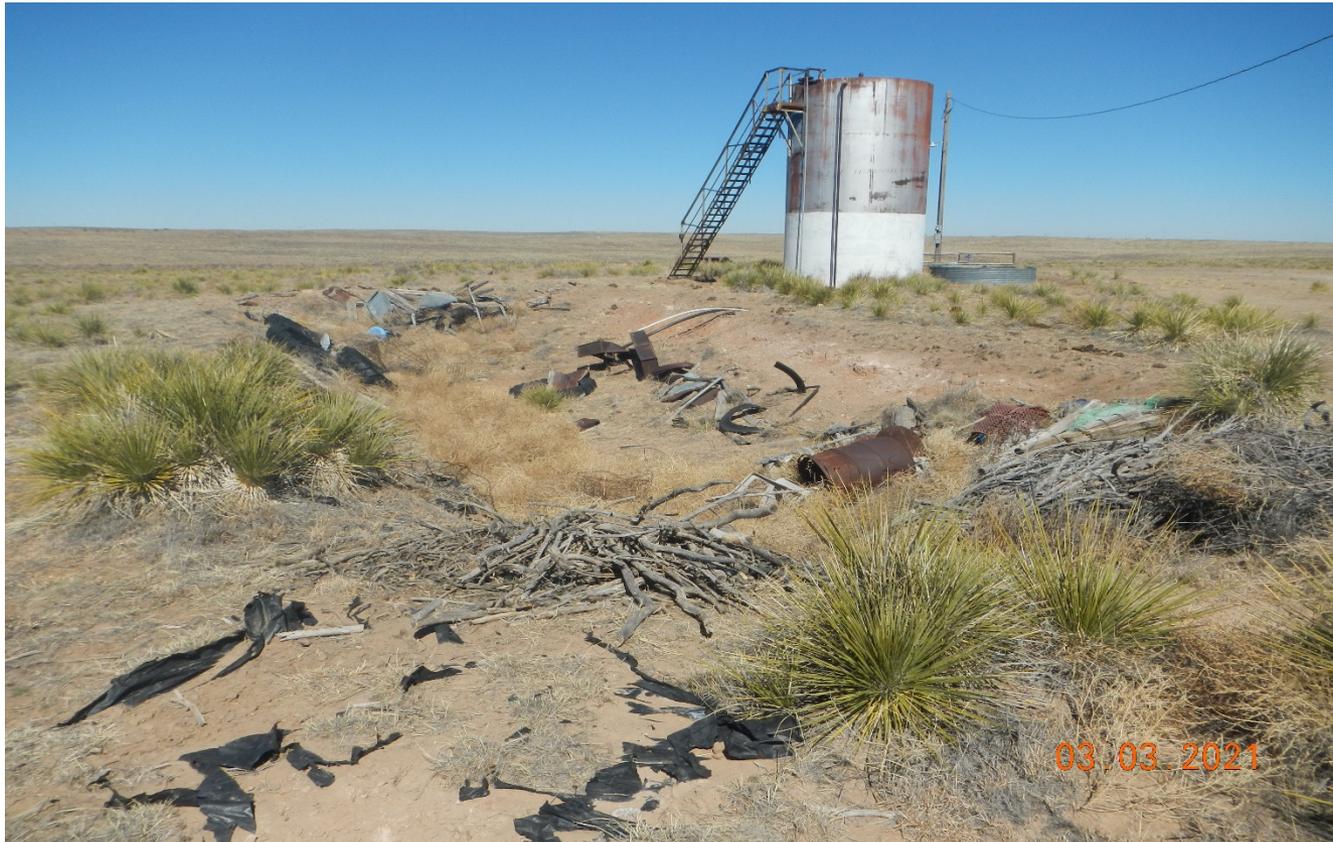
Photo 4. Facing northeast toward the pit. The pit liner is torn and degraded. There is various debris in the pit. The pit was never closed and reclaimed as required.
