Caerus Piceance LLC
J17
Location # 334872

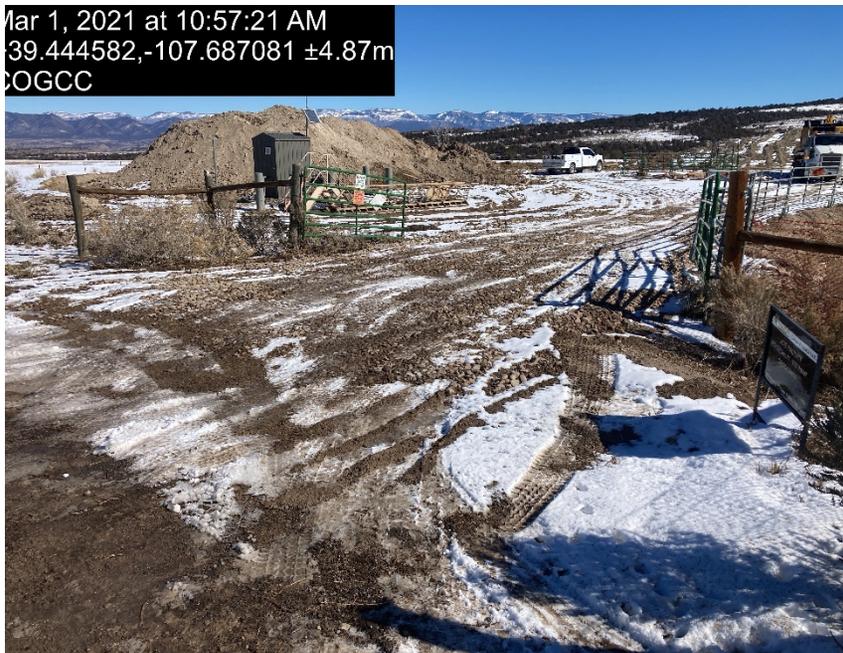
Location entrance

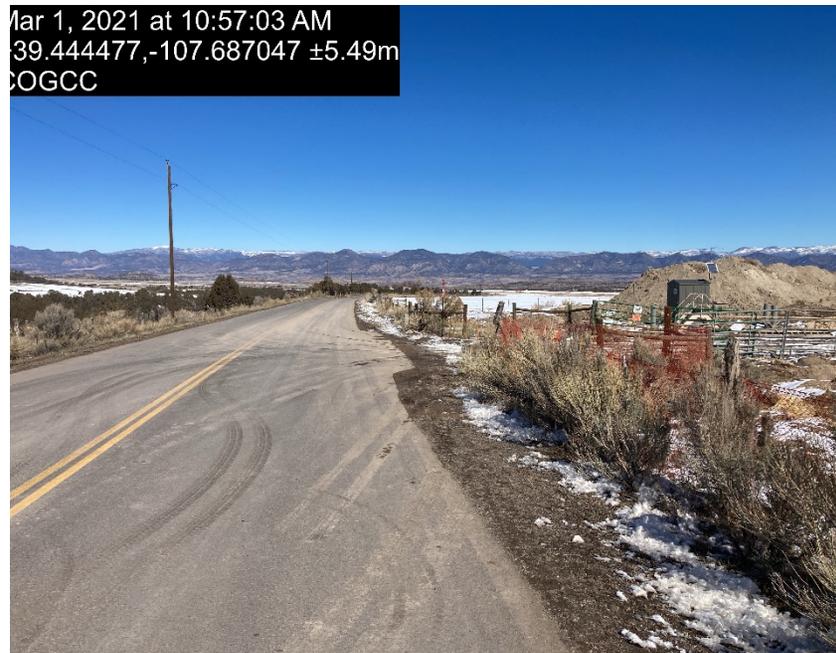
Looking north on CR 315 by entrance

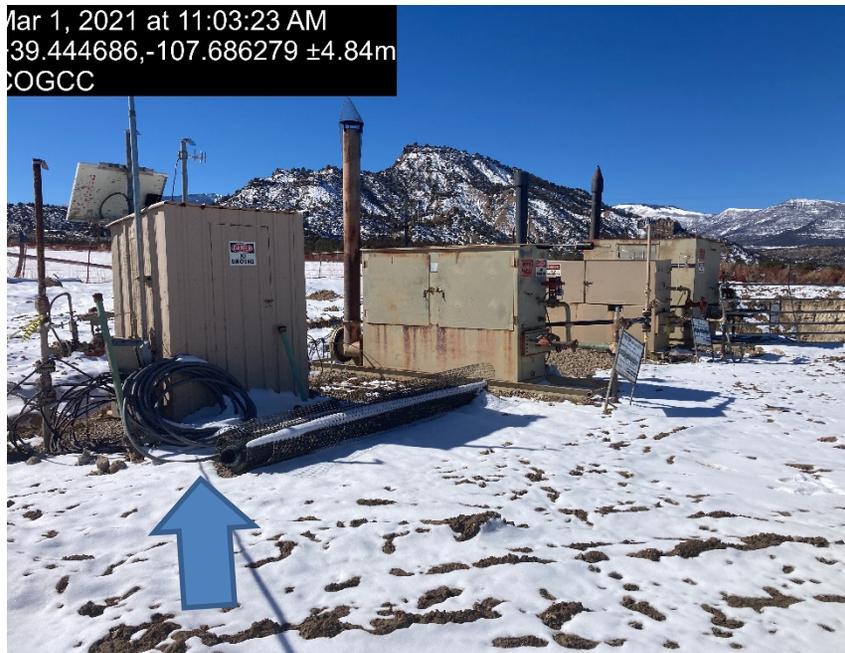
Location/ debris

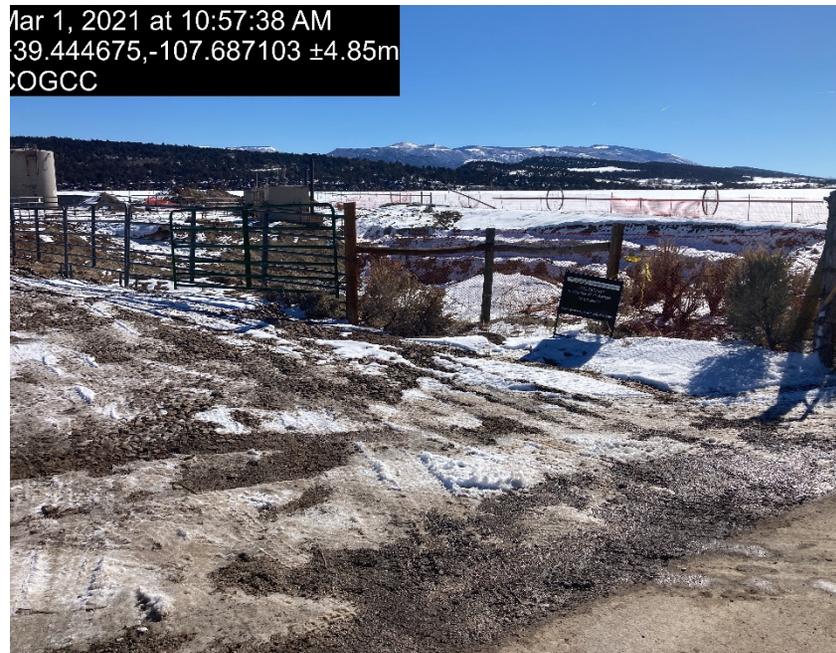
location entrance

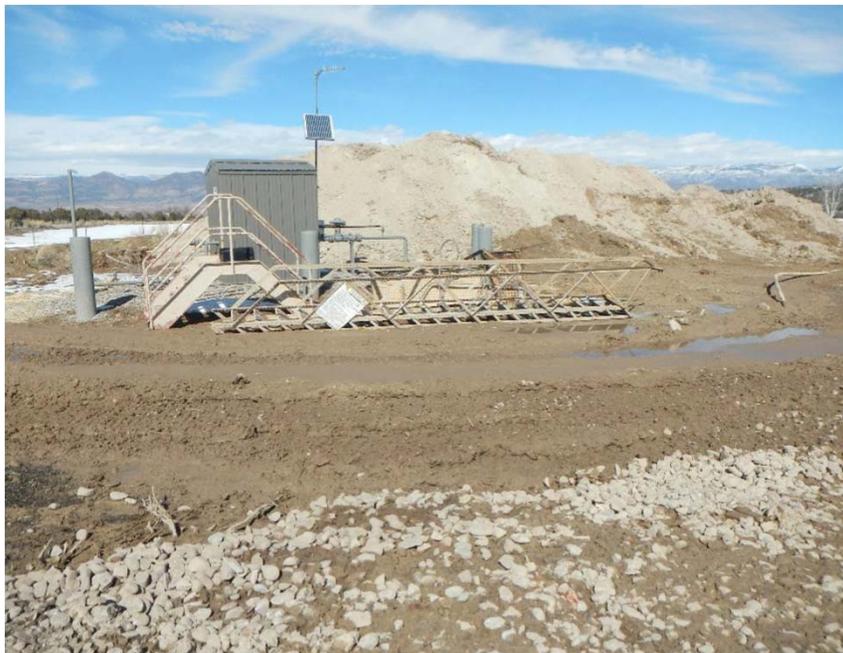
Previous inspection photo of equipment stored on pad surface

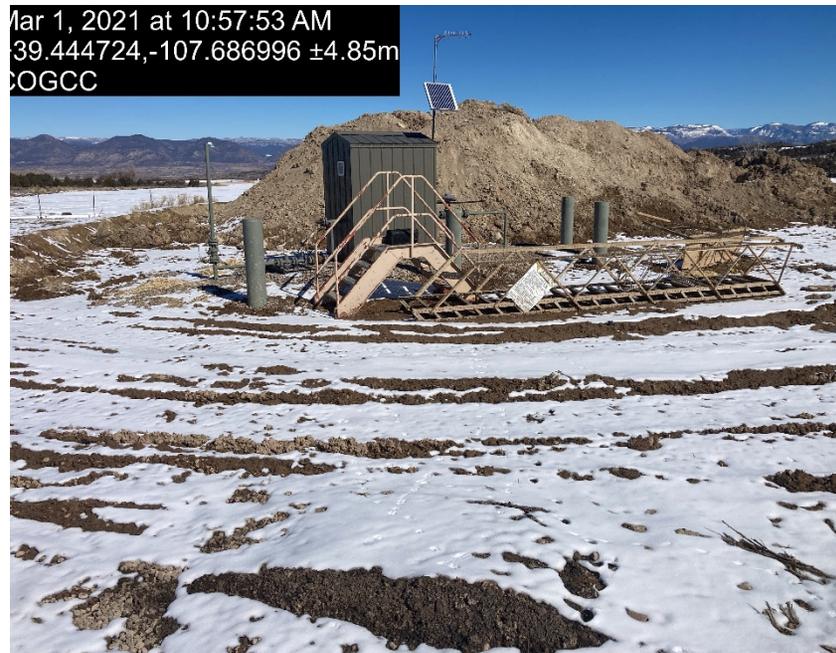
Follow up inspection photo of equipment still stored on pad surface

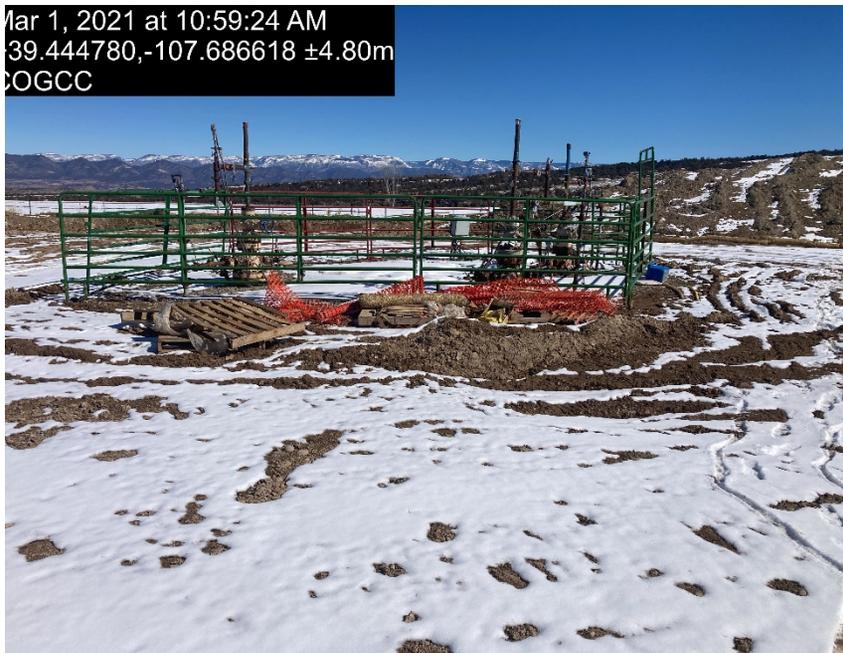
Random debris

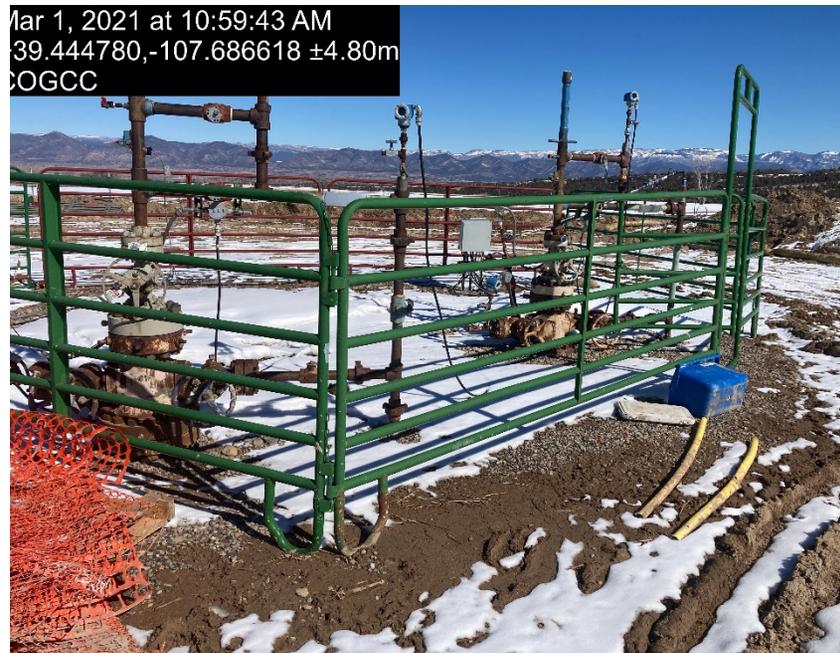
Random debris

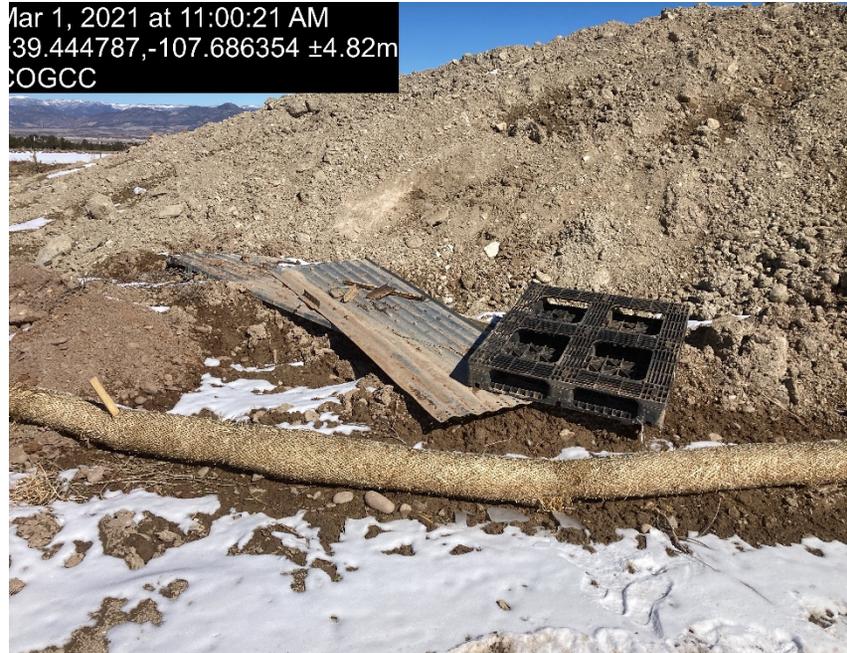
Random debris

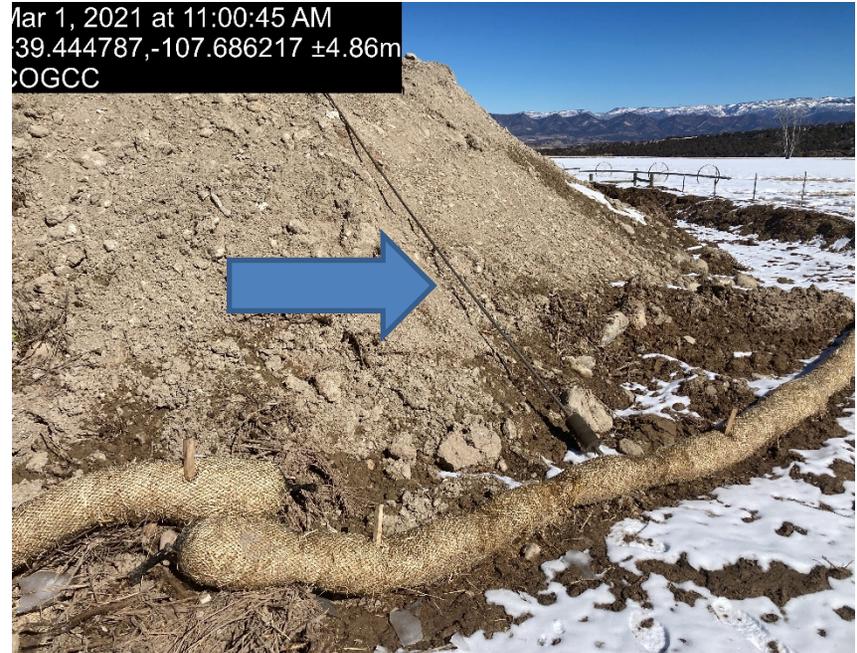
Random debris (ESD tank float)

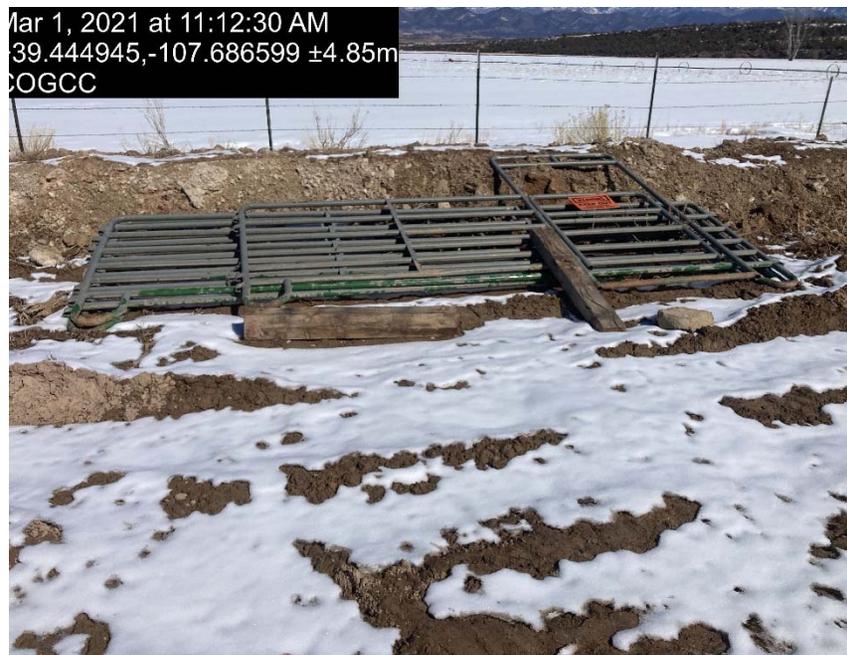
Random debris

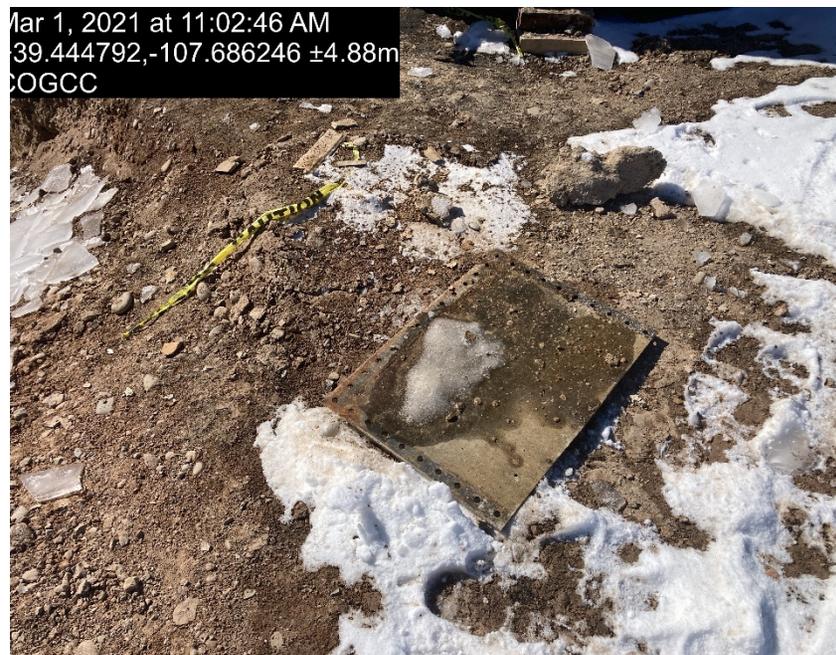
Random debris

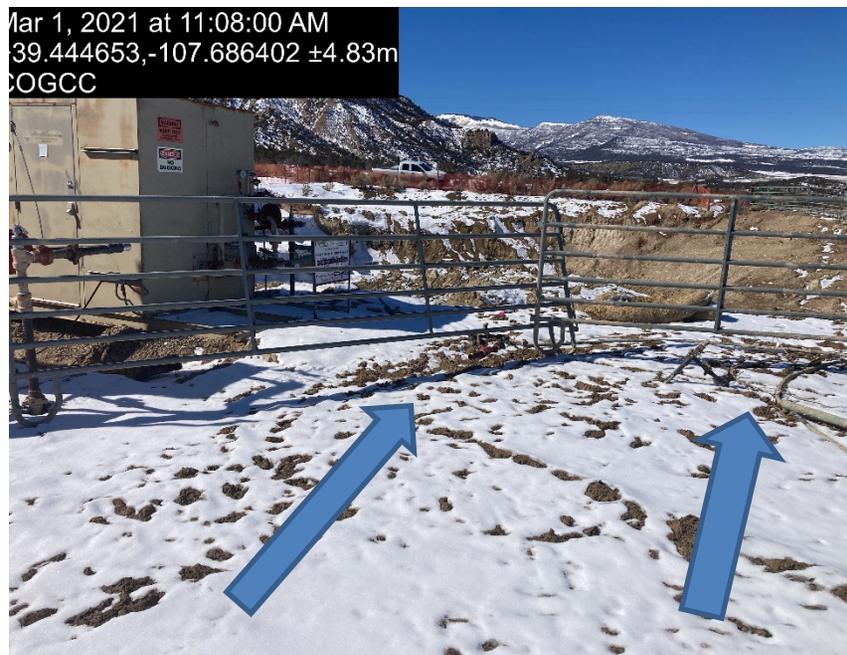
Random debris

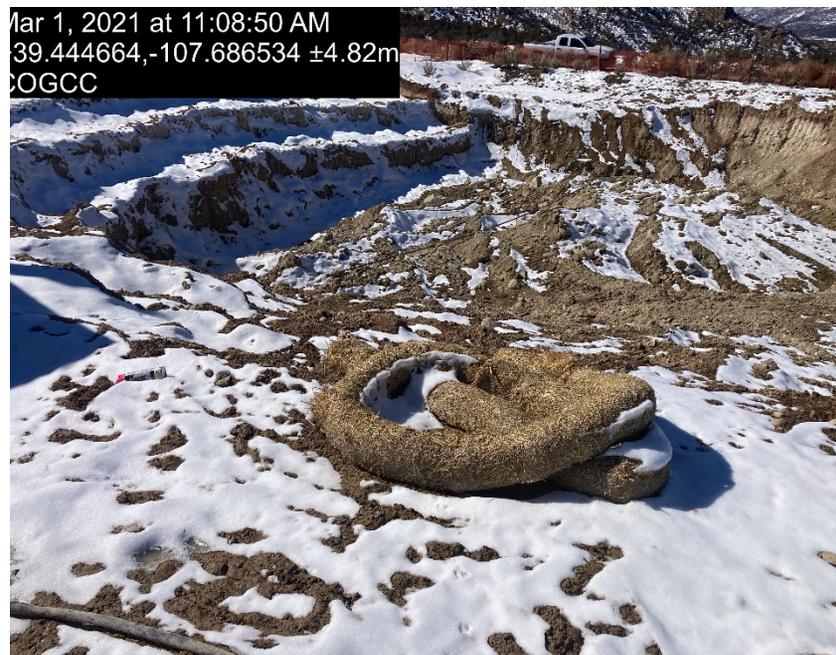
Random debris

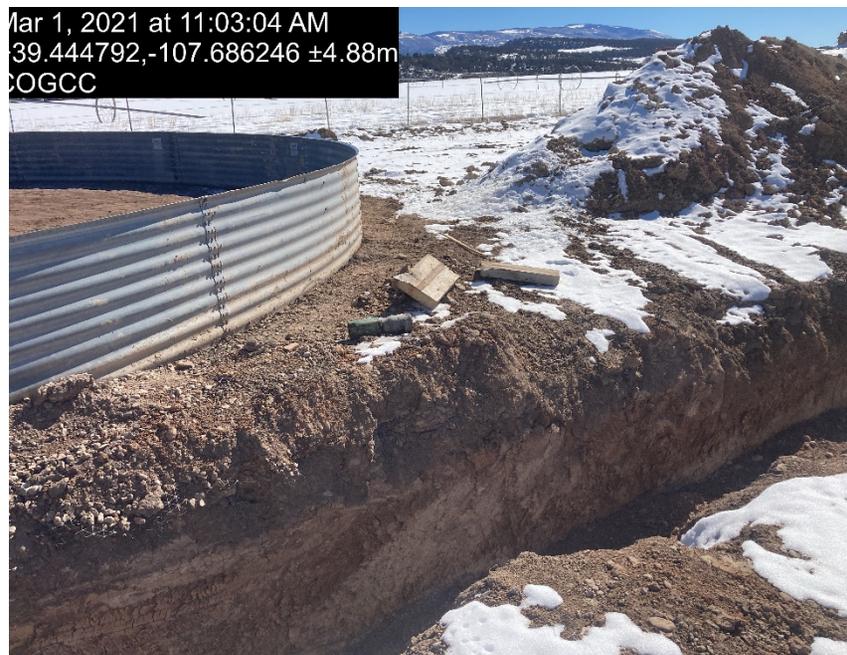
Random debris

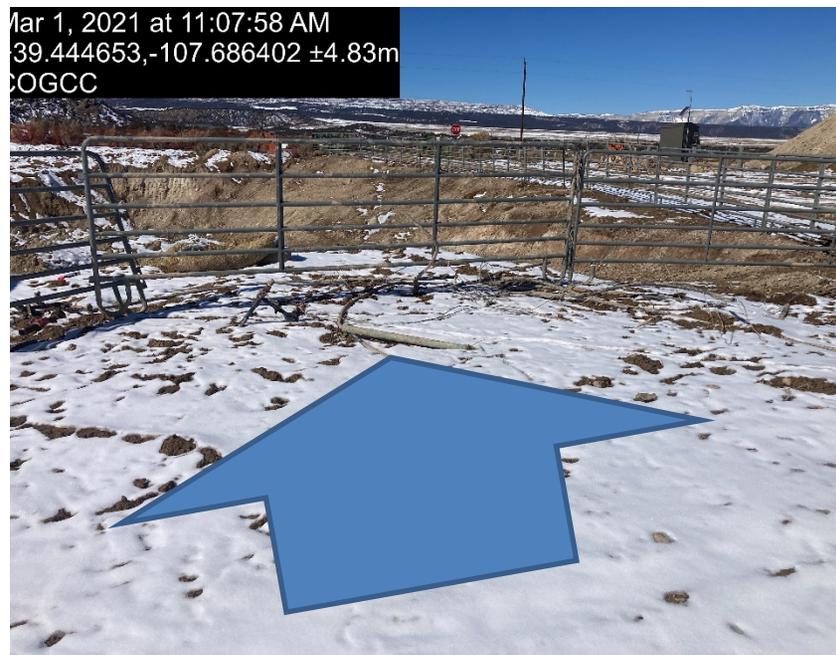
Random debris

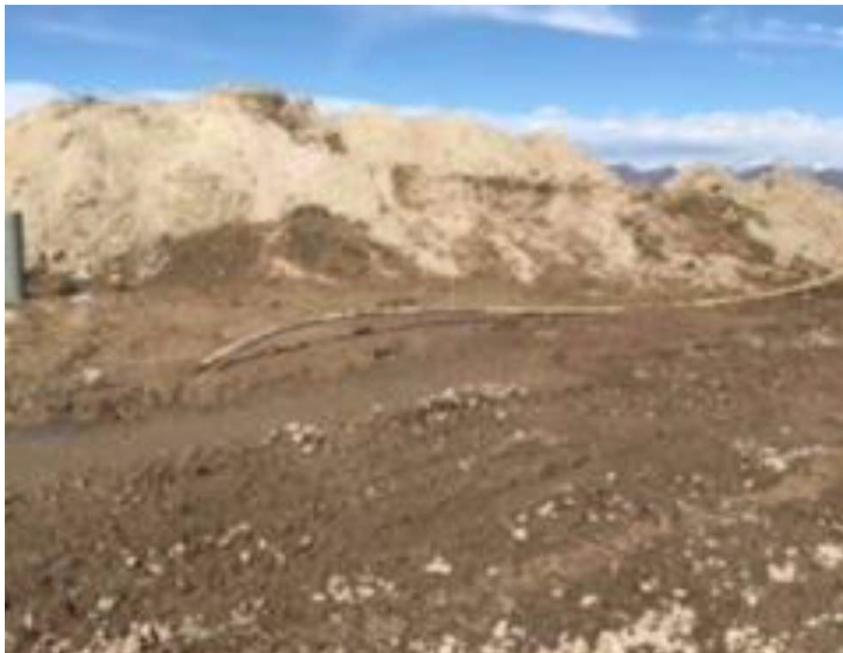
Previous inspection photo of soil storage on location

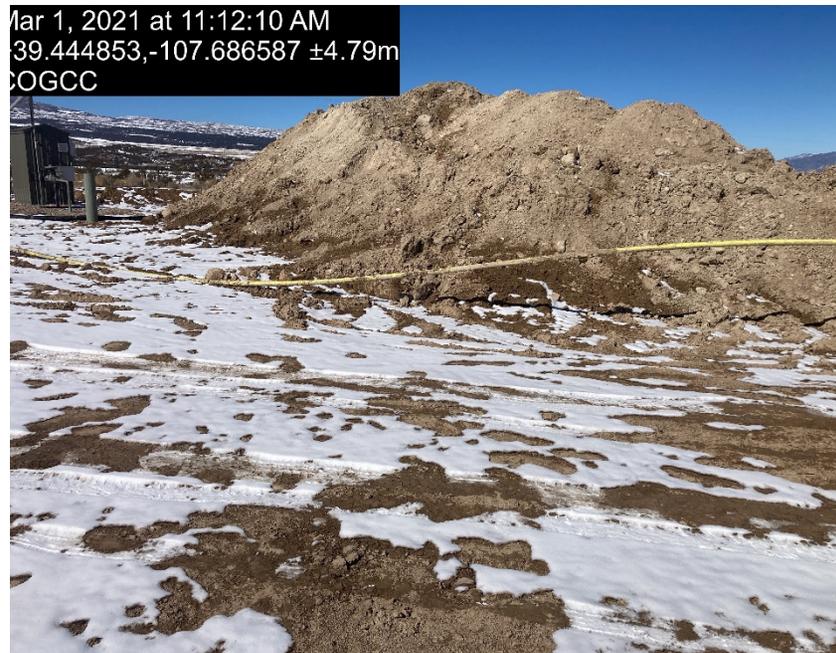
Follow up inspection photo of soil storage on location

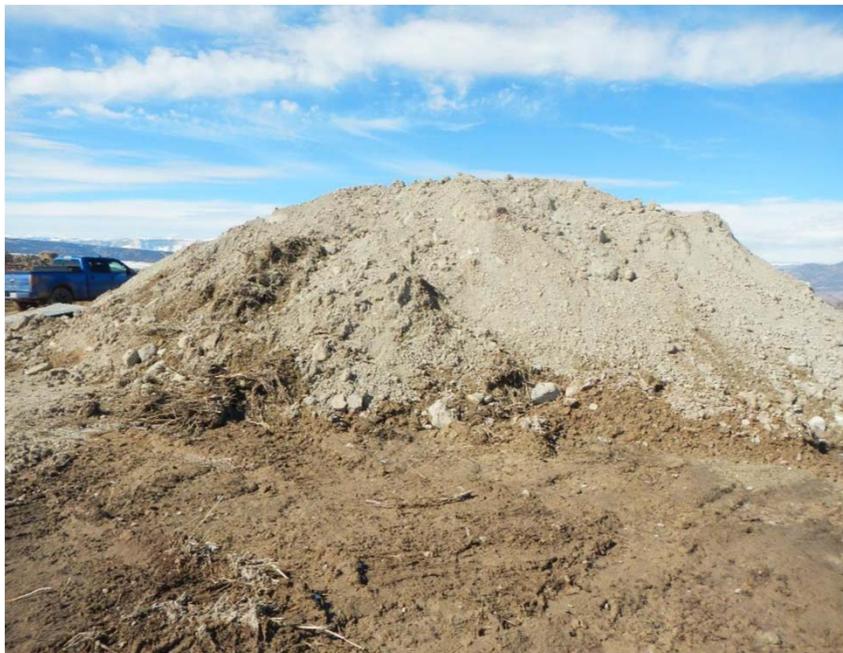
Previous inspection photo of material storage on pad surface

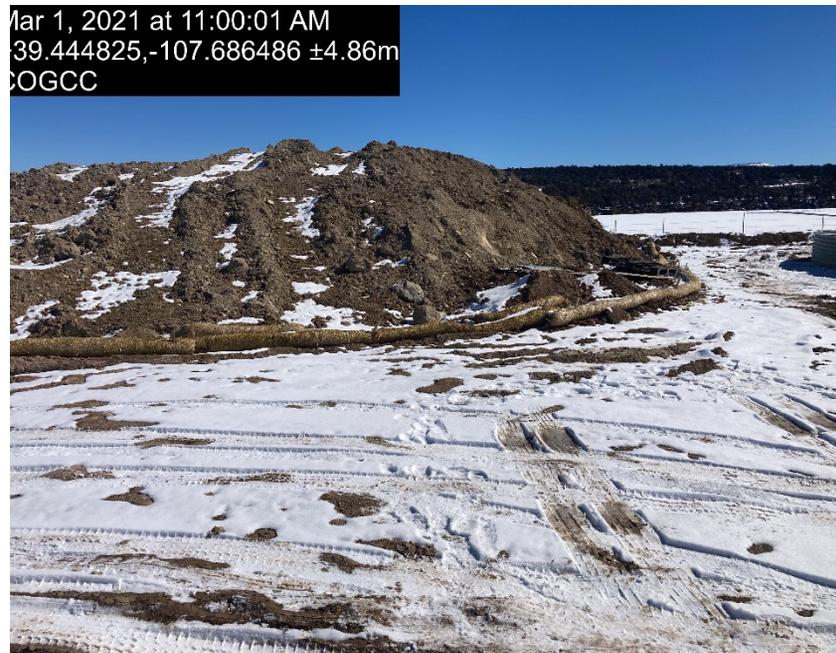
Follow up inspection photo of material storage on pad surface

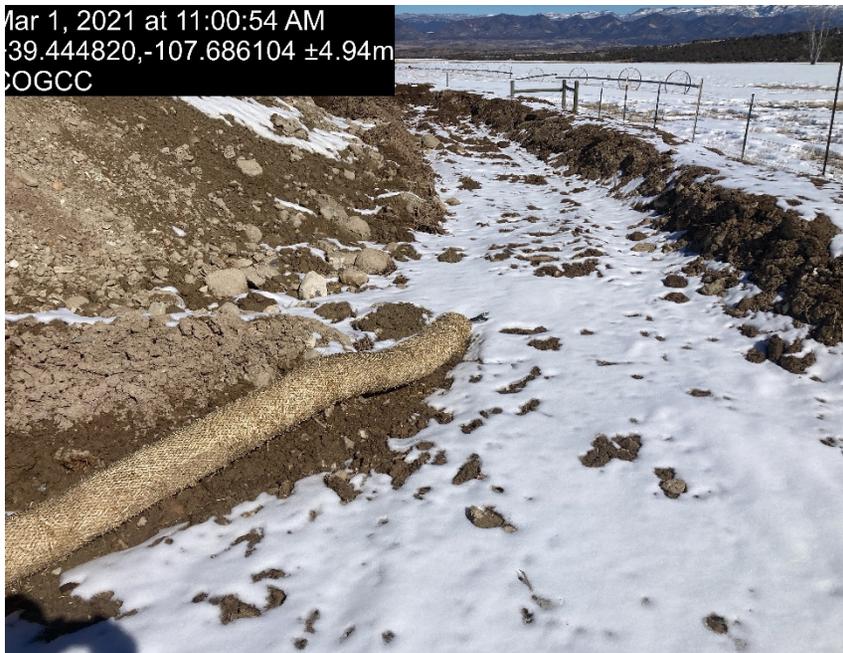
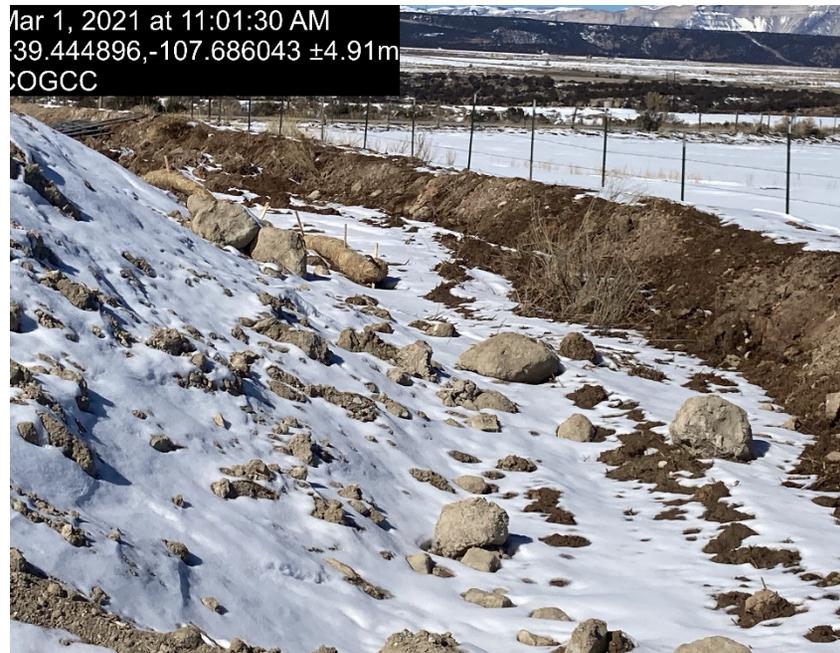
Follow up inspection photo of material storage on pad surface / BMP's are failing

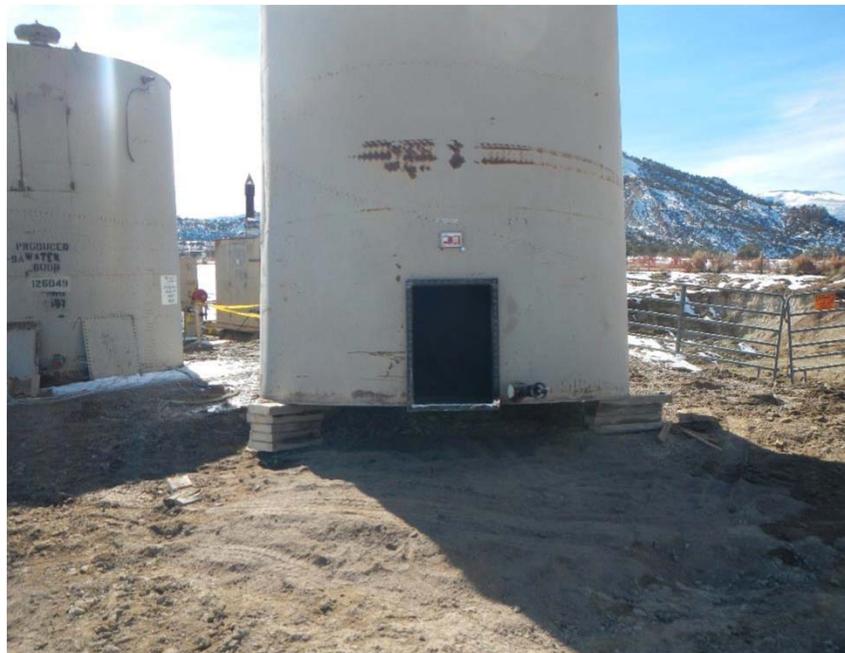
Previous inspection of manway open

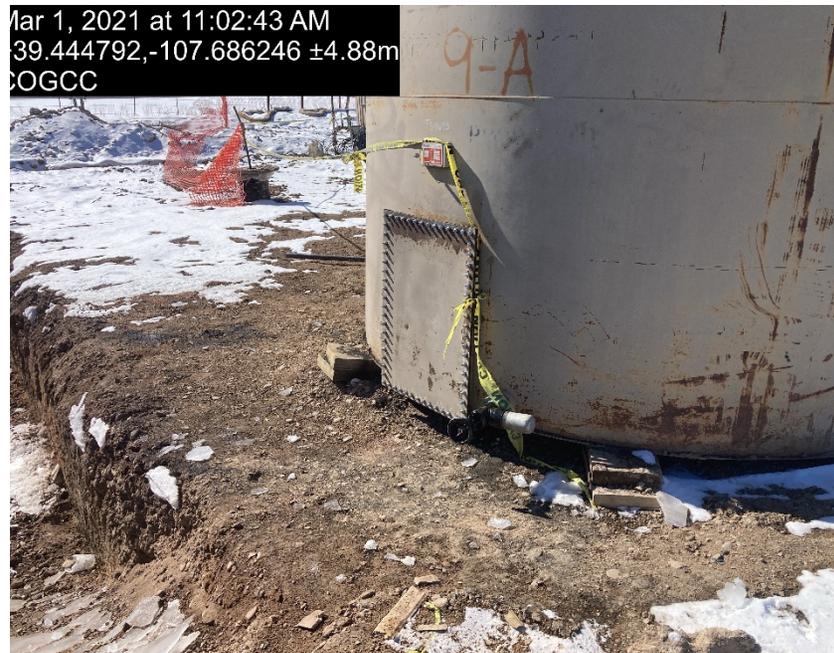
Follow up inspection of manway is sealed but still
no secondary containment
