Whiting Oil & Gas Corporation

WOLF 36-2623H CORRECTIVE ACTION INSPECTION PHOTOS

Location ID: 426053

Sec 35 T10N R59W

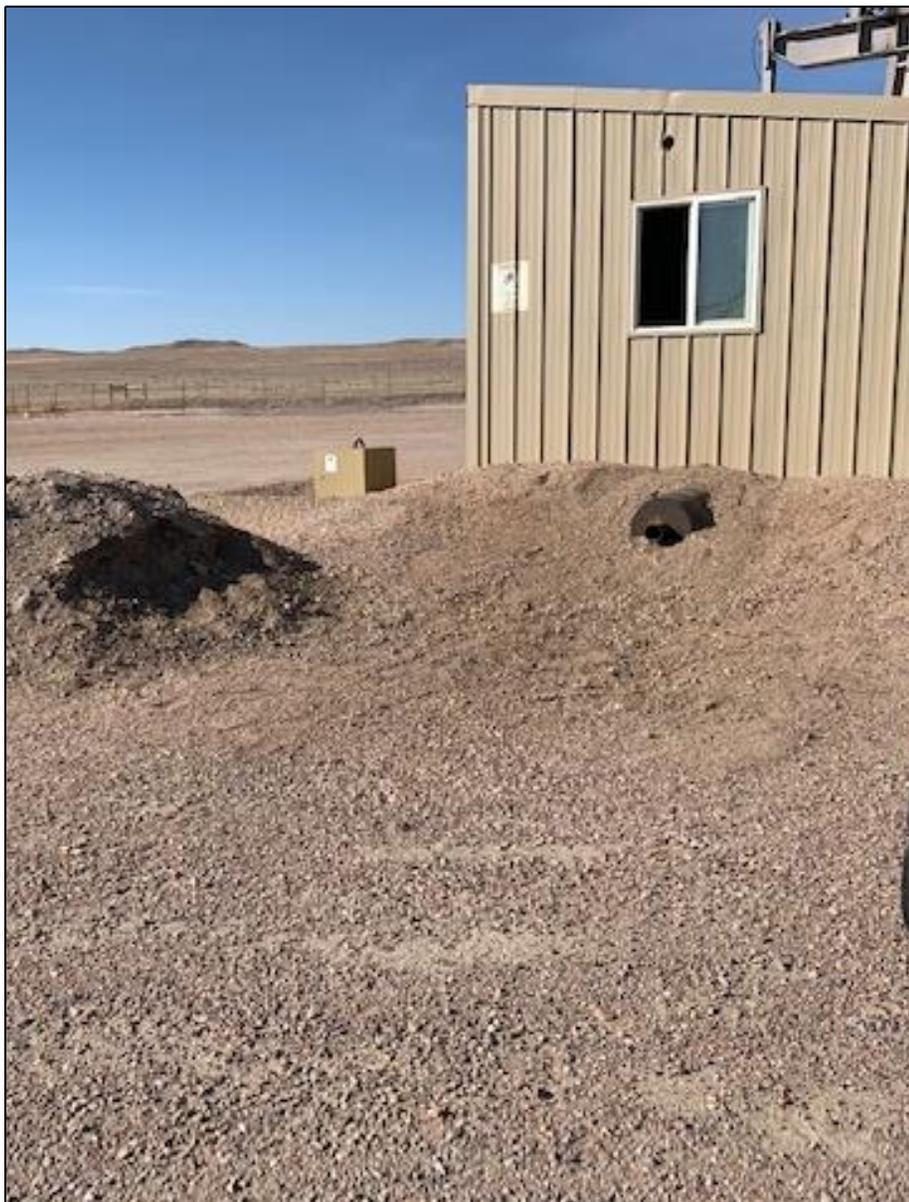
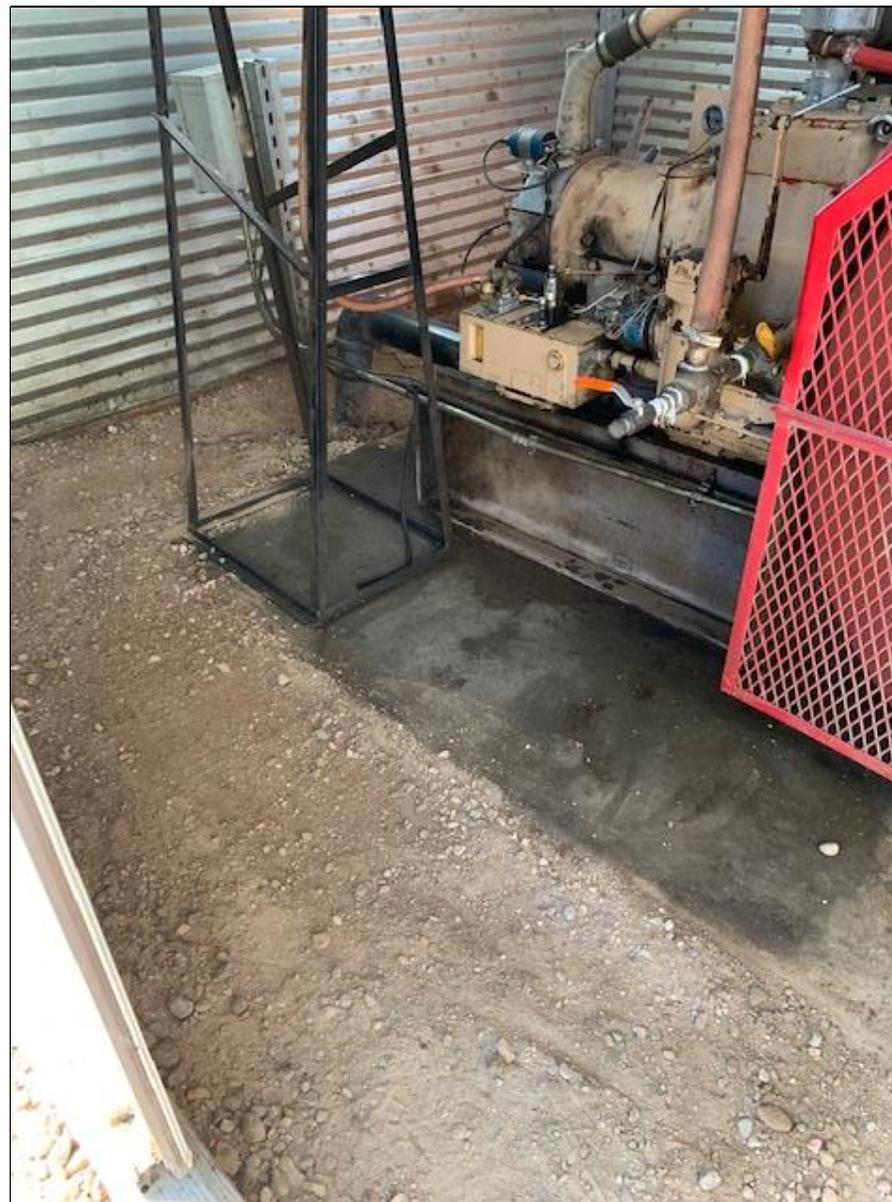
Impacted soils no longer at Pump Jack
