Inspection Photos

3/9/2021

Operator: CAERUS PICEANCE LLC #10456

Location ID: 335970

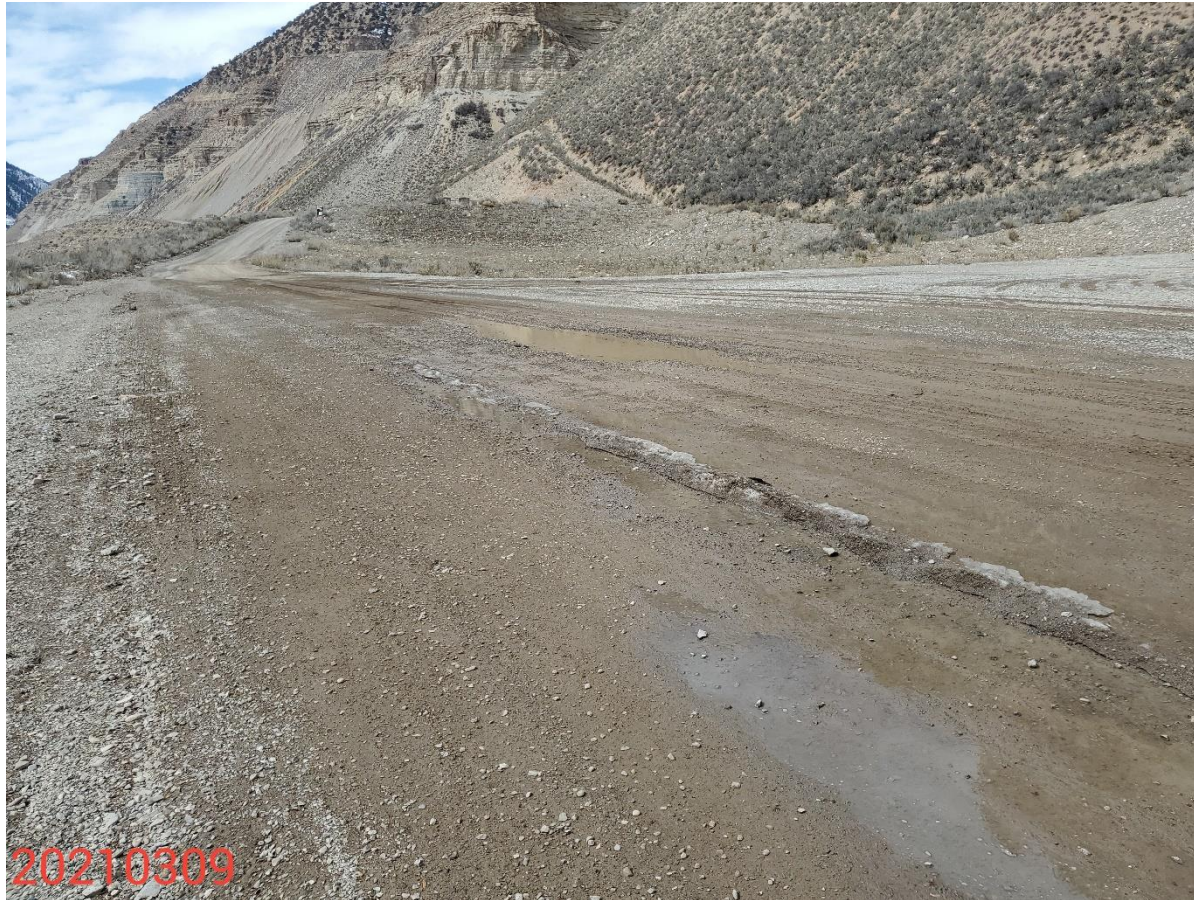
Photo 1: Photo taken from the south end of the Location, facing west. Photos 1-4 provide an overview of the Location from west, northwest, northeast to east.

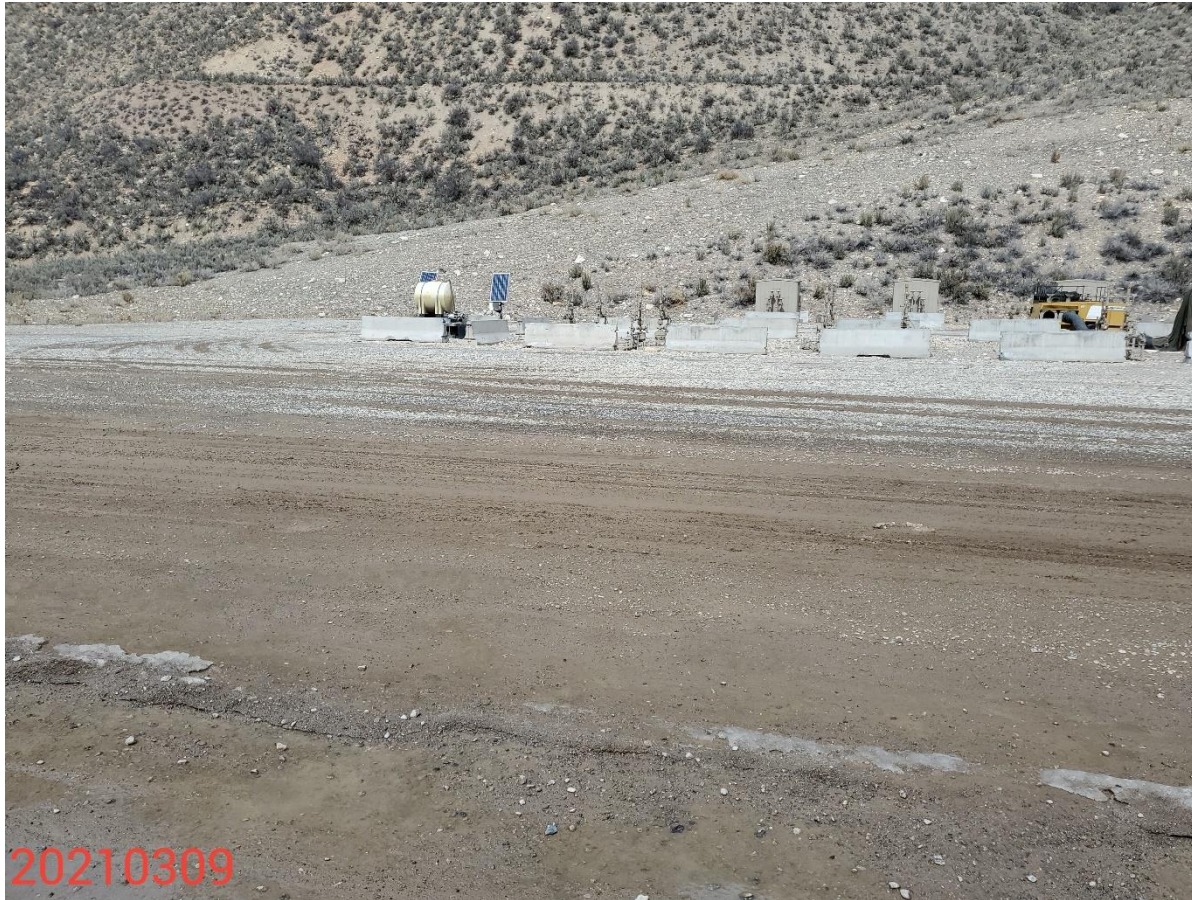
Photo 2: See comments under photo 1.

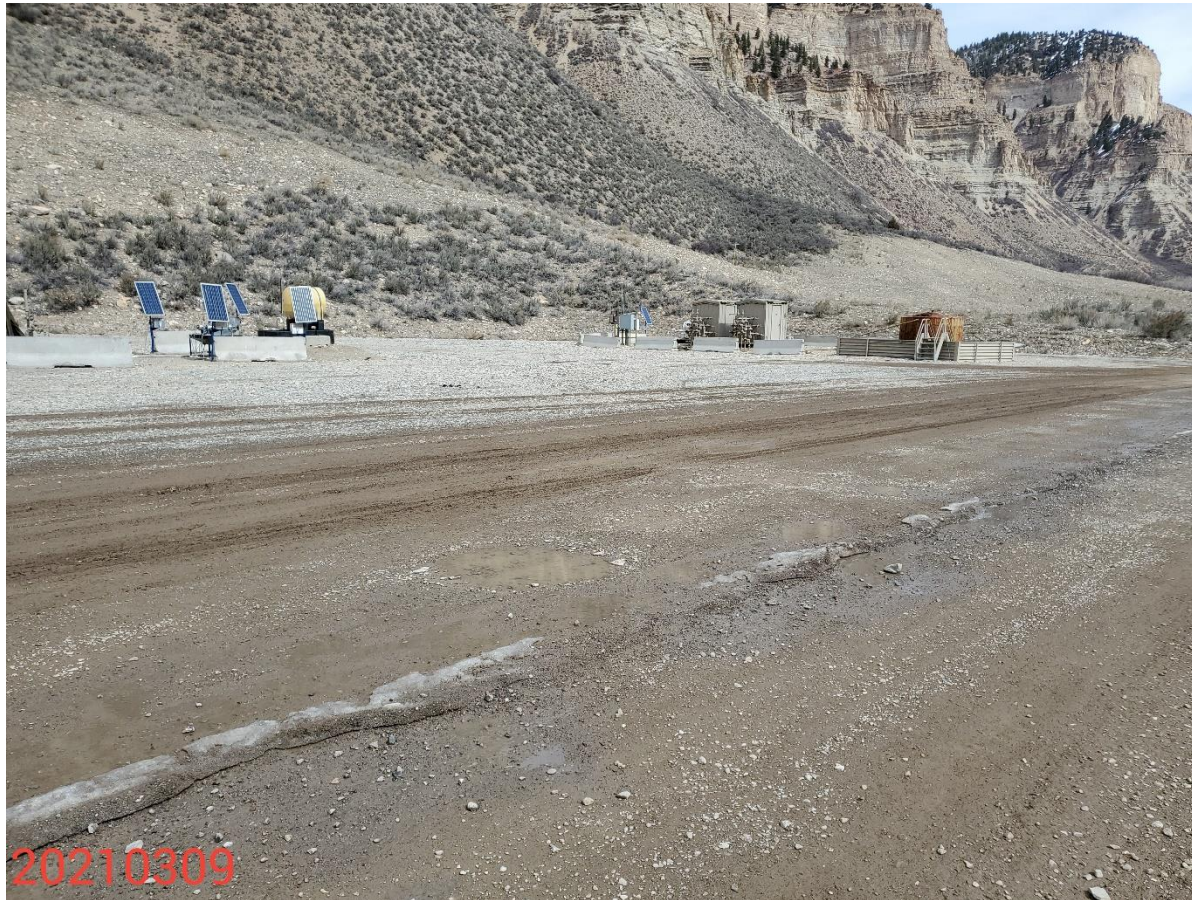
Photo 3: See comments under photo 1.

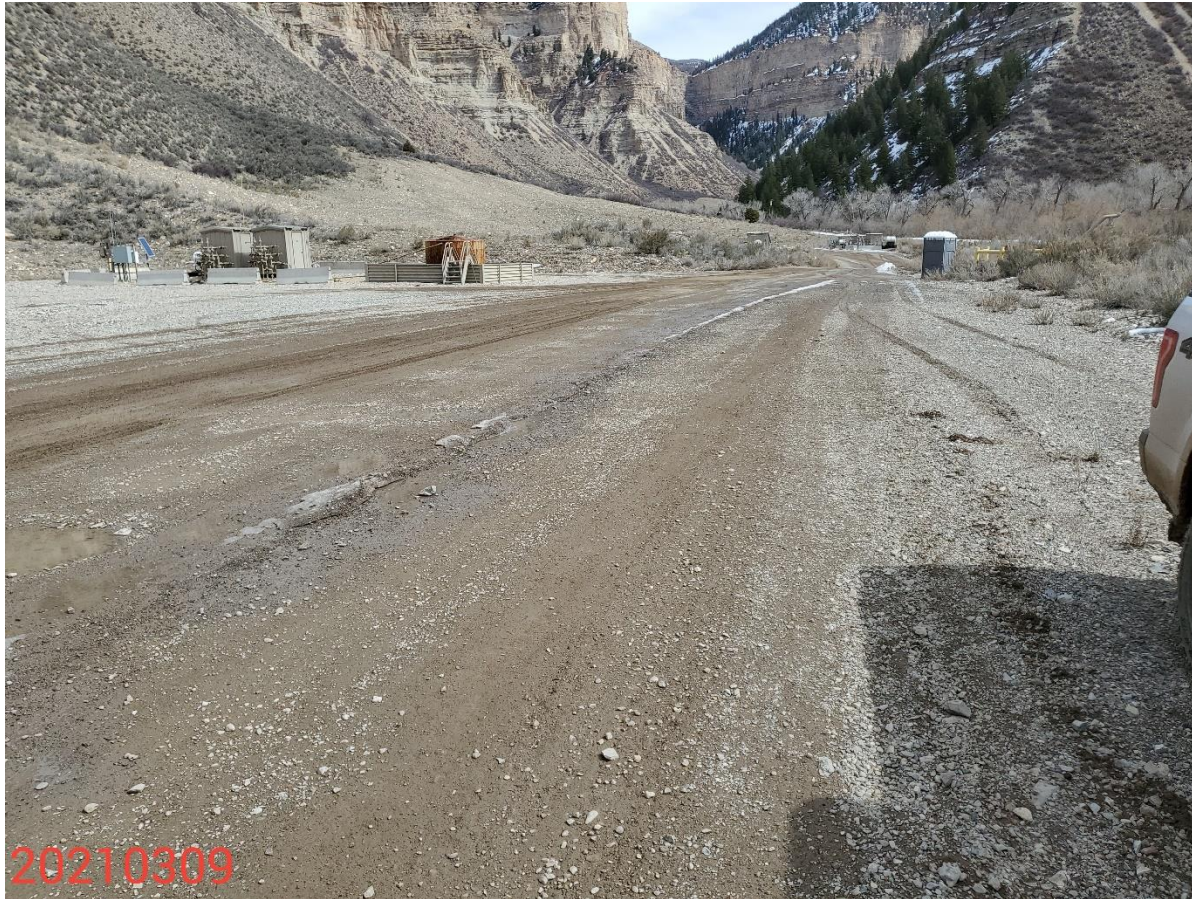
Photo 4: See comments under photo 1.

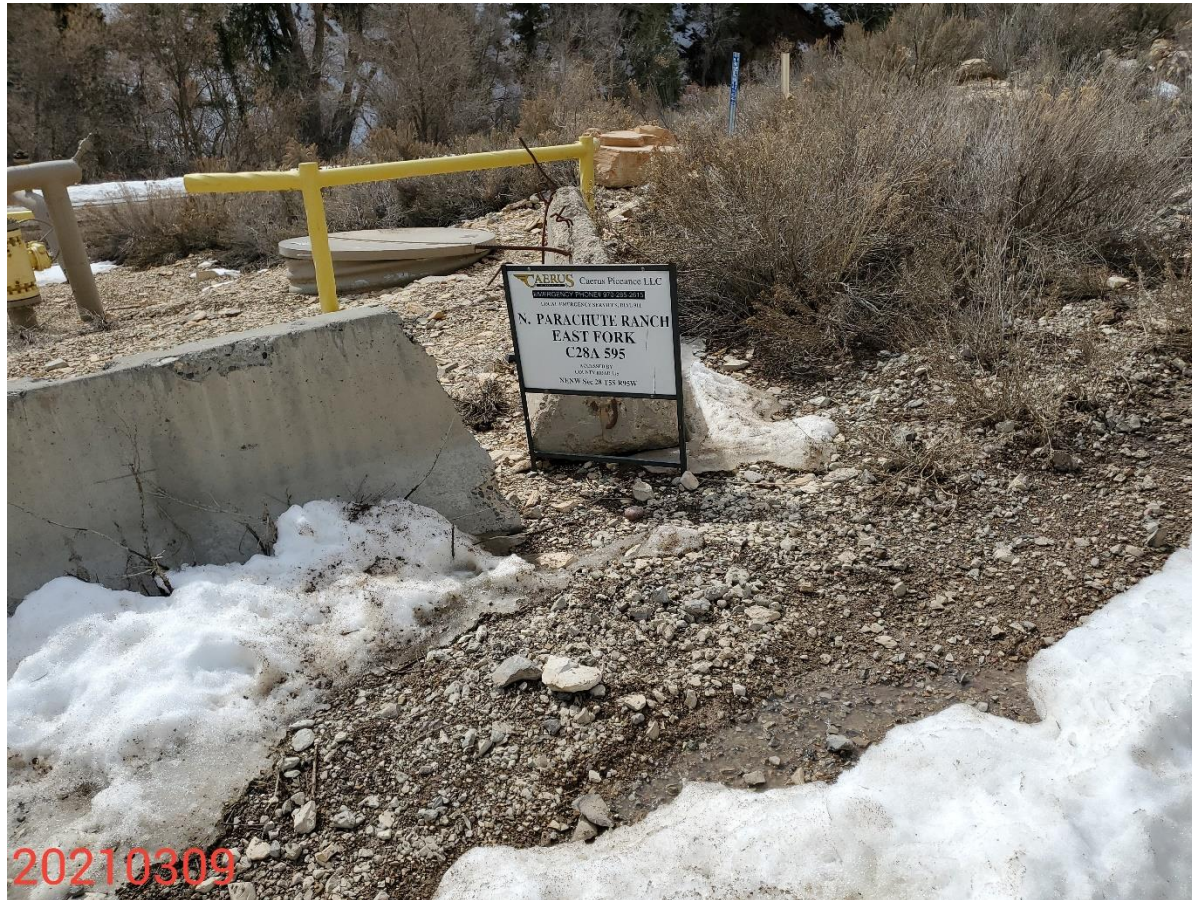
Photo 5: Photo of signs at location entrance.

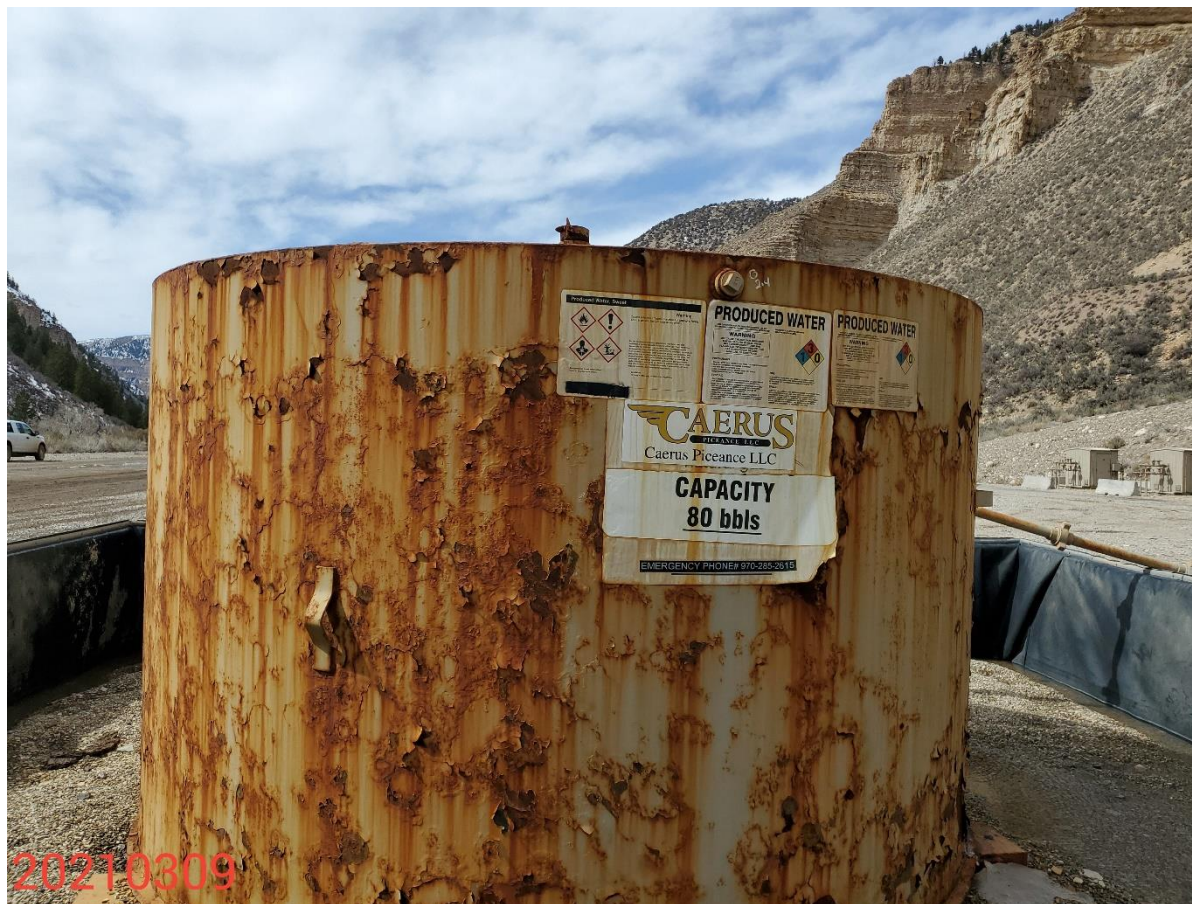
Photo 6: Photo of 80 bbl tank on Location. Signage peeling off. Inspection #701100324 observed that the tank is rusted and peeling paint. Inspection required Operator to "Inspect, maintain and repair tanks following standard industry practice such as API 12R" by 11/3/2020. Corrective action from FIR 701100324 does not appear to have been addressed.

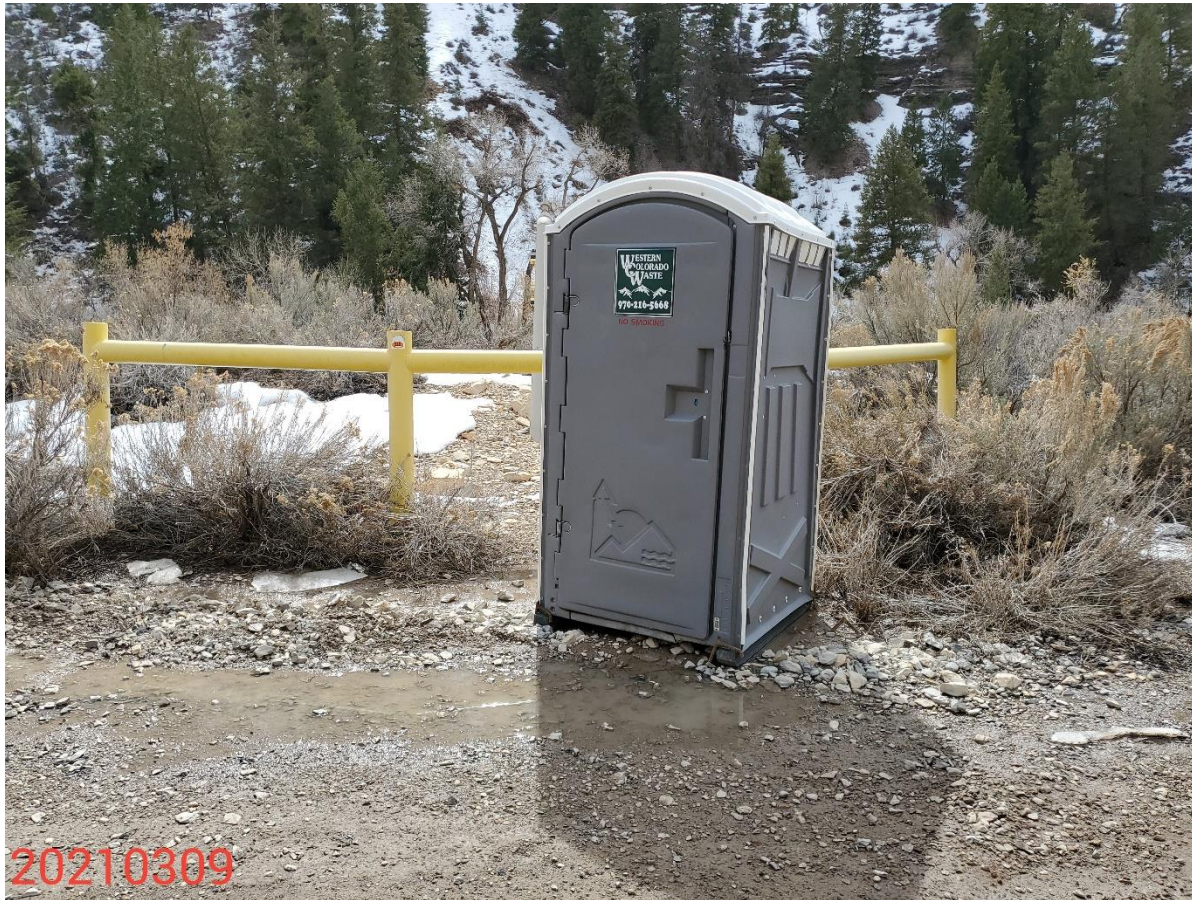
Photo 7: Photo shows porta-john on Location is properly secured.

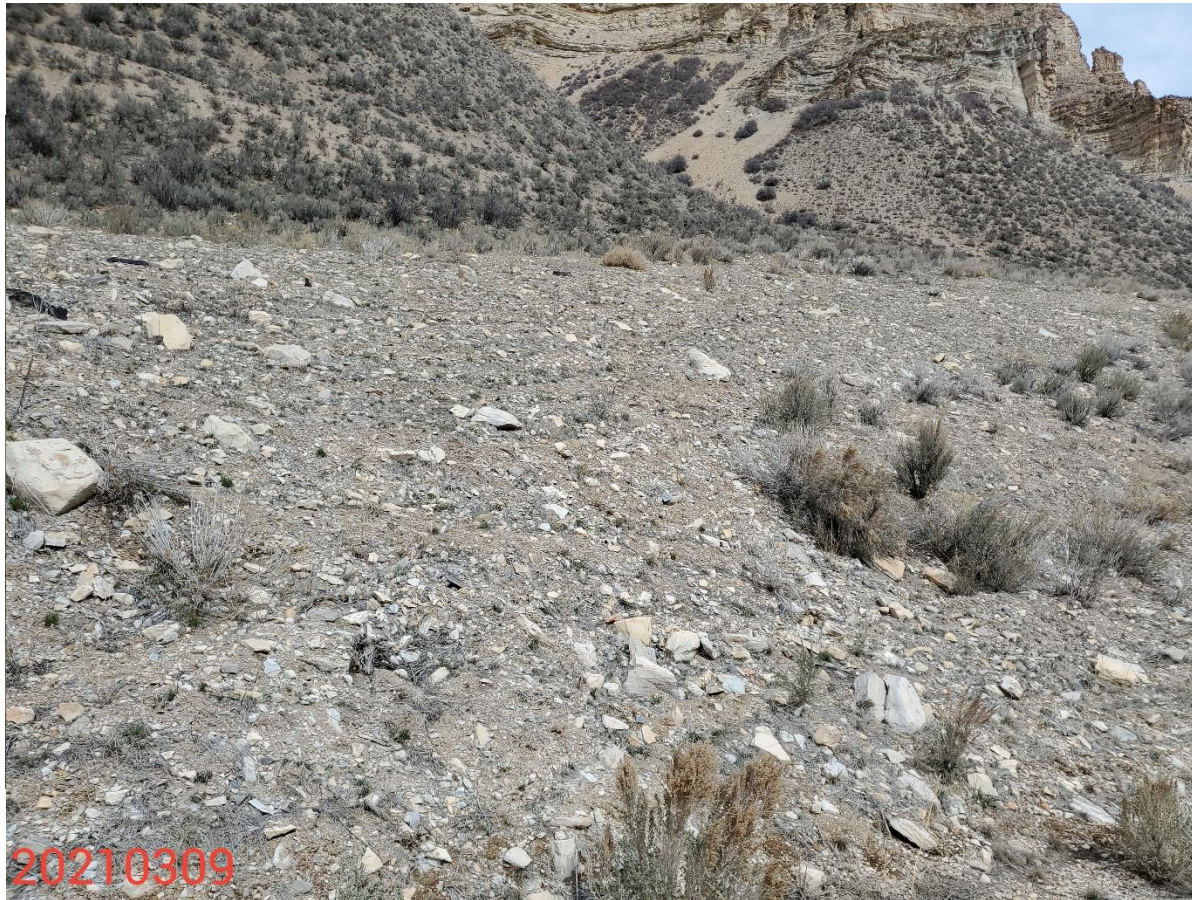
Photo 8: Photo taken from the northern interim areas. Interim areas appear to be progressing towards COGCC 1003 Standards. Photo also shows stormwater run-on ditch and berm installed at interim areas.
