Inspection Photos

3/9/2021

Operator: CAERUS PICEANCE LLC #10456

Location ID: 335594

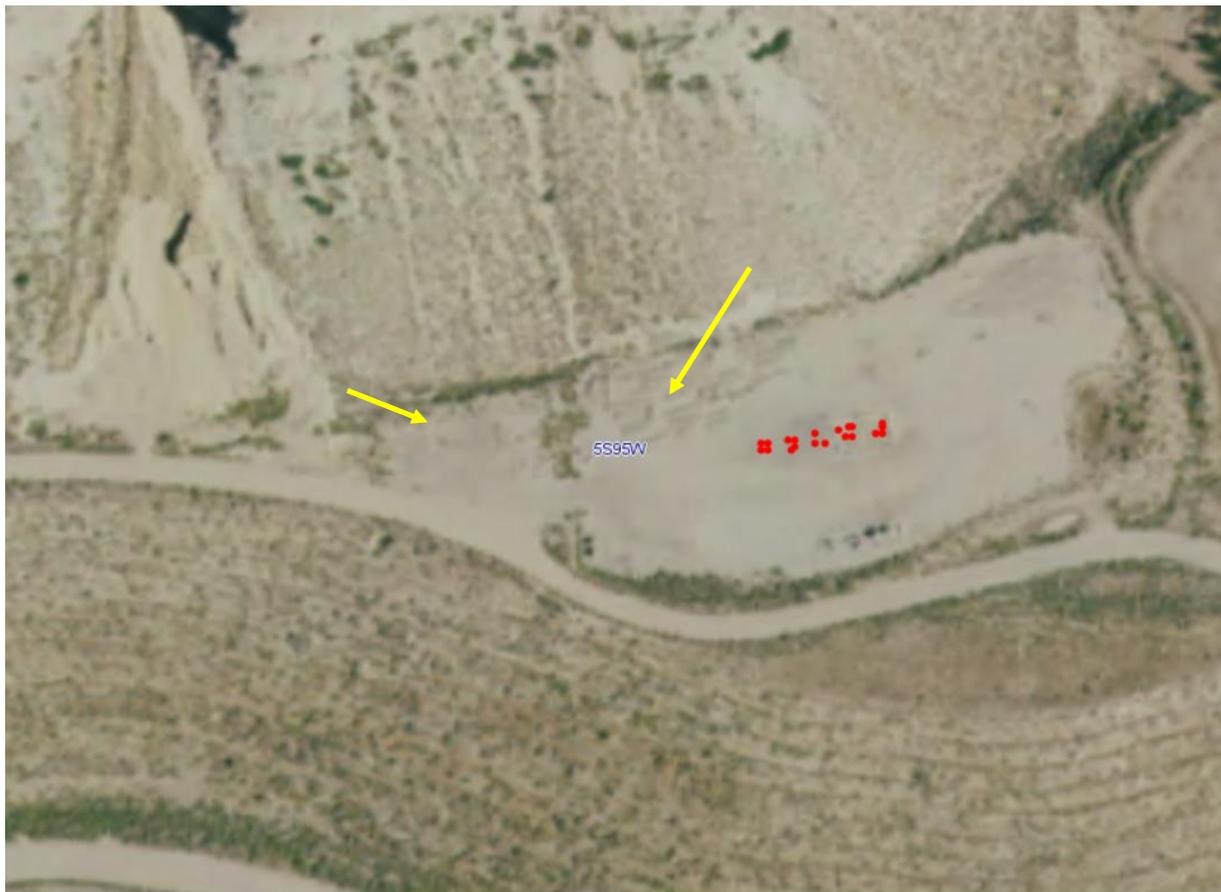
Photo 2: 2019 COGIS areal image. Photo shows constructed areas to the west, and northwest of the Location not needed for production, and require reclamation in accordance with COGCC 1003 rules. Remediation project #7966 currently in process on the northern and northeastern areas of the Location.

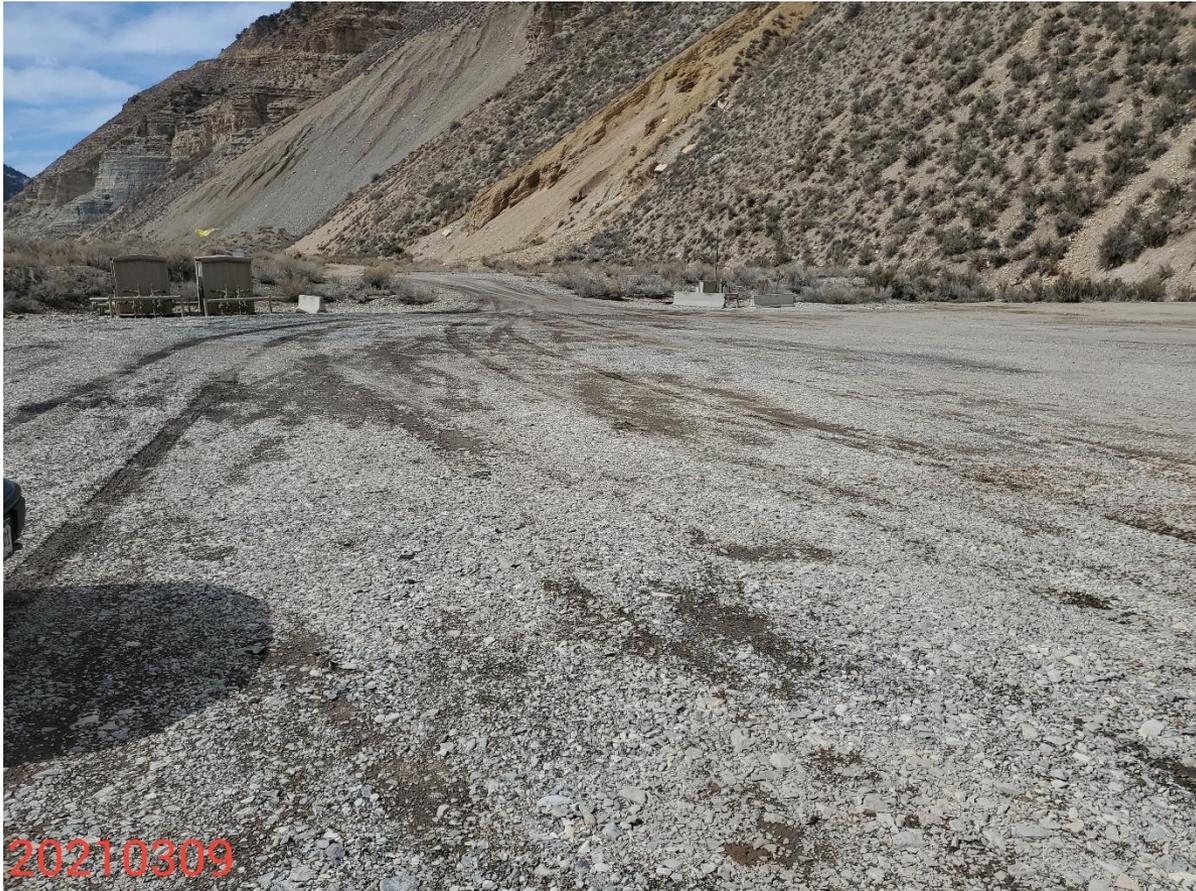
Photo 3: Photo taken from the south end of the Location, facing west. Photos 3-6 provide an overview of the Location from west, northwest, northeast to east. Photos also show areas on the northwest corner of the Location not necessary for production that requires reclamation.

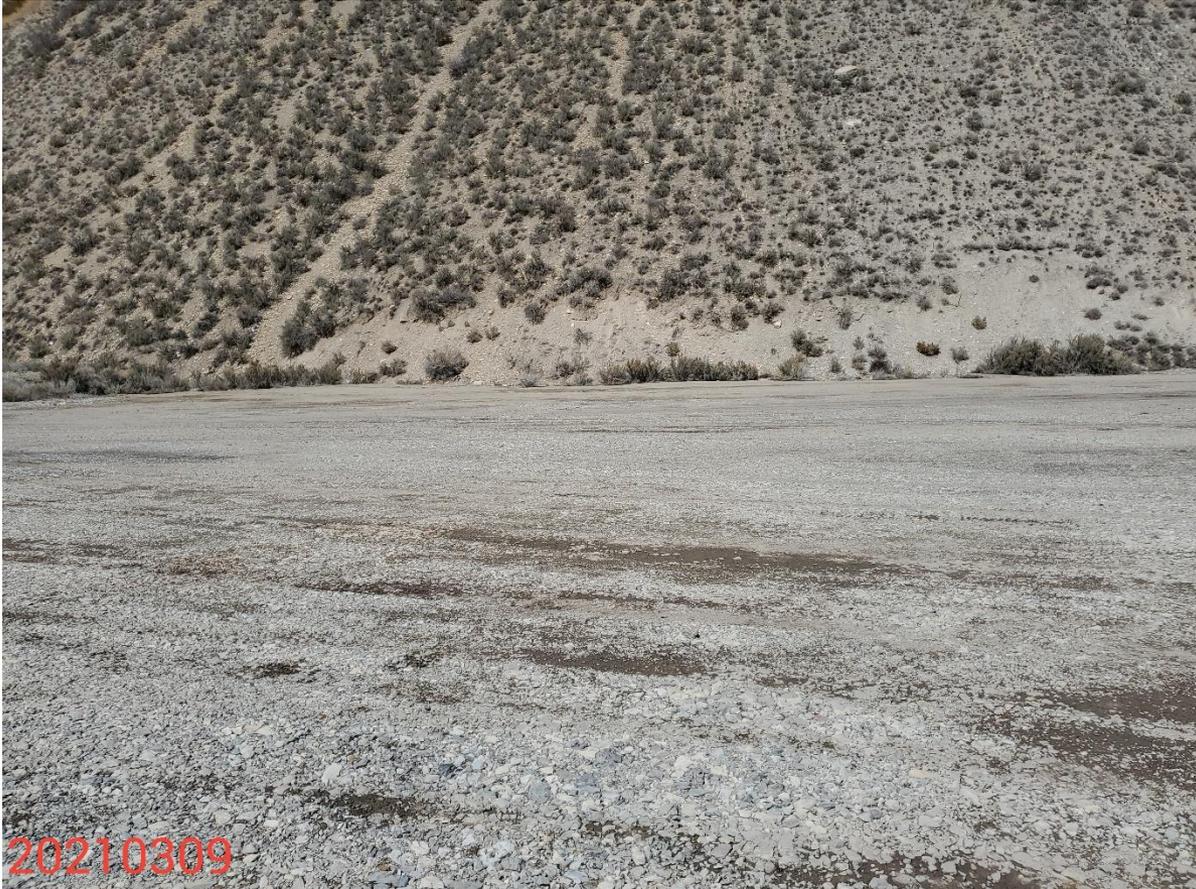
Photo 4: See comments under photo 3.

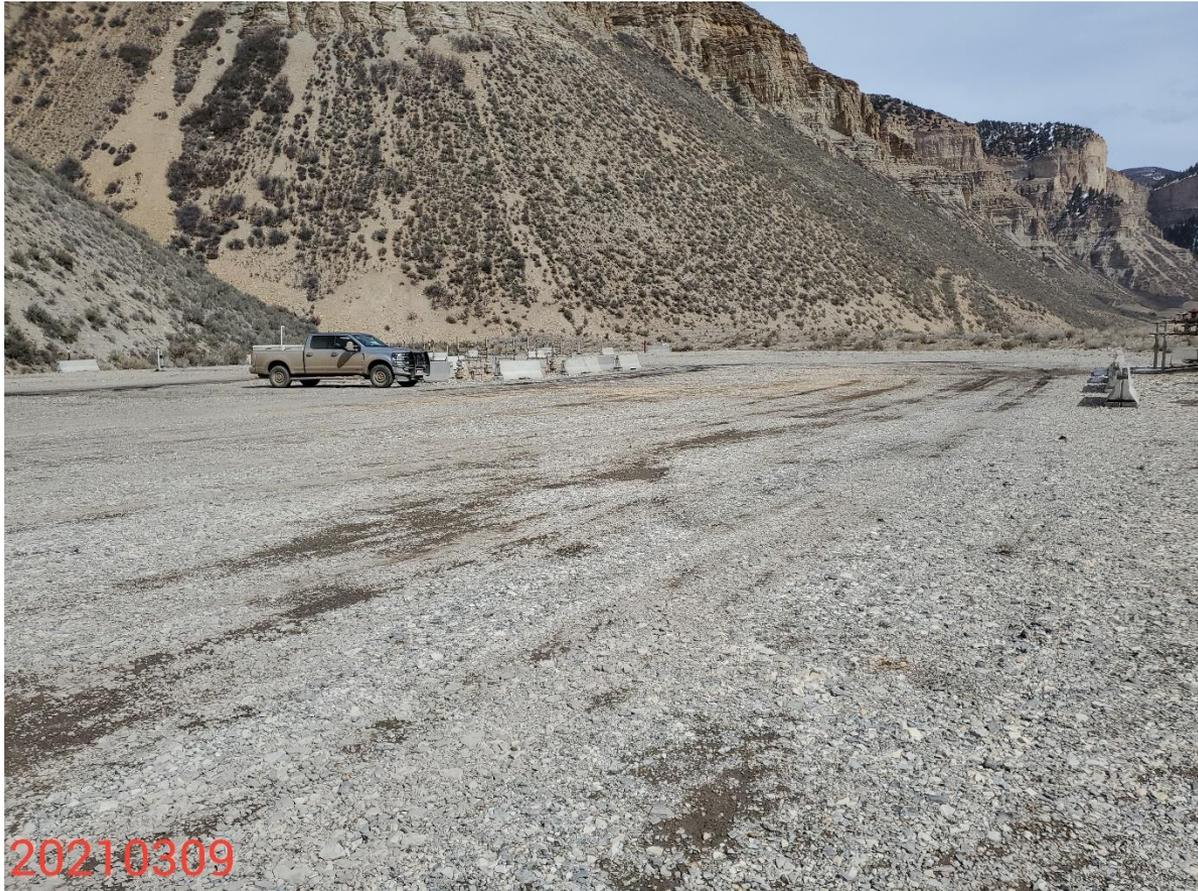
Photo 5: See comments under photo 3.

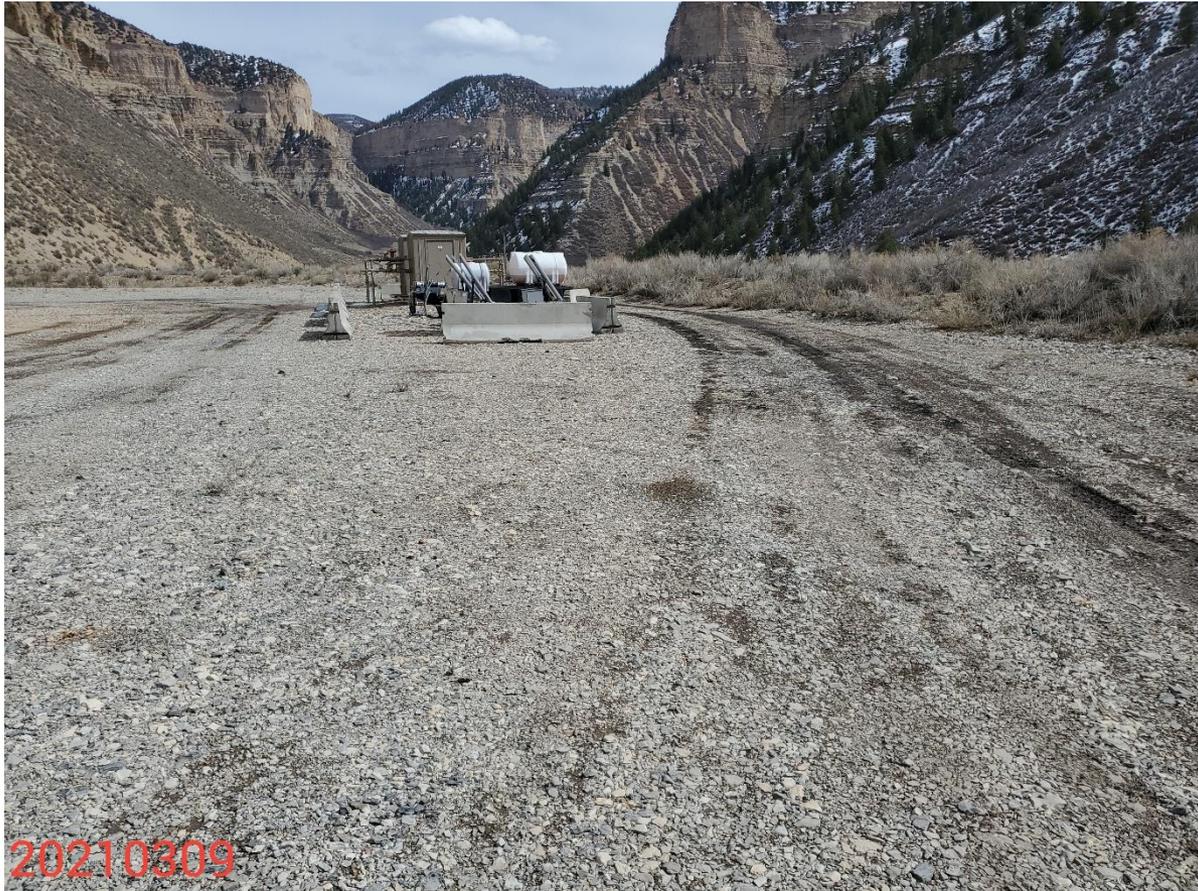
Photo 6: See comments under photo 3.

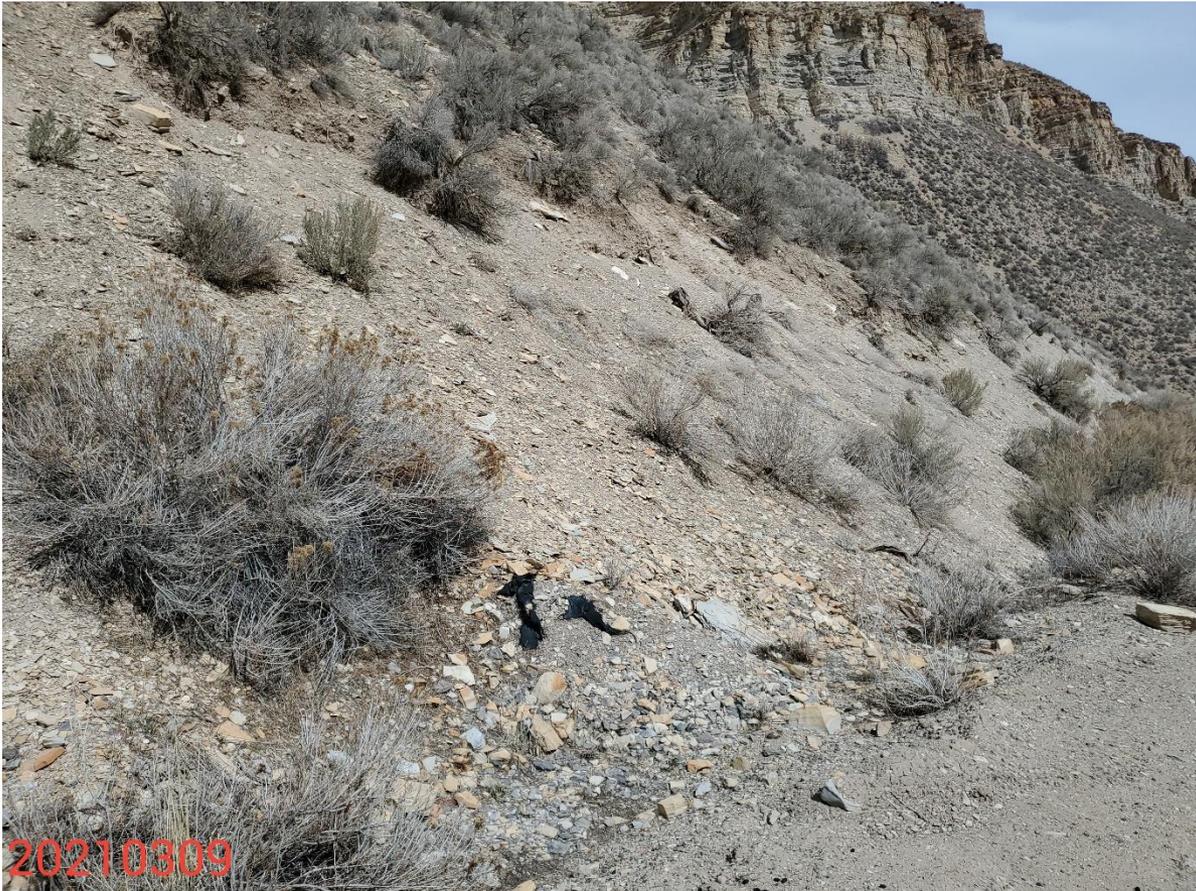
Photo 7: Photo taken from the slopes on the north end of the Location, facing northeast. Photo shows that control measures to stabilize and protect the slopes are missing or insufficient. Uniform vegetative establishment is not progressing towards 1003 standards.

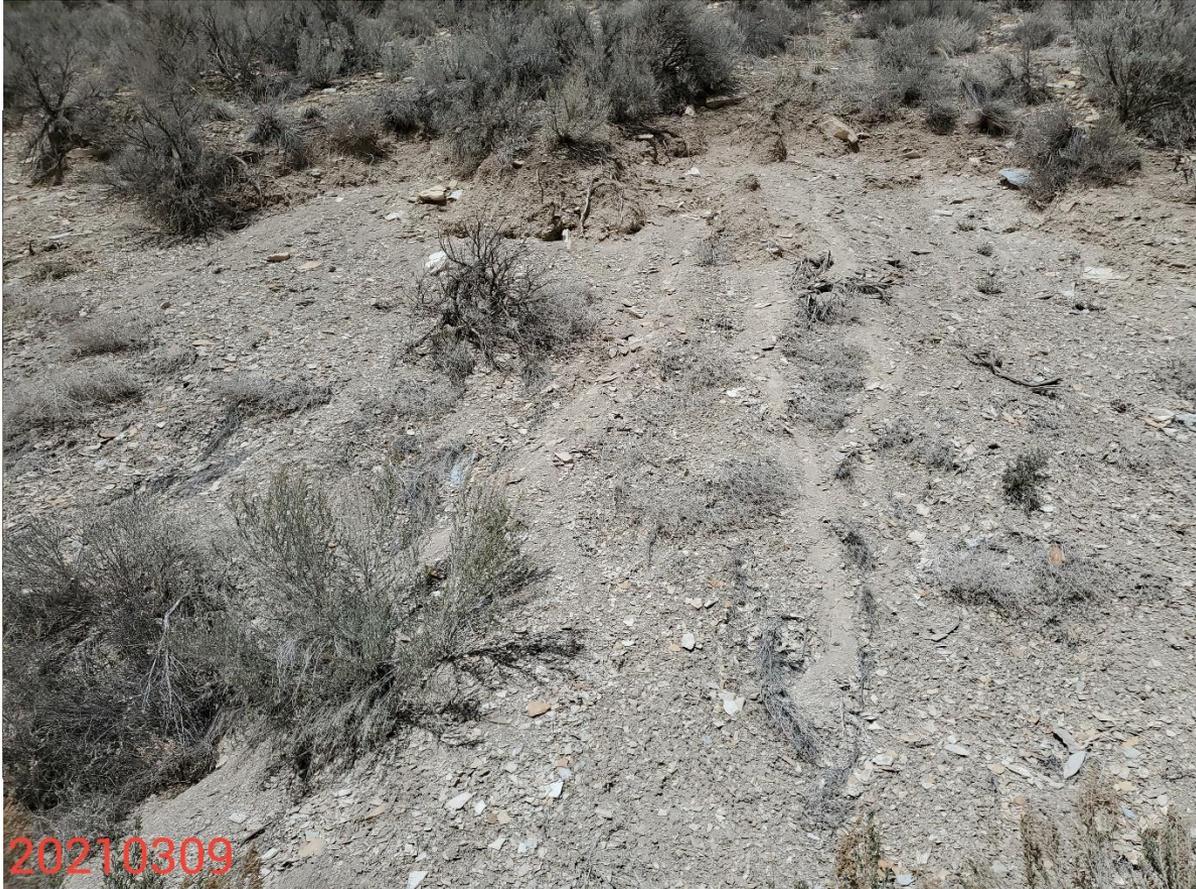
Photo 8: Photo taken from the slopes on the north end of the Location, facing north. Photo shows that control measures to stabilize and protect the slopes are missing or insufficient. Uniform vegetative establishment is not progressing towards 1003 standards.

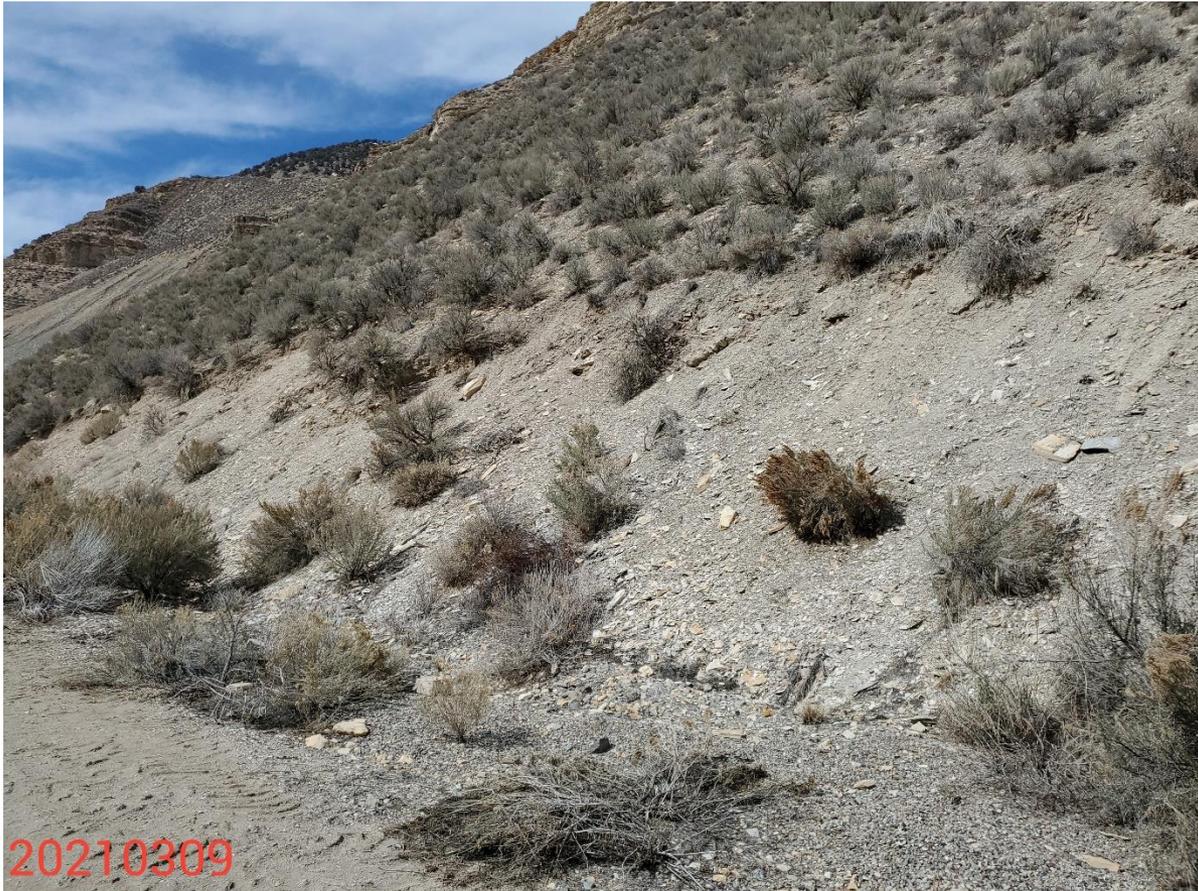
Photo 9: Photo taken from the slopes on the north end of the Location, facing northwest. Photo shows that control measures to stabilize and protect the slopes are missing or insufficient. Uniform vegetative establishment is not progressing towards 1003 standards.

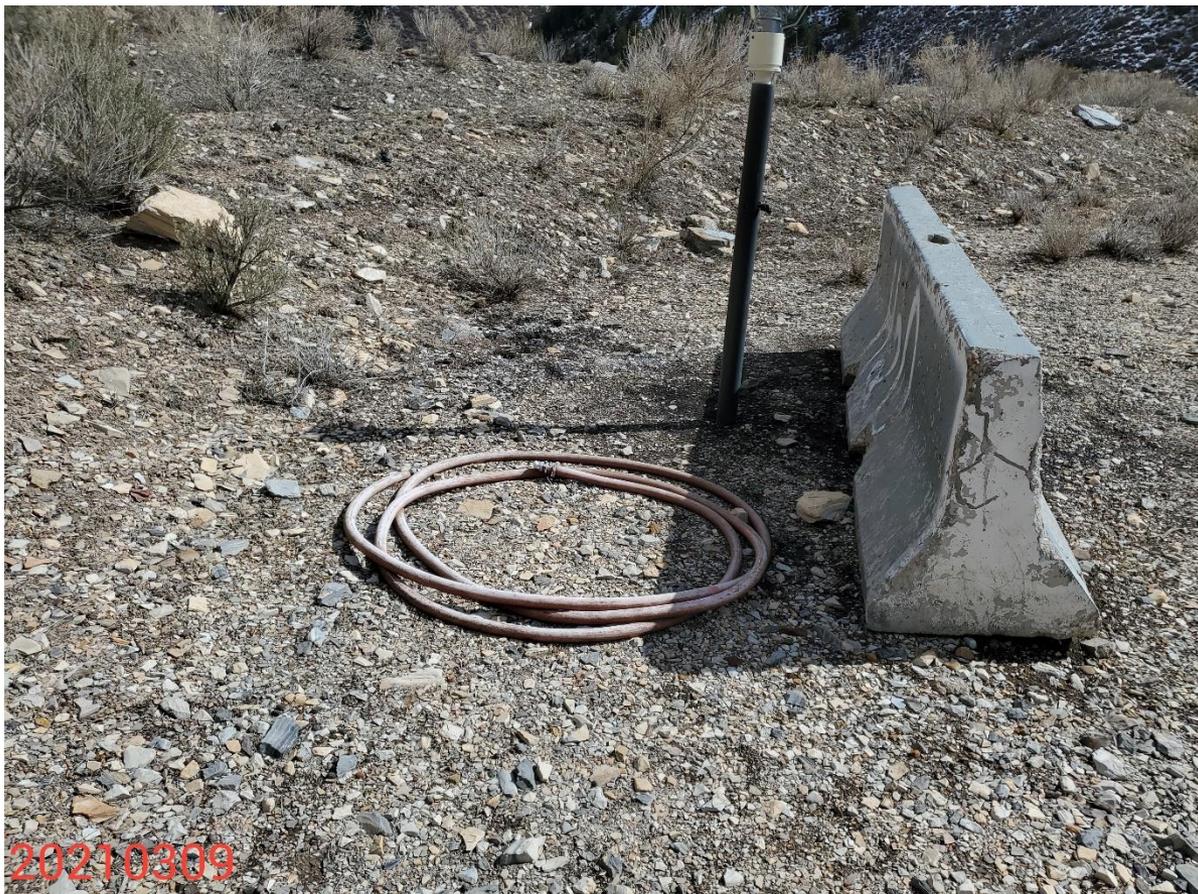
Photo 10: Photo shows unused hose equipment stored on the northeast corner of the Location.

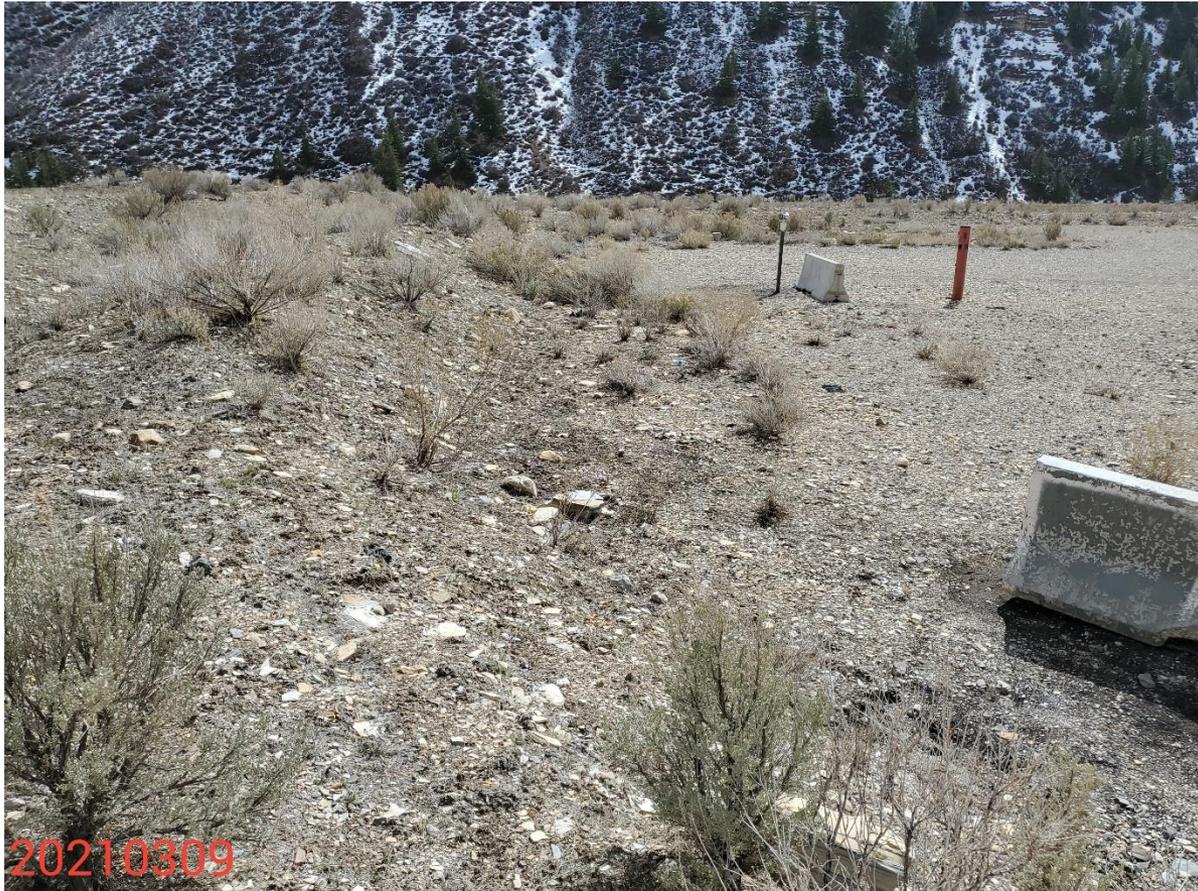
Photo 11: Photo taken from the northeast corner of the pad, facing south. Photos 11-13 provide an overview of the Location from south, southwest to west. Remediation project #7966 currently in process on the northern and northeastern areas of the Location.

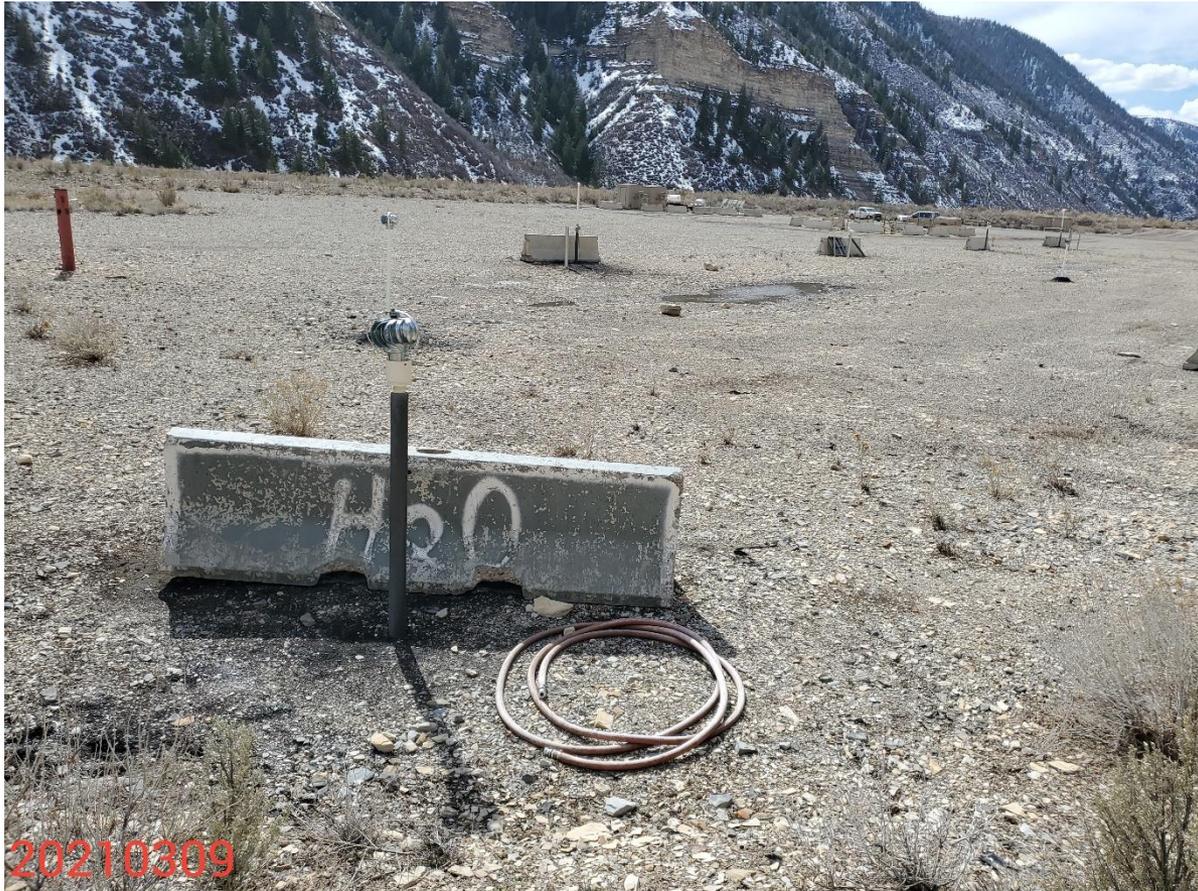
Photo 12: See comments under photo 11.

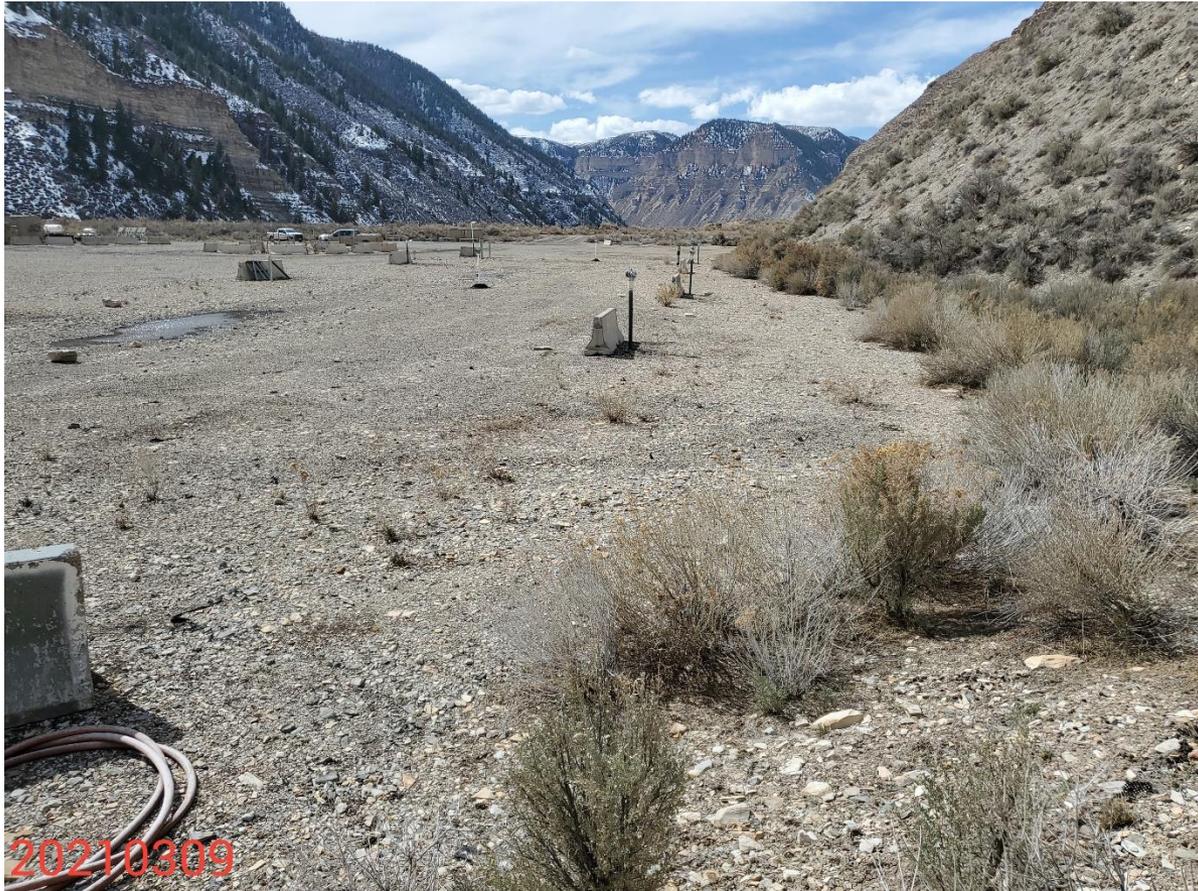
Photo 13: See comments under photo 11.

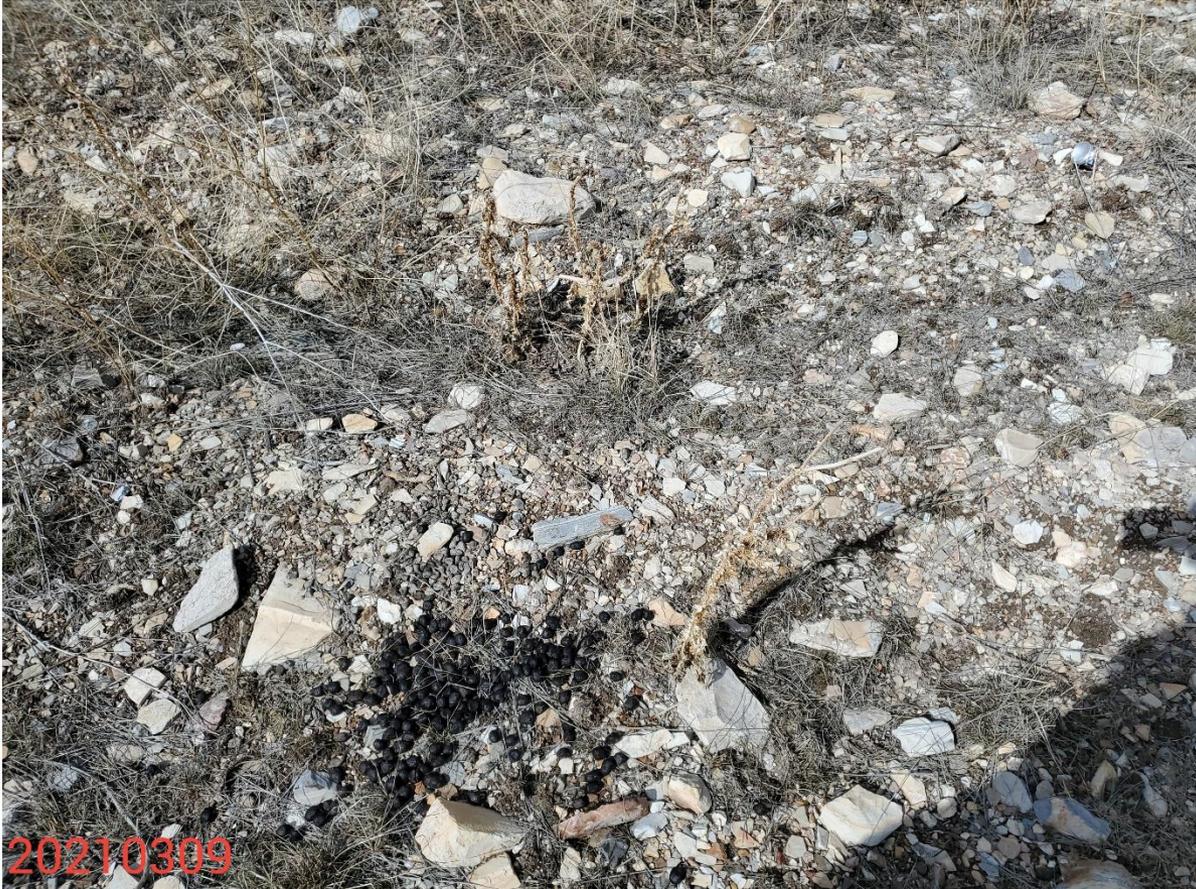
Photo 14: Photo taken from the southeastern interim areas. Photo shows Musk thistle remnants from the 2020 growing season. Unclear if sufficient noxious weed management efforts were performed prior to the onset of winter conditions. A follow up inspection will be conducted to determine compliance with Rule 1003.f

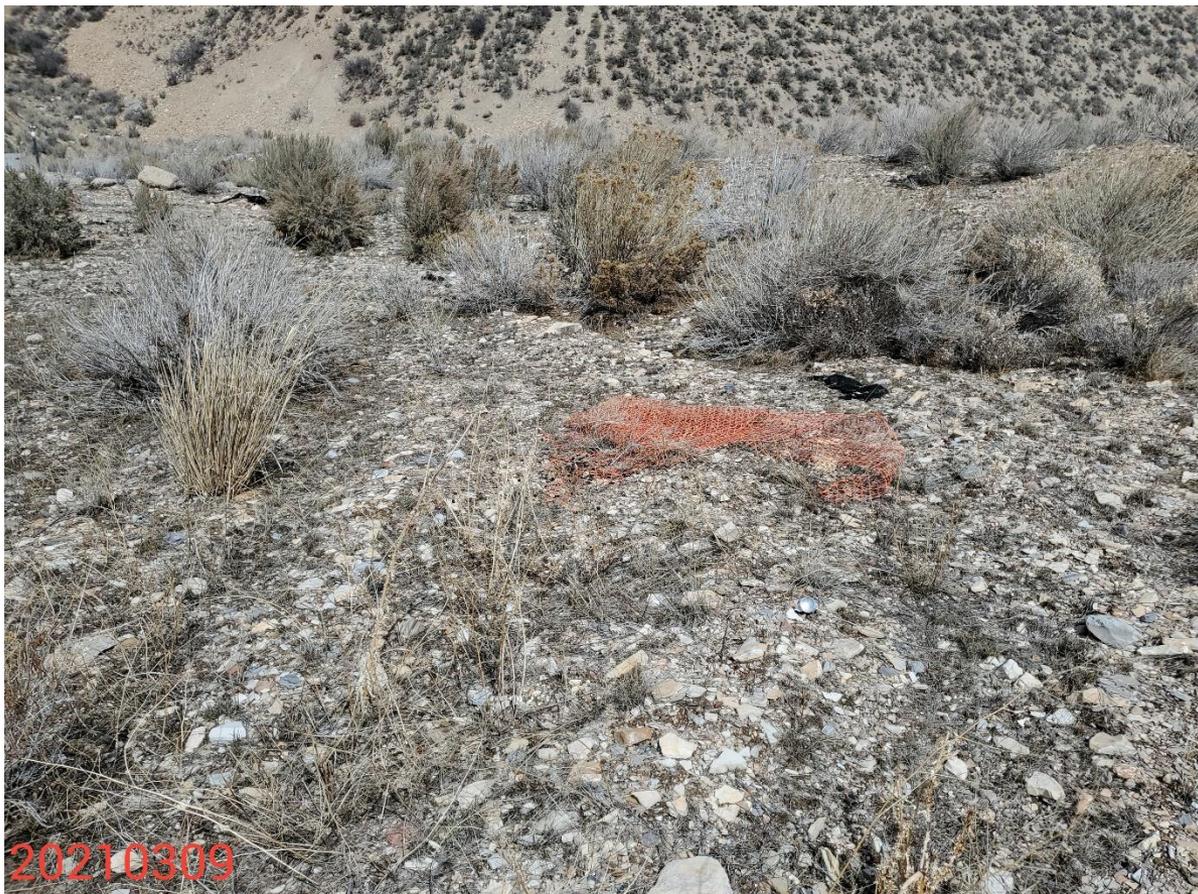
Photo 15: Photo taken from the southeastern interim areas, facing north. Photo shows trash debris (orange safety fence).
