Whiting Oil & Gas Corporation

WILDHORSE 05-0514H CORRECTIVE ACTION INSPECTION PHOTOS

Location ID: 427525

3-12-2021

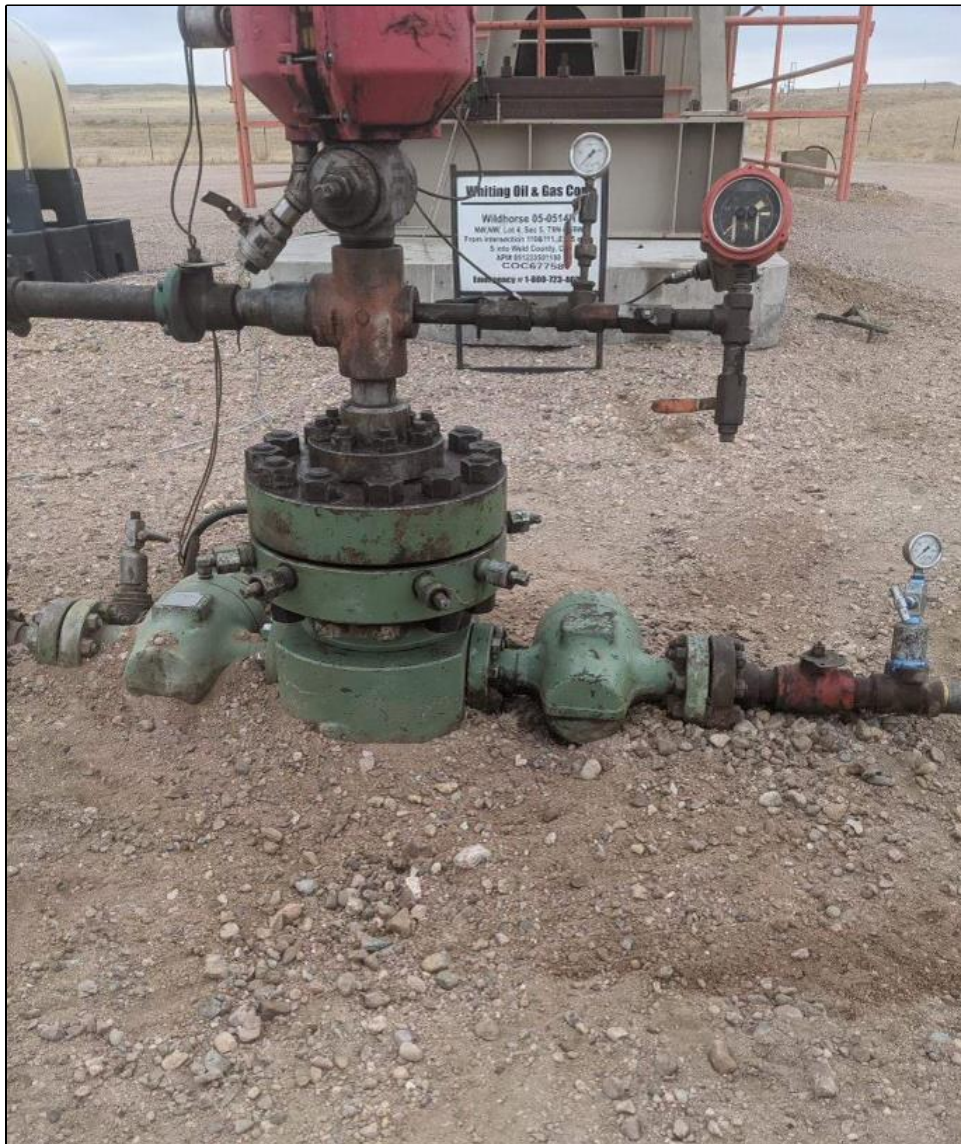
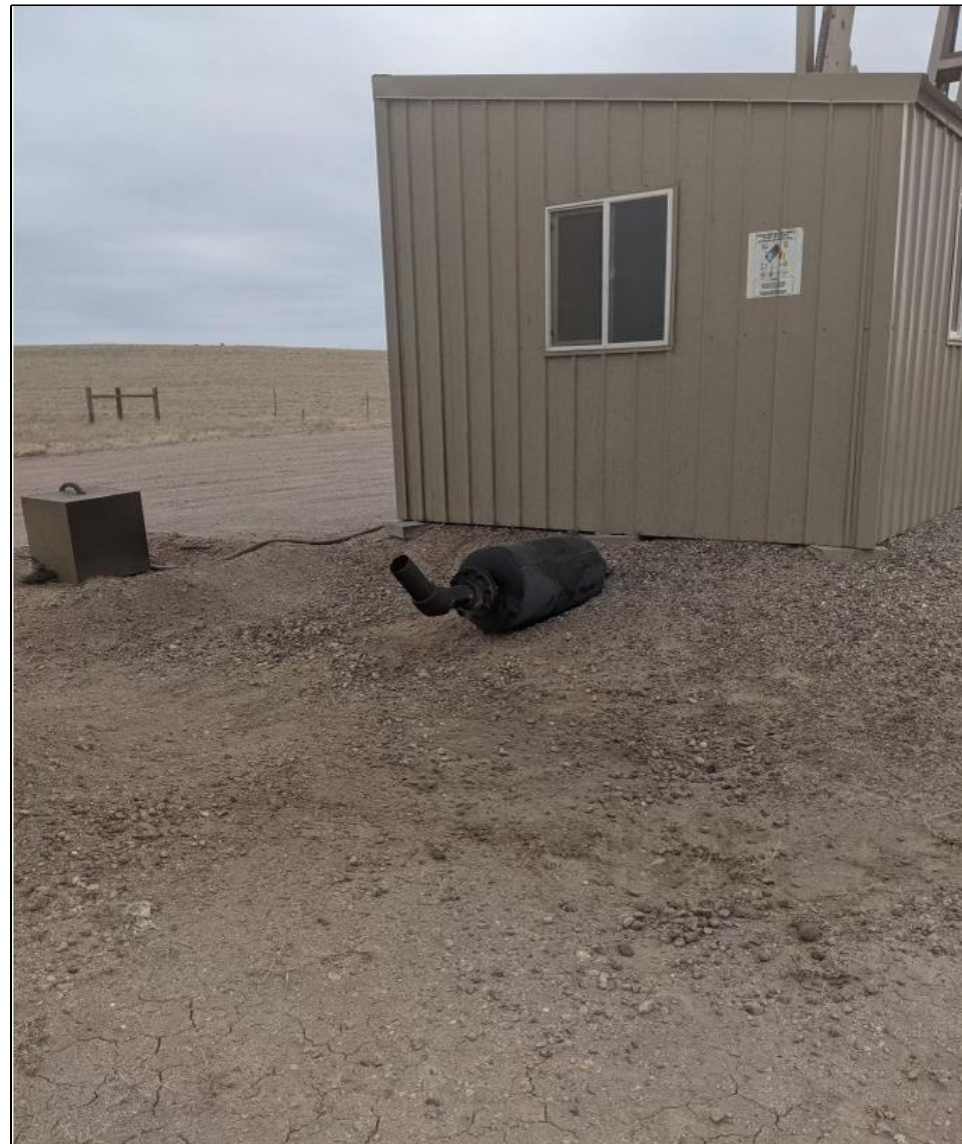
Impacted soils no longer at Wellhead or Exhaust
