Inspection Photos
Operator: Simcoe
API: 067-08843
Date: 3/10/2021

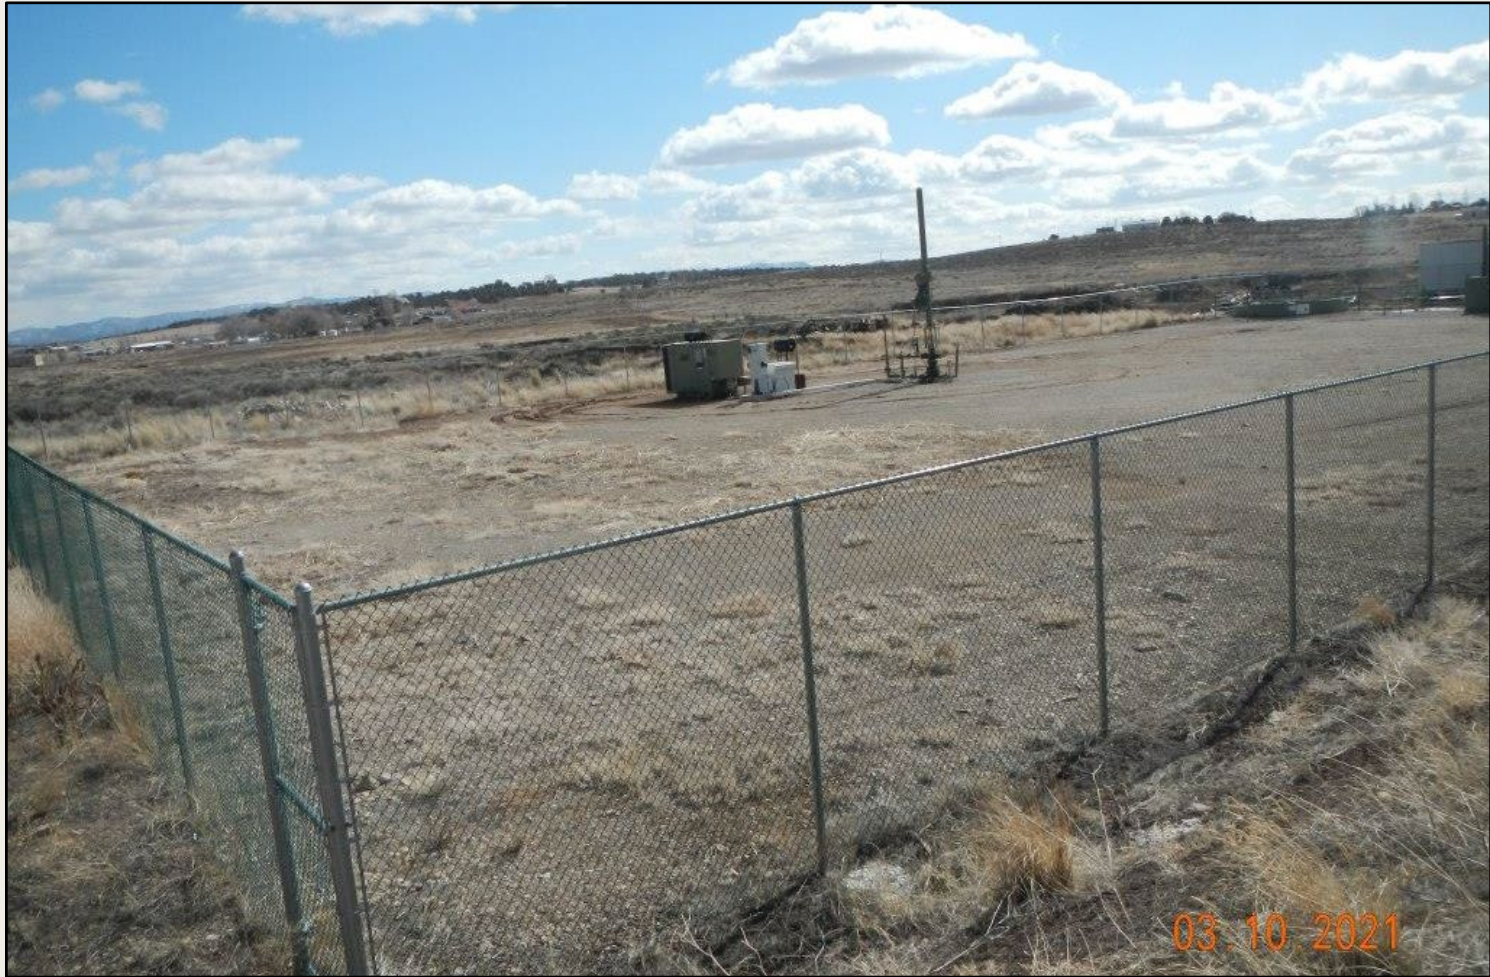
Photo 1. View of the project area from the northwestern corner facing center.

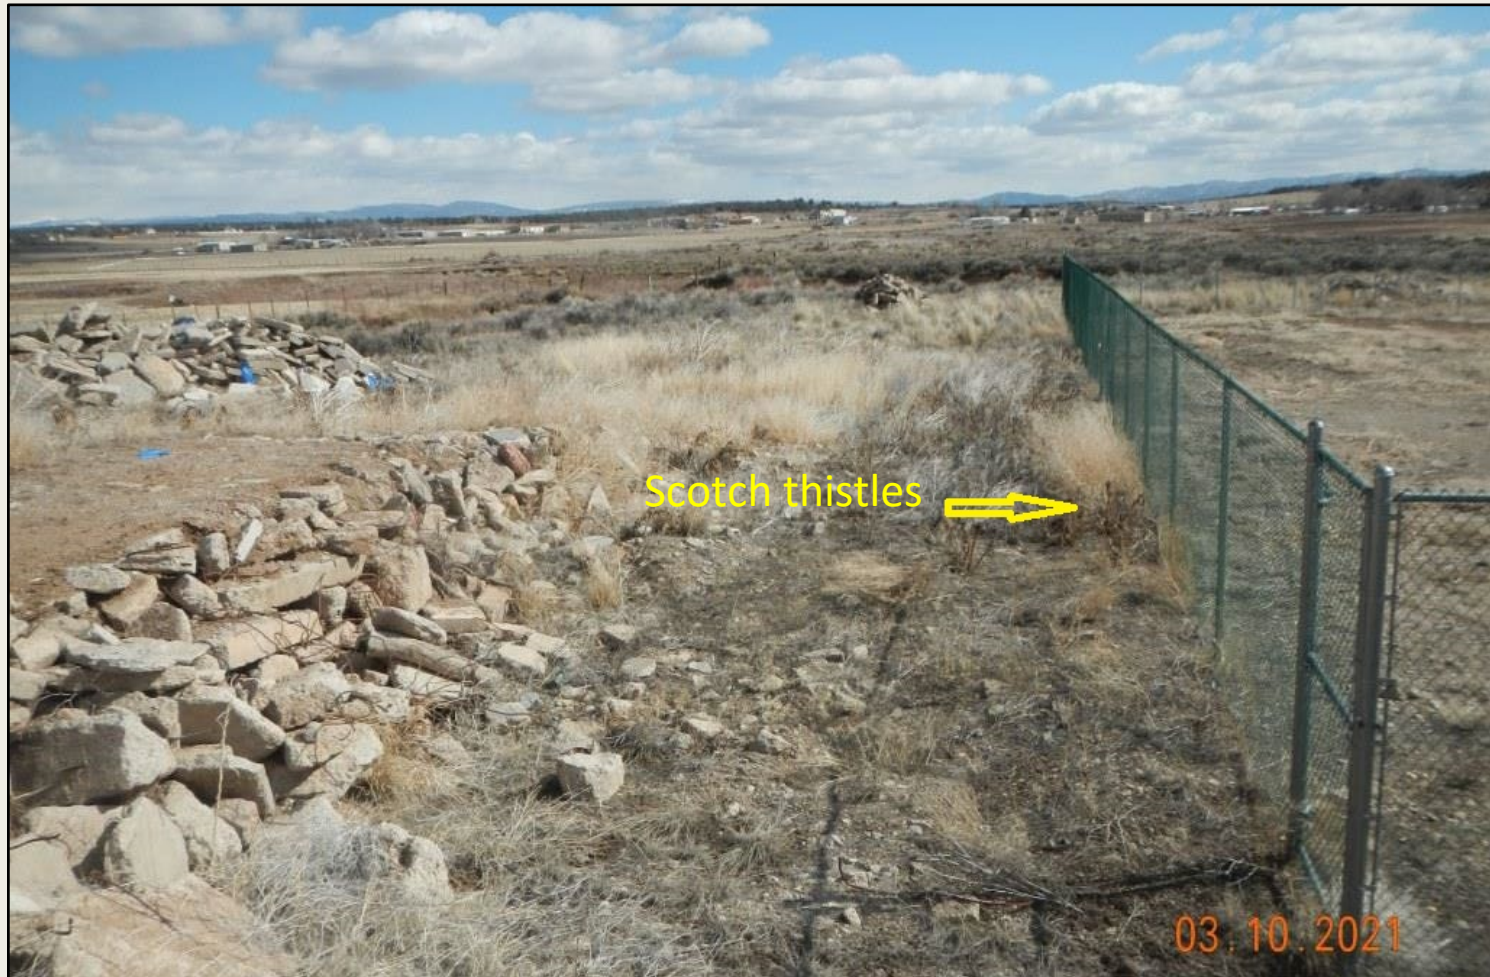
Photo 2. View of the northern project area facing eastward. Reclamation areas are infested with weeds such as Scotch thistle (approx. 200 individuals) and kochia debris.

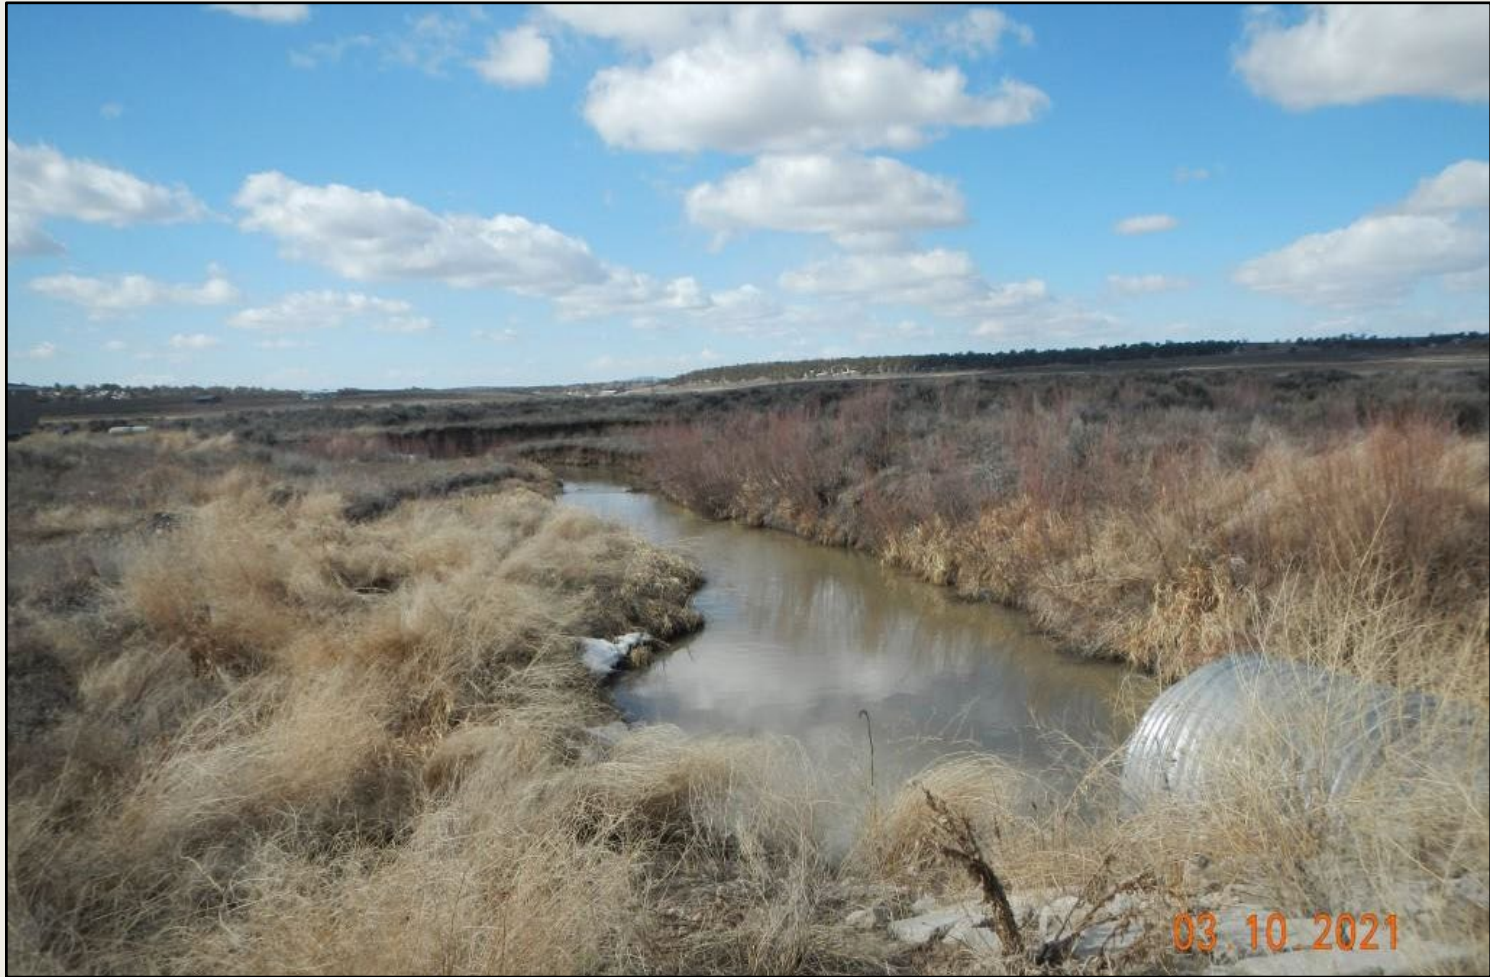
Photo 3. View of culvert crossing on access road, appears to be stabilized at this time.

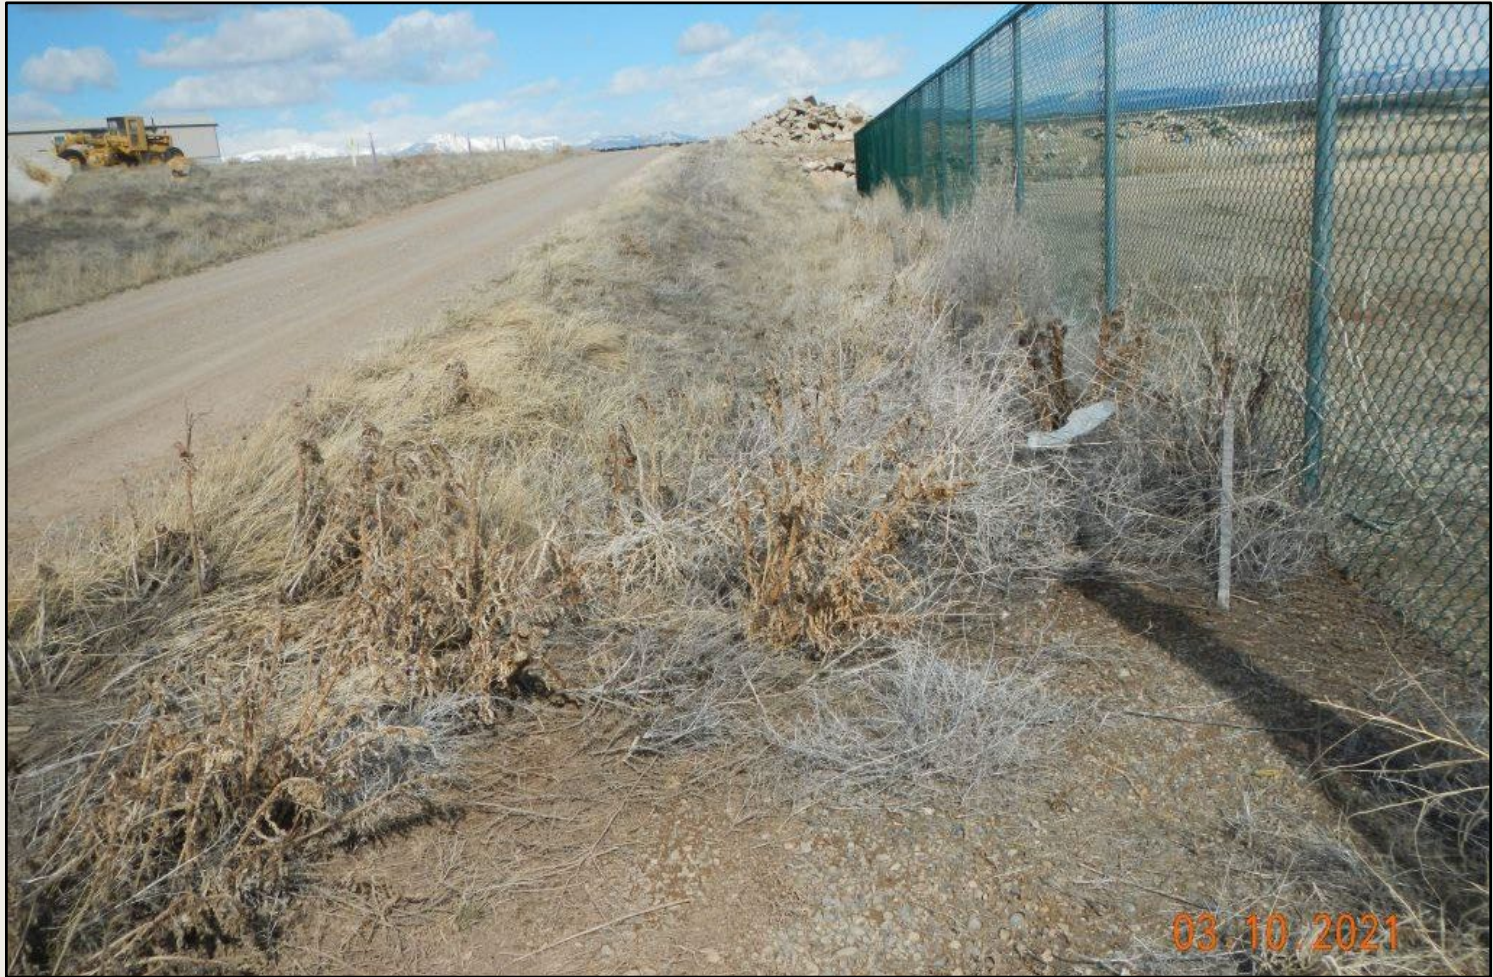
Photo 4. View of the western project area facing northward.

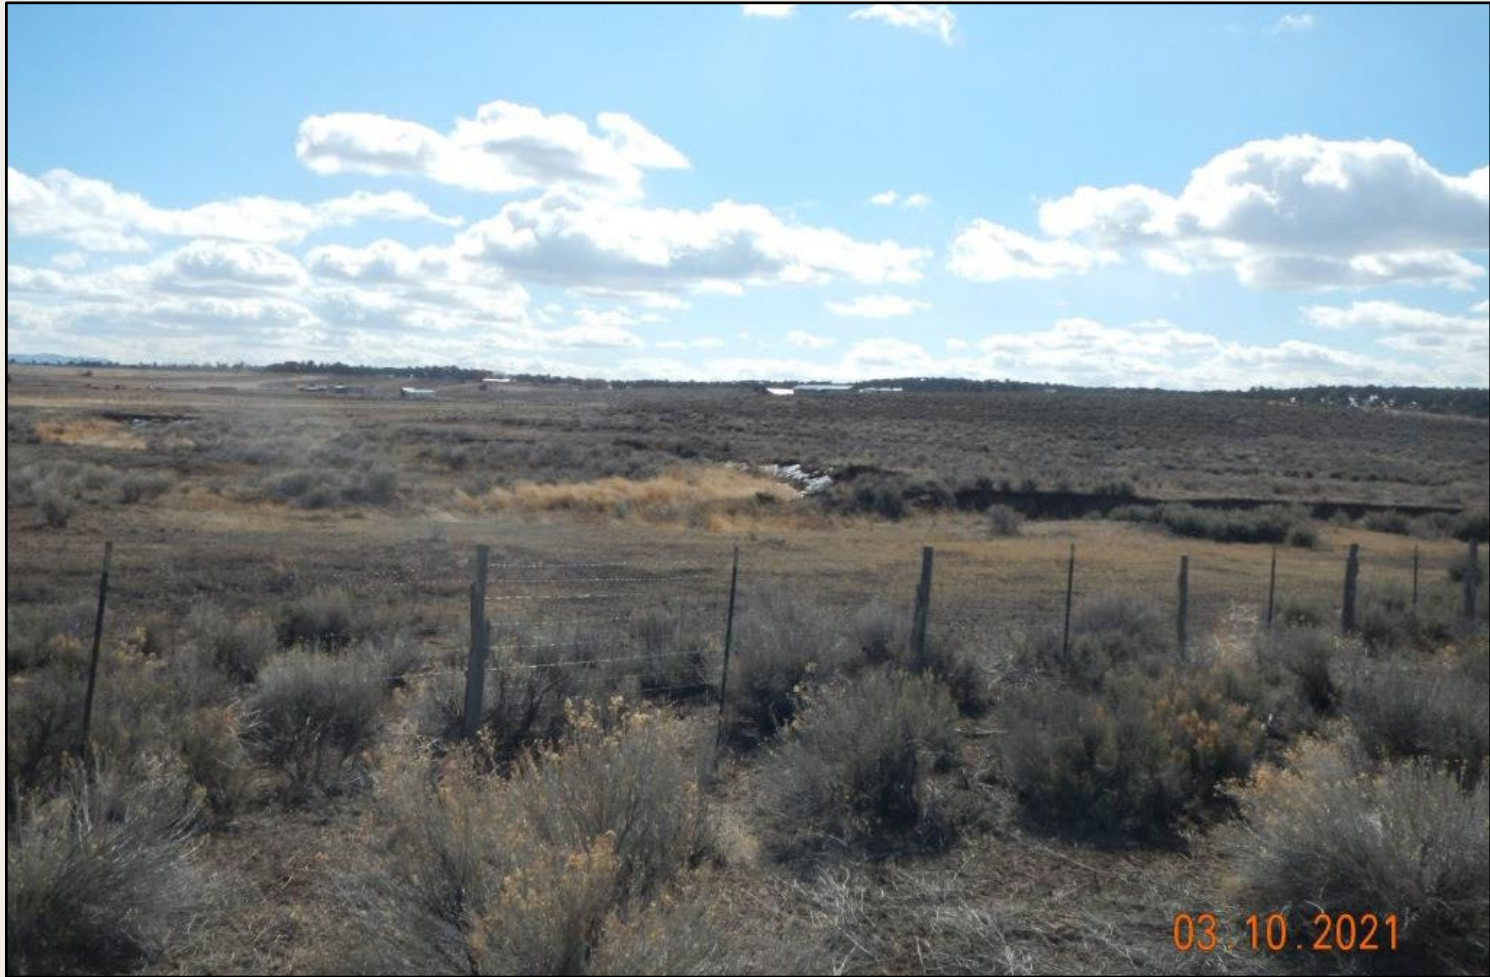
Photo 5. View of reference area comprised of sagebrush and grassland mosaic with grasses such as western wheatgrass and forbs that are dormant at this time.
