Inspection Photos

API: 073-06713

Operator: UNIT PETROLEUM COMPANY

Inspection Date: 3/17/2021

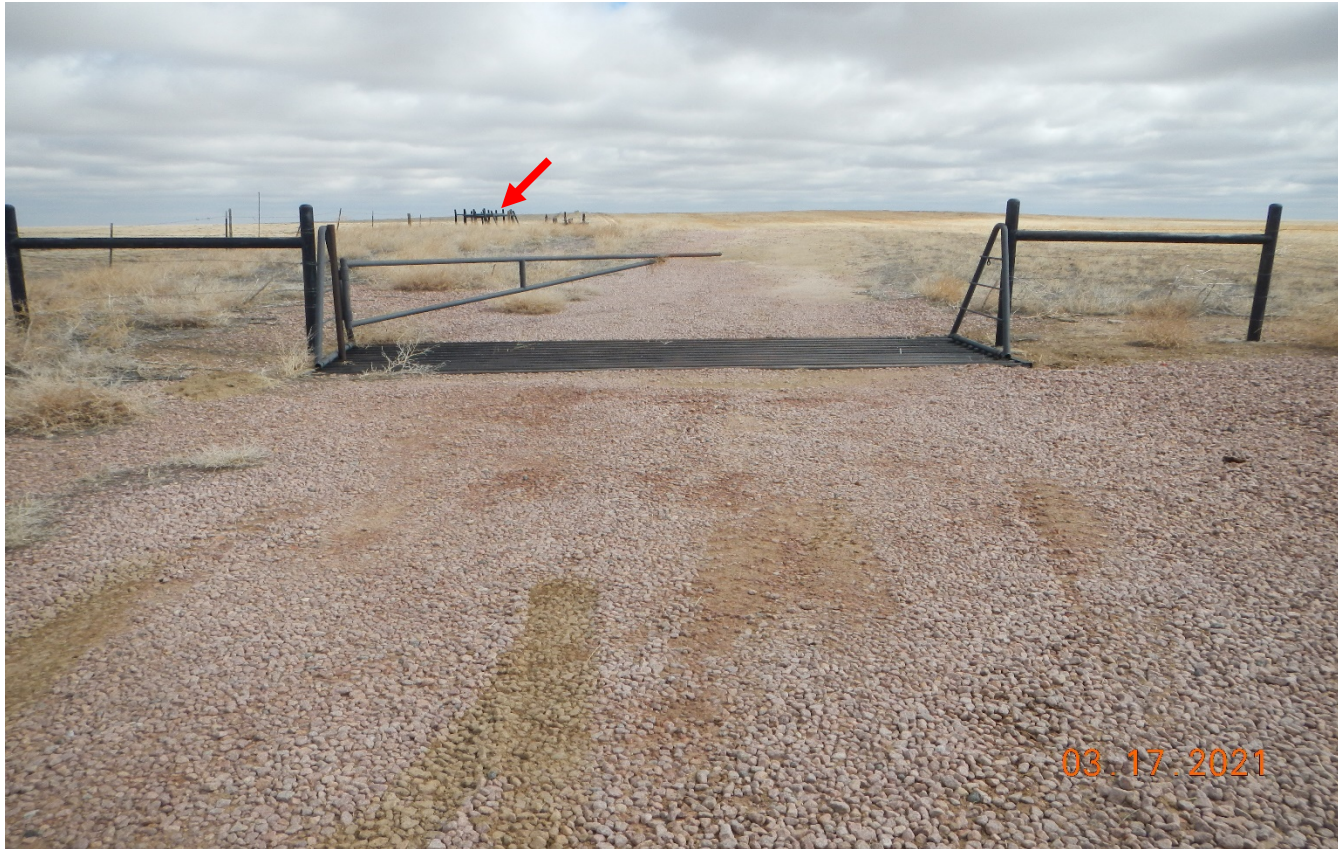
Photo 1. Facing north at the beginning of the access road. The gravel and cattleguard remains and the fence has not been put back to original place. Additional H-brace posts are shown at red arrow.

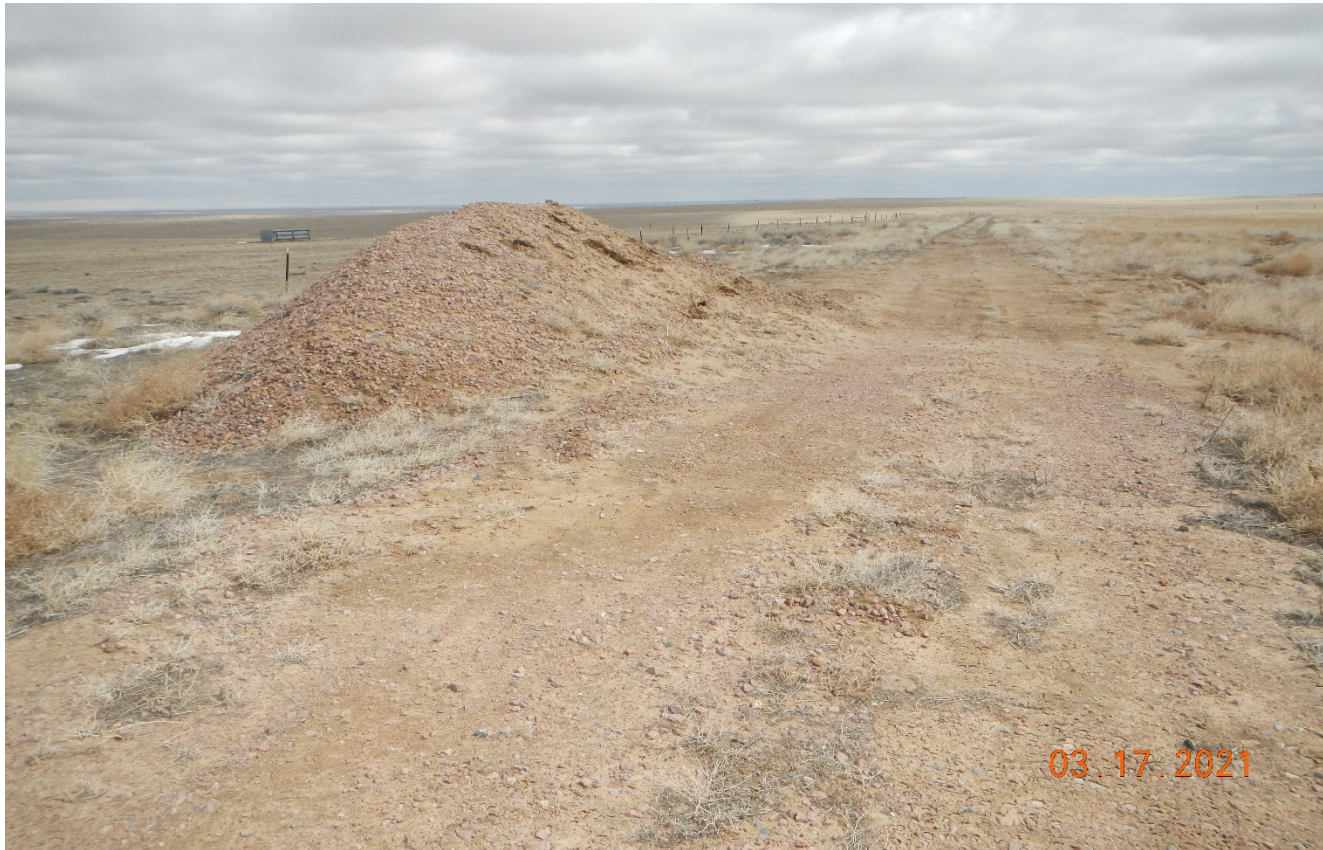
Photo 2. There is a gravel pile that remains near the location. The gravel pile needs to be removed.

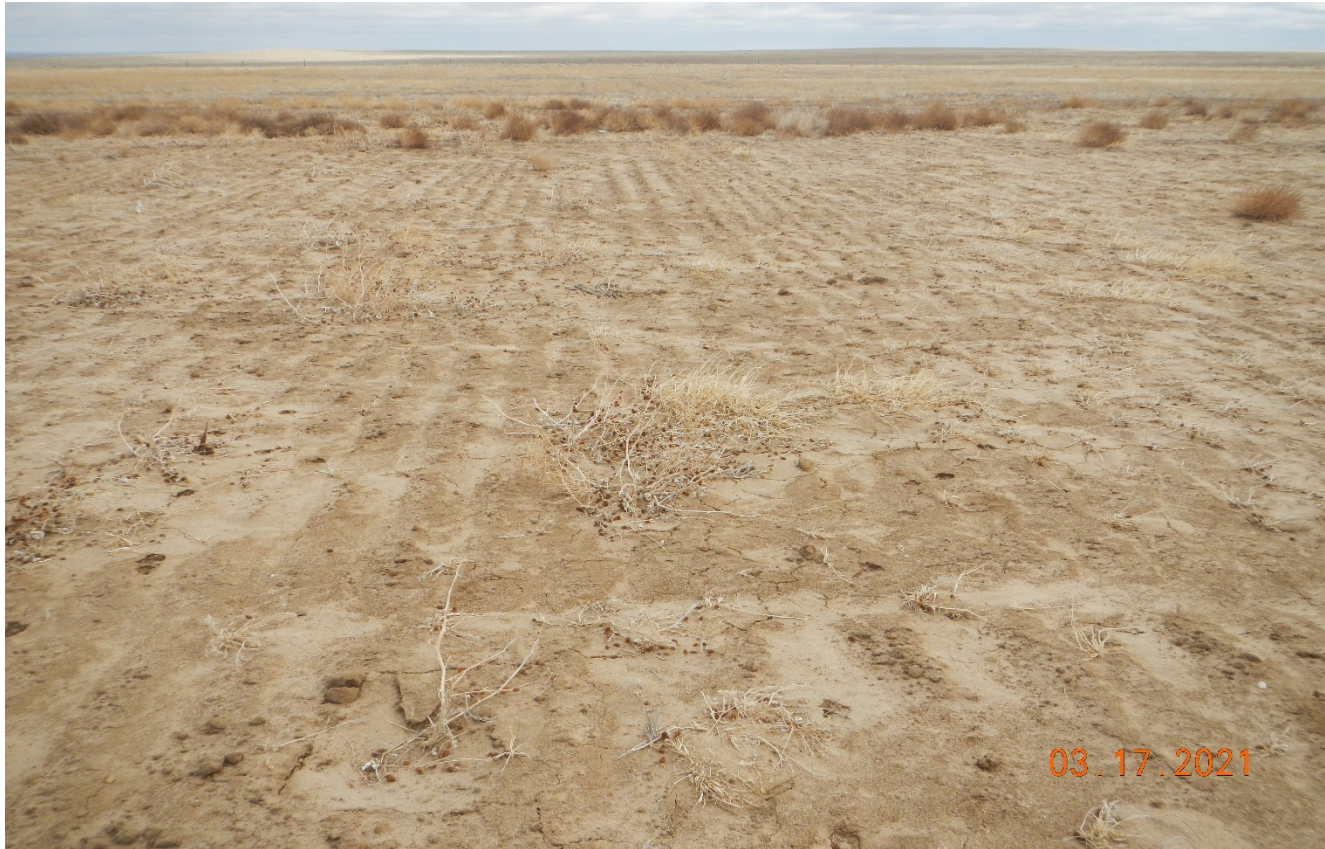
Photo 3. Facing south towards the location. It appears the location has been cross-ripped. The location needs to be seeded and stabilized.

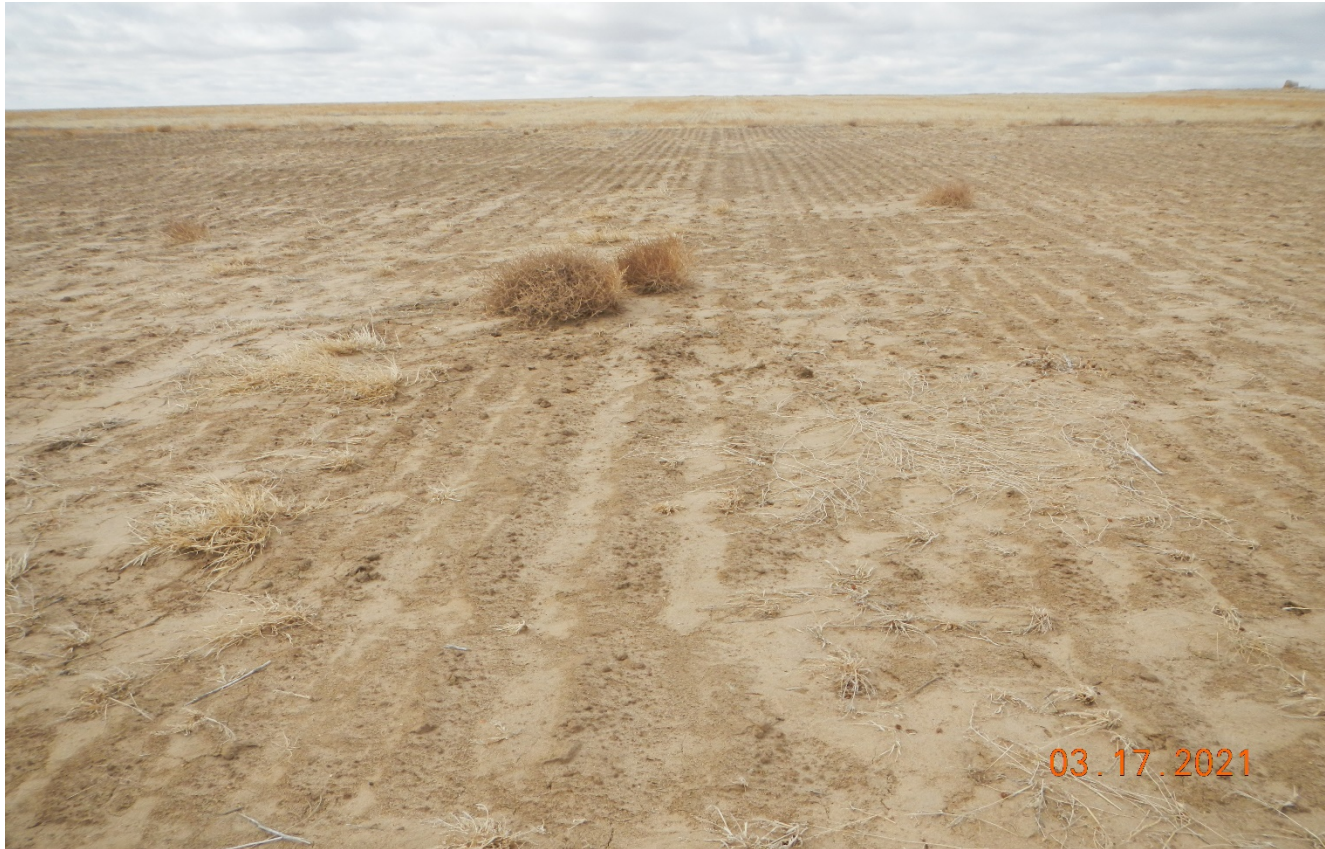
Photo 4. Facing west towards the location. It appears the location has been cross-rippled. The location needs to be seeded and stabilized.

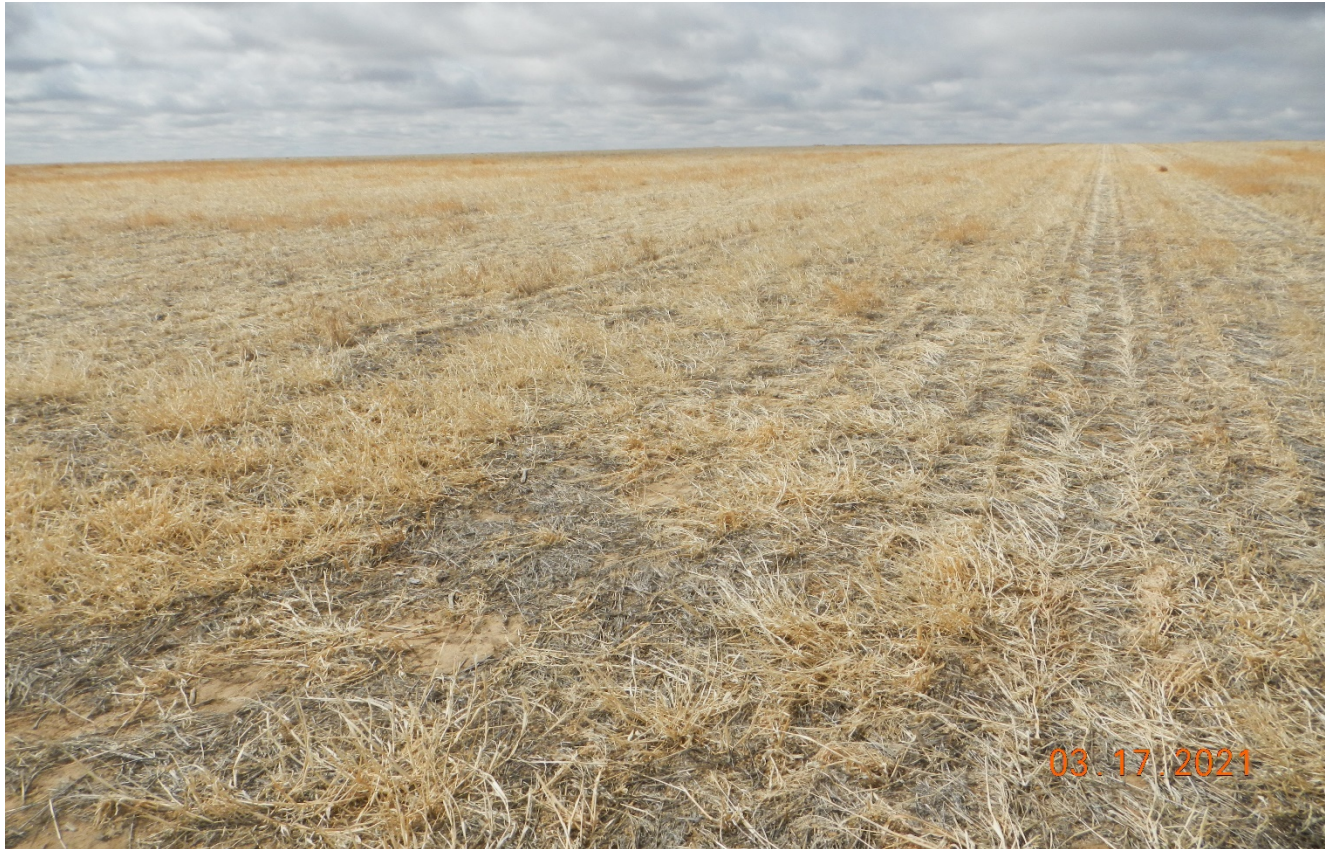
Photo 5. Facing southwest toward the undisturbed surrounding reference. There is vegetation planted in the surround crop field.
