Inspection Photos
Location Name: Dryer 1
Location ID: 306577

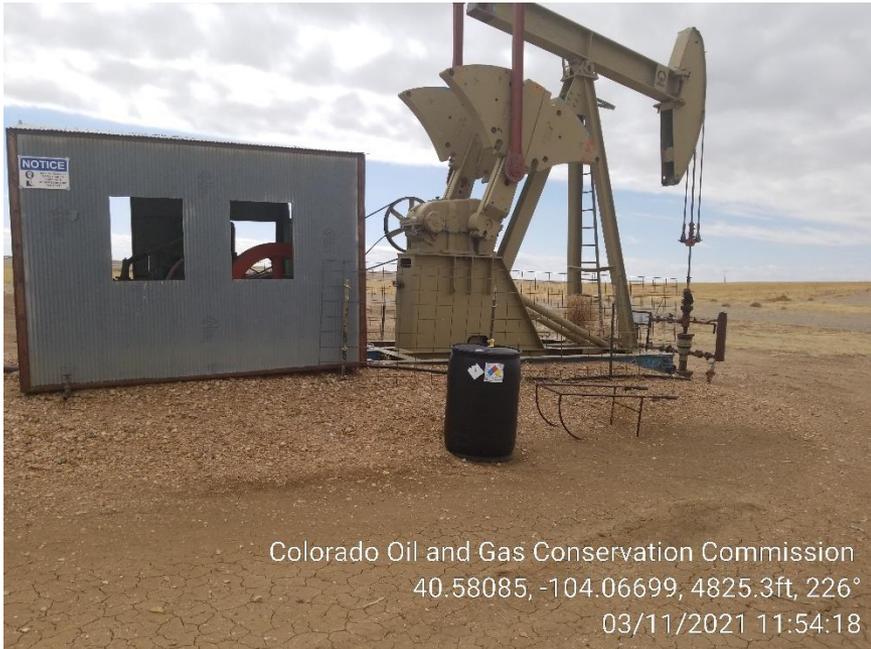
Photo 1 – Pumping Unit

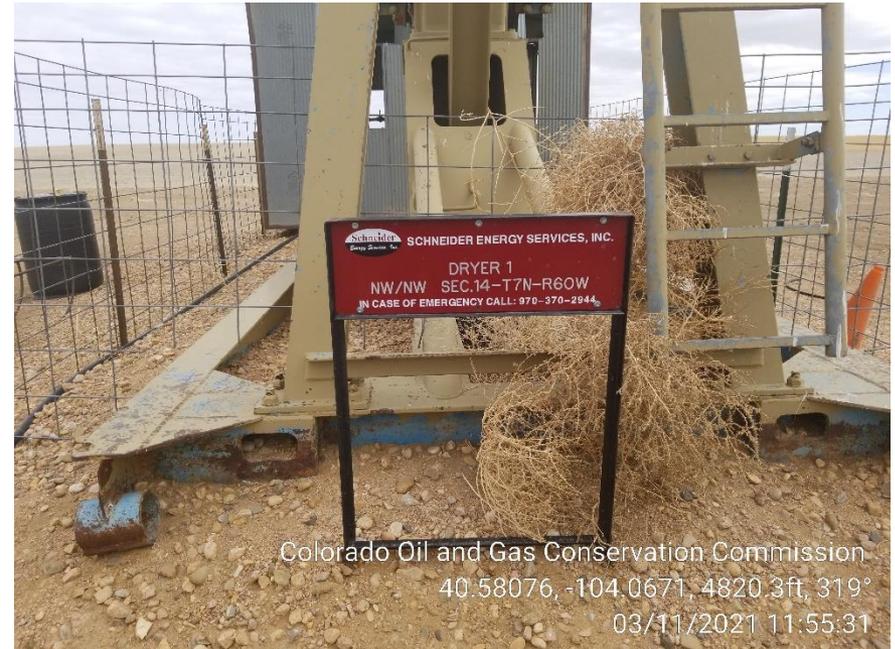
Photo 2 – Wellhead Sign

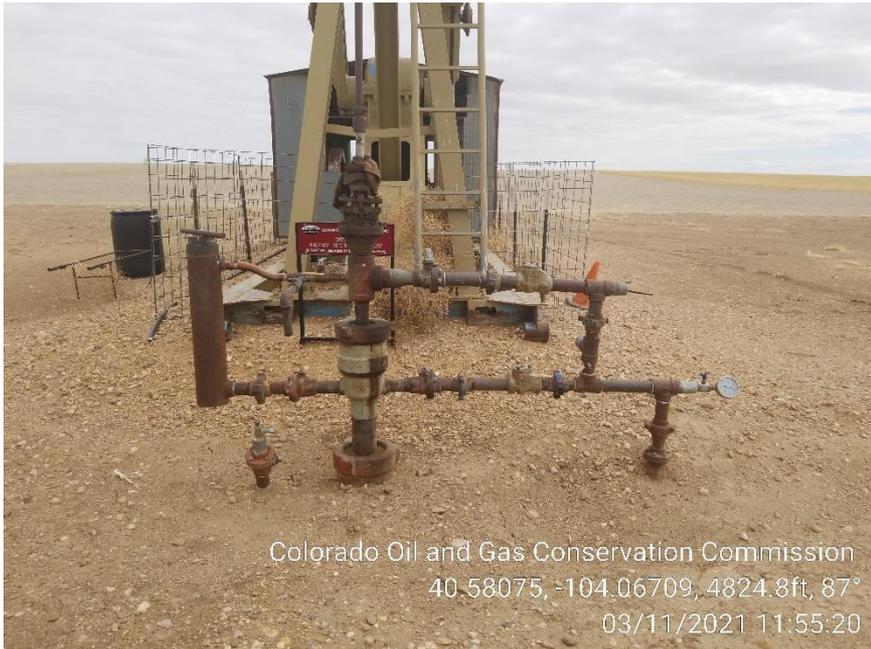
Photo 3 – Wellhead

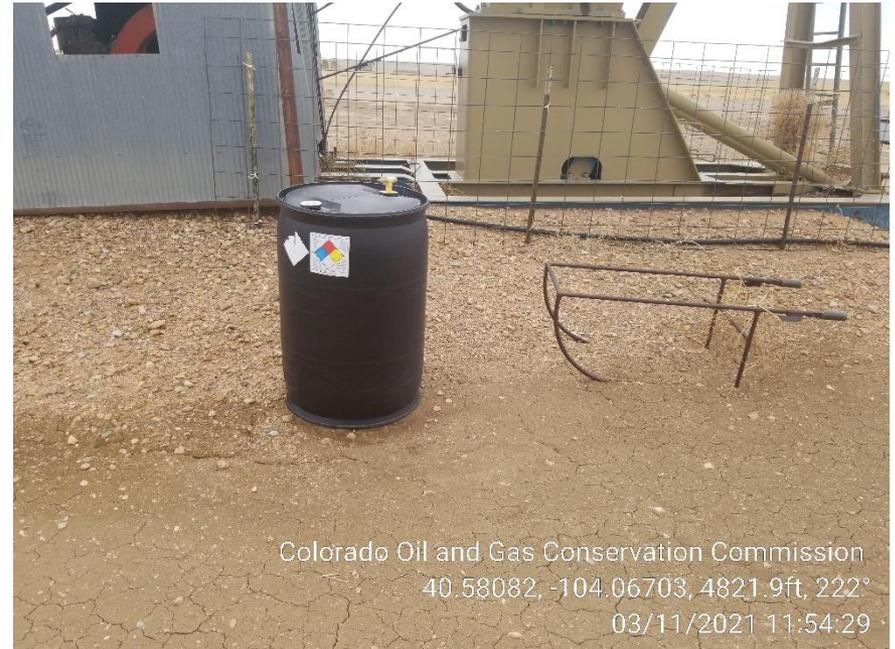
Photo 4 – Black Container – Missing Content and NFA Label has faded

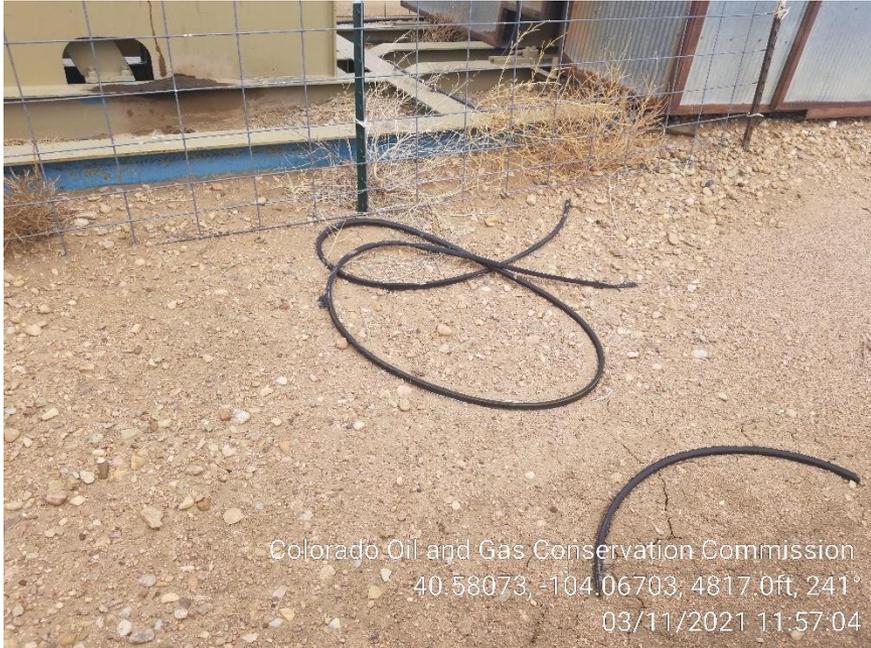
Photo 5 – Unused Belts

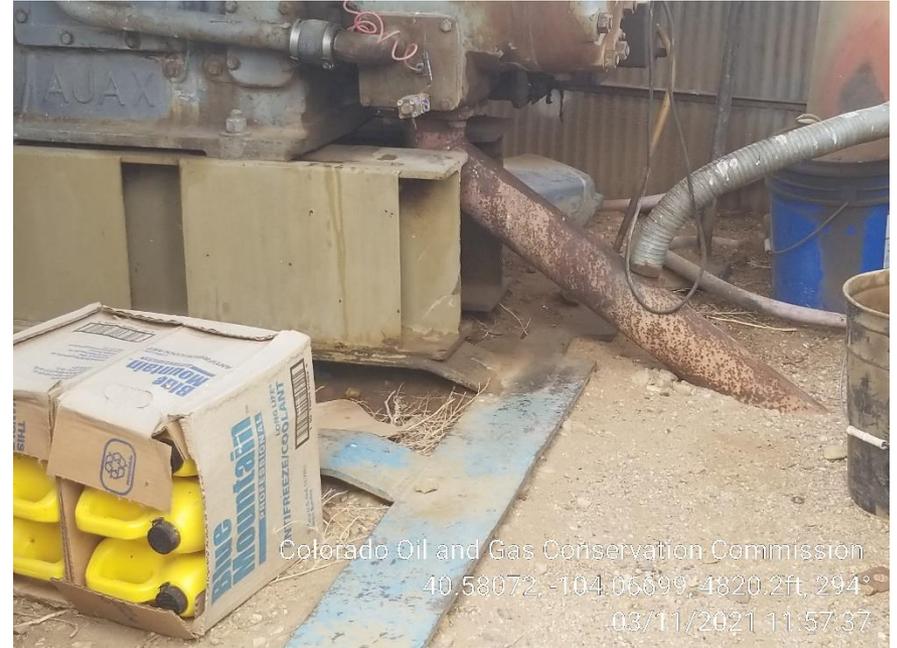
Photo 6 – Inside Engine House
