Inspection Photos

Location Name: CAERUS PICEANCE LLC HYRUP /2-34B

Location ID: 334103

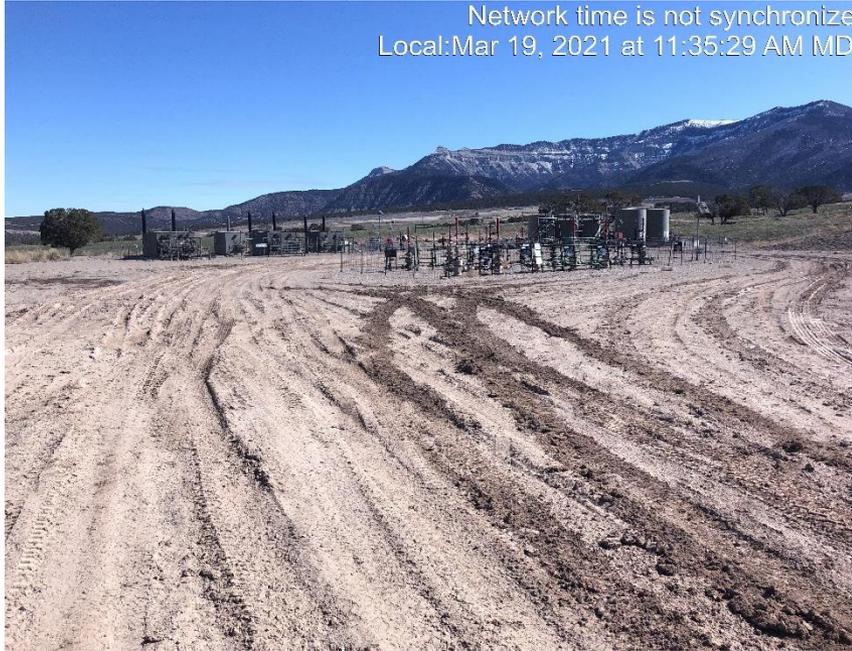
Photo #3202 from entrance to location.

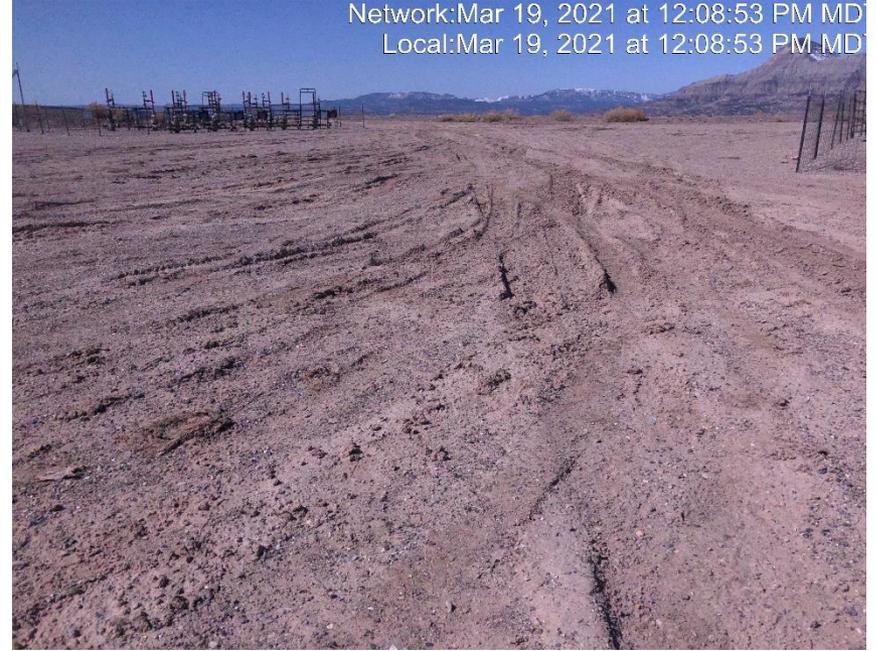
Photo #3204 Location lacks stabilization.

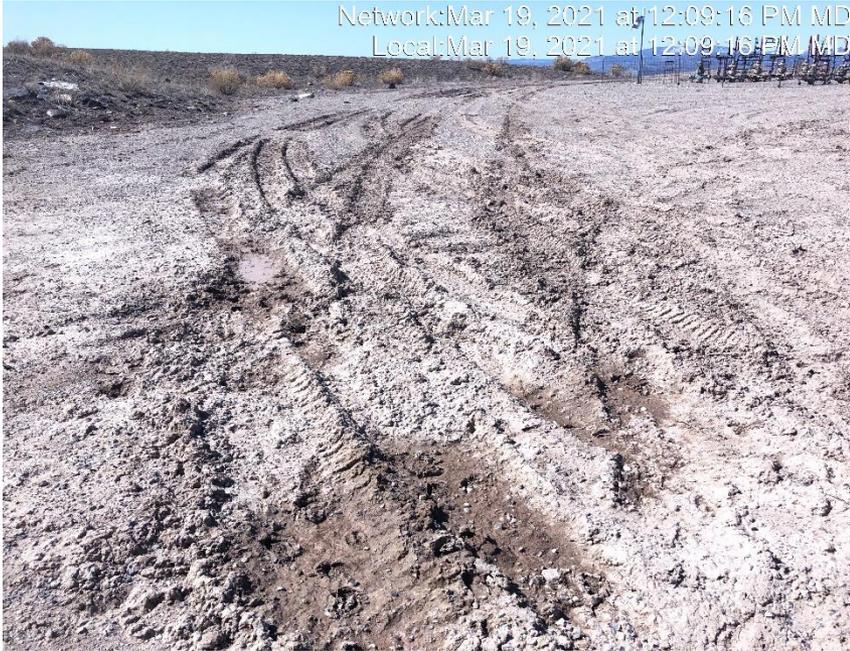
Photo #3205 Location lacks stabilization.

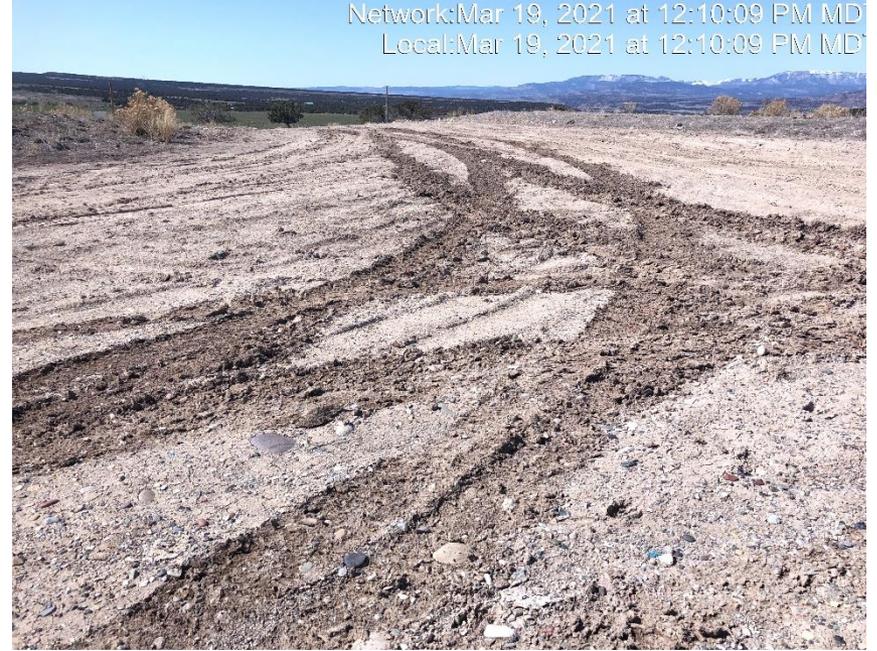
Photo #3206 Location lacks stabilization.

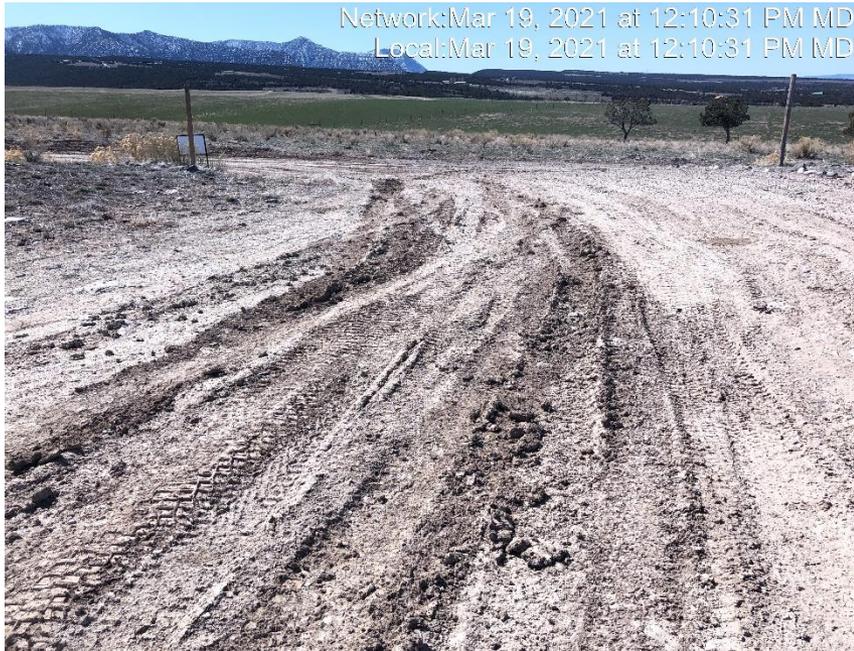
Photo #3207 No form of tracking control at entrance to location.
