**TEP ROCKY MOUNTAIN LLC  
CHEVRON-66S96W 20NENW  
Location # 335458**

**COLORADO**  
Oil & Gas Conservation  
Commission  
Department of Natural Resources

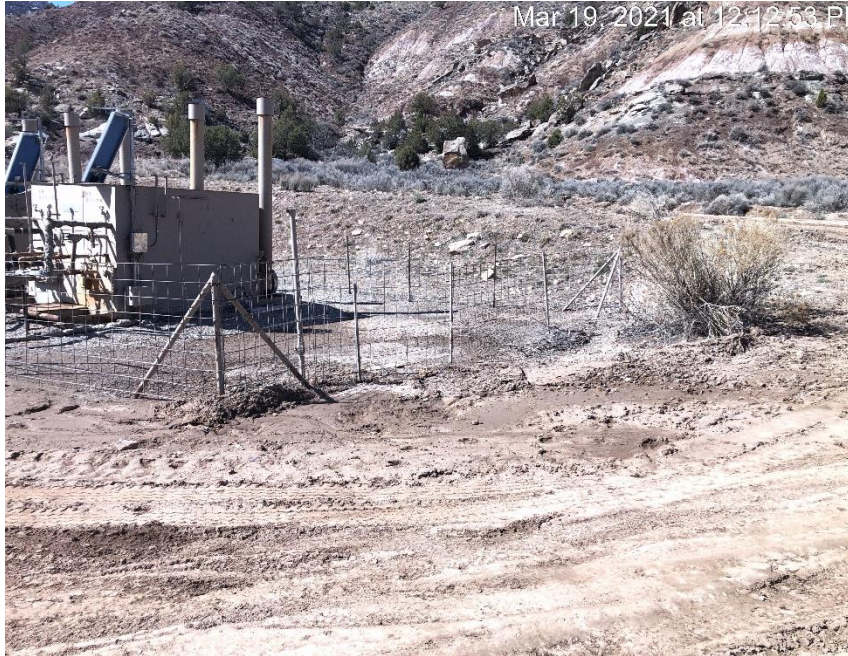
**Storm water run-on from access road.**

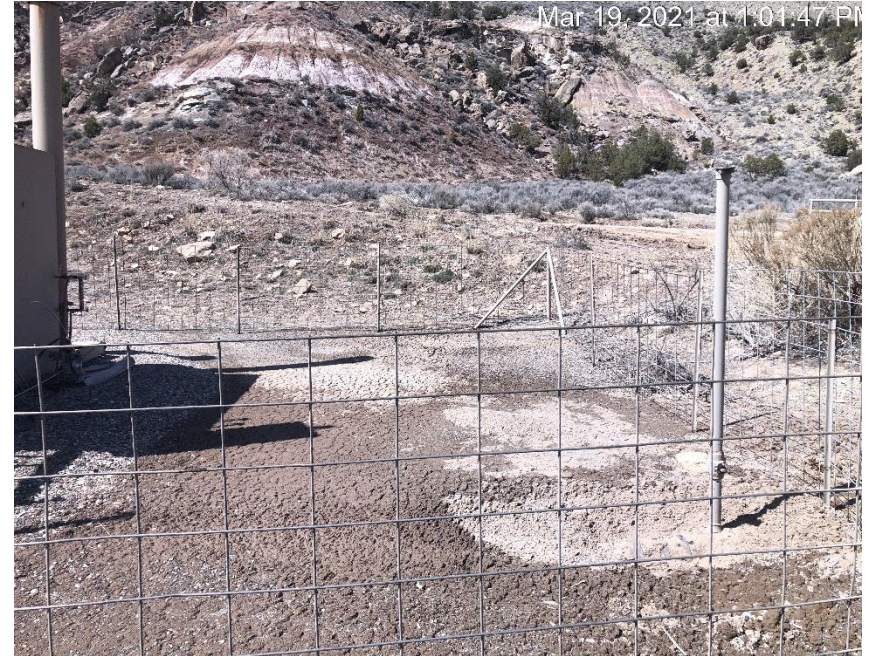
**Sediment build up in back corner of fence.**

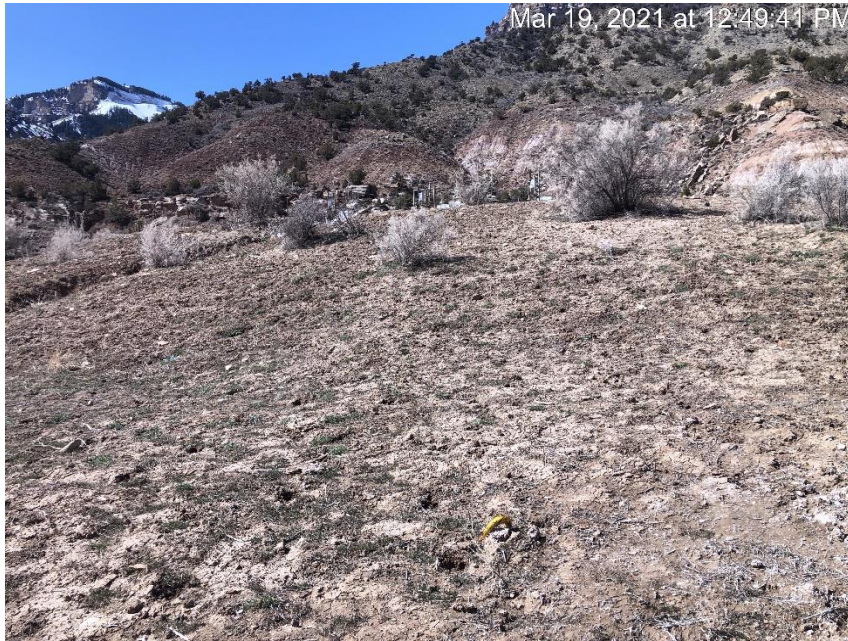
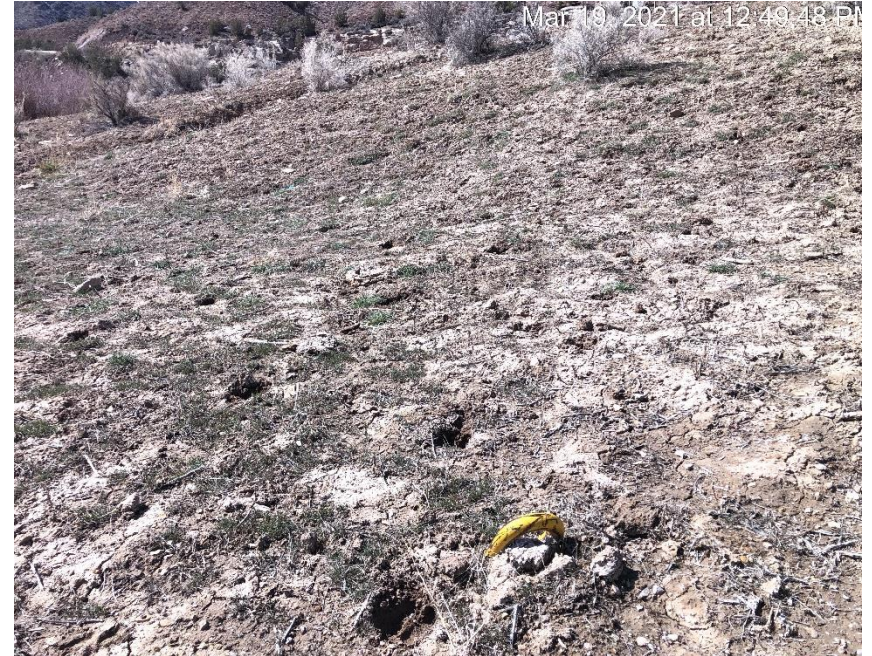
**Unmarked deadman over north east edge  
of location.**

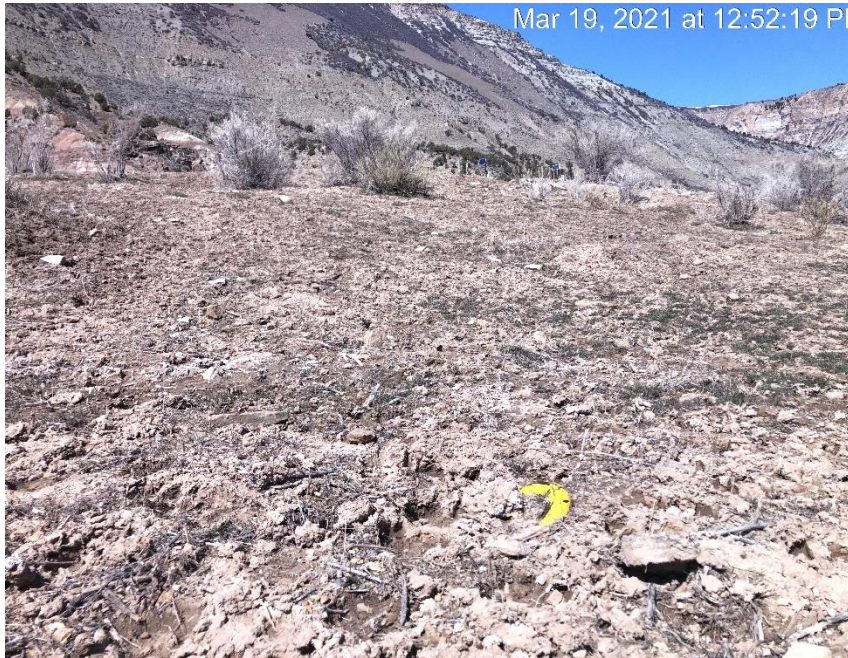
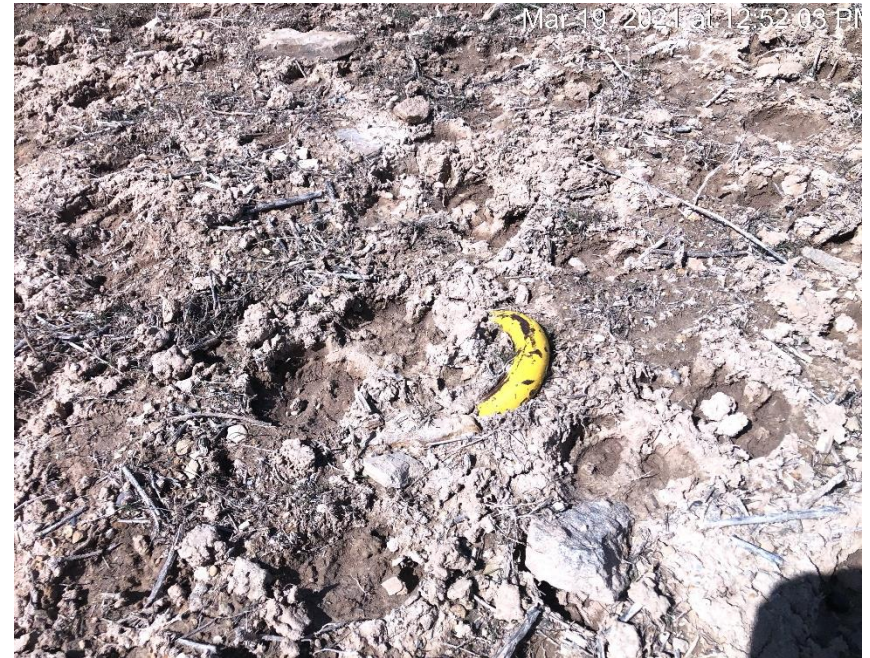
**Unmarked deadman over south east edge  
of location.**

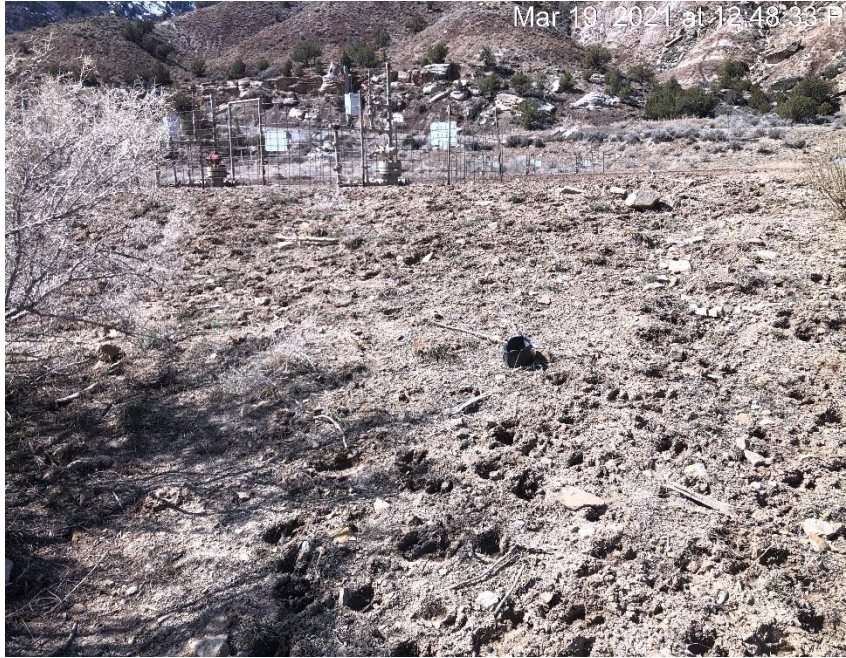
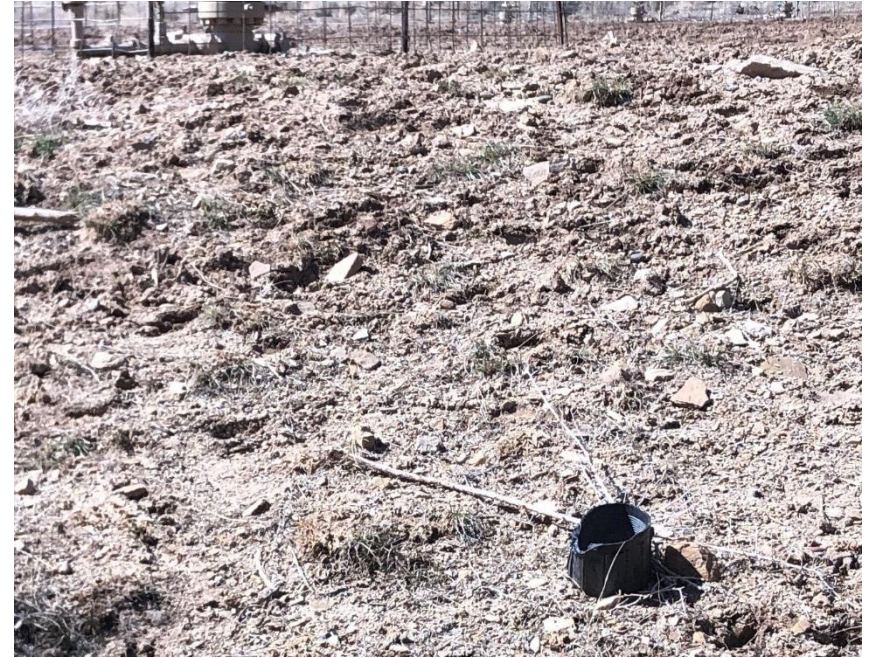
**Tread protector north east of the east side wells.**

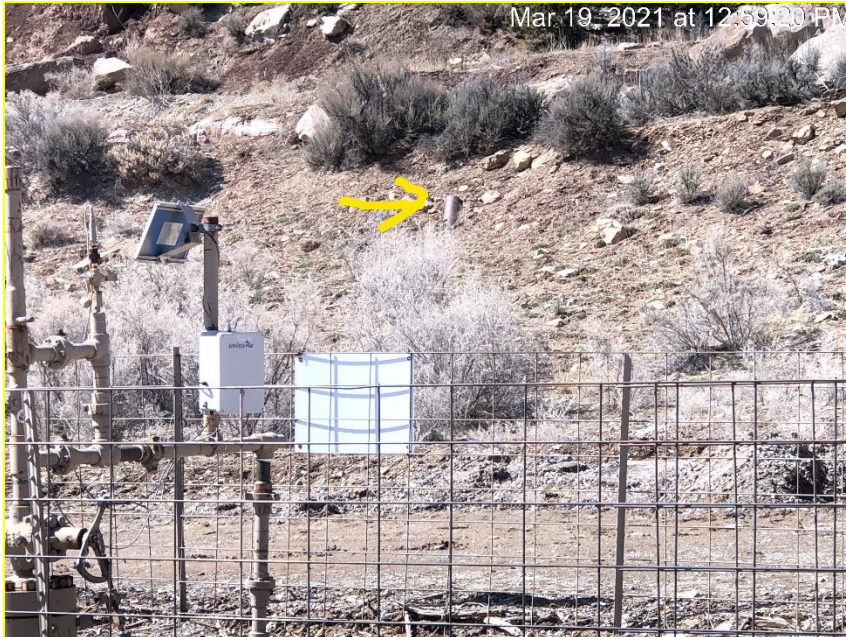
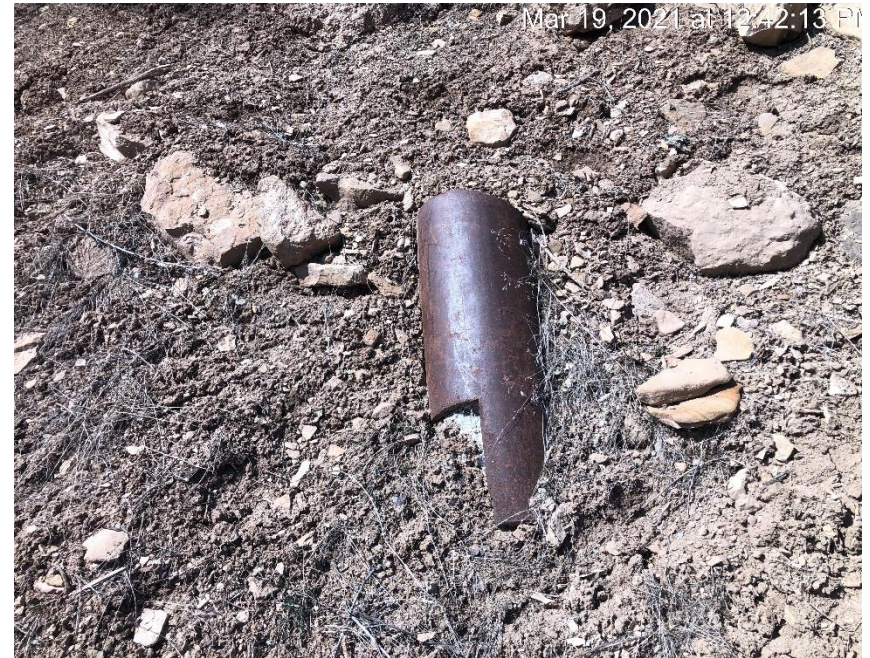
**Piece of 8" casing on edge of location.**

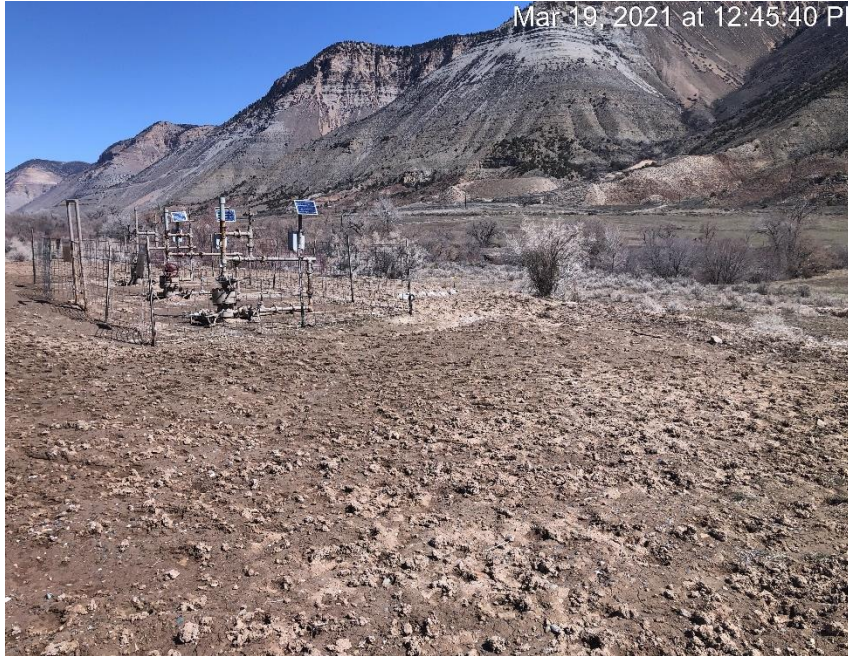
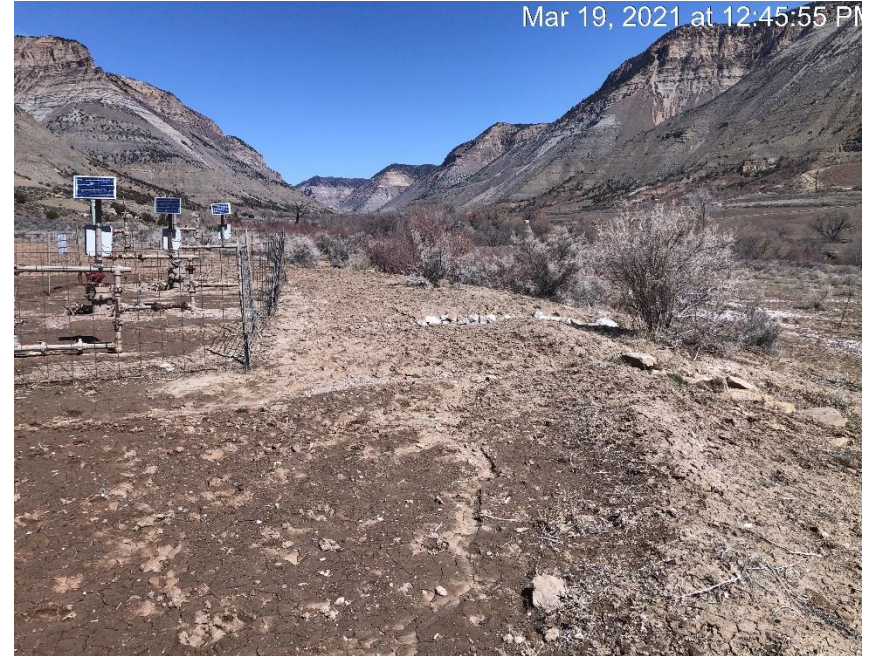
**Drains running off location behind wells.**

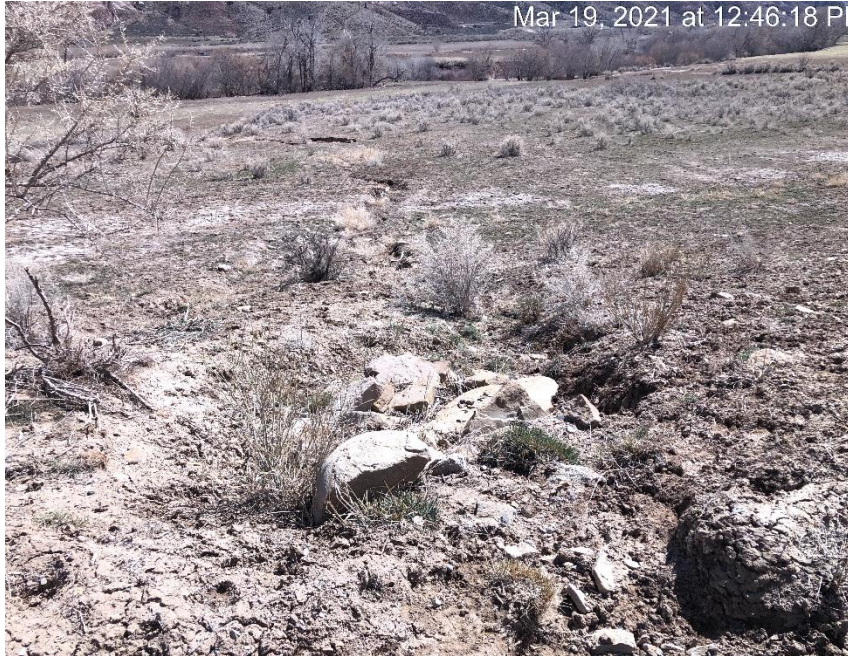
**South drain needs maintained.**

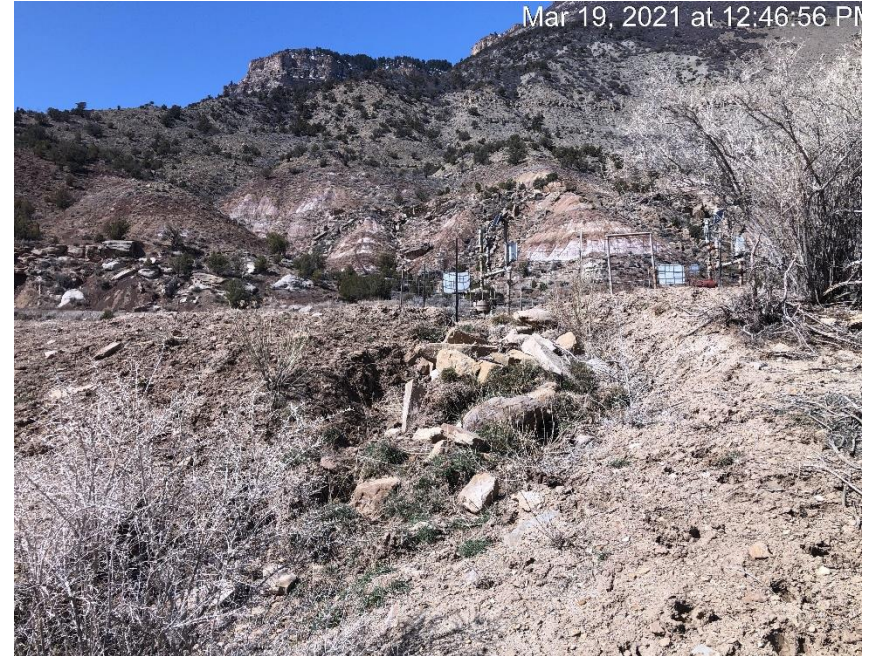
**South drain needs maintained.**

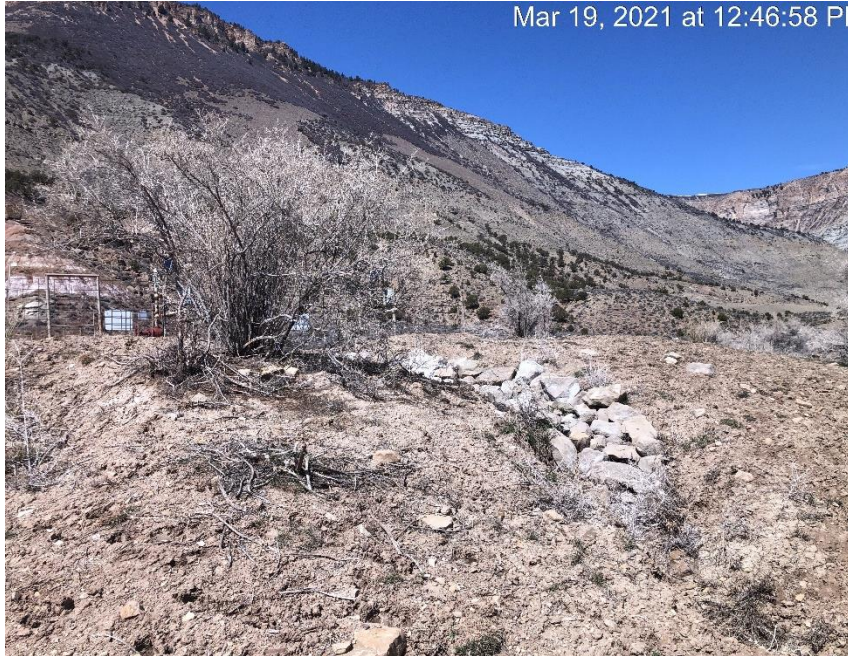
**North drain needs maintained.**

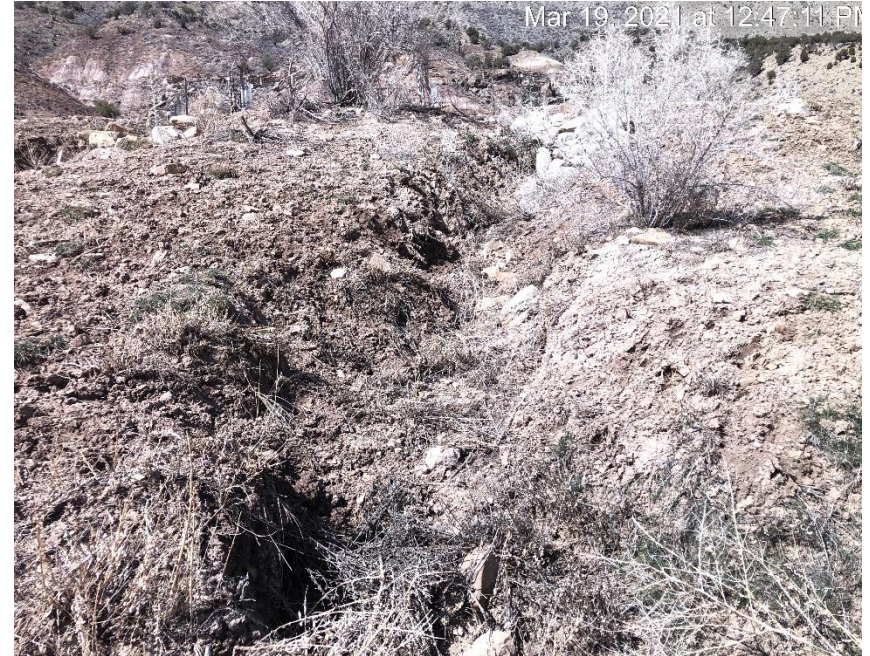
**North drain needs maintained.**

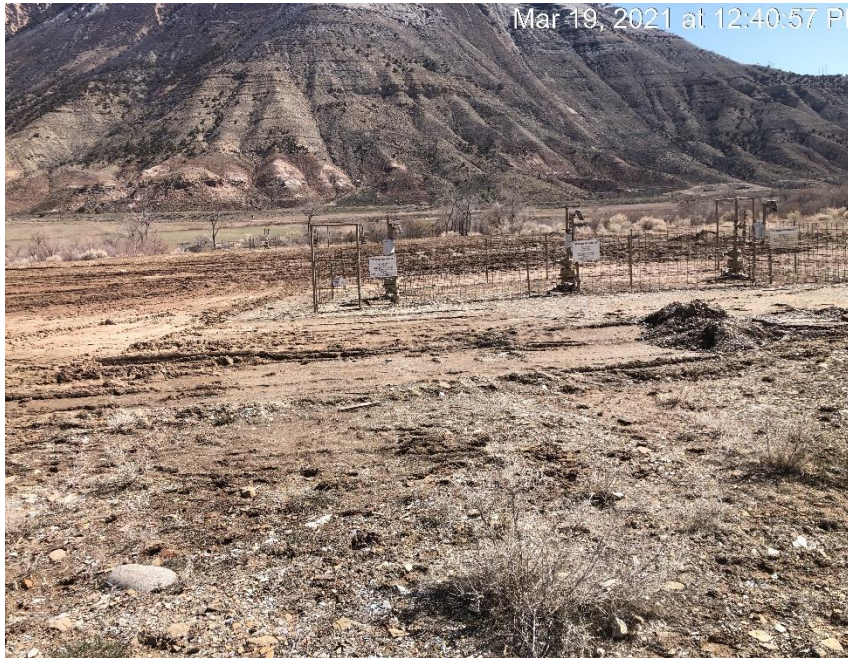
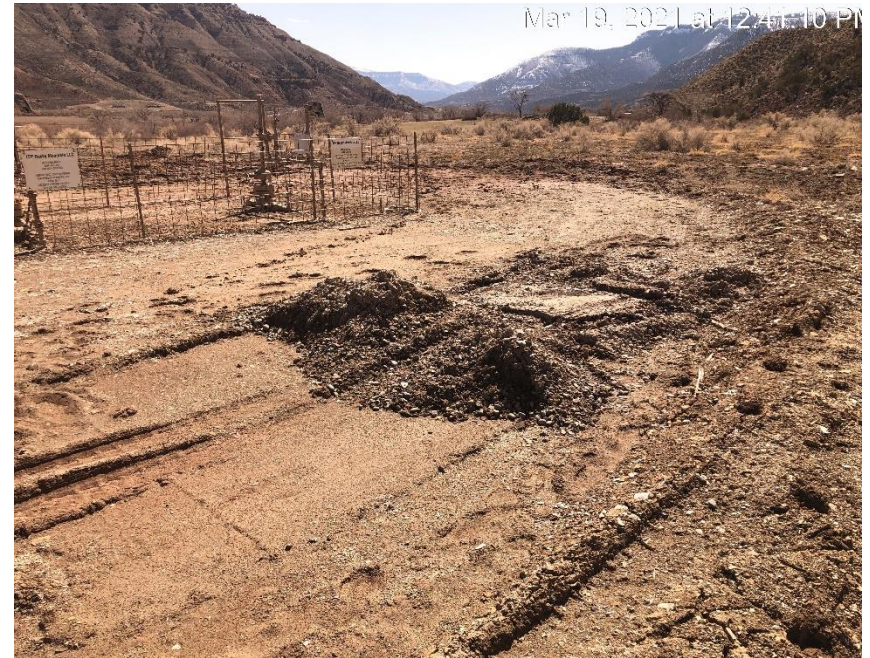
**Rock stock pile in front of west set of wells.**

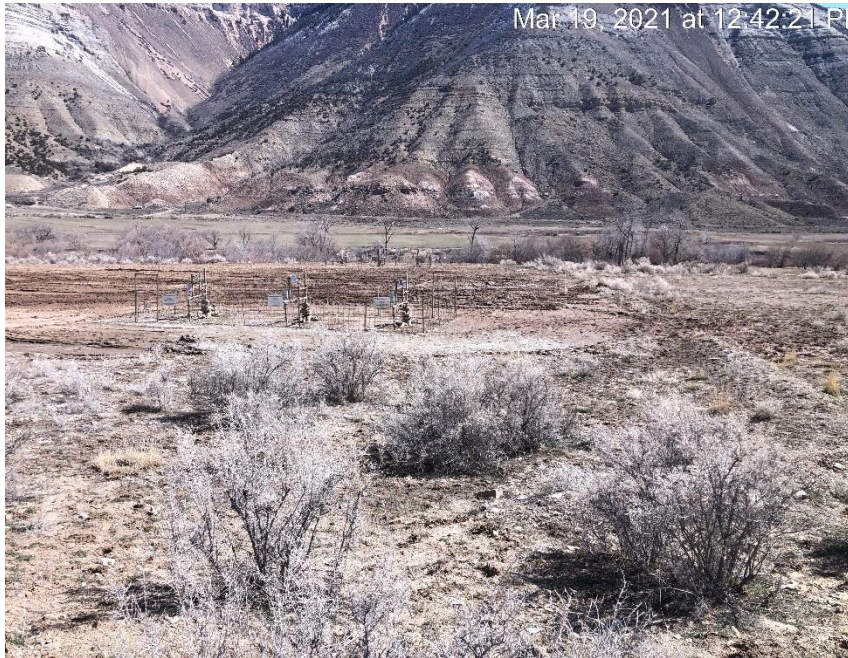
**Location lacks stabilization.**

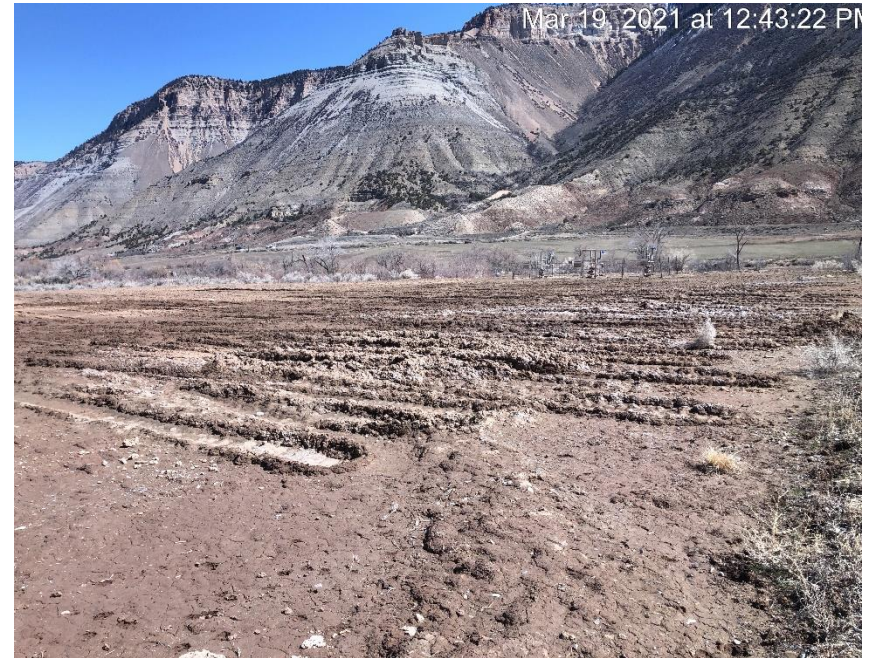
**Location lacks stabilization.**

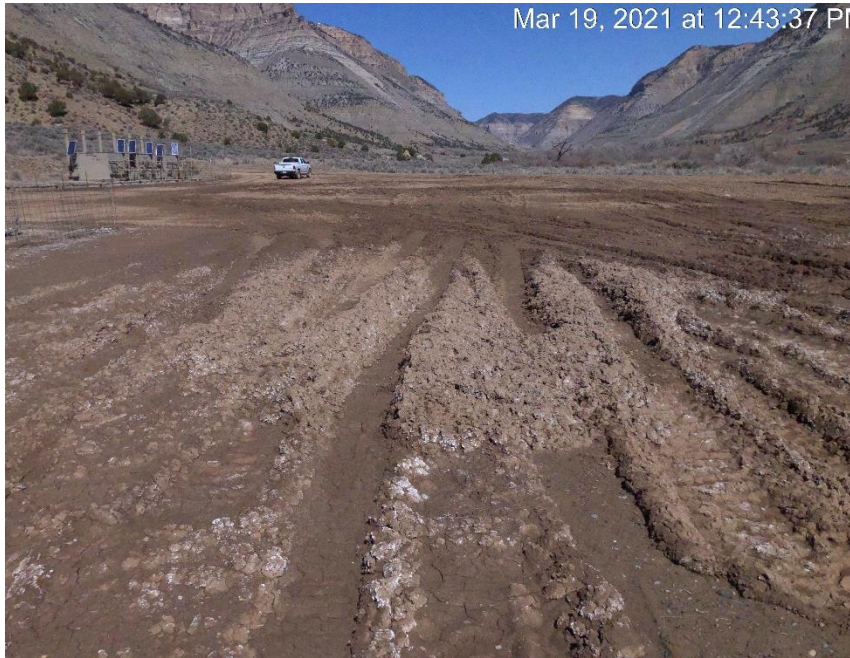
**Location lacks stabilization.**

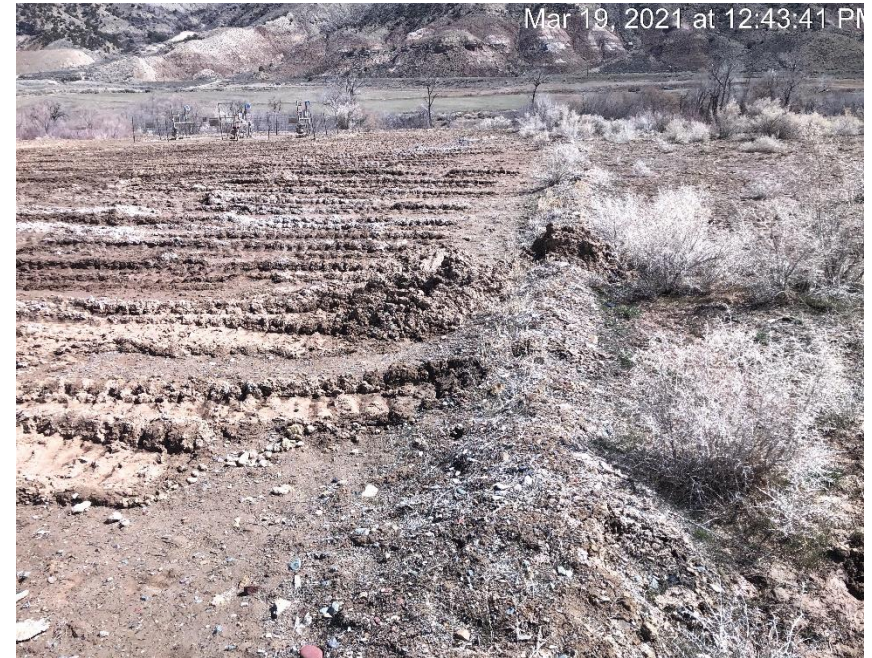
**Location lacks stabilization.**

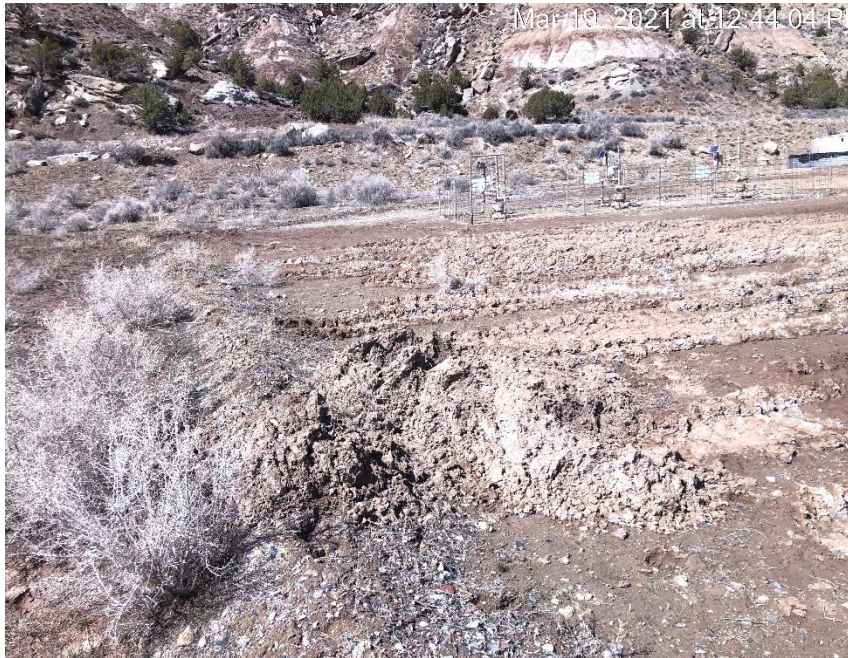
**Location lacks stabilization.**

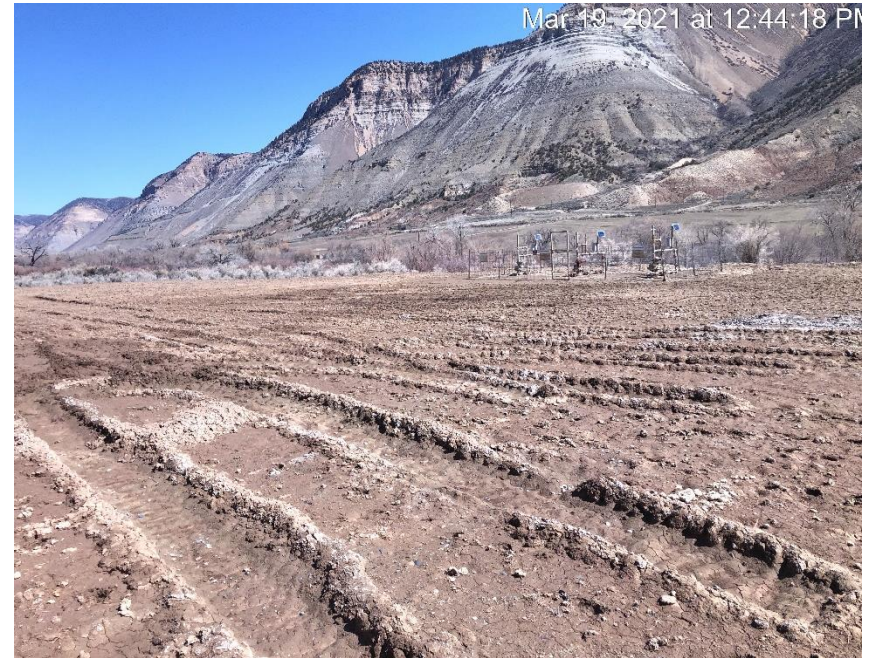
**Location lacks stabilization.**

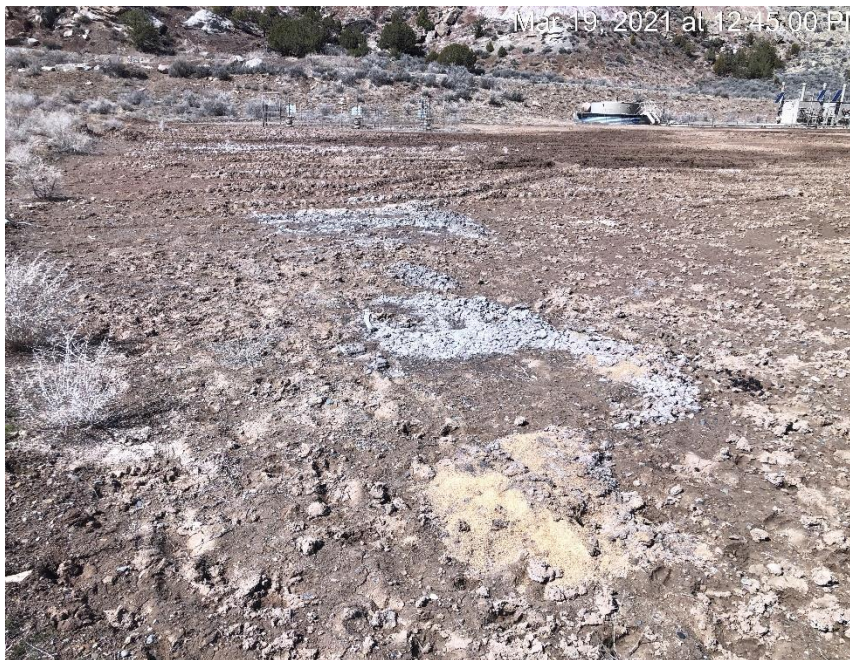
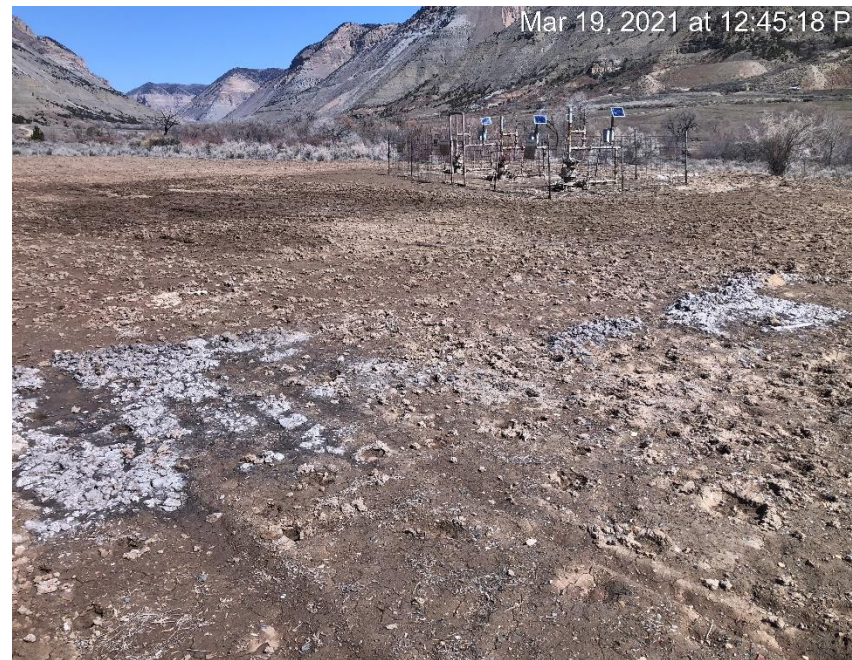
**Drillings products from staging drilling rig  
during rig move.**

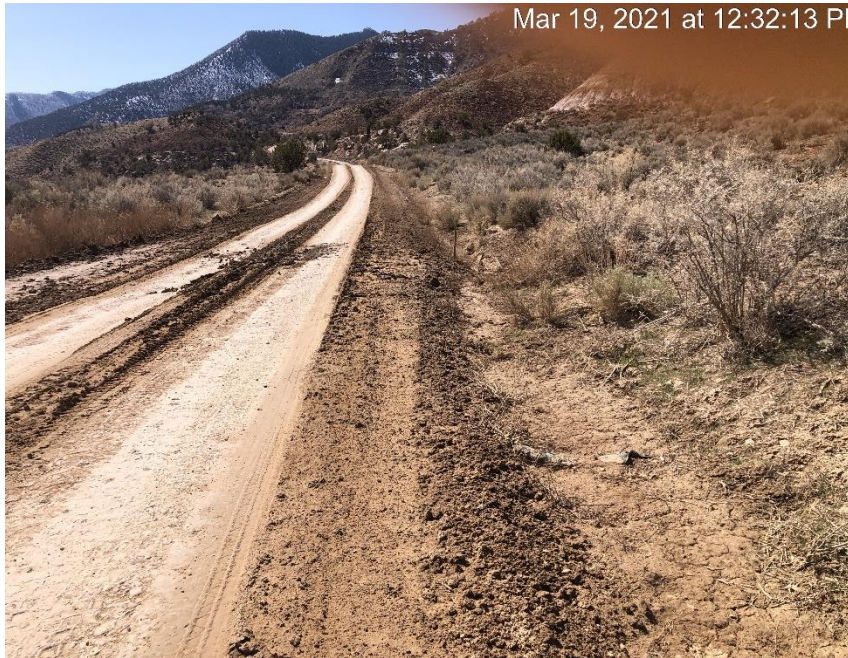
**Culvert and ditch need maintained.**

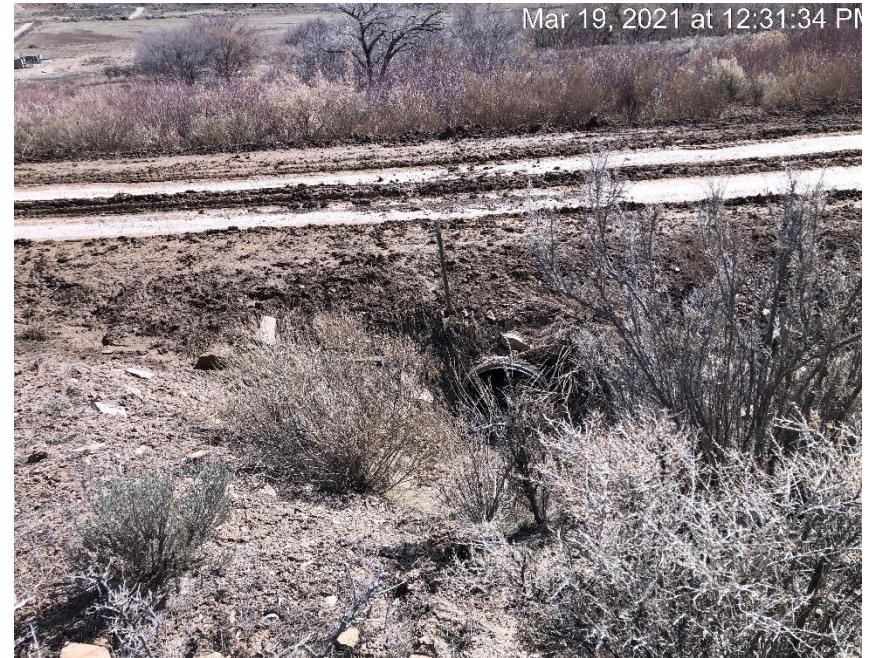
**Culvert needs maintained.  
39.51834 108.13325**

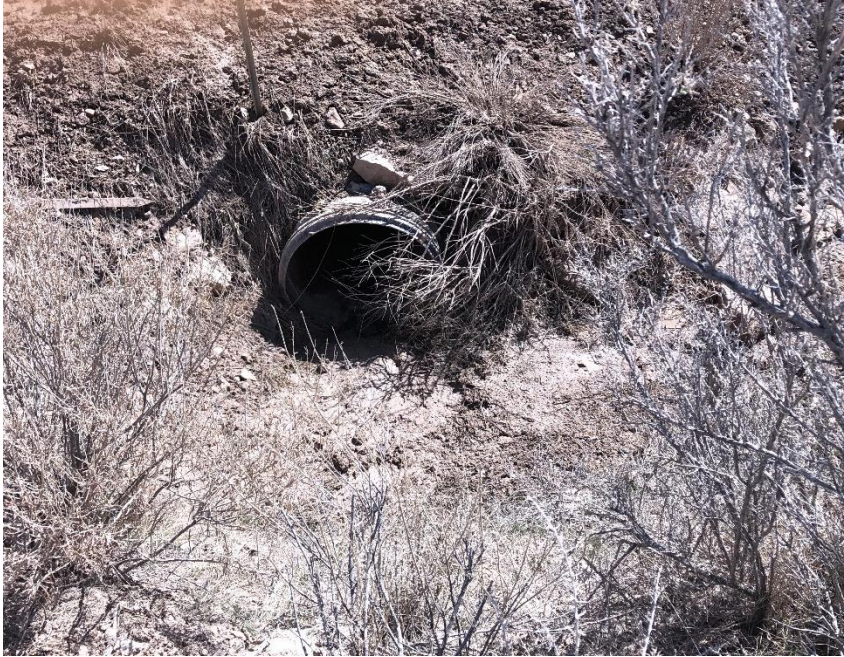
**Culvert needs maintained.  
39.51834 108.13325**

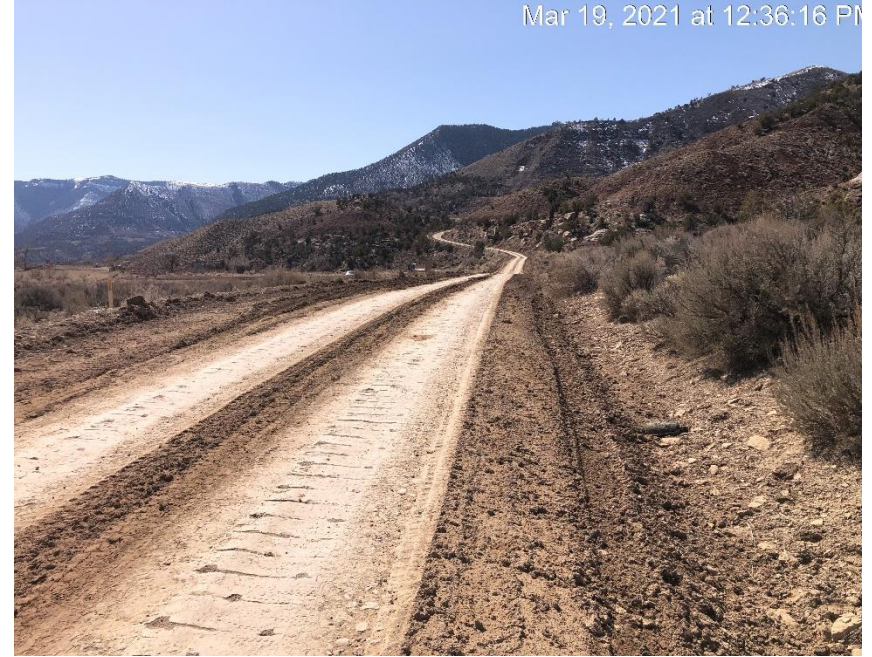
**Ditch damaged from traffic.**

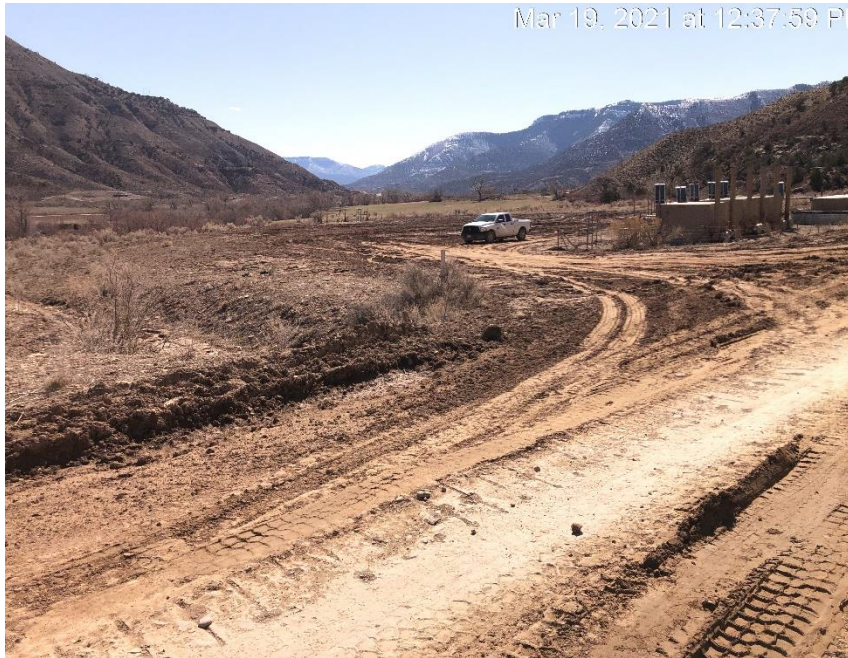
**Location lacks stabilization.**

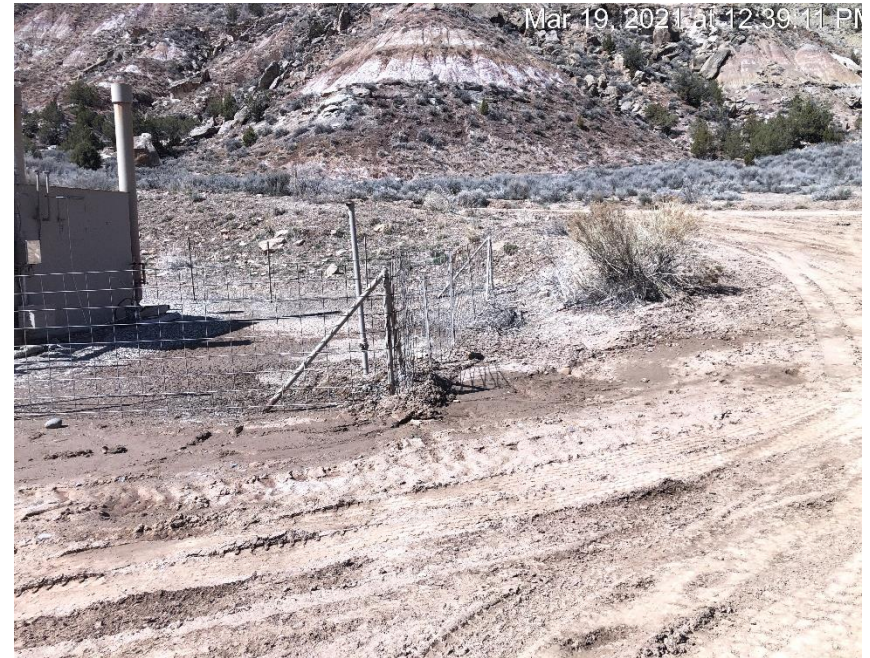
**Run on storm water from access road.**

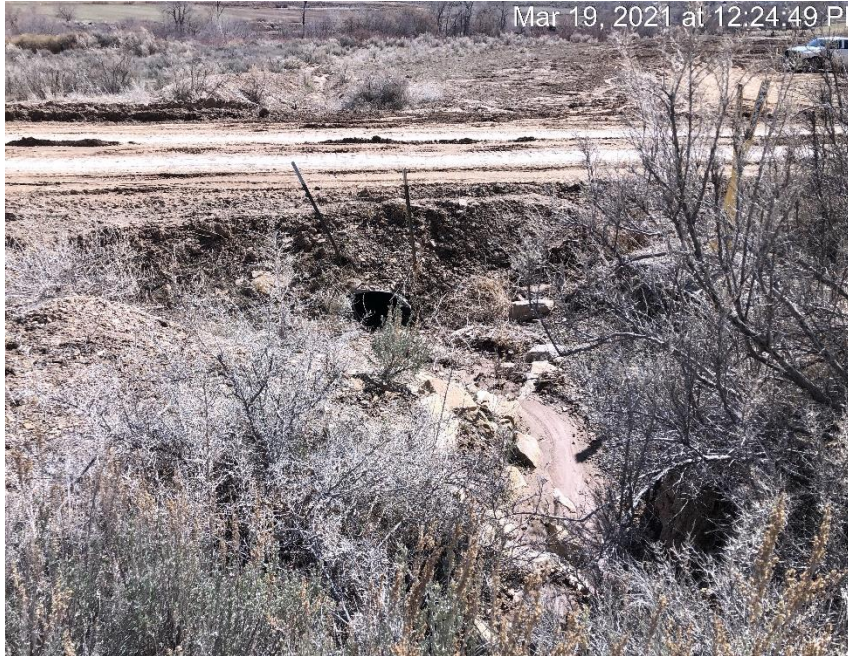
**Culvert needs maintained.  
39.51834 108.13400**

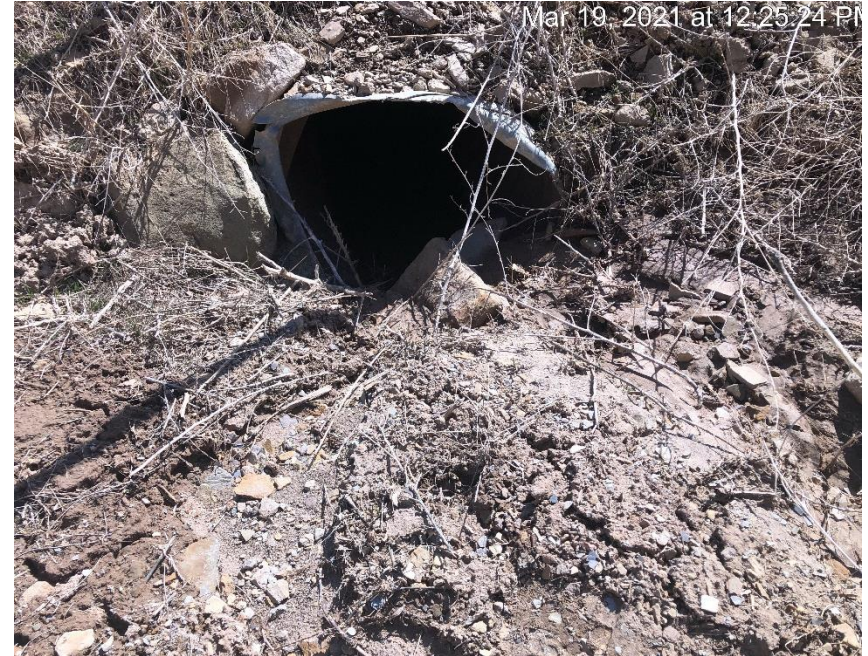
**Culvert needs maintained.**

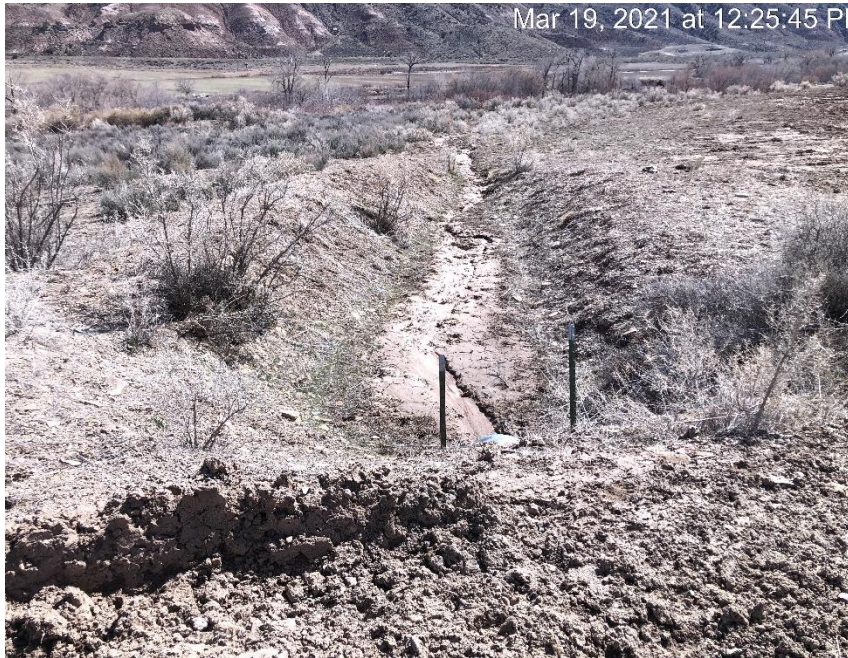
**Culvert needs maintained.  
39.51834 108.13400**

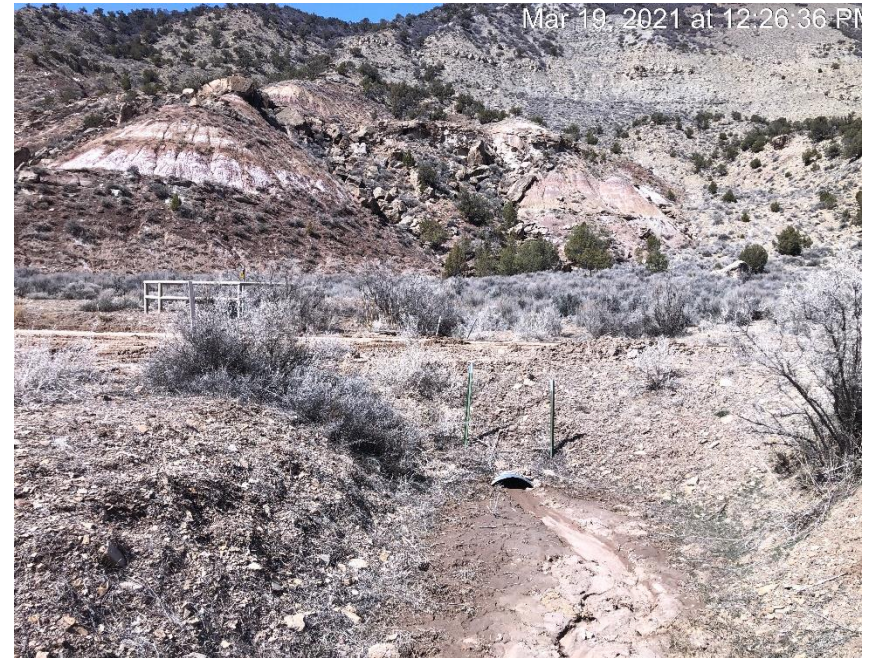
**Culvert needs maintained.**

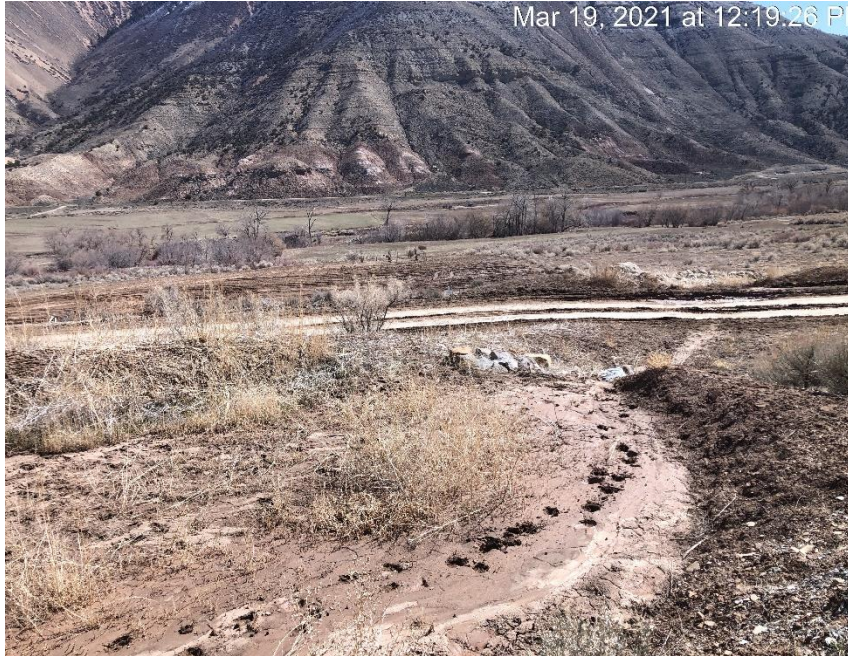
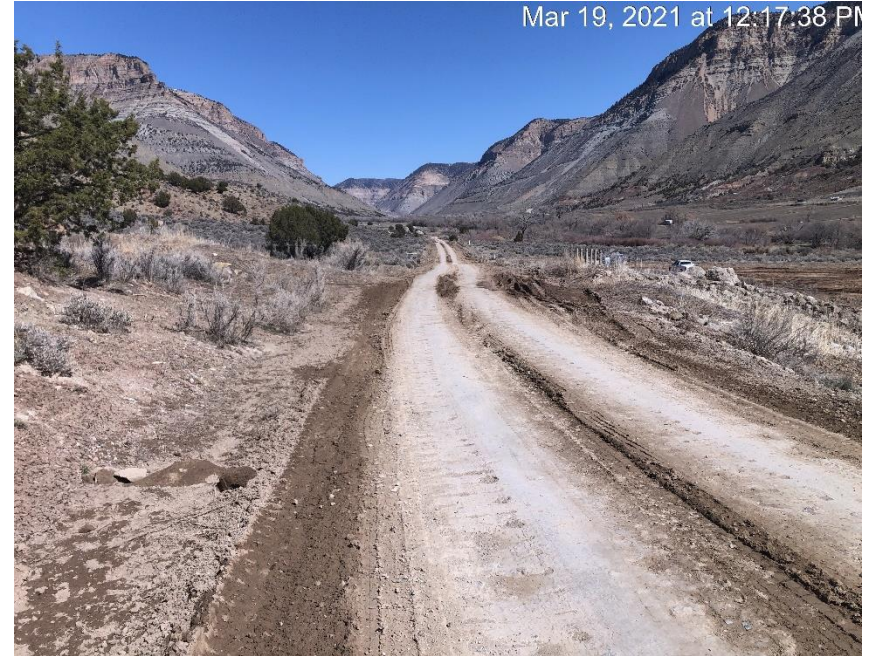
**Low water cross on access road.  
39.51610 108.13443**

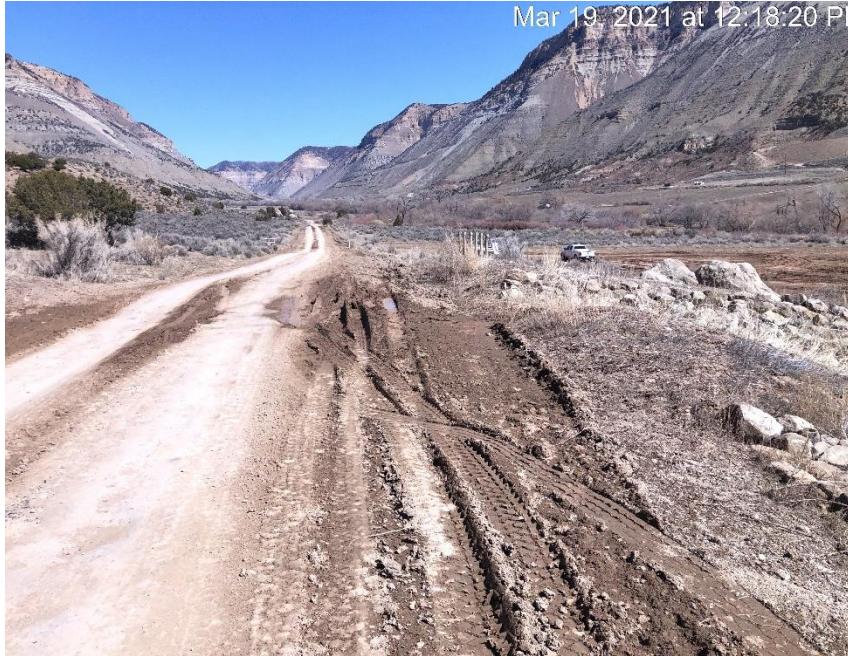
**Storm water not flowing effectively.**

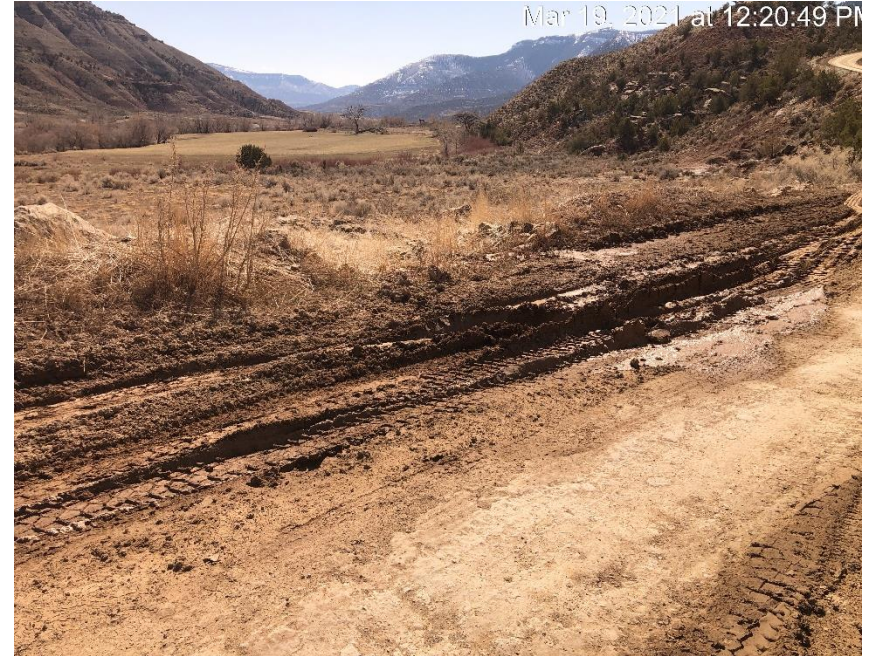
**Road is damaged on run off side of low water crossing.**
