**TEP ROCKY MOUNTAIN LLC  
CHEVRON-66S96W 20NENW  
Location # 335458**

**COLORADO**  
Oil & Gas Conservation  
Commission  
Department of Natural Resources

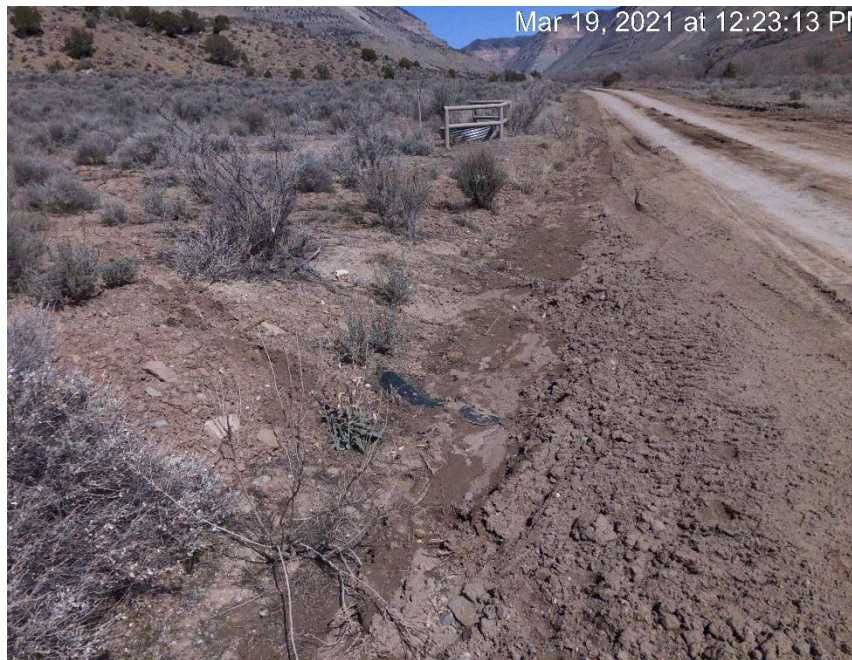
**Sediment build up and traffic damage in ditch.**

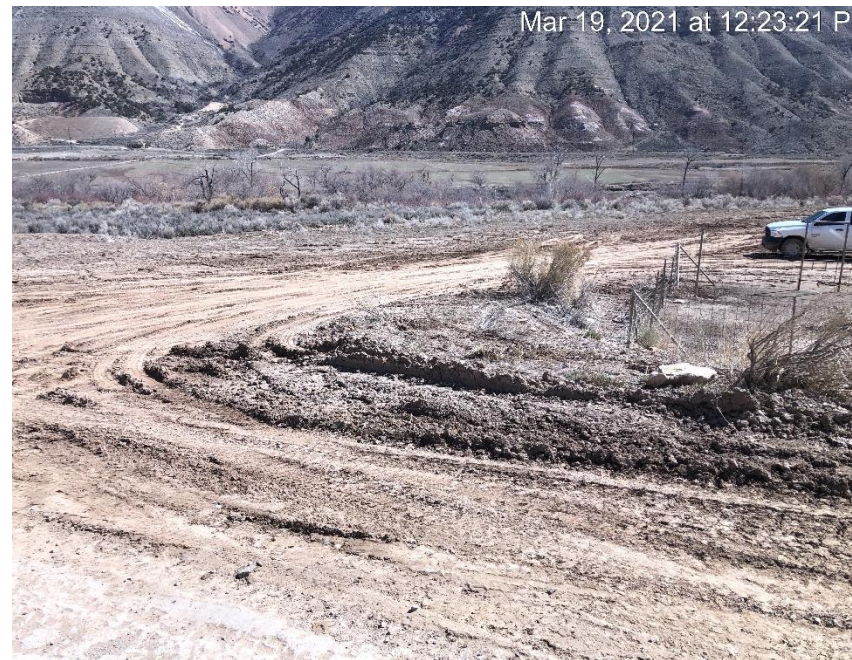
**No apparent BMPs at entrance of location.**

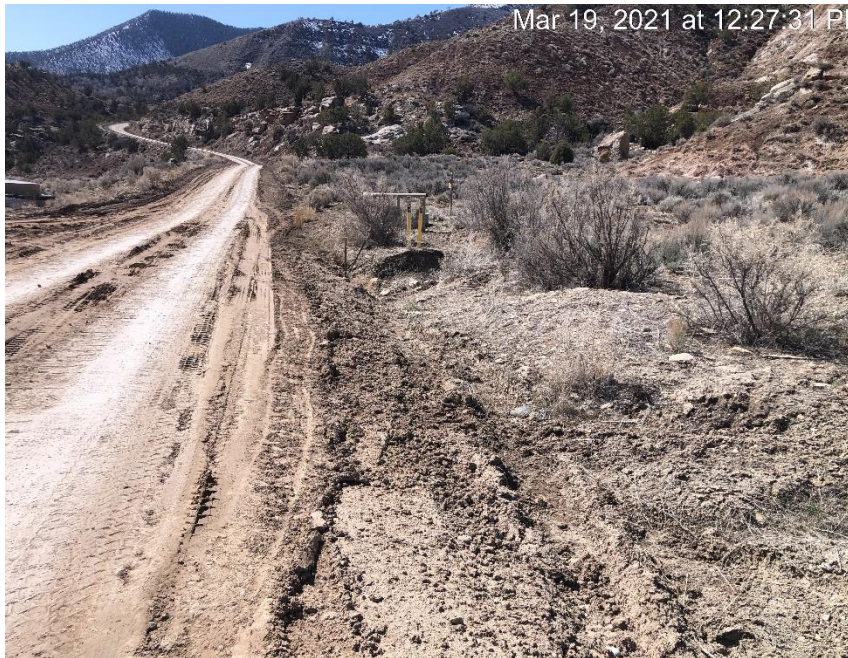
**Sediment build up and traffic damage in ditch.**

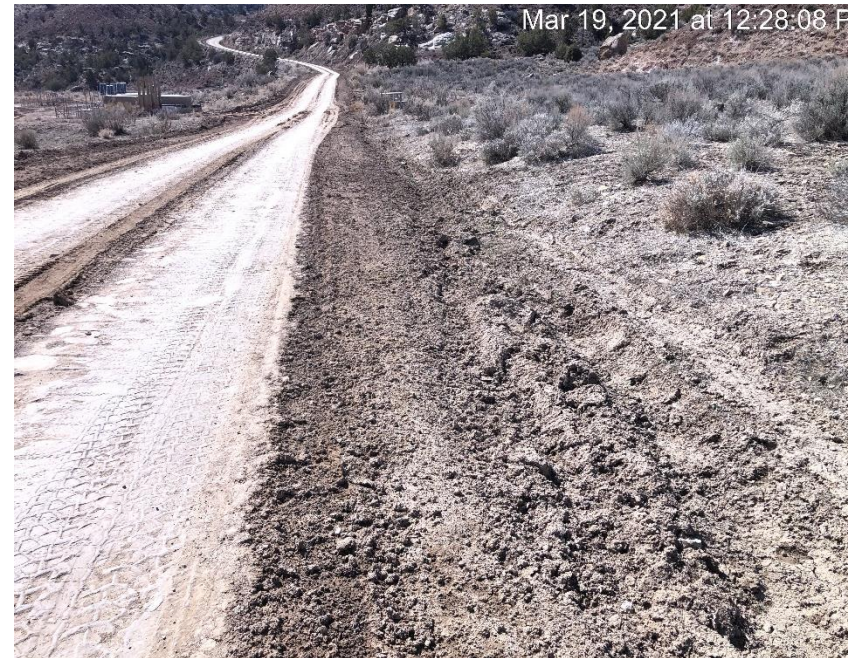
**Sediment build up and traffic damage in ditch.**
