**CAERUS PICEANCE LLC**  
**GASAWAY-66S99W /20NESE**  
**Location # 324233**

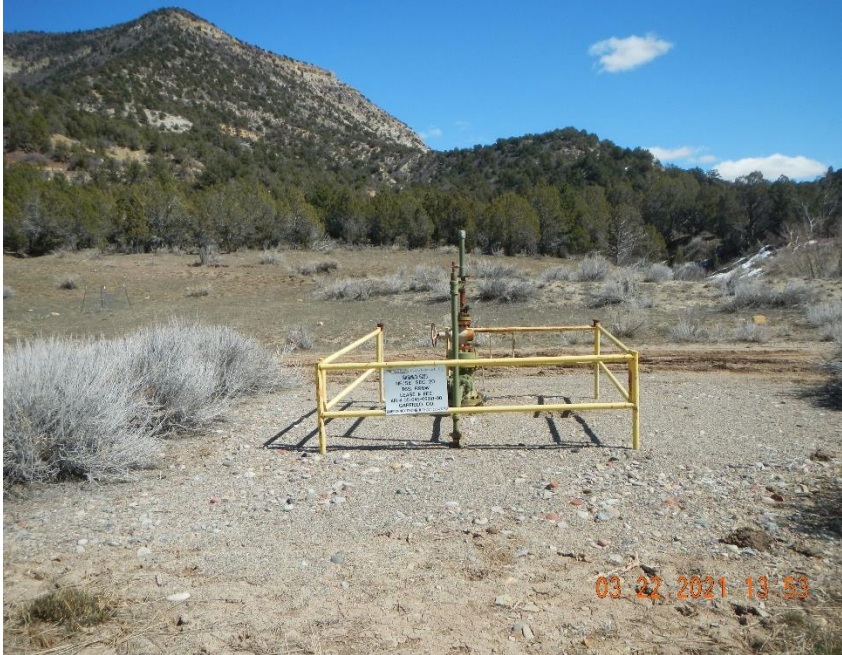
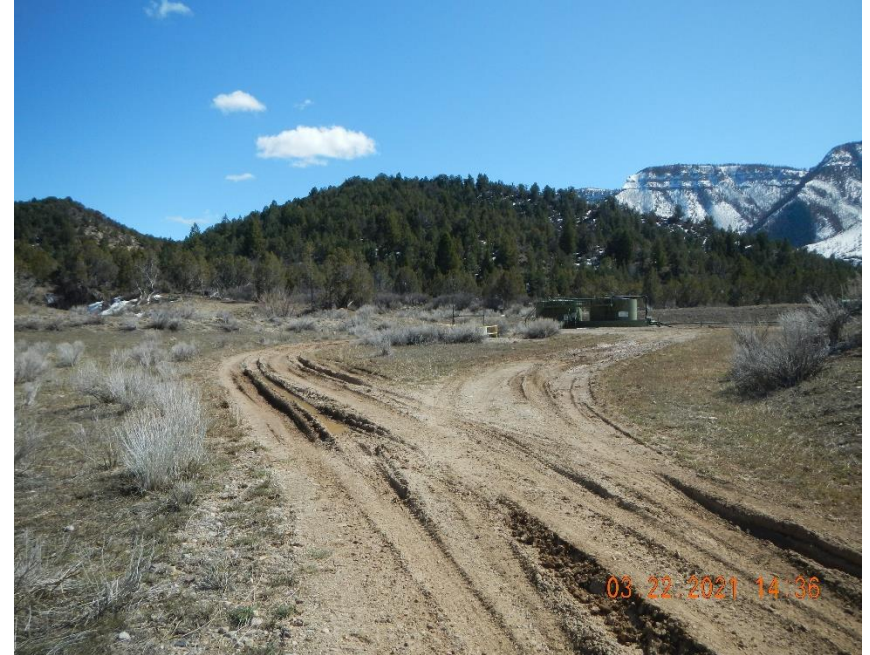
**Location lack stabilization.**

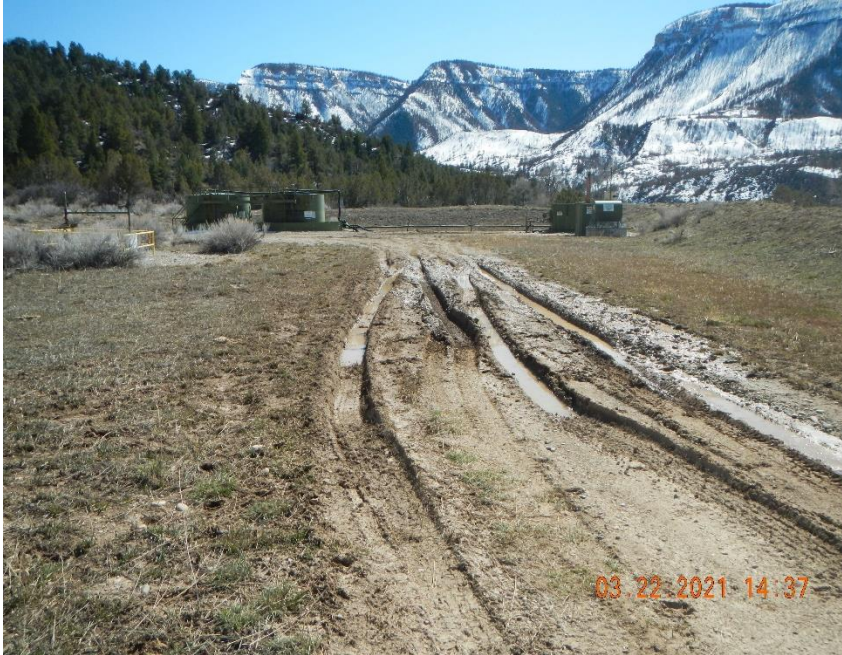
**Location lack stabilization.**

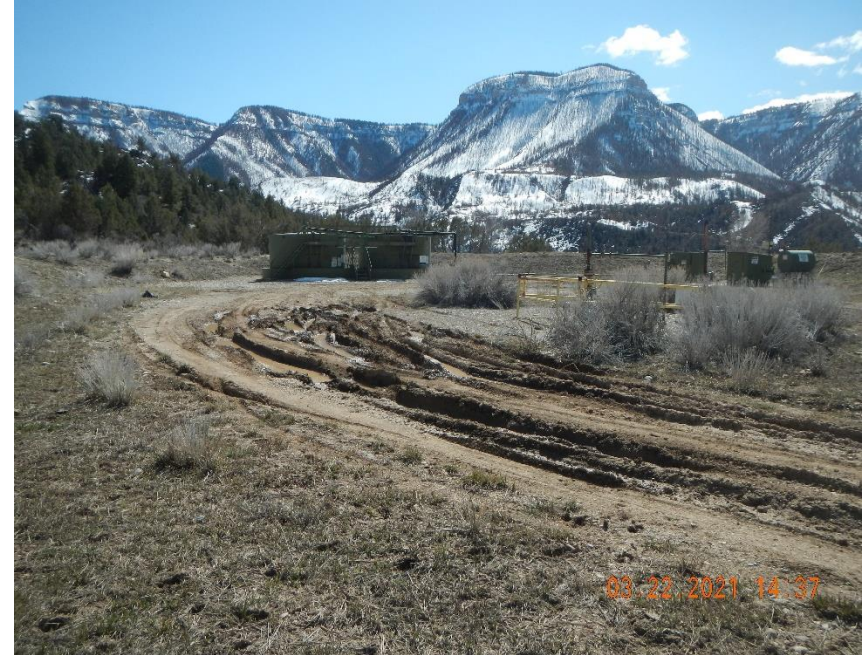
**Location lack stabilization.**

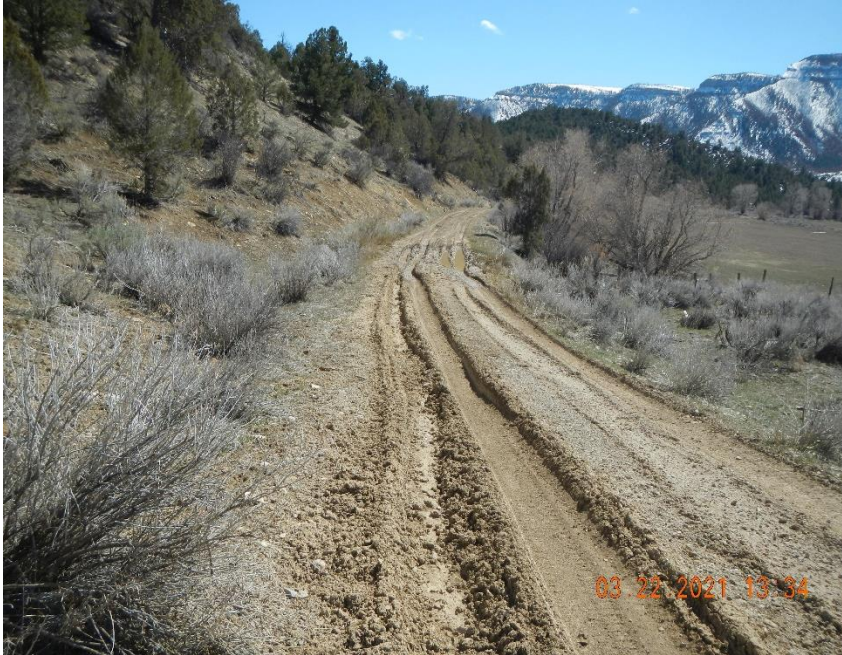
**Rutted mud holes on roadway.**

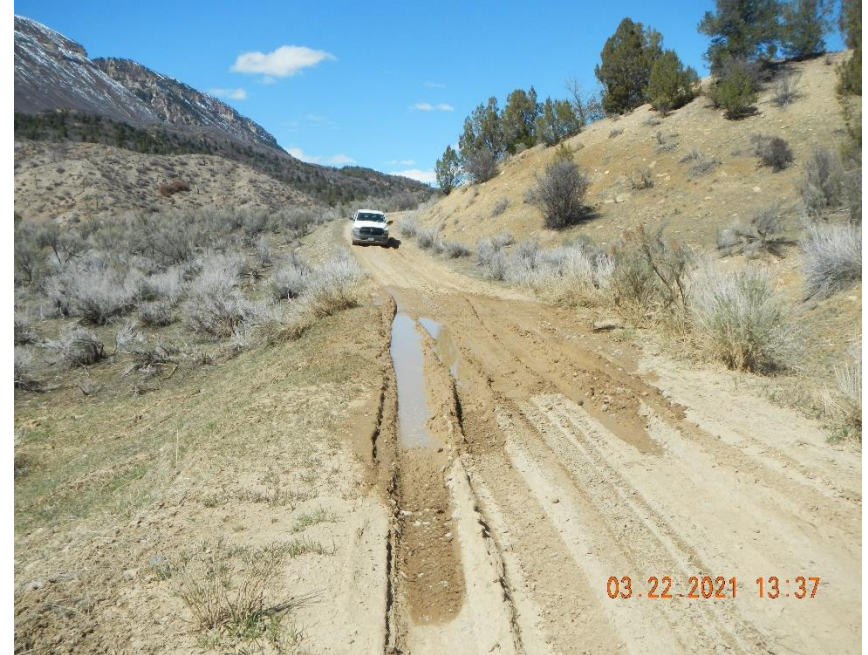
**Rutted mud holes on roadway.**

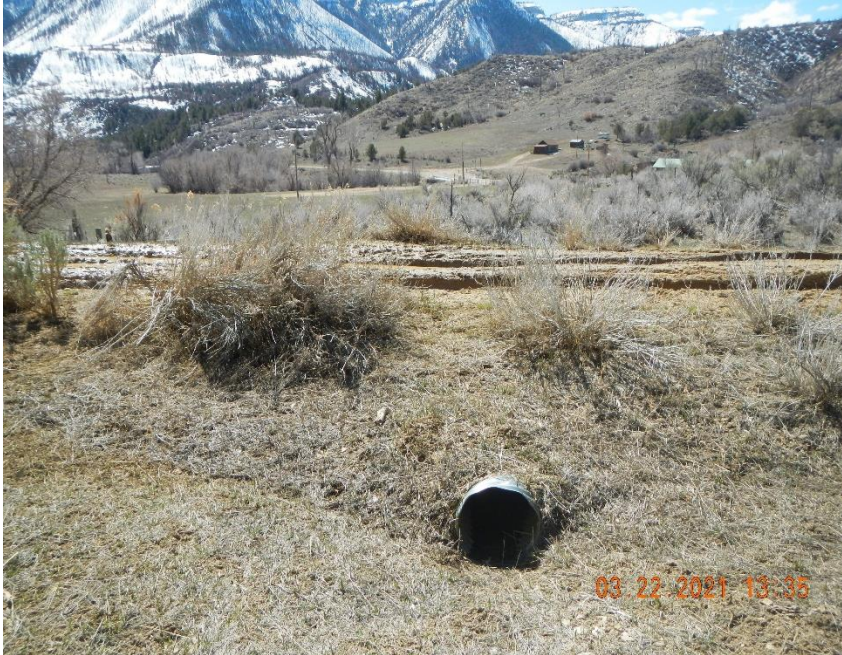
**Coordinates 39.52002 108.46124**

**Culvert**

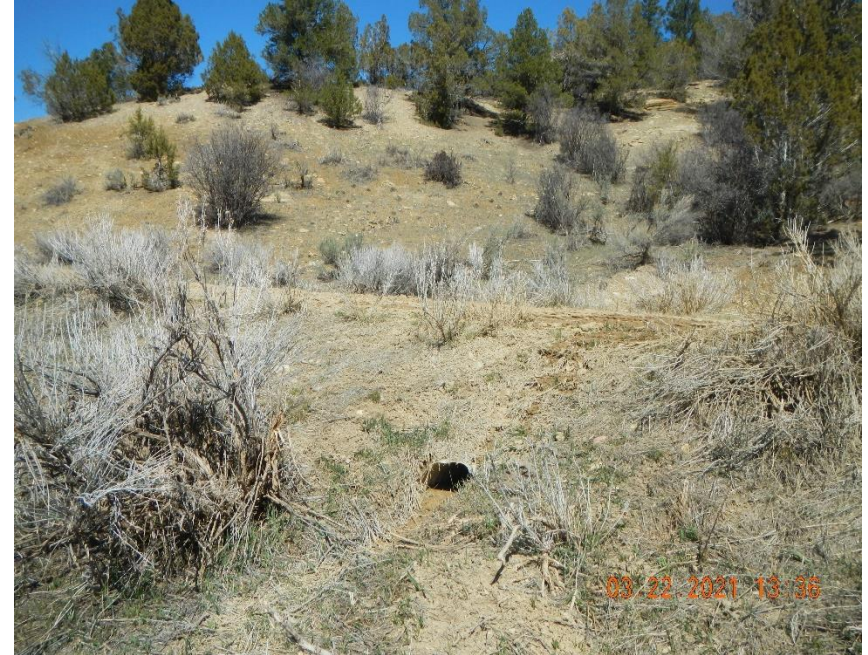
**Culvert needs maintained.**

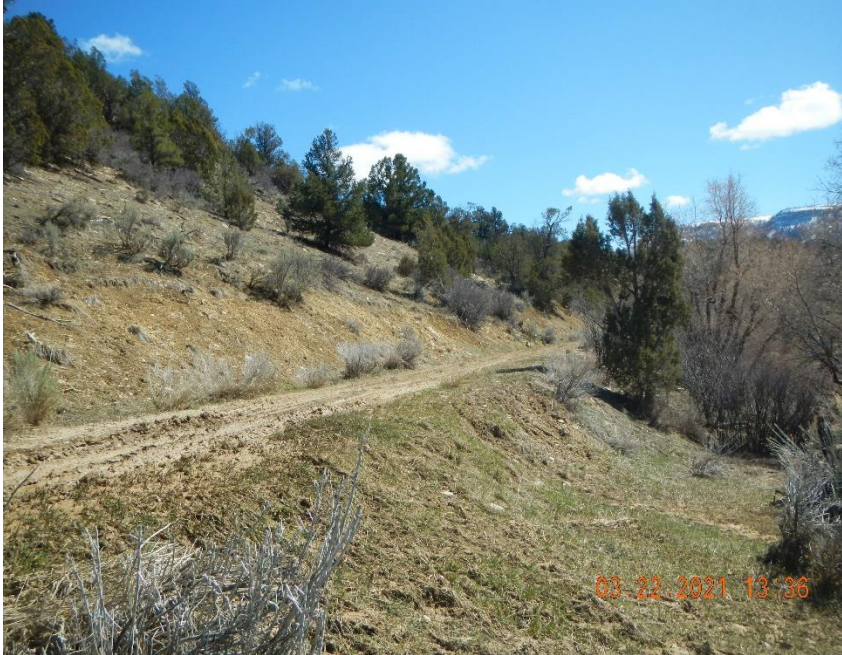
**Sediment moving over shoulder of access road.**

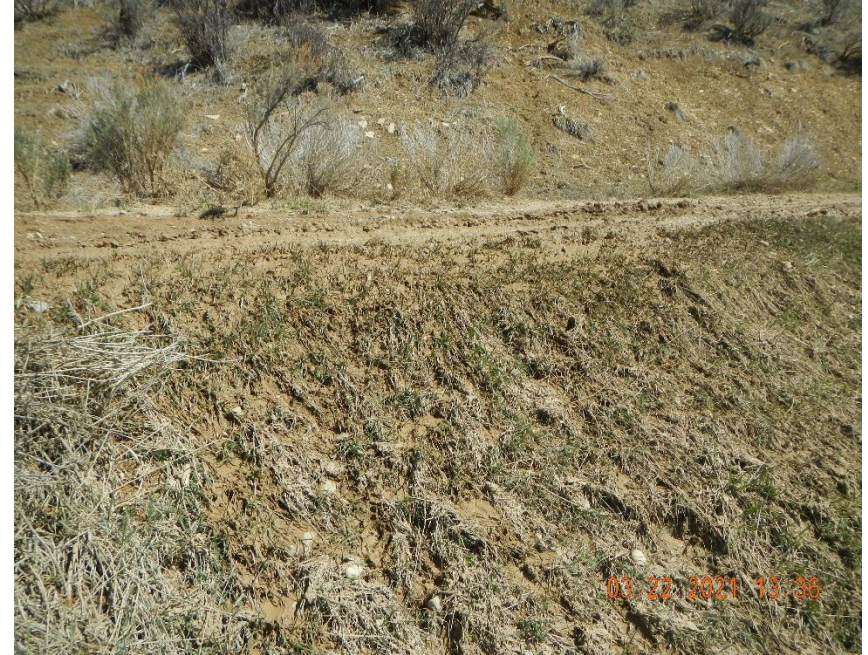
**Sediment moving over shoulder of access road.**

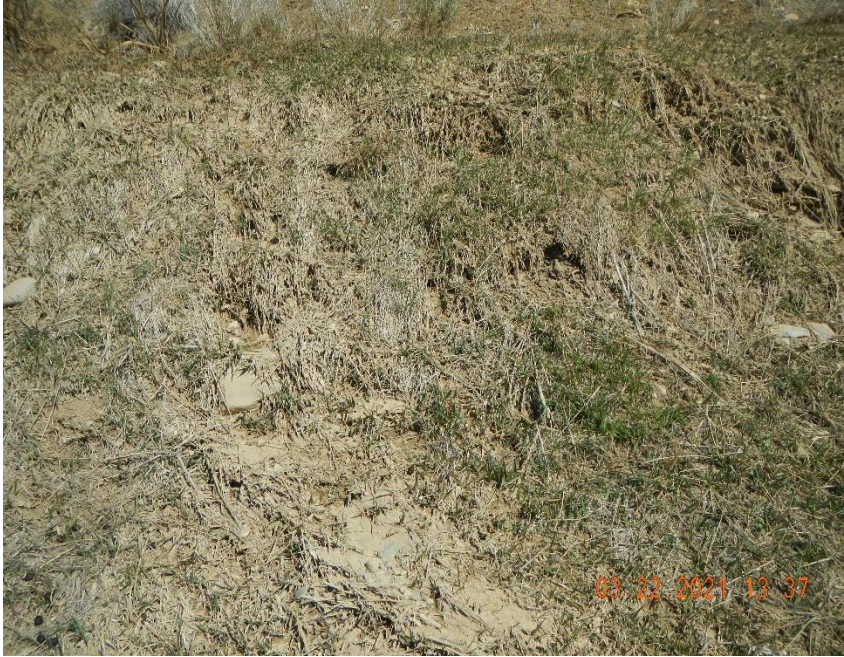
**Sediment moving over shoulder of access road.**

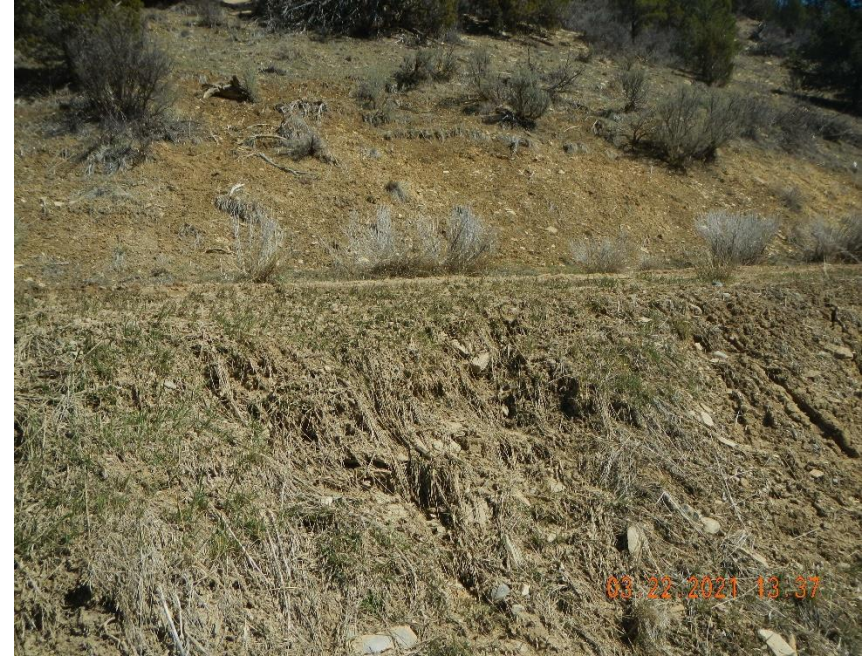
**Washing erosion of road embankment.**

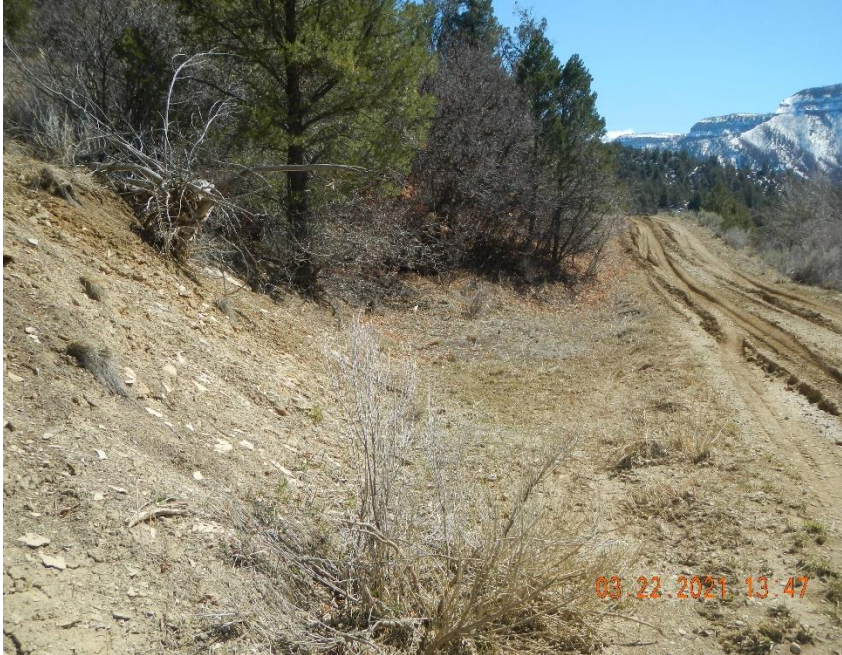
**Rutted mud holes on roadway.**

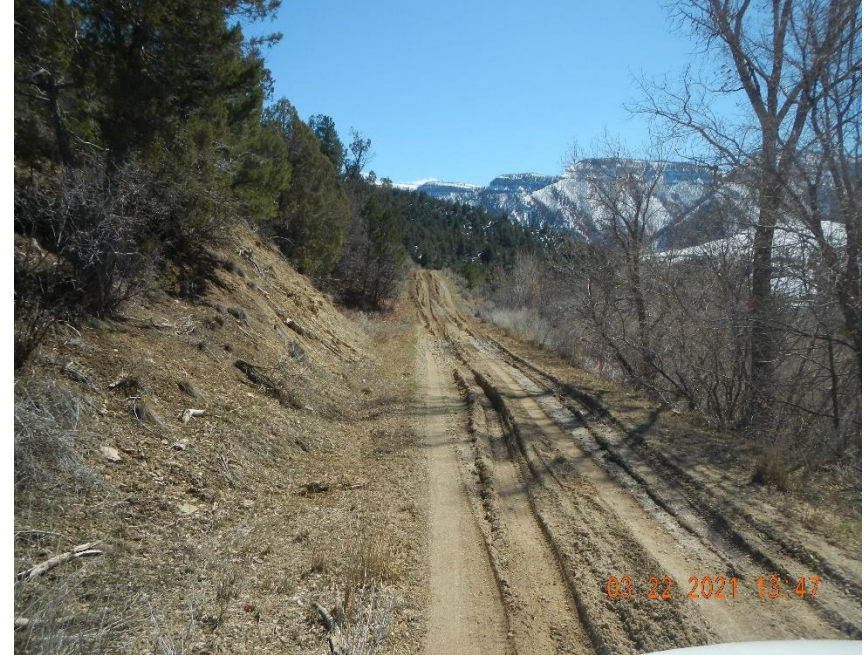
**Rutted mud holes on roadway.**

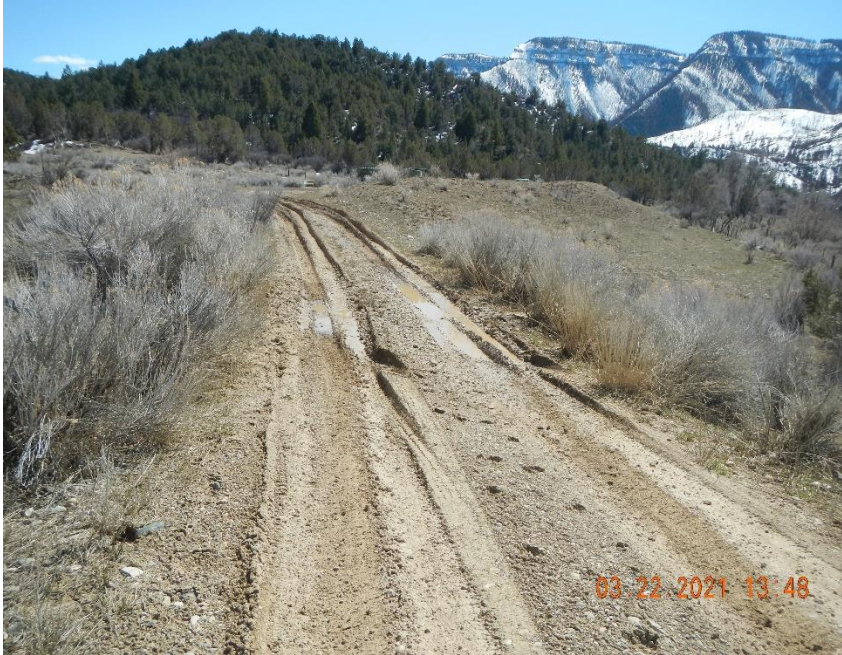
**Rutted mud holes on roadway.**

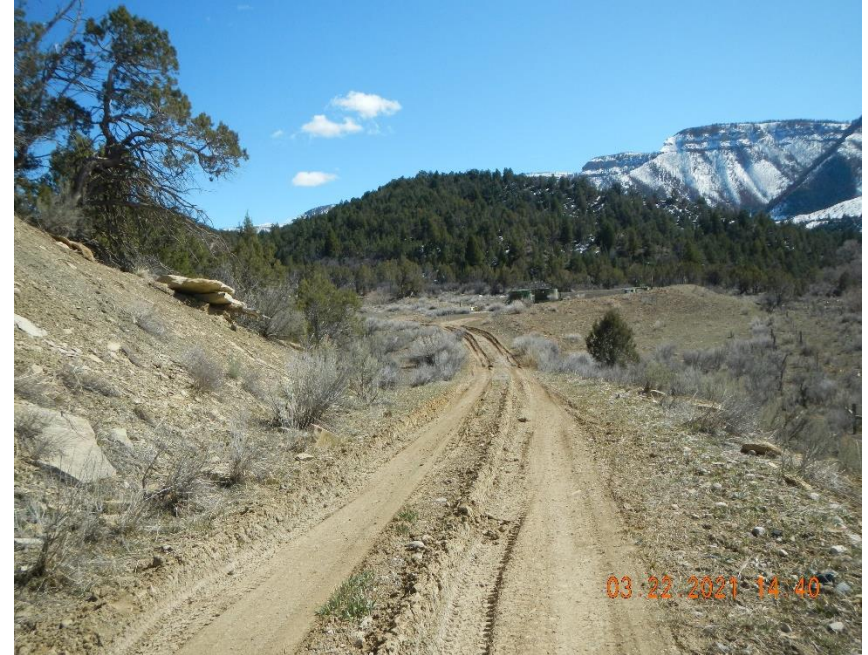
**Rutted mud holes on roadway.**
