Inspection Photos
Operator: Logos Operating
Facility: 067-05470
Date: 3/16/2021

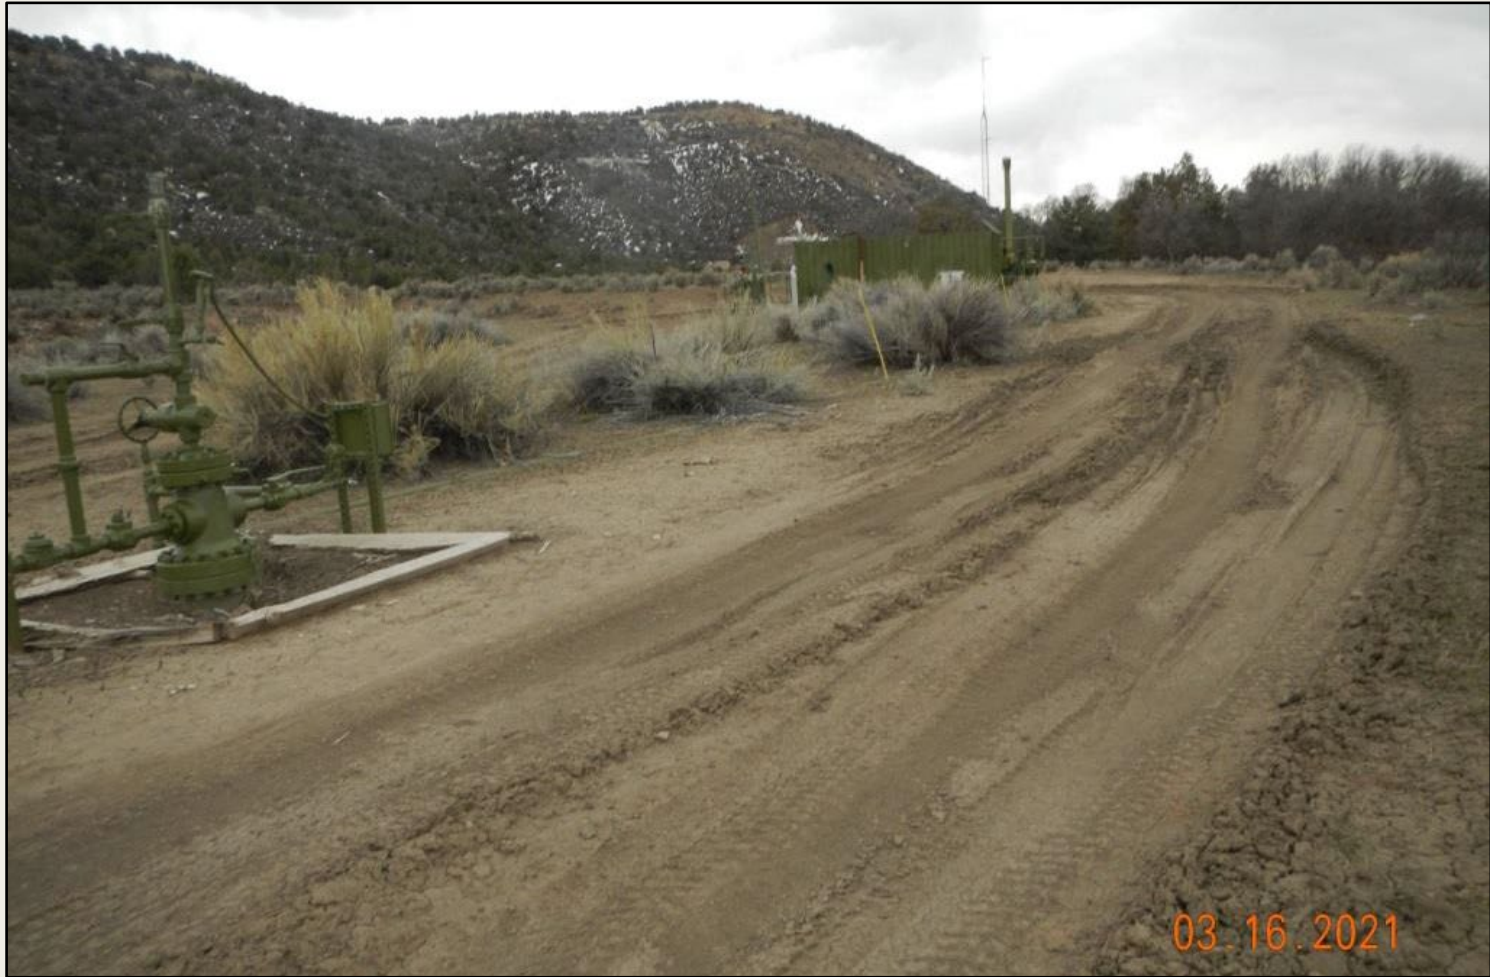
Photo 1. View of the project area from the northwestern corner facing center.

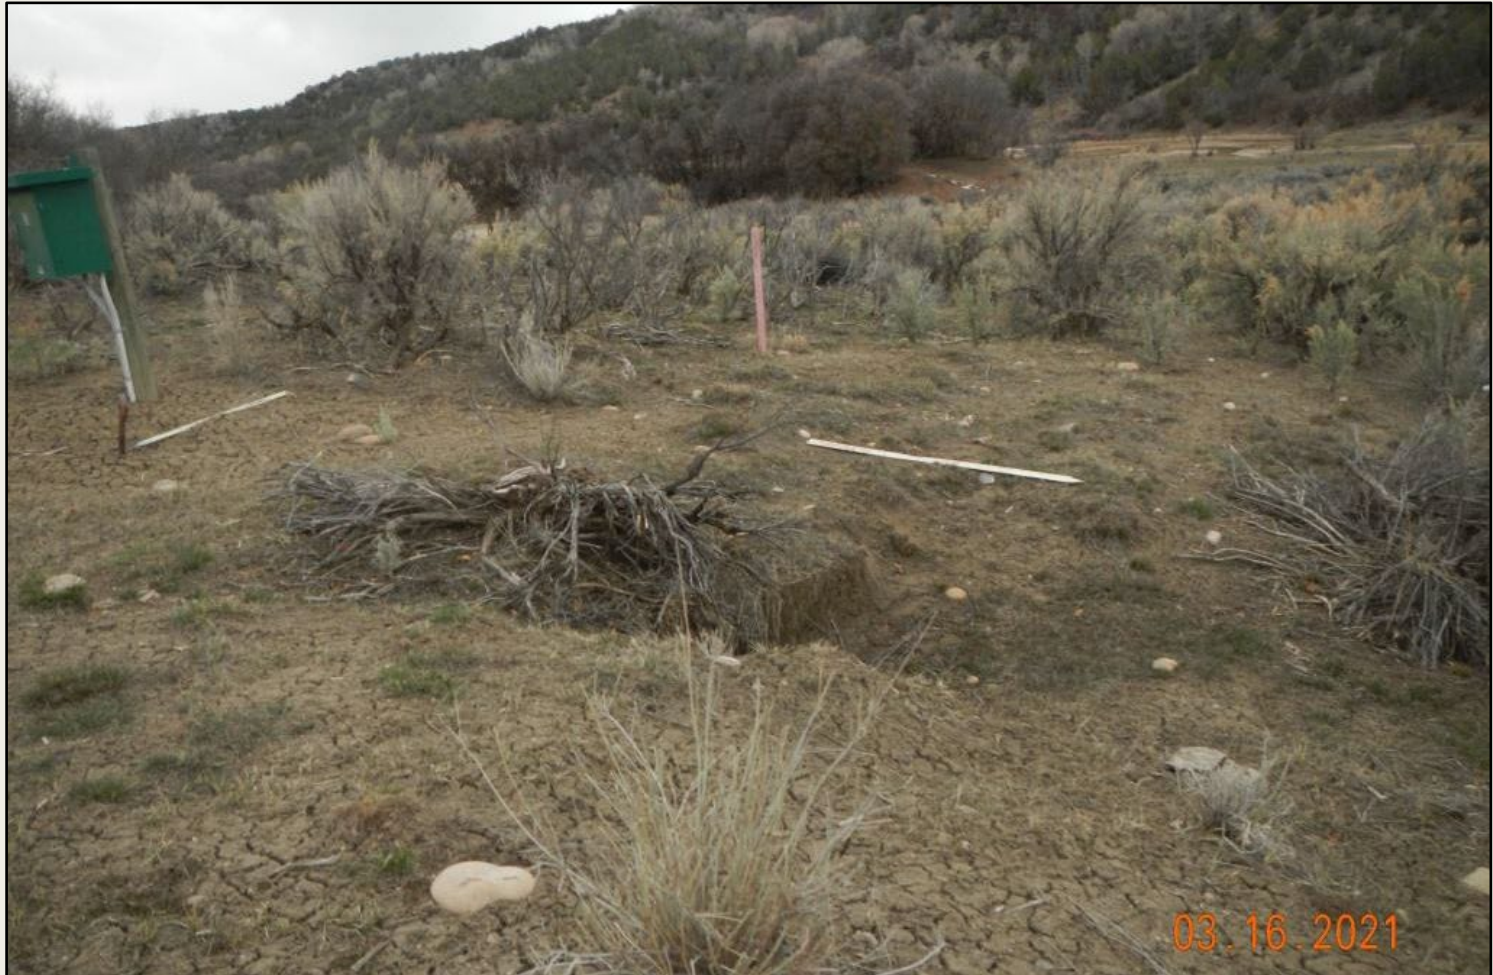
Photo 2. View of erosional channel forming within the western project area. Channel is approximately 2.5 wide and 2 feet deep.

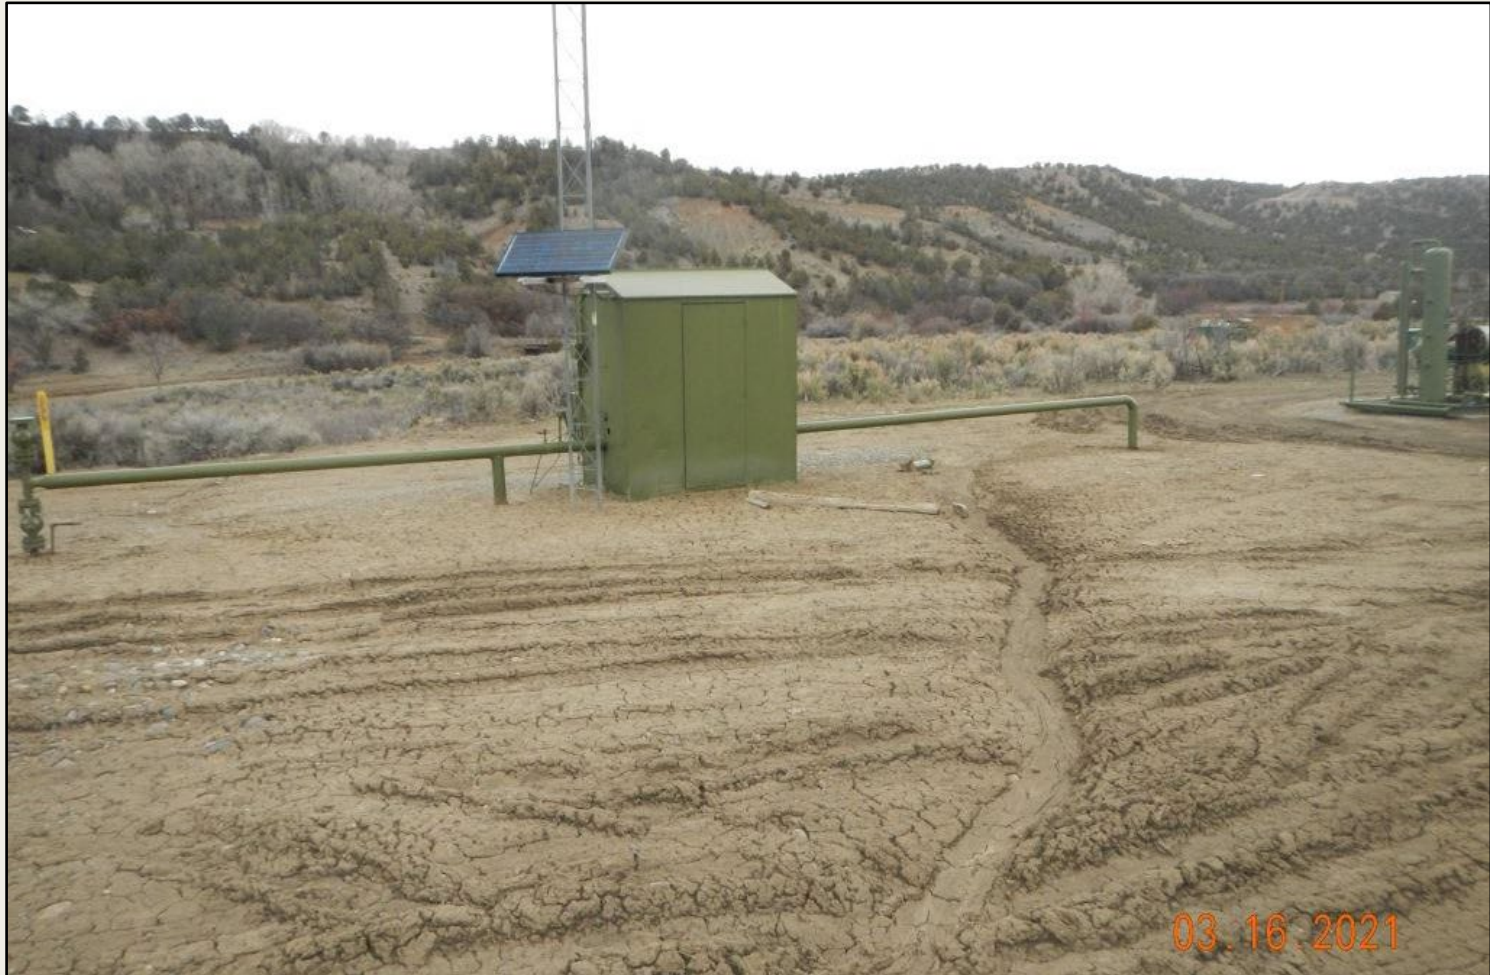
Photo 3. View of erosional channeling and rilling on the well pad working surface, facing eastward (upslope).

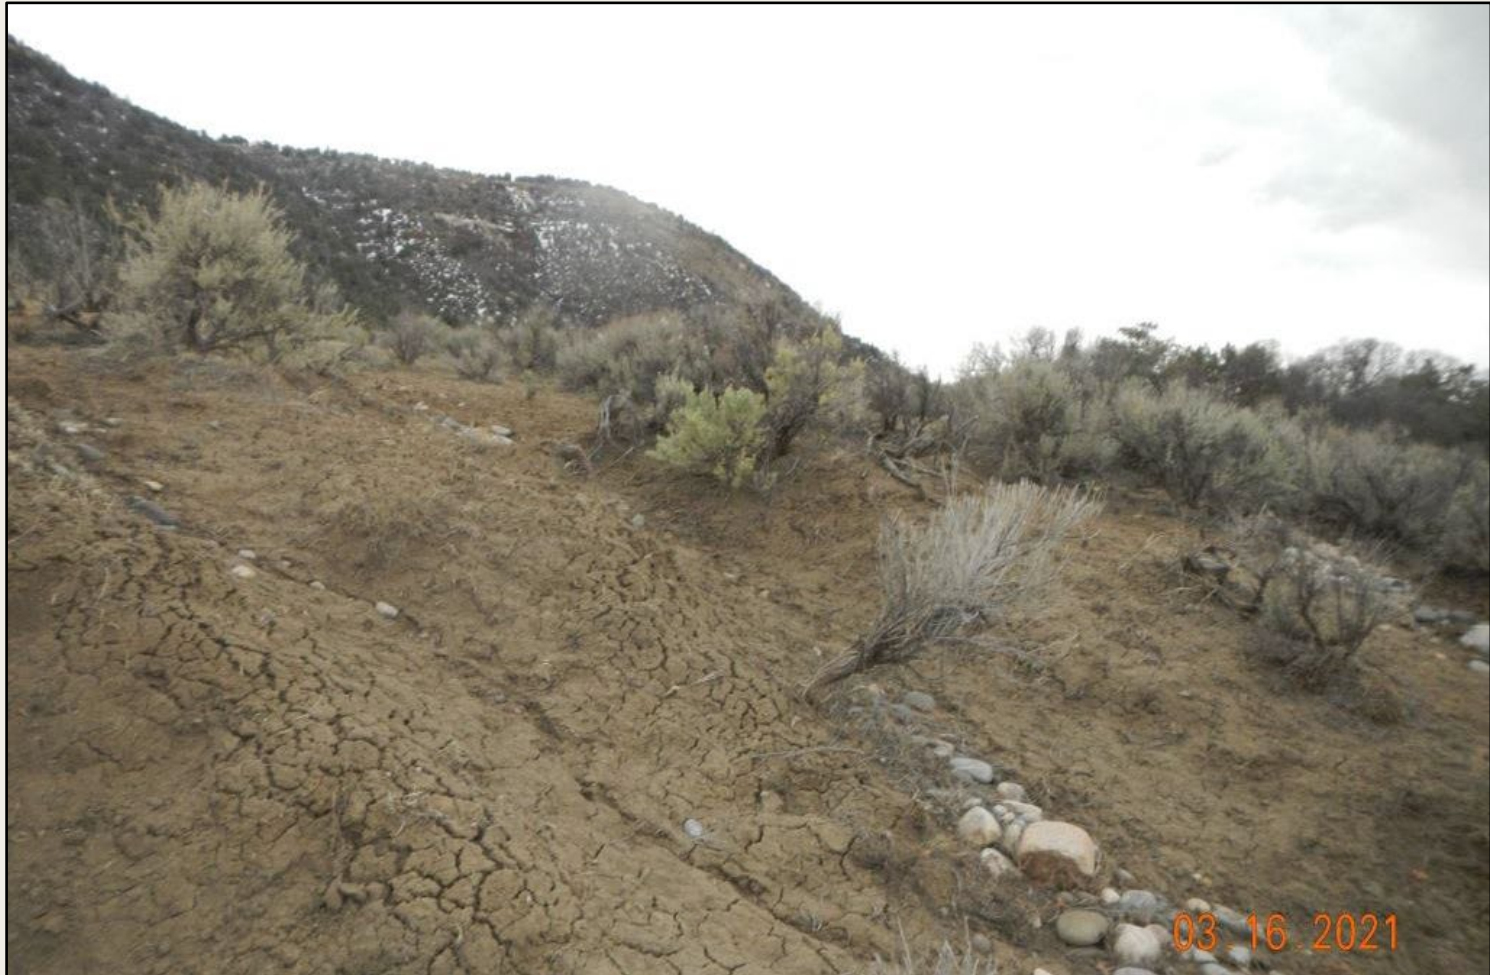
Photo 4. View of erosional channeling within the southeastern project area. Cobble is placed within the erosional channels are full of sediment and not adequate BMPs in this area.

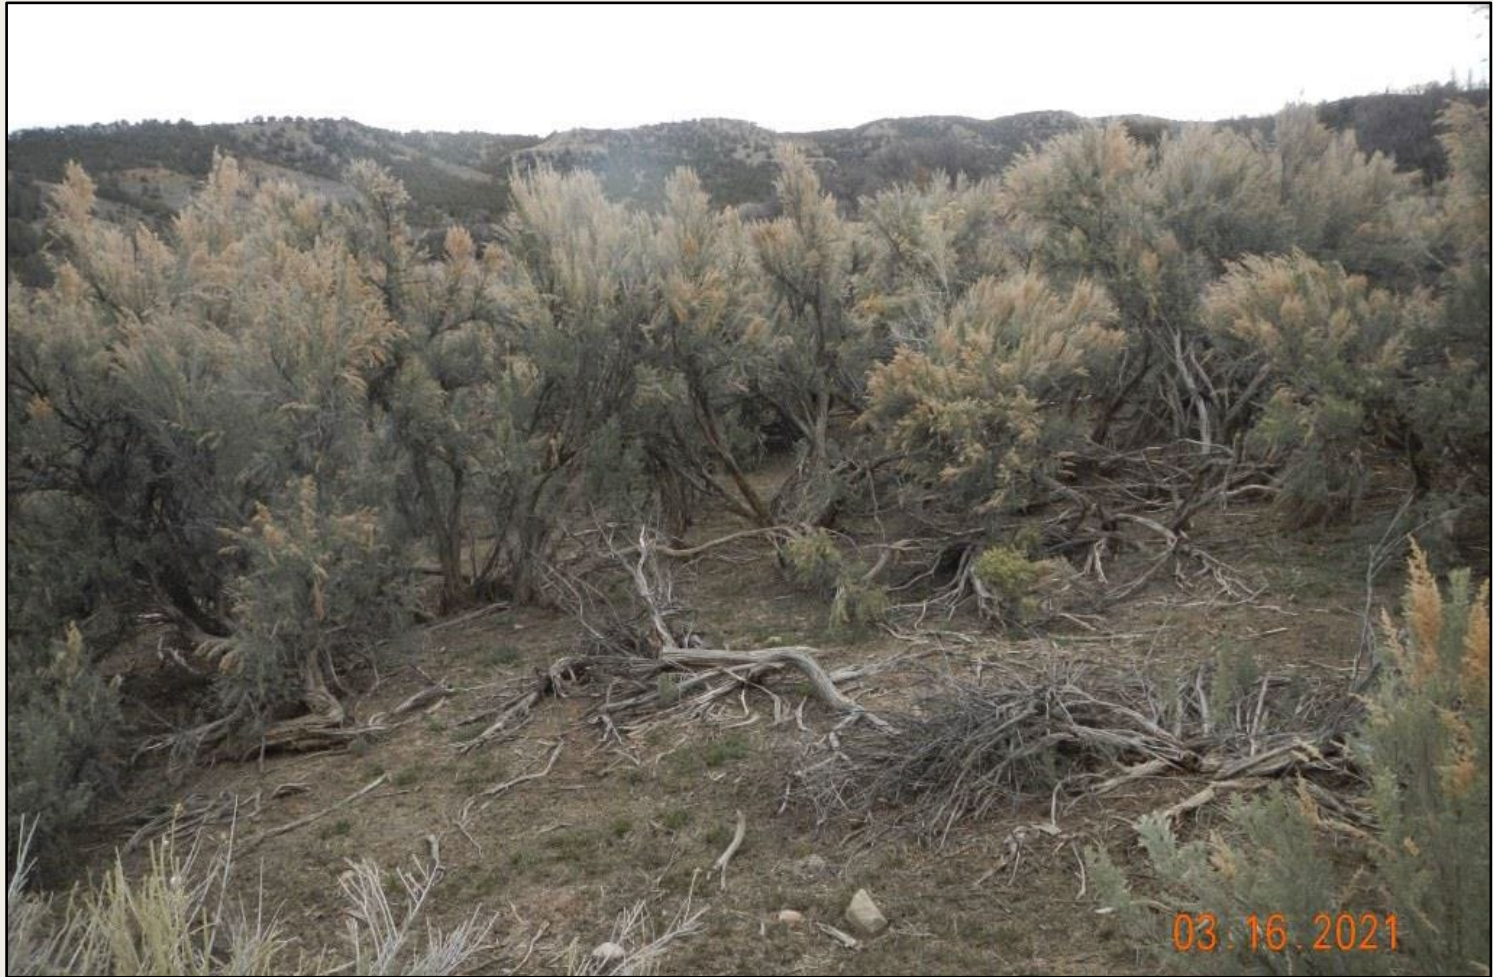
Photo 5. View of reference area comprised of sagebrush shrubland with understory of western wheatgrass and crested wheatgrass.
