Inspection Photos

3/25/2021

Operator: TEP ROCKY MOUNTAIN LLC - 96850

Location ID: 334721

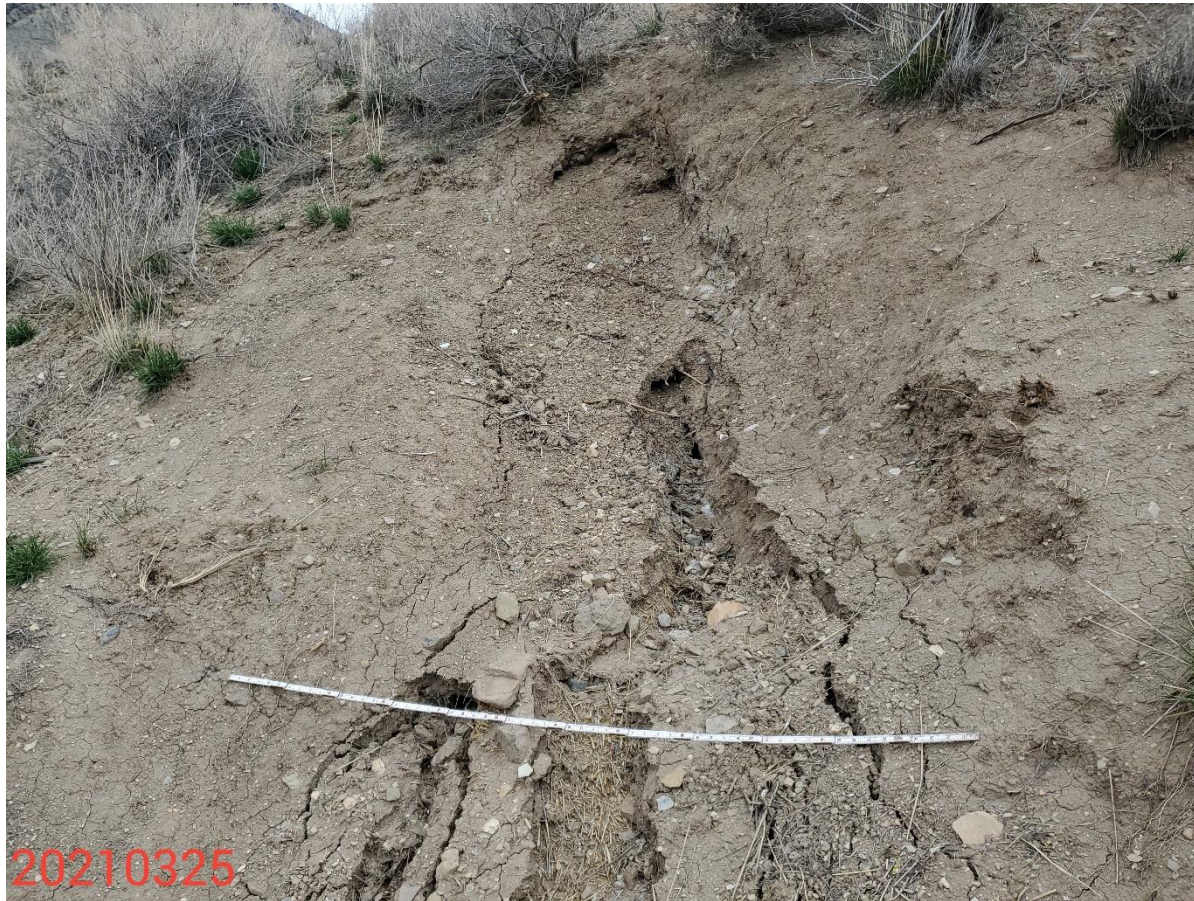
Photo 1: Photo taken from the gully erosion on slopes of the south end of the Location. Operator appears to have placed soils in an effort to repair gully, however, Operator has failed to install required stormwater and erosion control measures to stabilize and protect slopes. 6 foot measuring stick for reference.

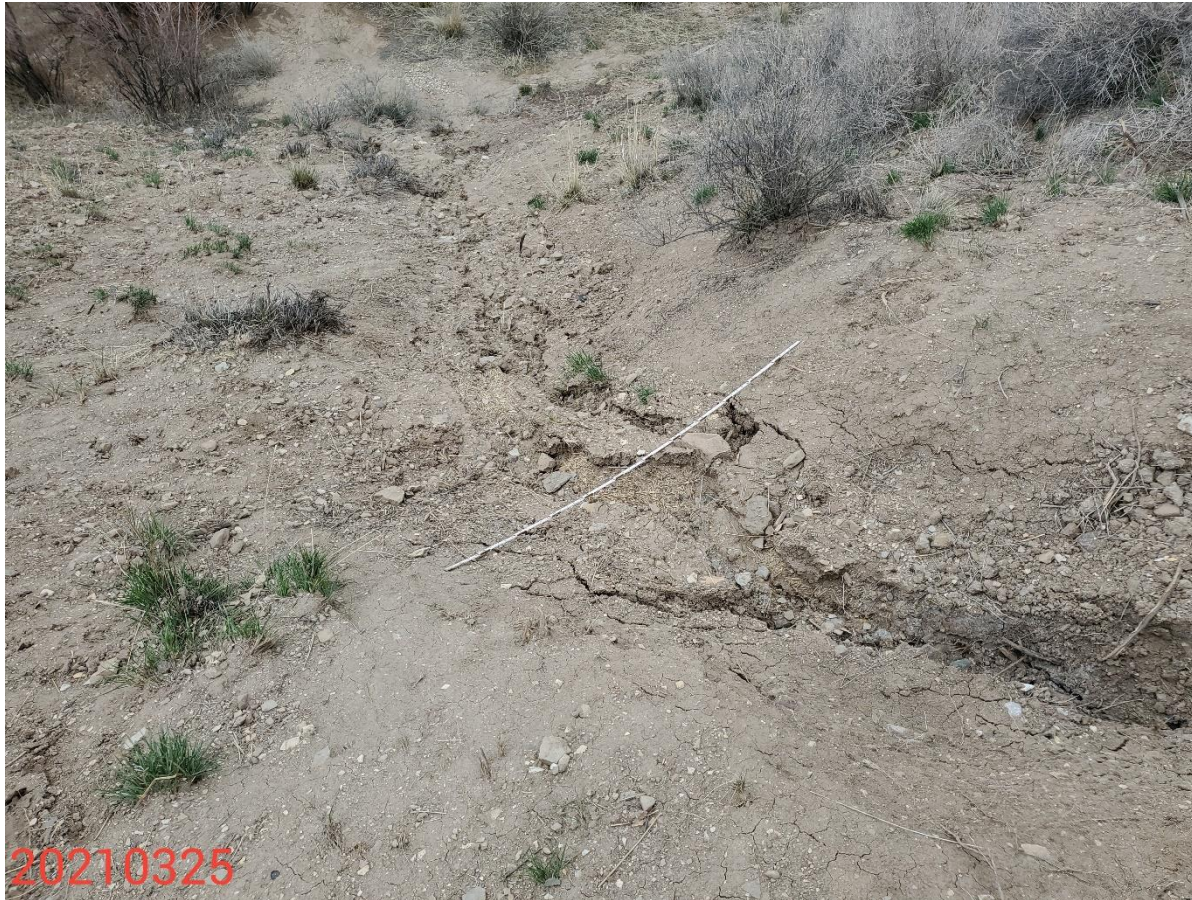
Photo 2: Continued from photo 1. Photo shows that Operator appears to have placed soils in an effort to repair gully, however, Operator has failed to install required stormwater and erosion control measures to stabilize and protect slopes. 6 foot measuring stick for reference.

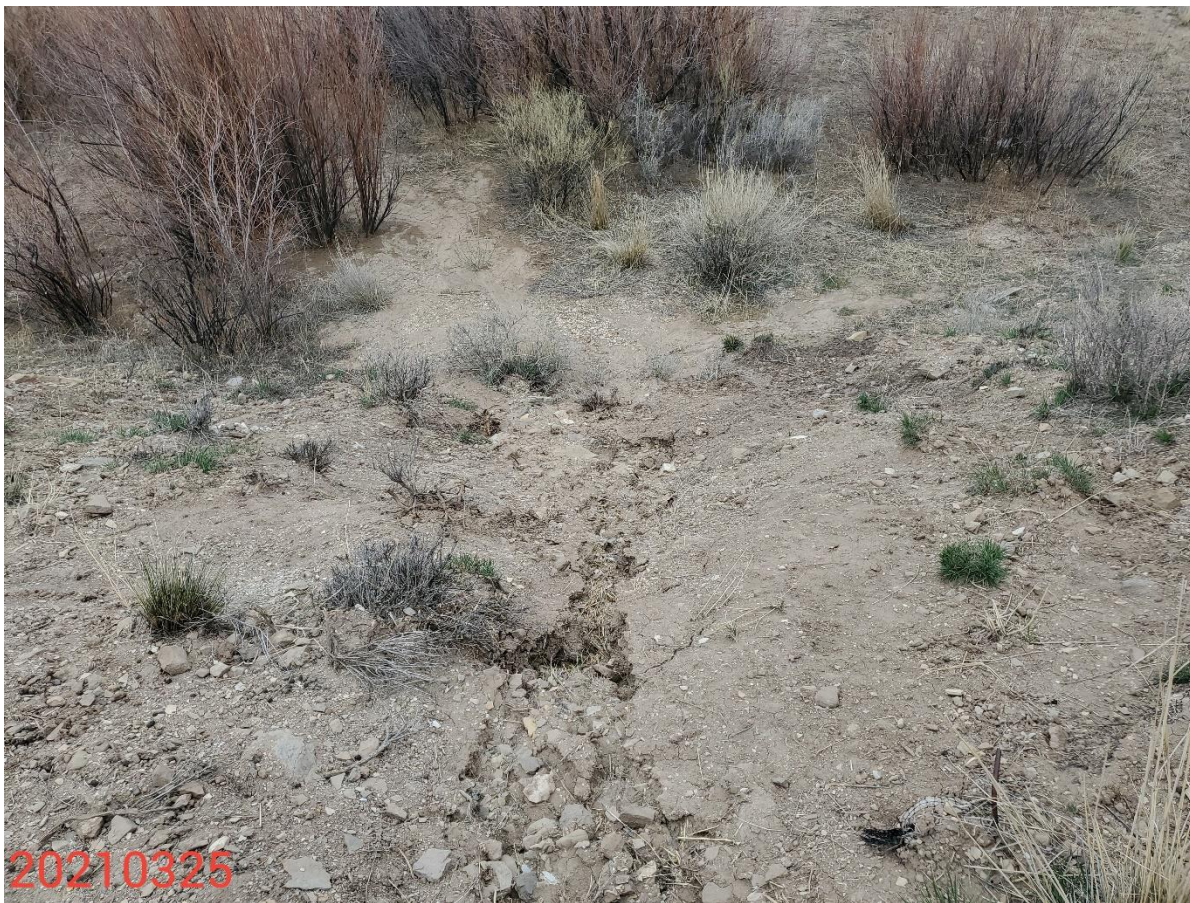
Photo 3: Continued from photo 2. Photo shows off-location sediment transport and deposition due to erosion degradation and runoff from the Location's slopes.

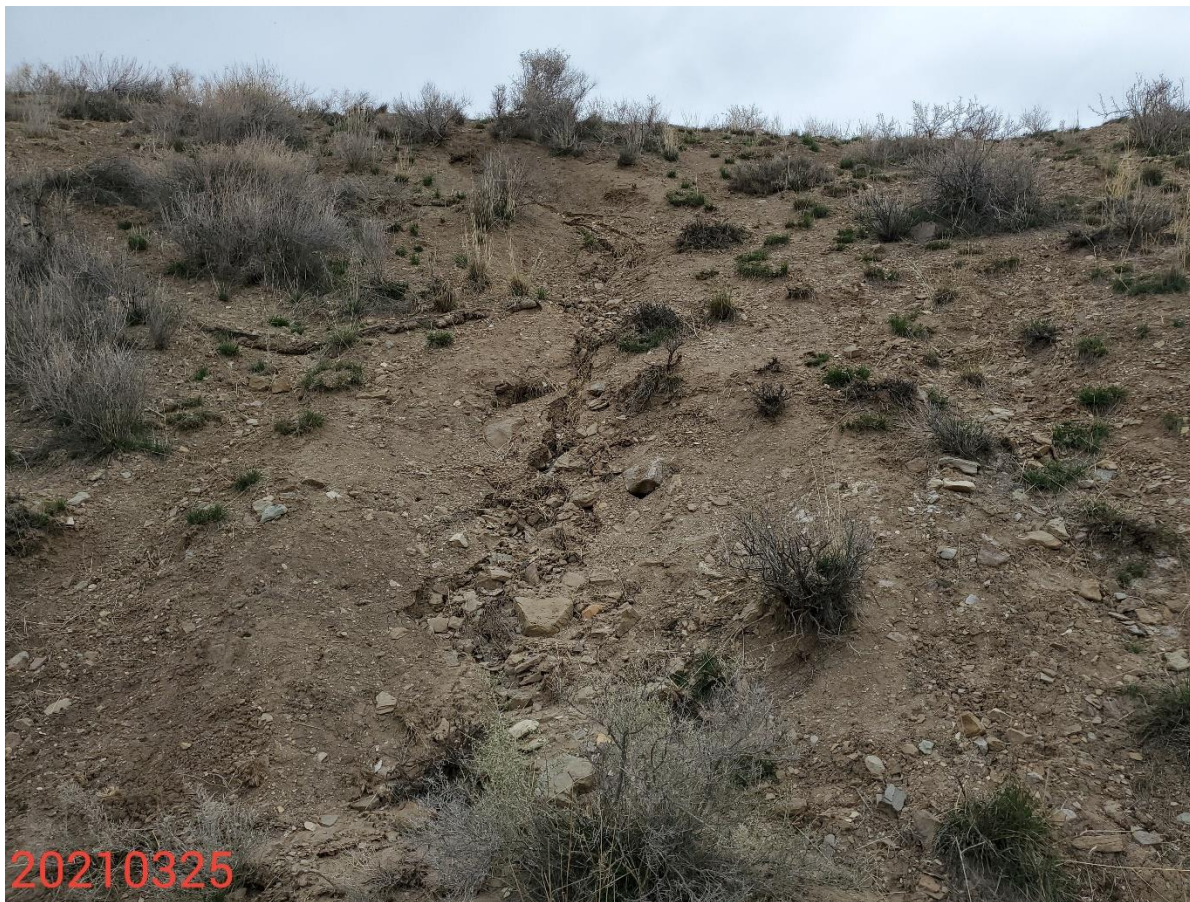
Photo 4: Photo taken from the gully erosion on slopes of the south end of the Location. Operator appears to have placed soils in an effort to repair gully, however, Operator has failed to install required stormwater and erosion control measures to stabilize and protect slopes. 6 foot measuring stick for reference.

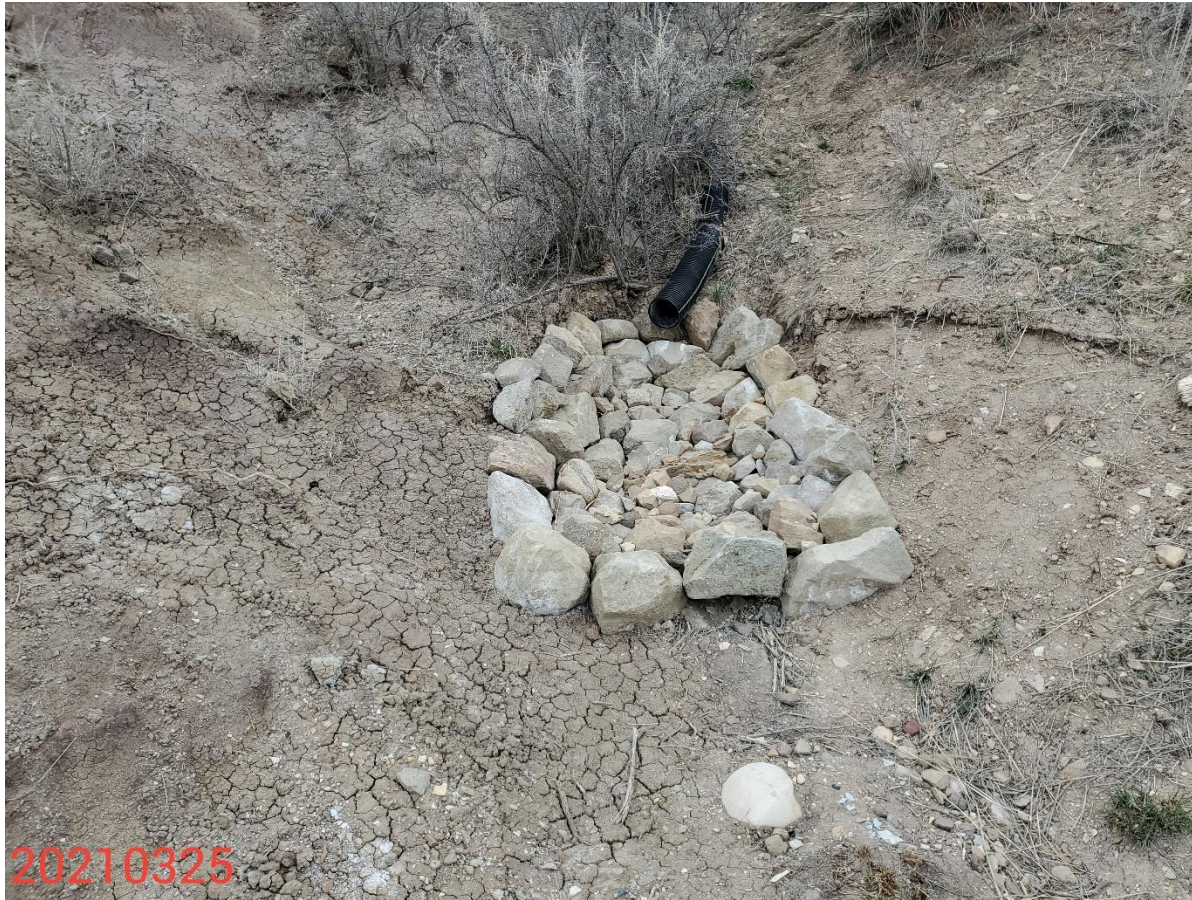
Photo 5: Photo taken from the slope drain outlet for the western-most sediment trap. Operator has installed rip-rap as an outlet; unclear if outlet has been constructed in accordance with good engineering practices in regards to size and installation; additional monitoring will be required to determine if BMP is adequate and in proper functioning condition.

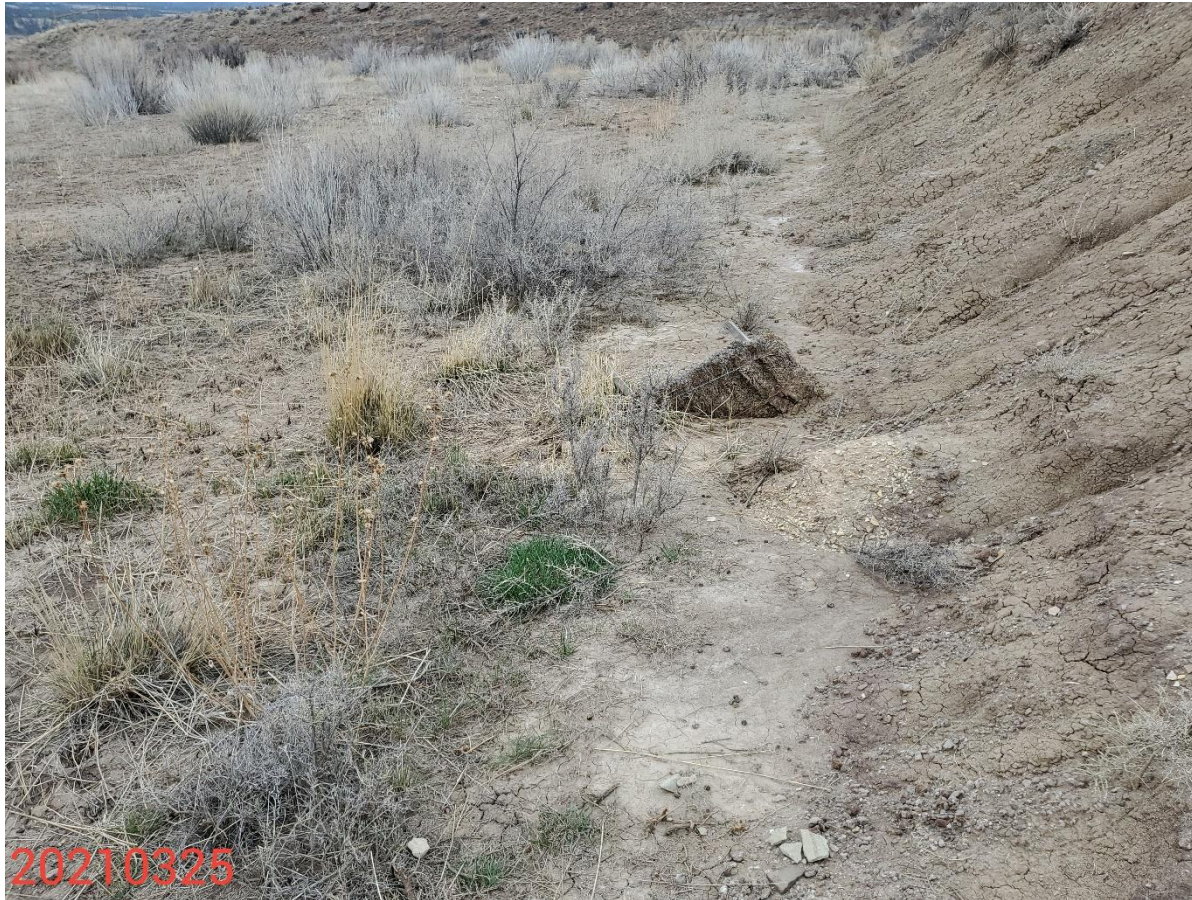
Photo 6: Photo taken from the west end of the drain outlet, facing west. Photo shows hay bale control measure remains in disrepair. Hay bale is considered debris.
