MARALEX RESOURCES INC
DRY FORK FEDERAL 1-29
Location ID: 322423

COLORADO
Oil & Gas Conservation
Commission
Department of Natural Resources

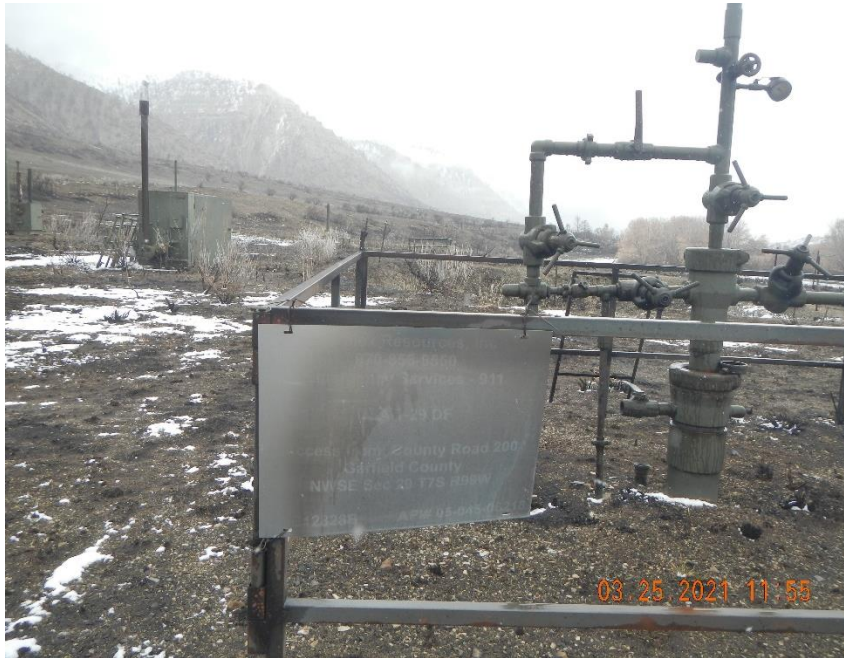
Well sign illegible.

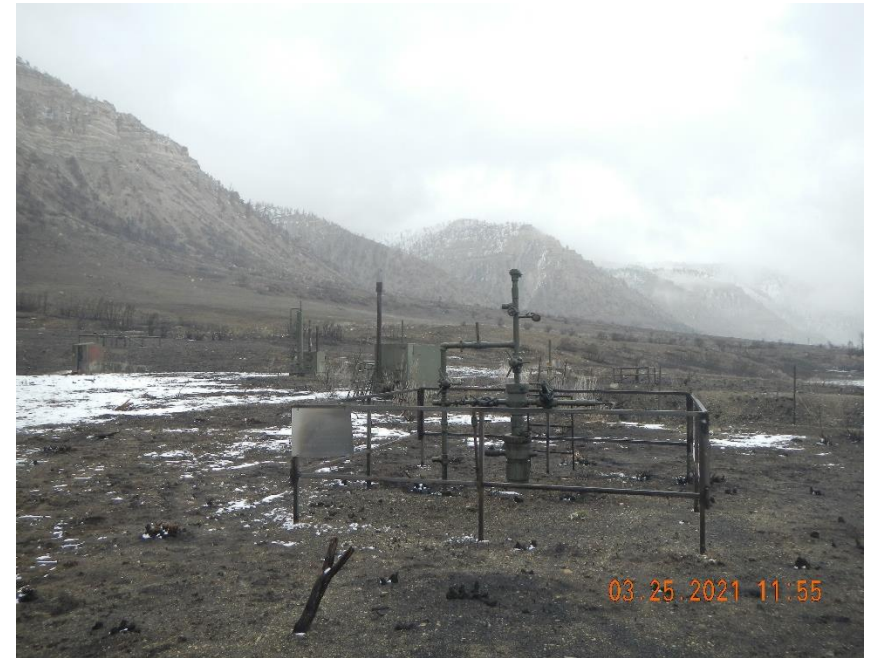
Well sign illegible.

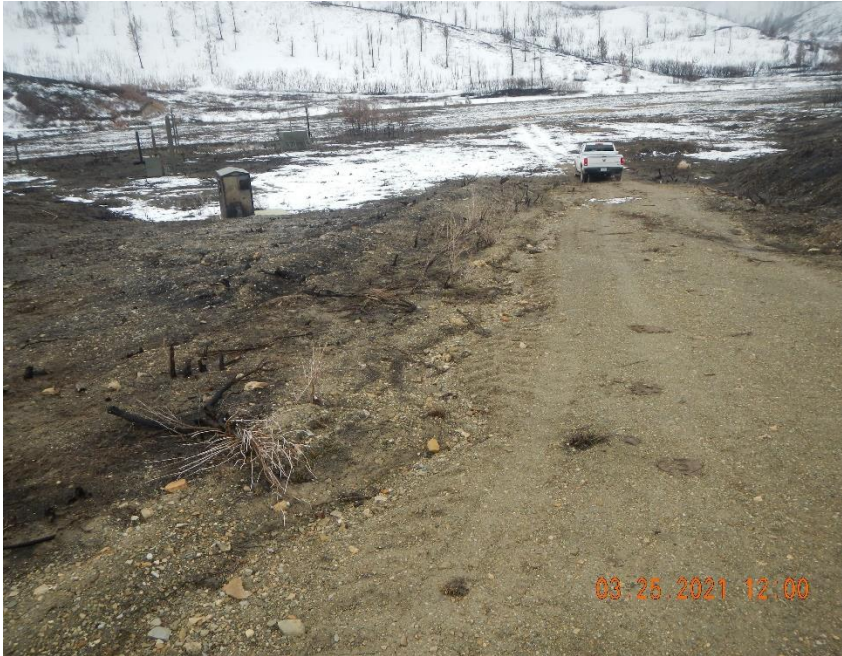
Road ditch needs maintained.

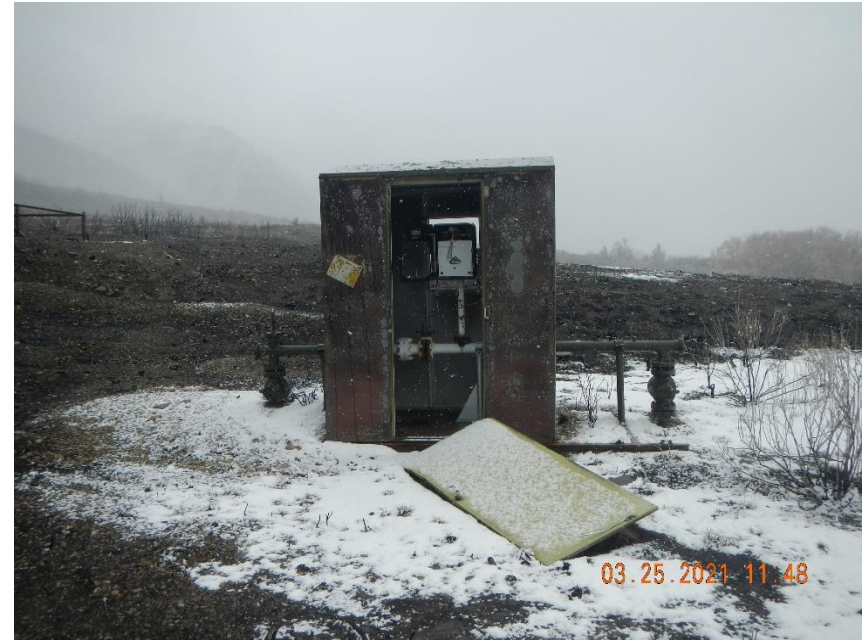
Door has fallen off meter shed.

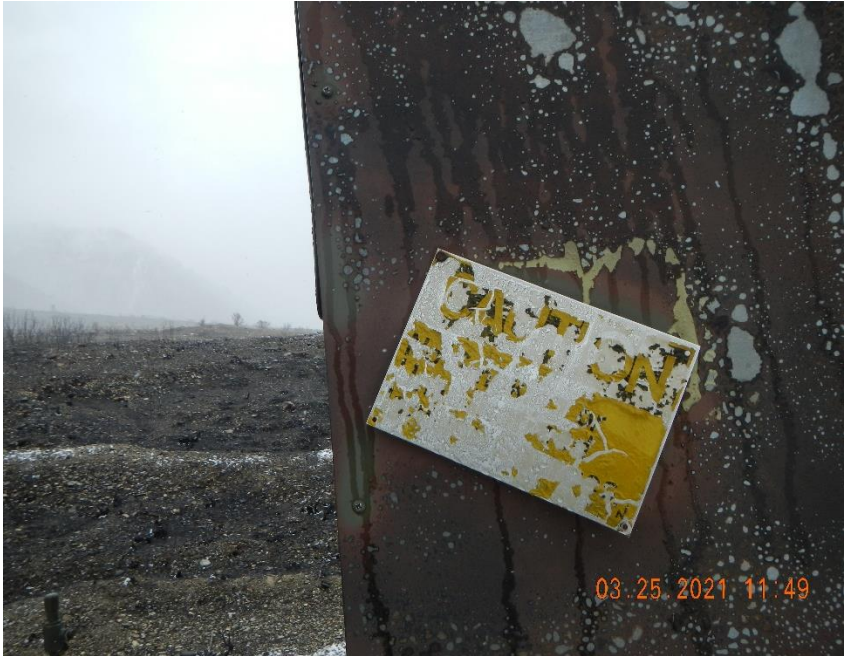
Damaged caution sign on meter shed.

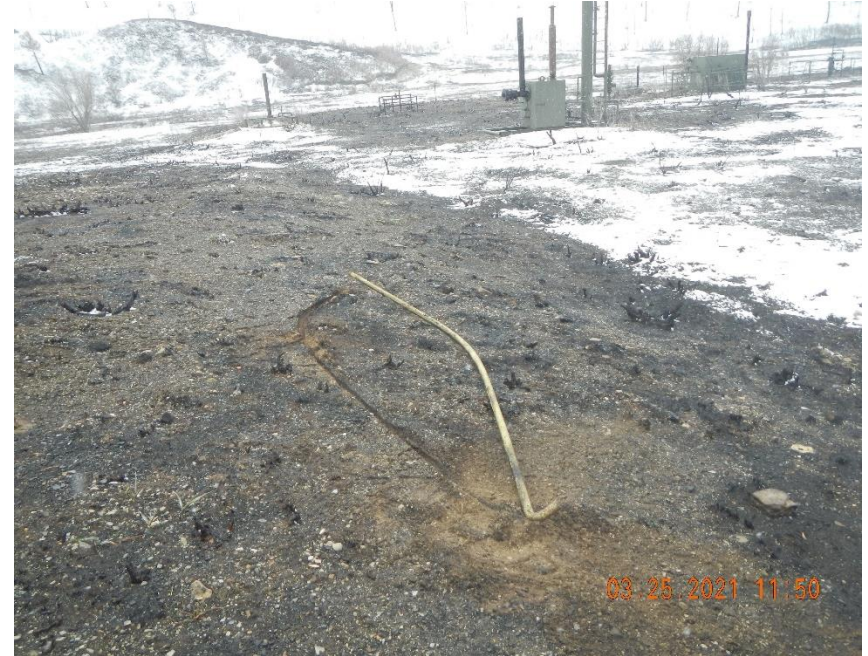
Piece of 1" pipe on the ground behind meter shed.

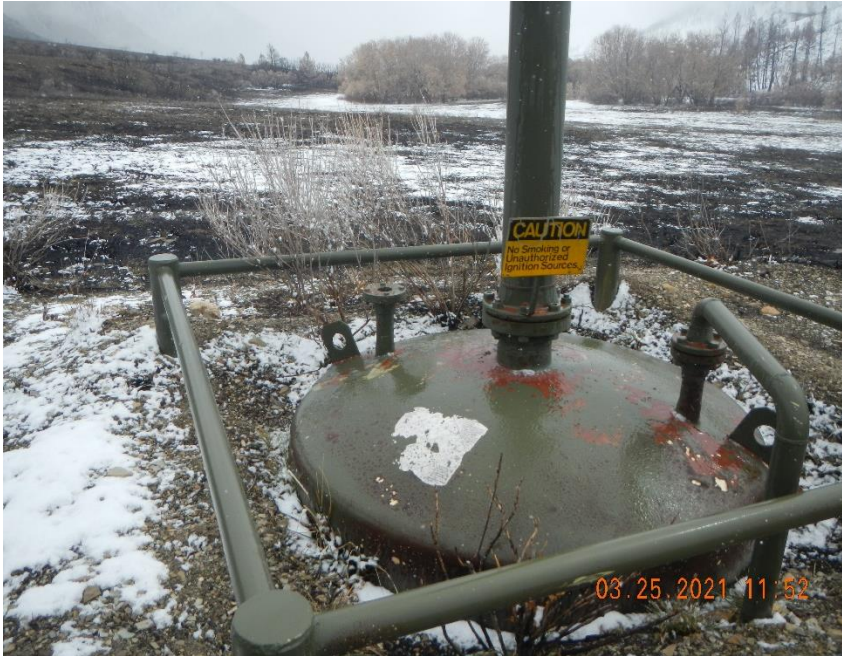
Label in illegible on buried tank.

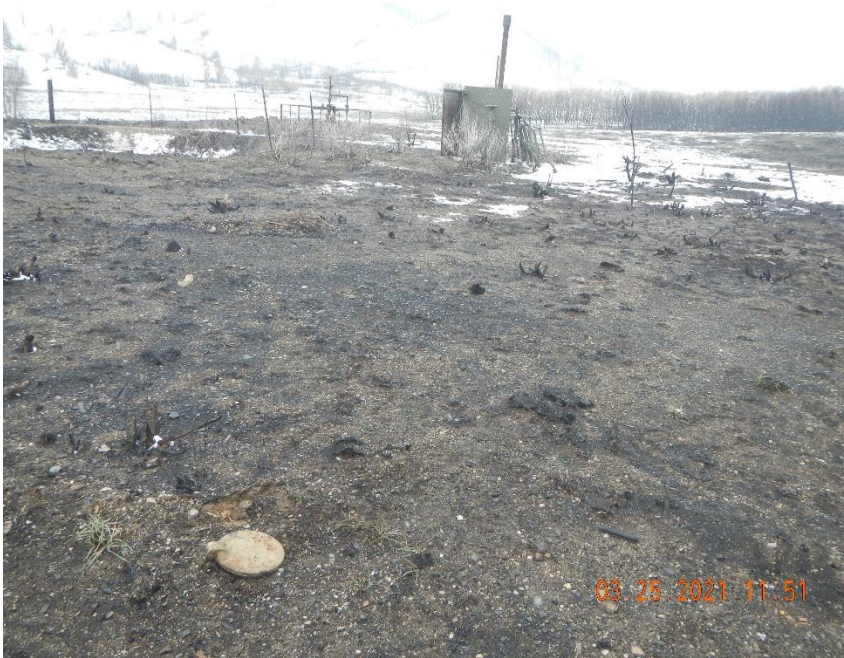
Junk on location.

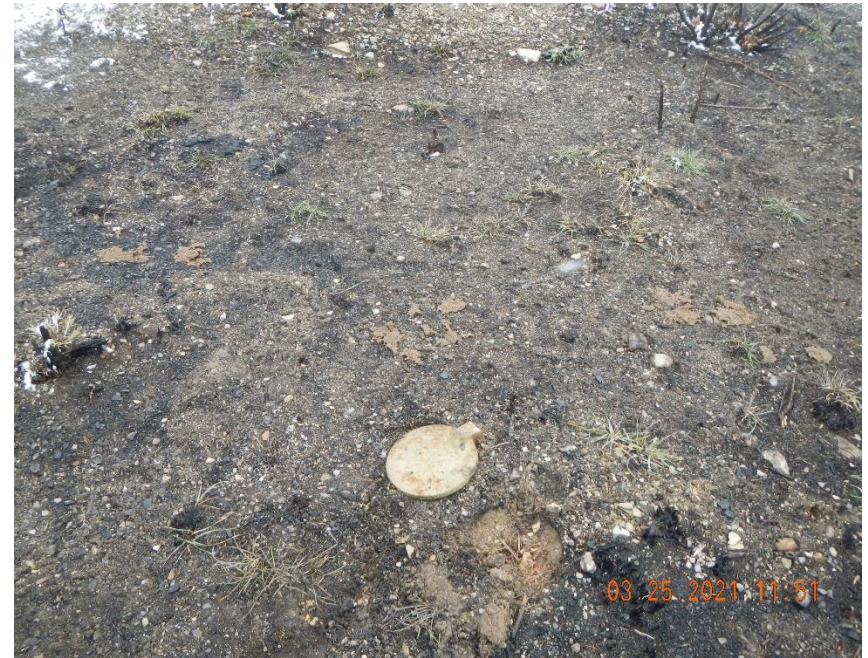
Junk on location.

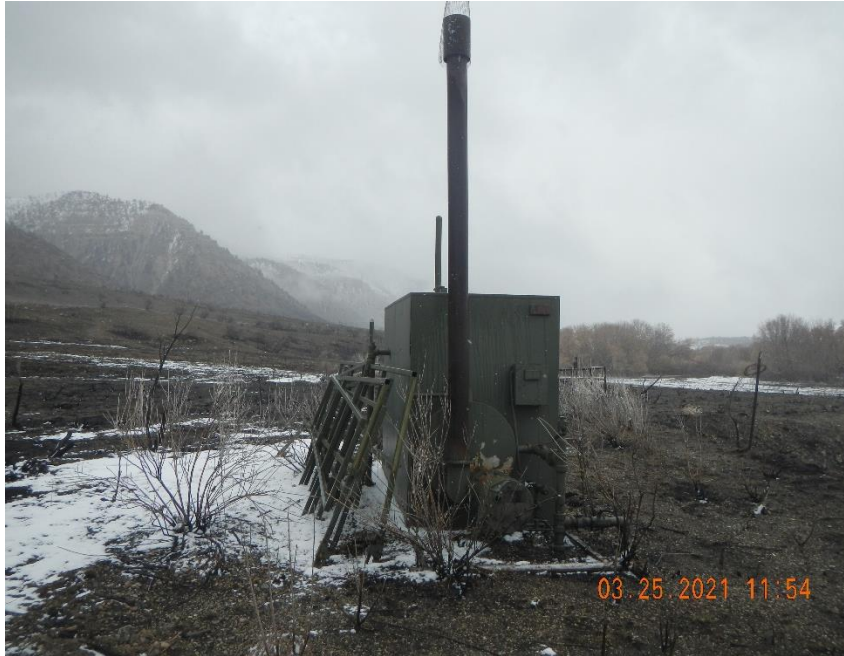
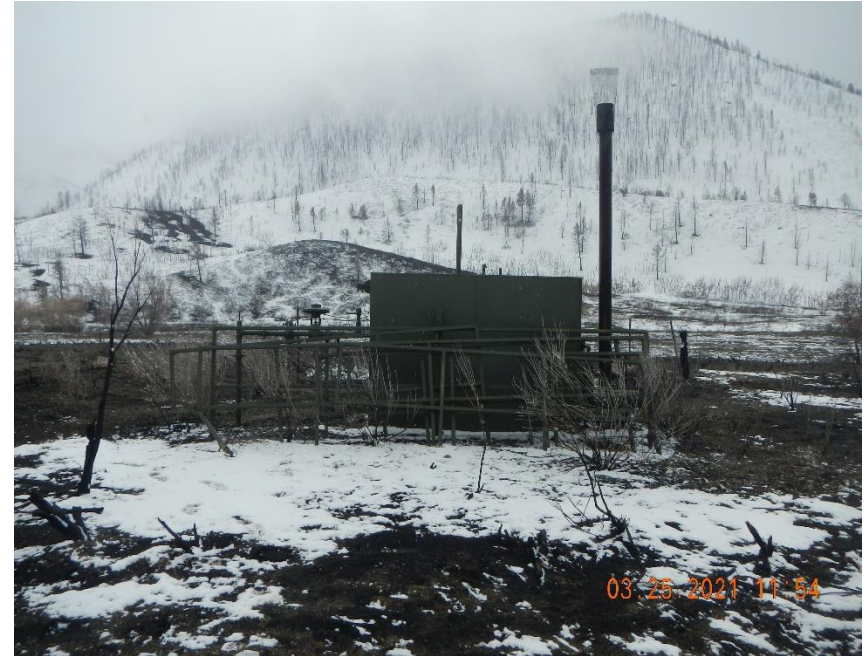
Unused equipment laying against separator.

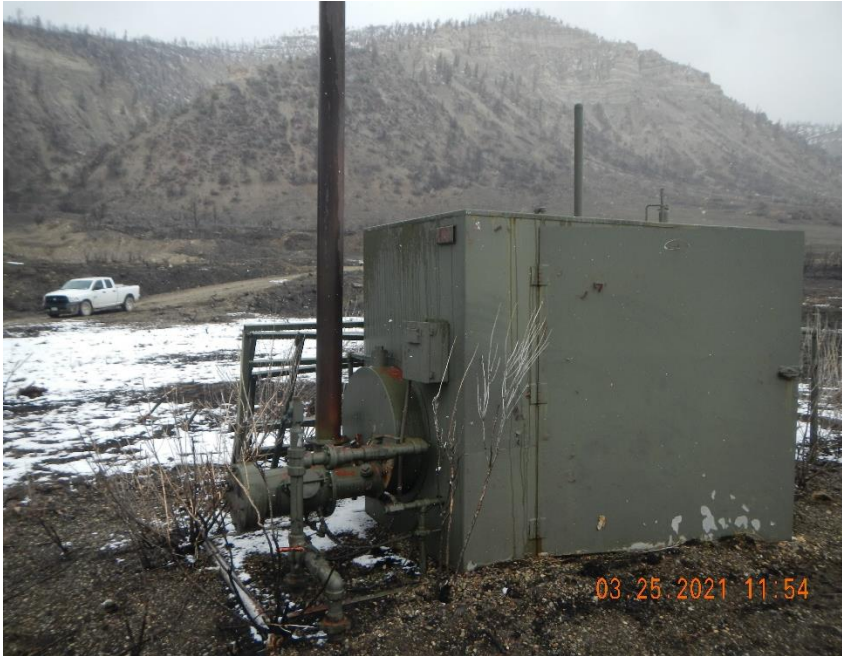
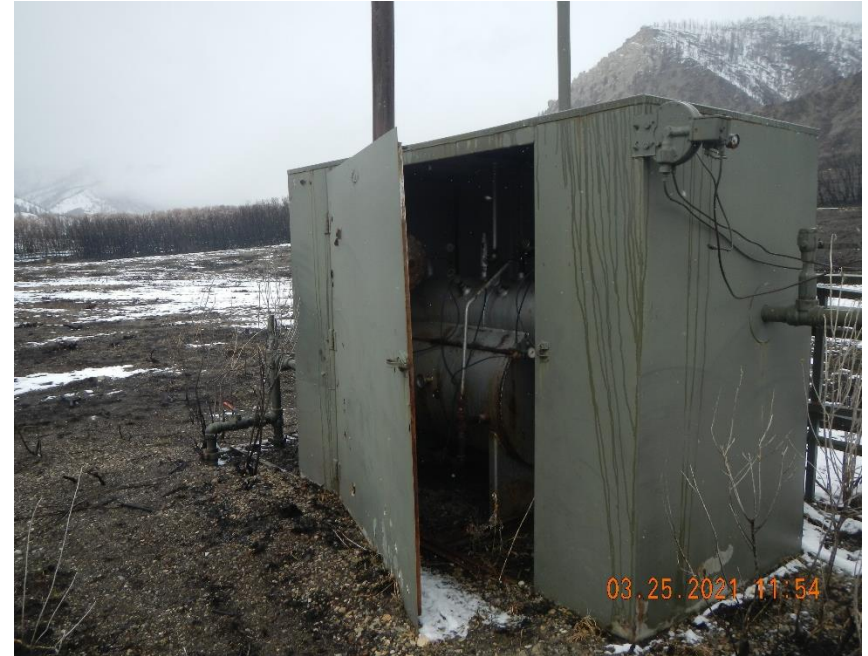
Door is open on separator.

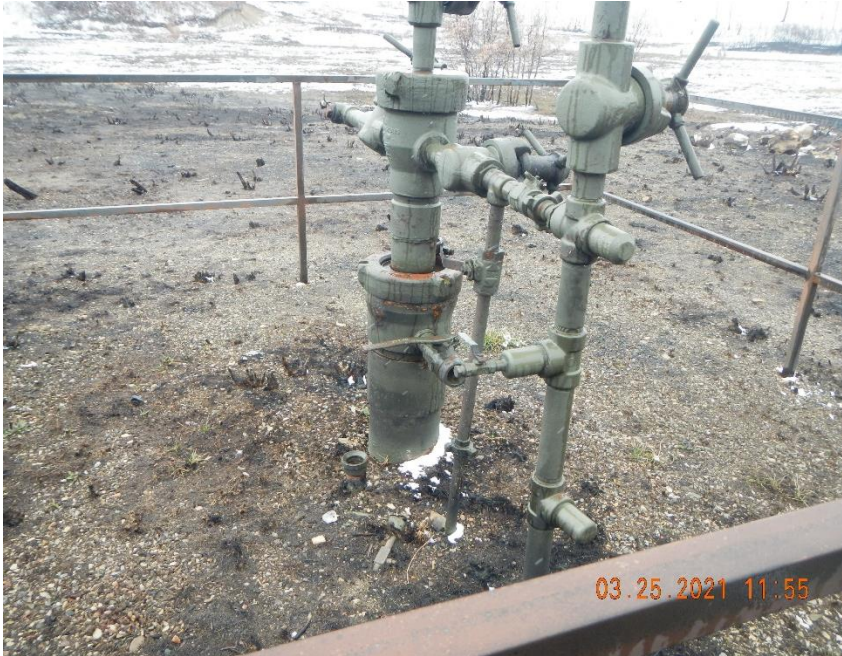
Open ended 2" unused riser at well

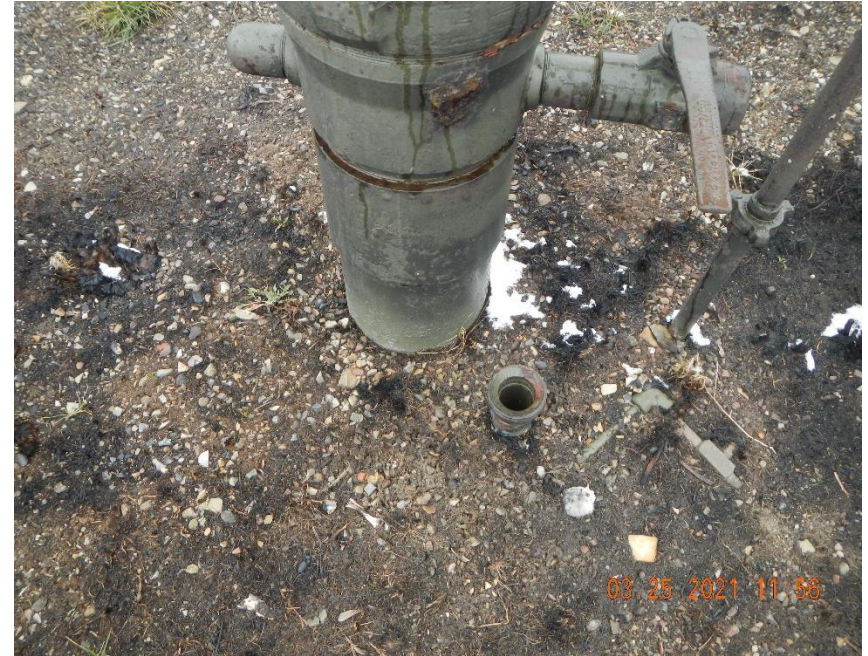
No access for braden.

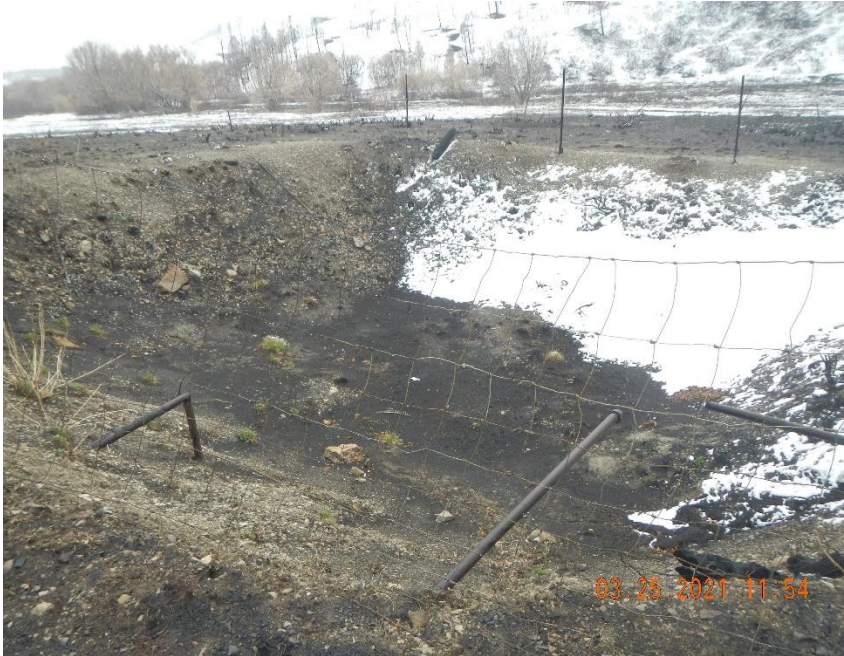
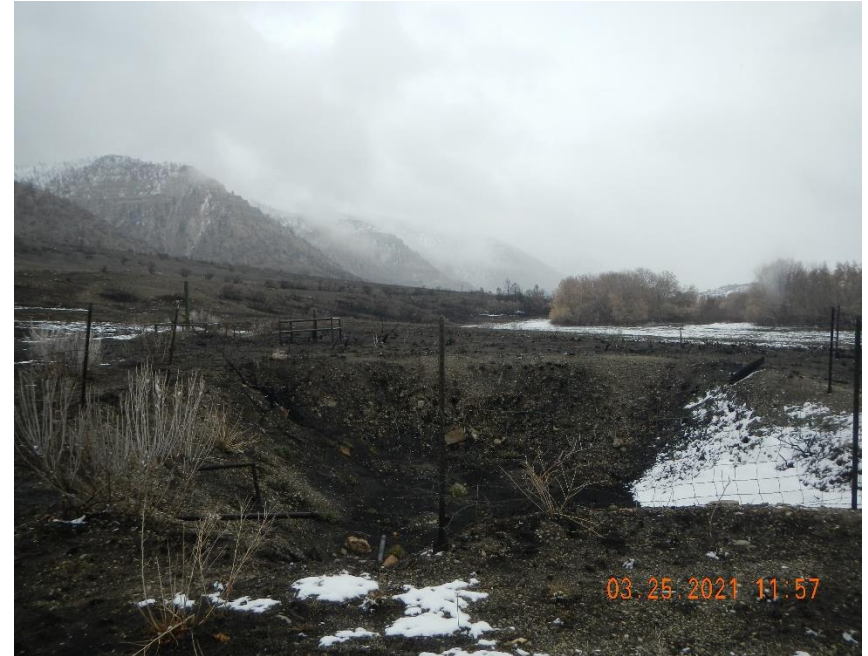
Fence around pit is falling over.

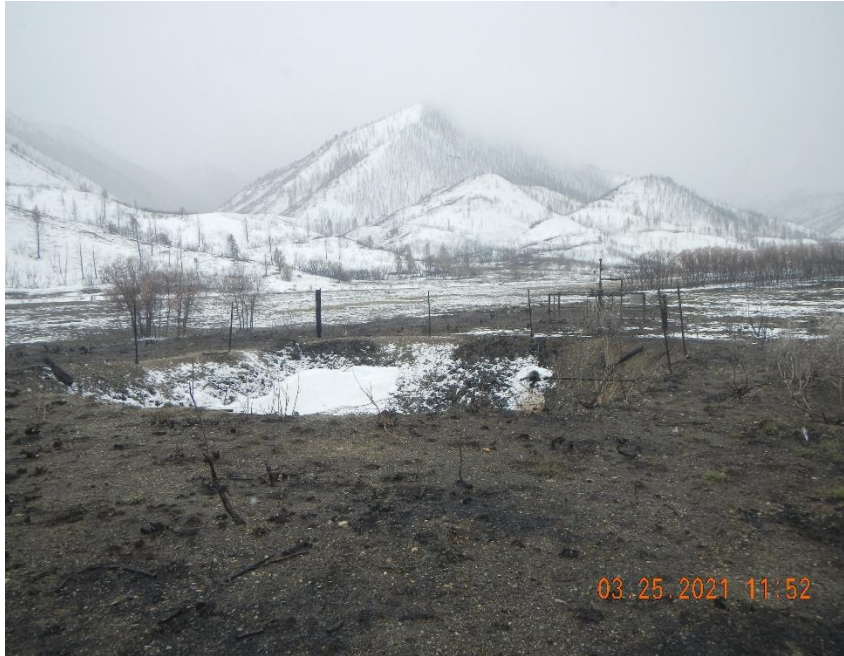
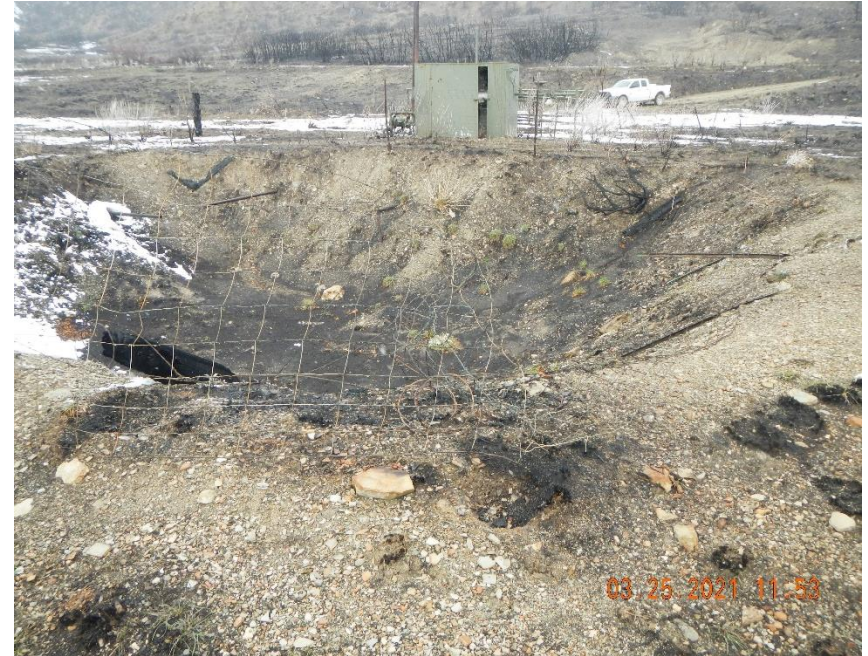
**Fence post burnt up and fence on eastside
of pit has fallen down.**

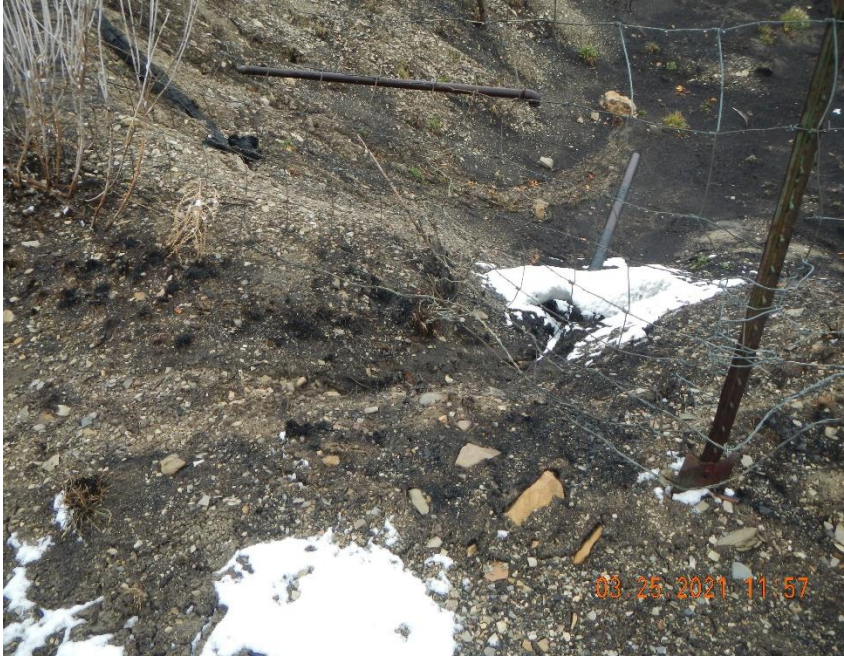
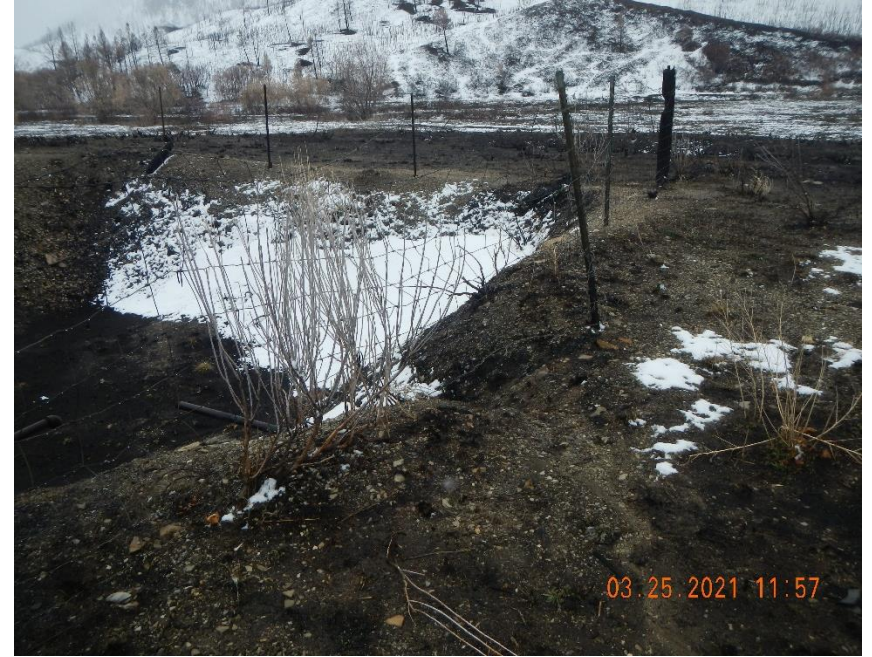
Channel running into pit.

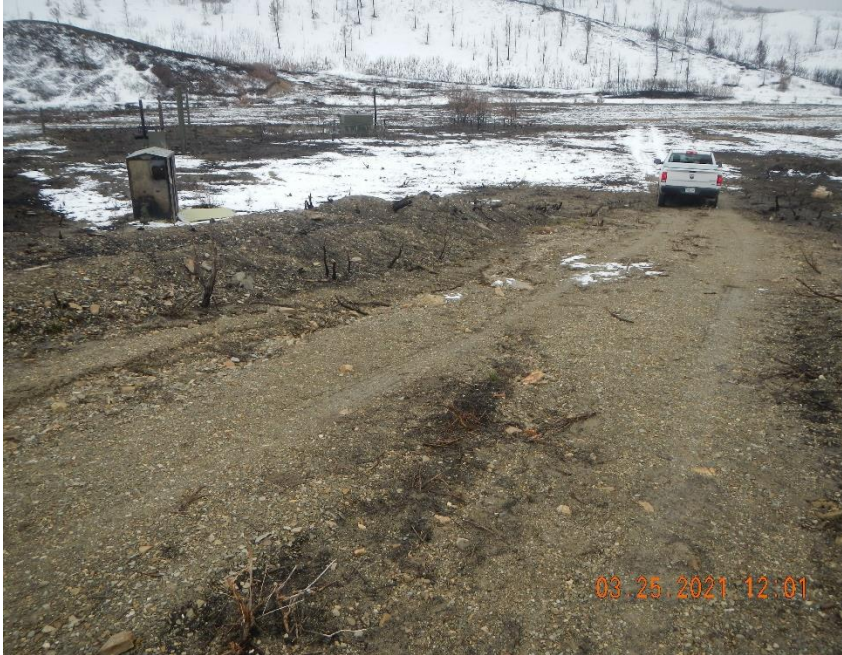
Erosion rill down roadway.

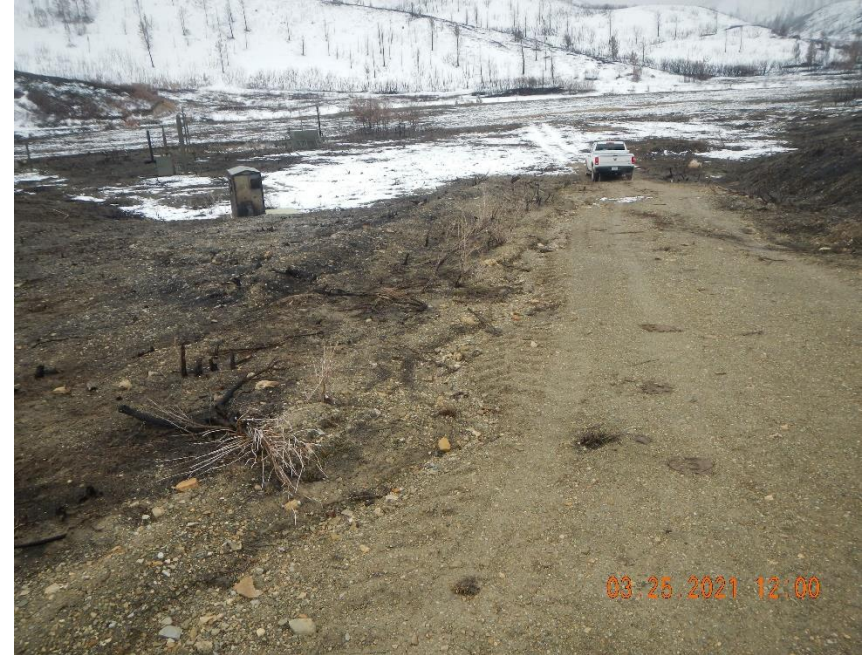
Ditch on roadway needs maintained.

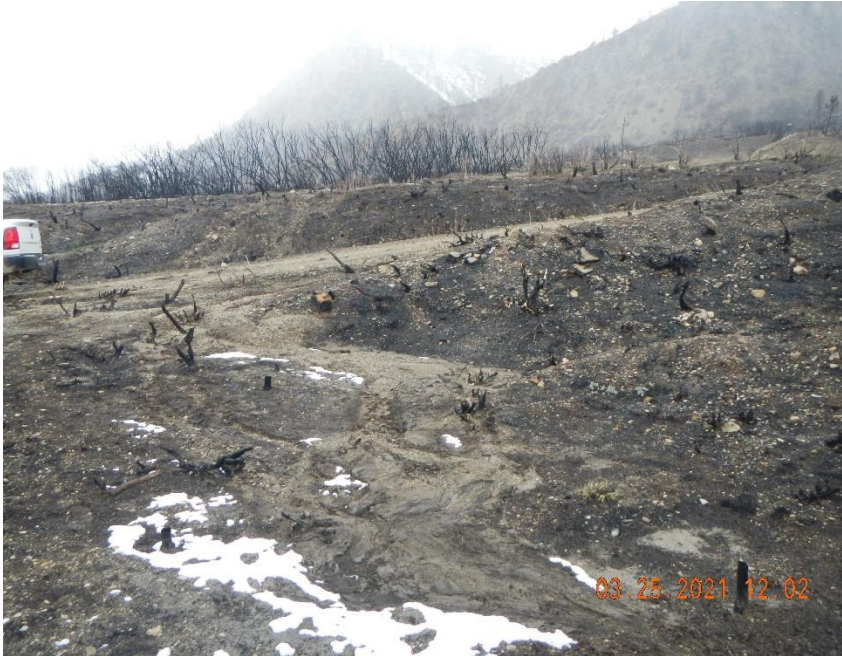
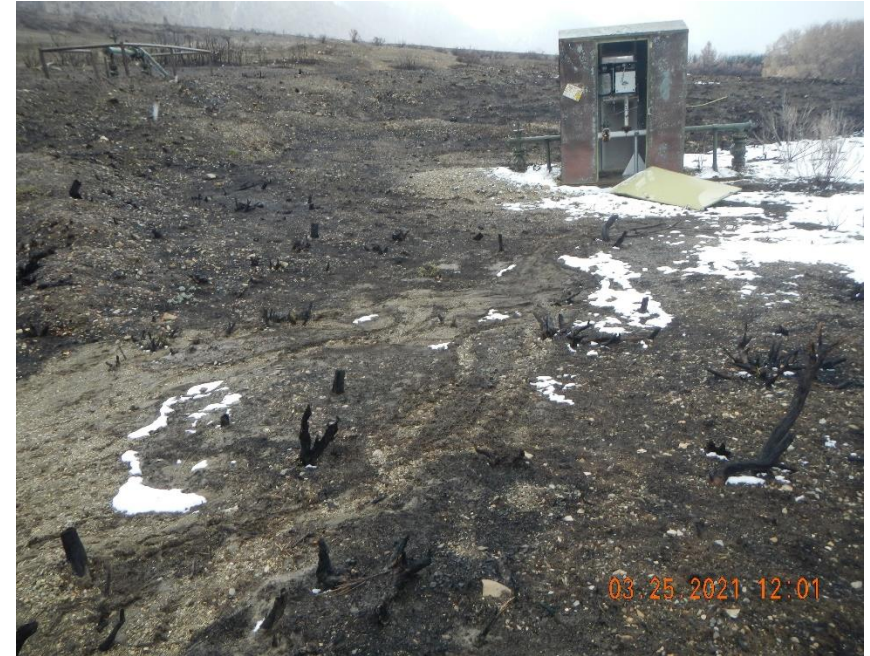
Sediment moving from roadway onto location.
