## Inspection Photos

Location Name: CAERUS PICEANCE LLC ORCHARD-68S96W /10NWSE

Location ID: 312690

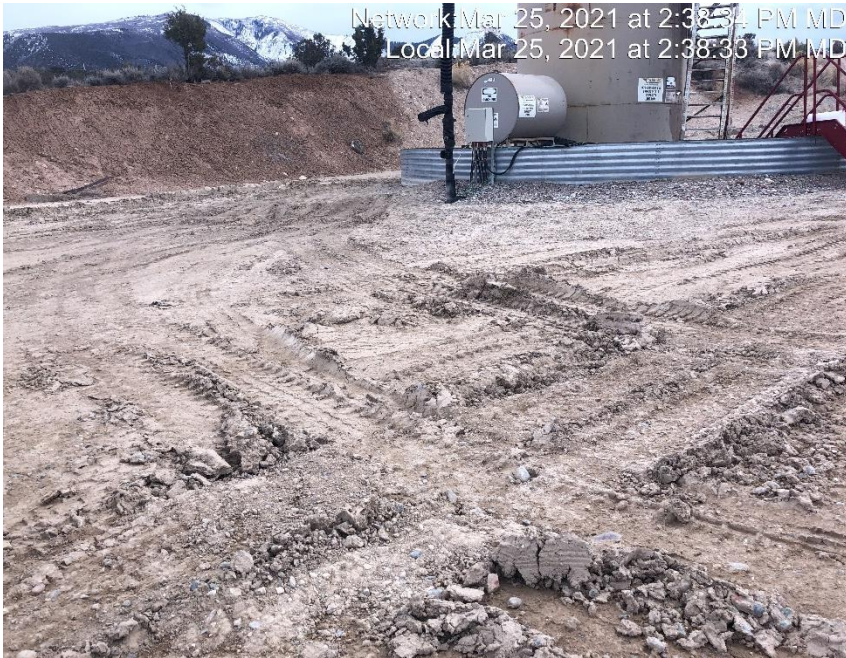
**Photo #3295 Location lacks stabilization.**

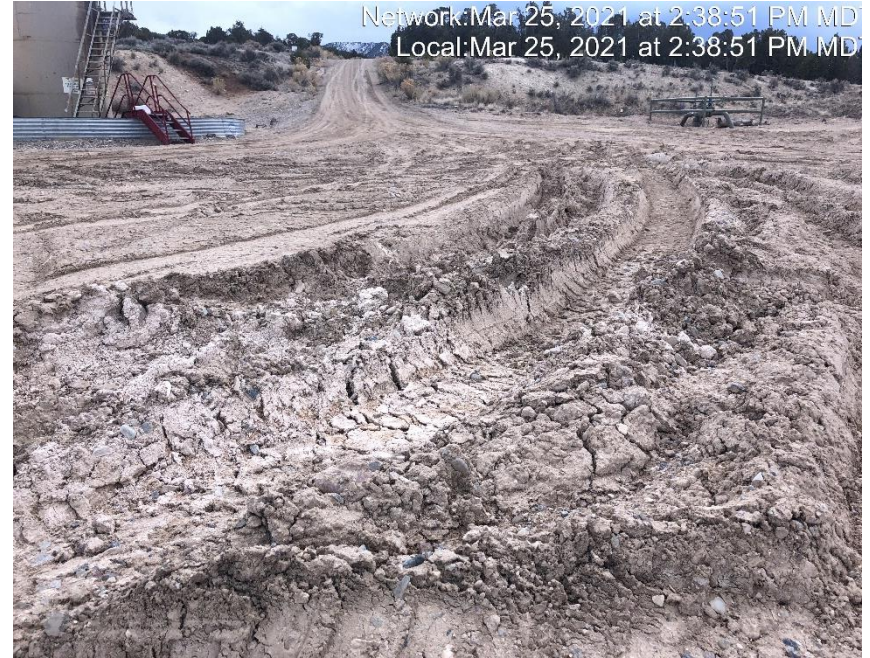
**Photo #3296 Location lacks stabilization.**

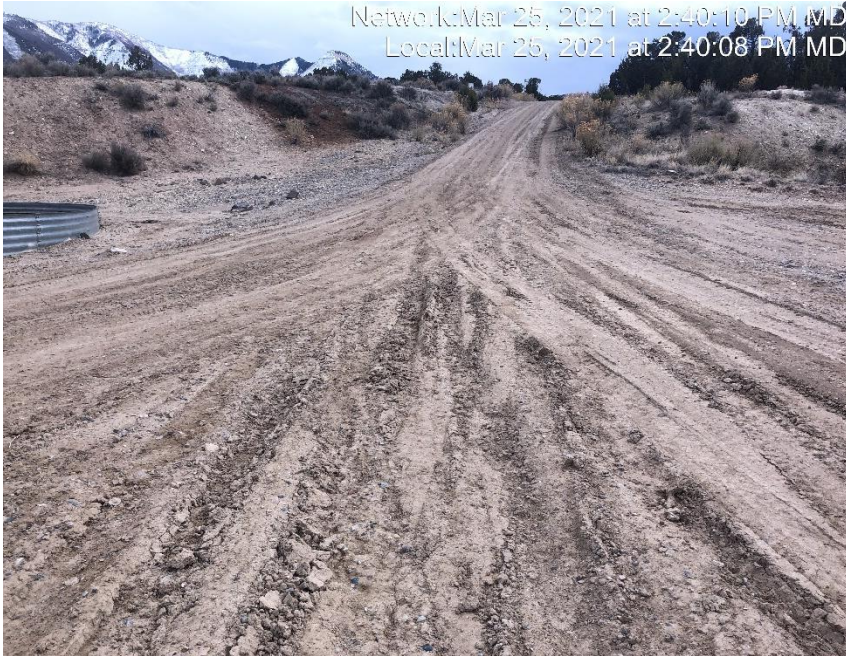
**Photo #3297** No form of tracking control at entrance to location.

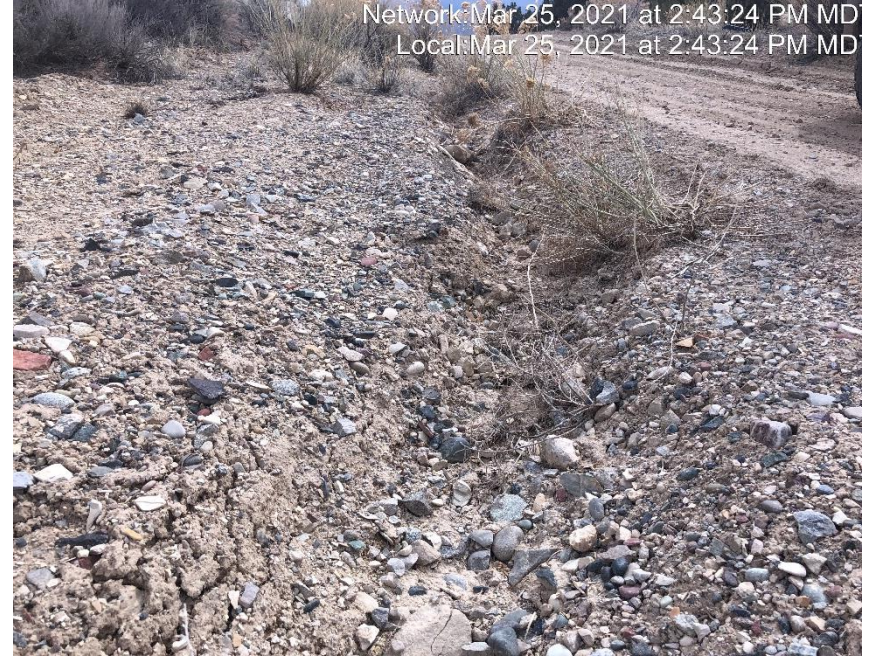
**Photo #3303** Gully erosion occurring in ditch on East side of access road.

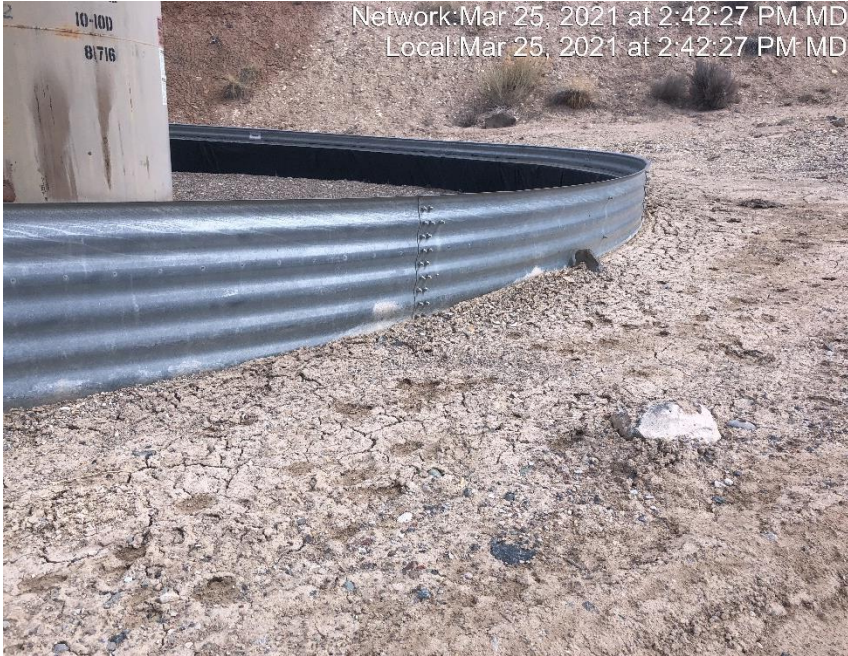
**Photo #3300 Sediment has migrated on to location and is collecting against tank containment.**
