Inspection Photos

Location Name: Robert G Berge #2

Spill ID 476918 (CL)/ Remediation Project No. 15743

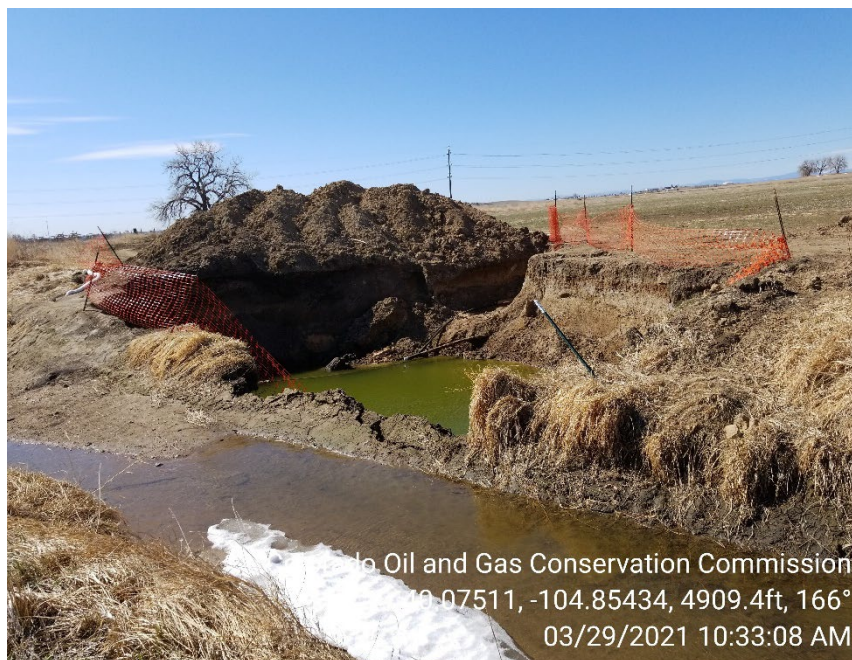
Photo 1 – Collapsed wall of Brantner Irrigation ditch during 3/29/2021 inspection. Additional collapse of the ditch wall has occurred since 3/24/2021 inspection.

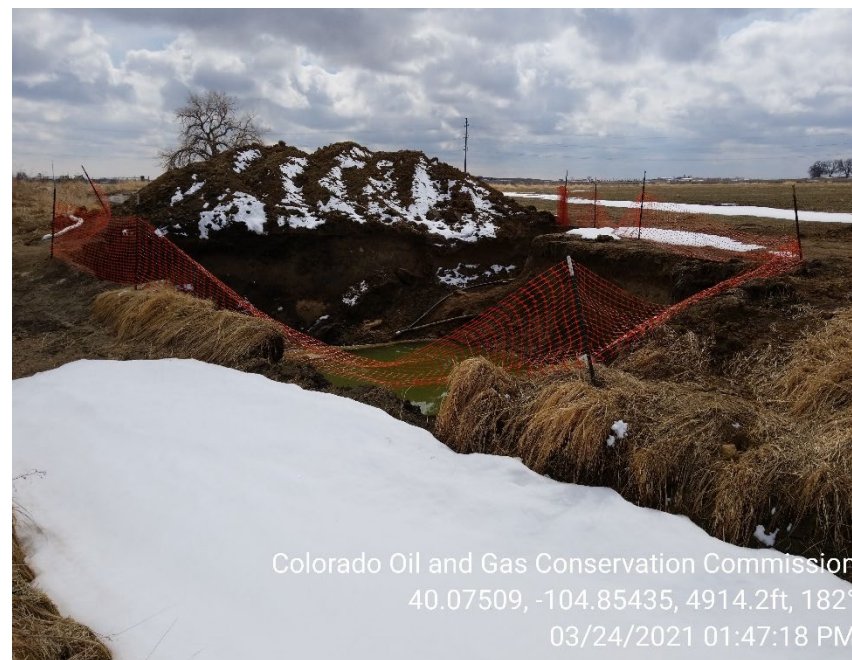
Photo 2 – Collapsed wall of Brantner Irrigation ditch during 3/24/2021 inspection.

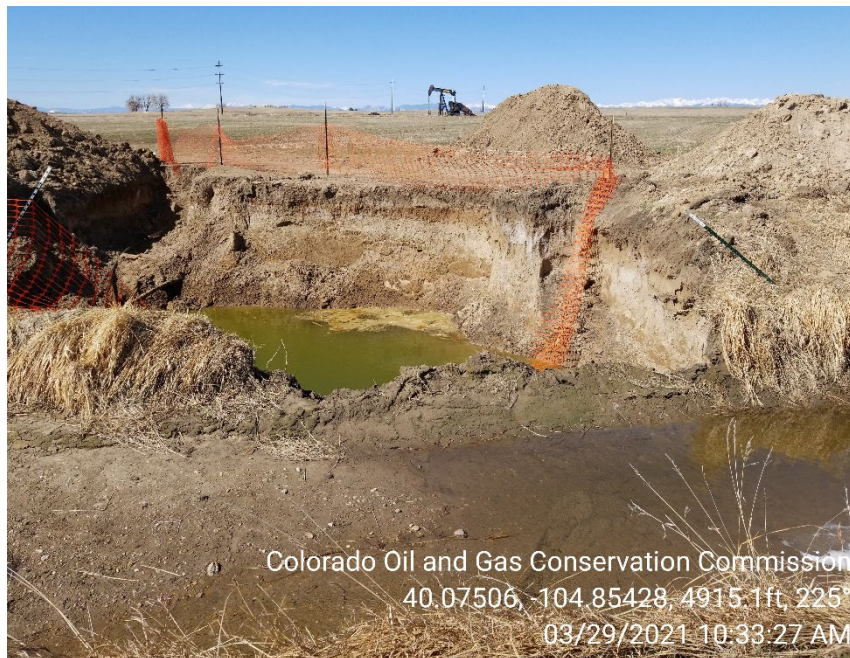
Photo 3 – Collapsed wall of Brantner Irrigation ditch during 3/29/2021 inspection. Fencing down around portions of the open excavation.

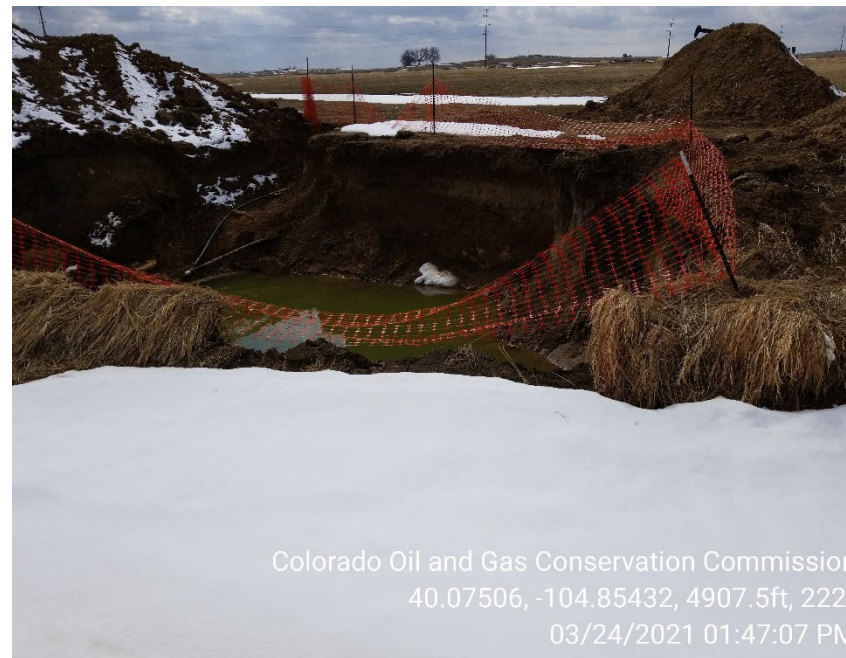
Photo 4 – Collapsed wall of Brantner Irrigation ditch during 3/24/2021 inspection.

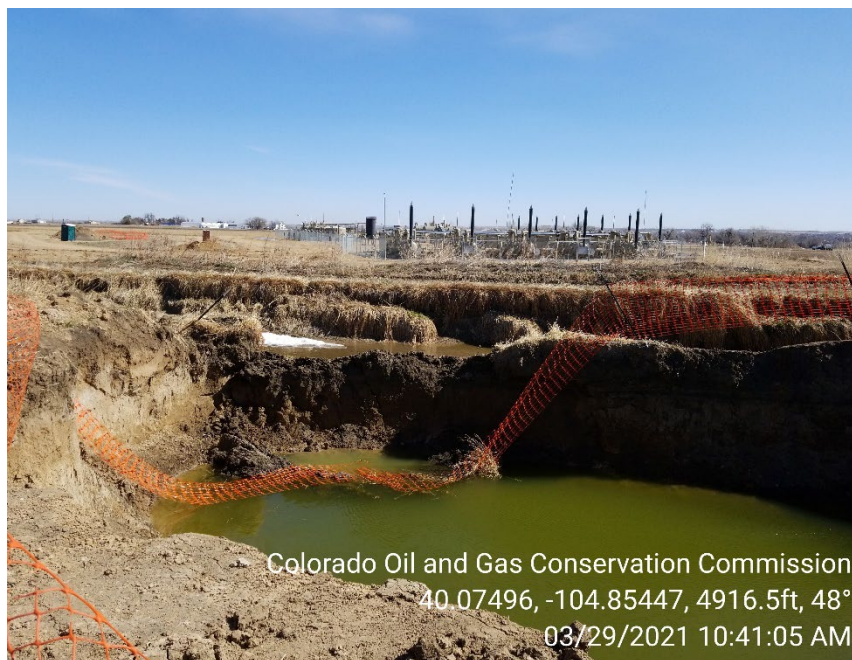
Photo 5 – Collapsed wall of Brantner Irrigation ditch during 3/29/2021 inspection.

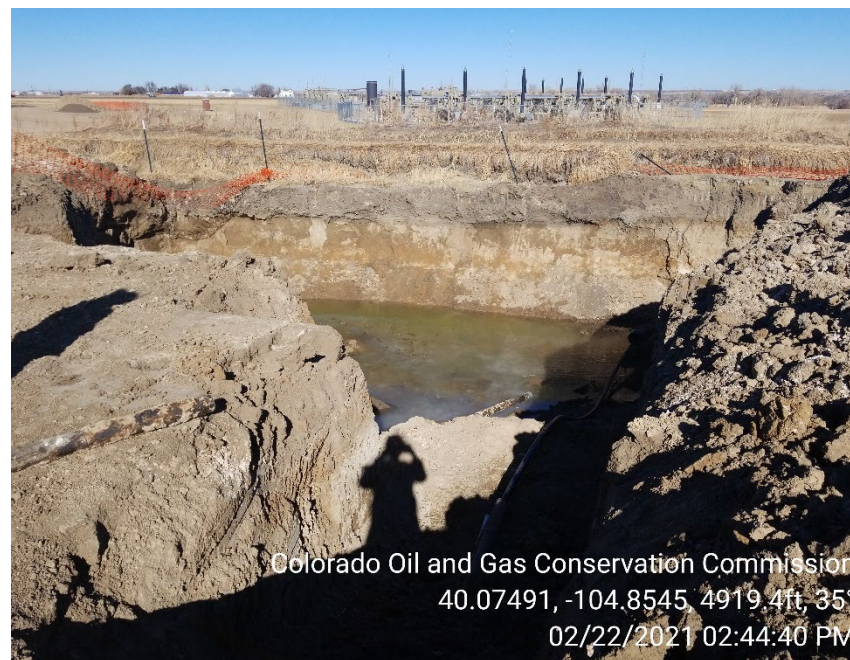
Photo 6 – Wall of Brantner Irrigation ditch during 2/22/2021 inspection.

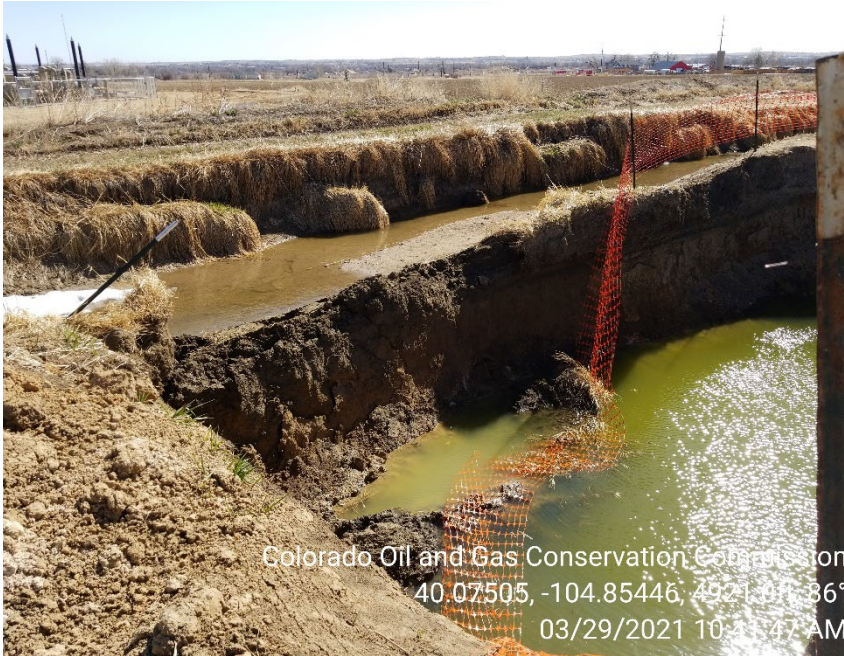
Photo 7 – Collapsed wall of Brantner Irrigation ditch during 3/29/2021 inspection. Fencing has fallen into open excavation. Groundwater observed in excavation.

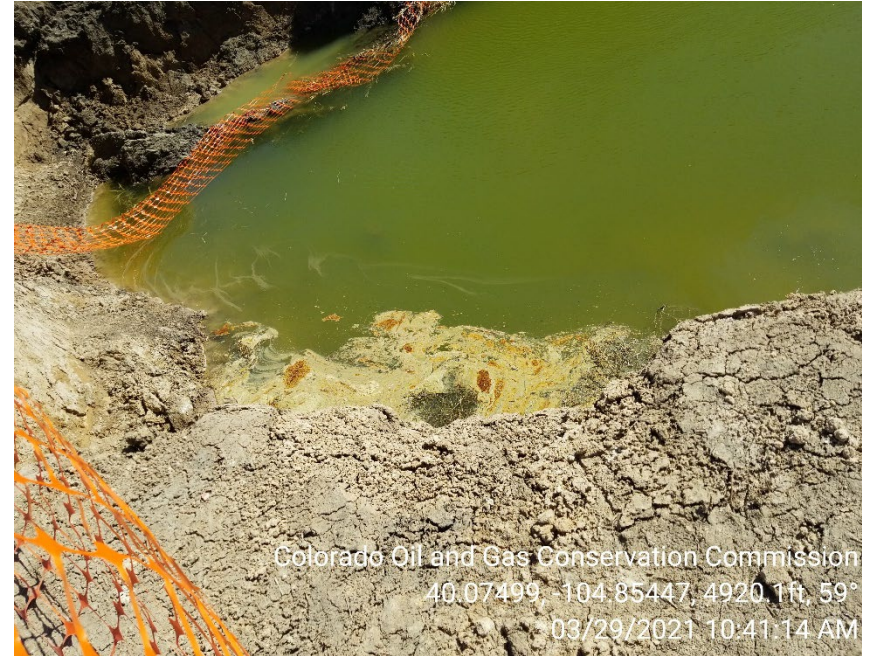
Photo 8 – Groundwater and sludge observed in open excavation.

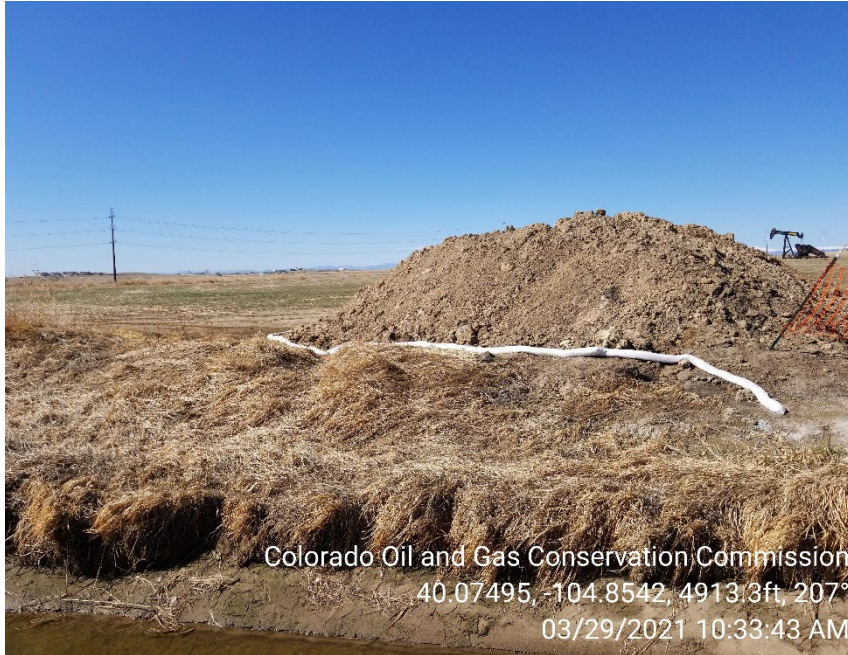
Photo 9 – Soils stored on location; BMPs inadequate to contain runoff

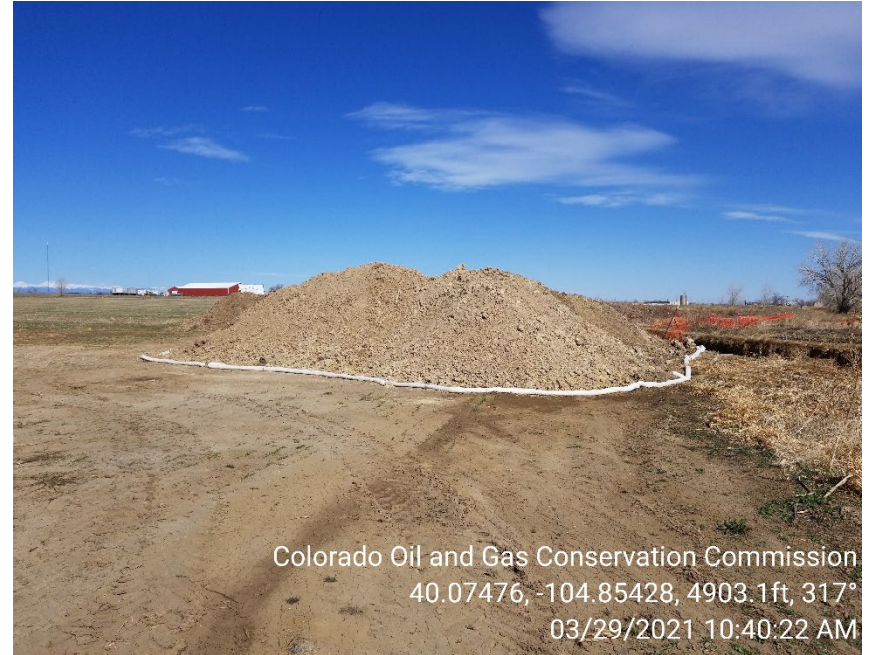
Photo 10 – Soils stored on location; BMPs inadequate to contain runoff

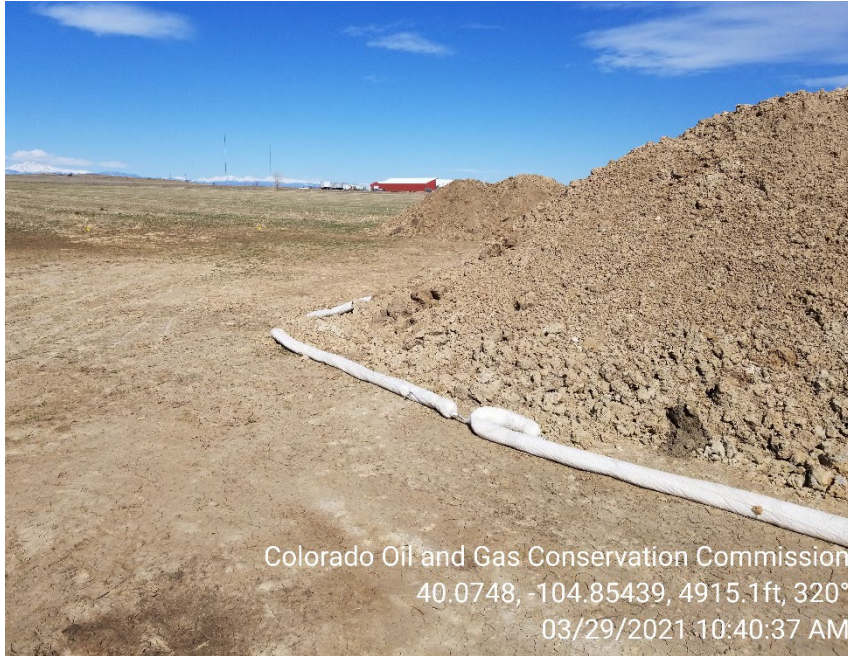
Photo 11 –BMPs inadequate to contain runoff

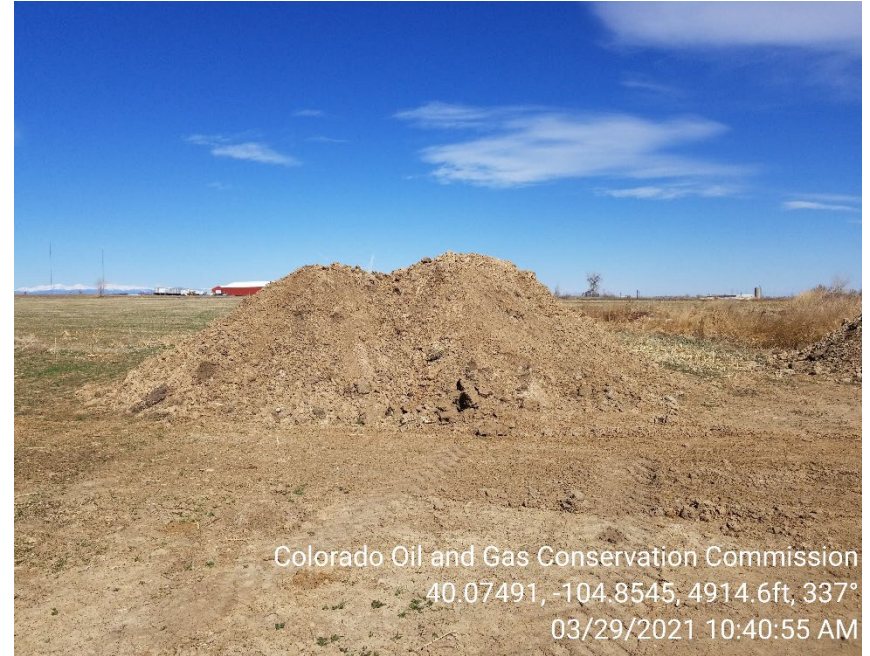
Photo 12 – Soils stored on location with no BMPs

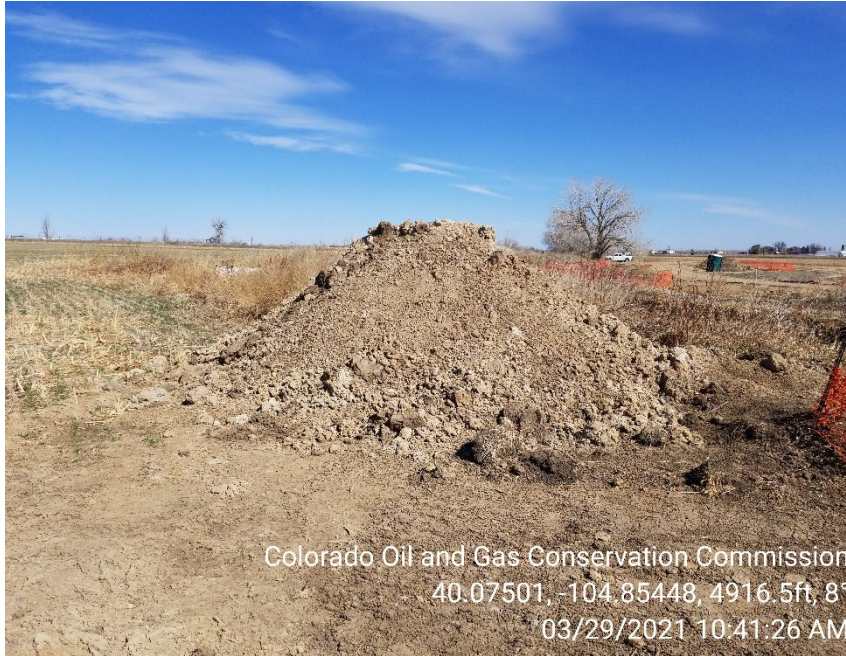
Photo 13 – Soils stored on location with no BMPs

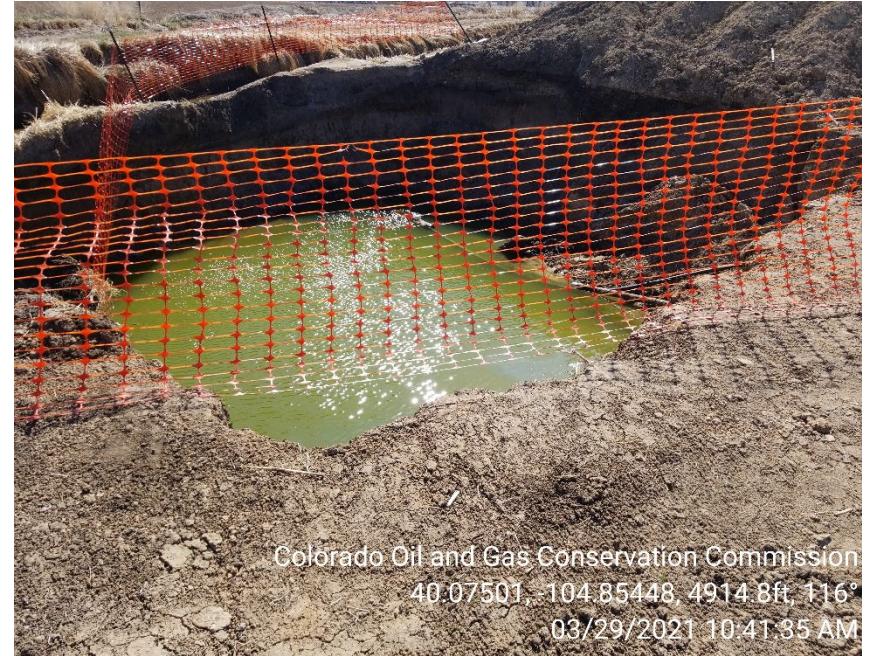
Photo 14 – Fencing inadequate to prevent access to open excavation.
