Inspection Photos  
Operator: Simcoe  
Facility: 067-10003  
Date: 3/29/2021

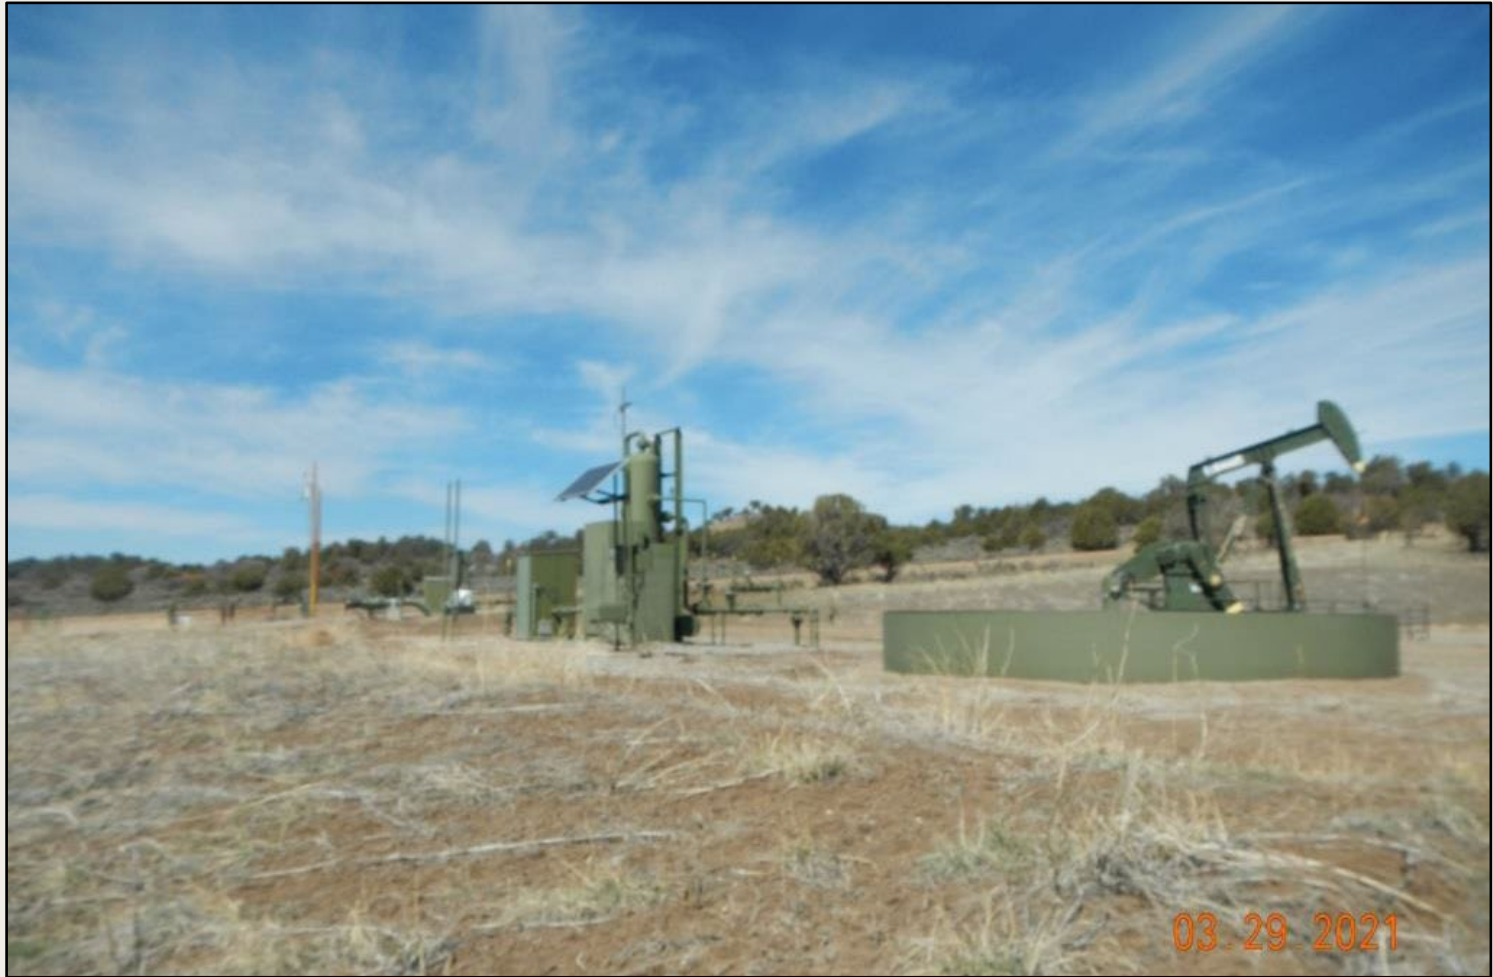
Photo 1. View of the southeastern corner facing center.

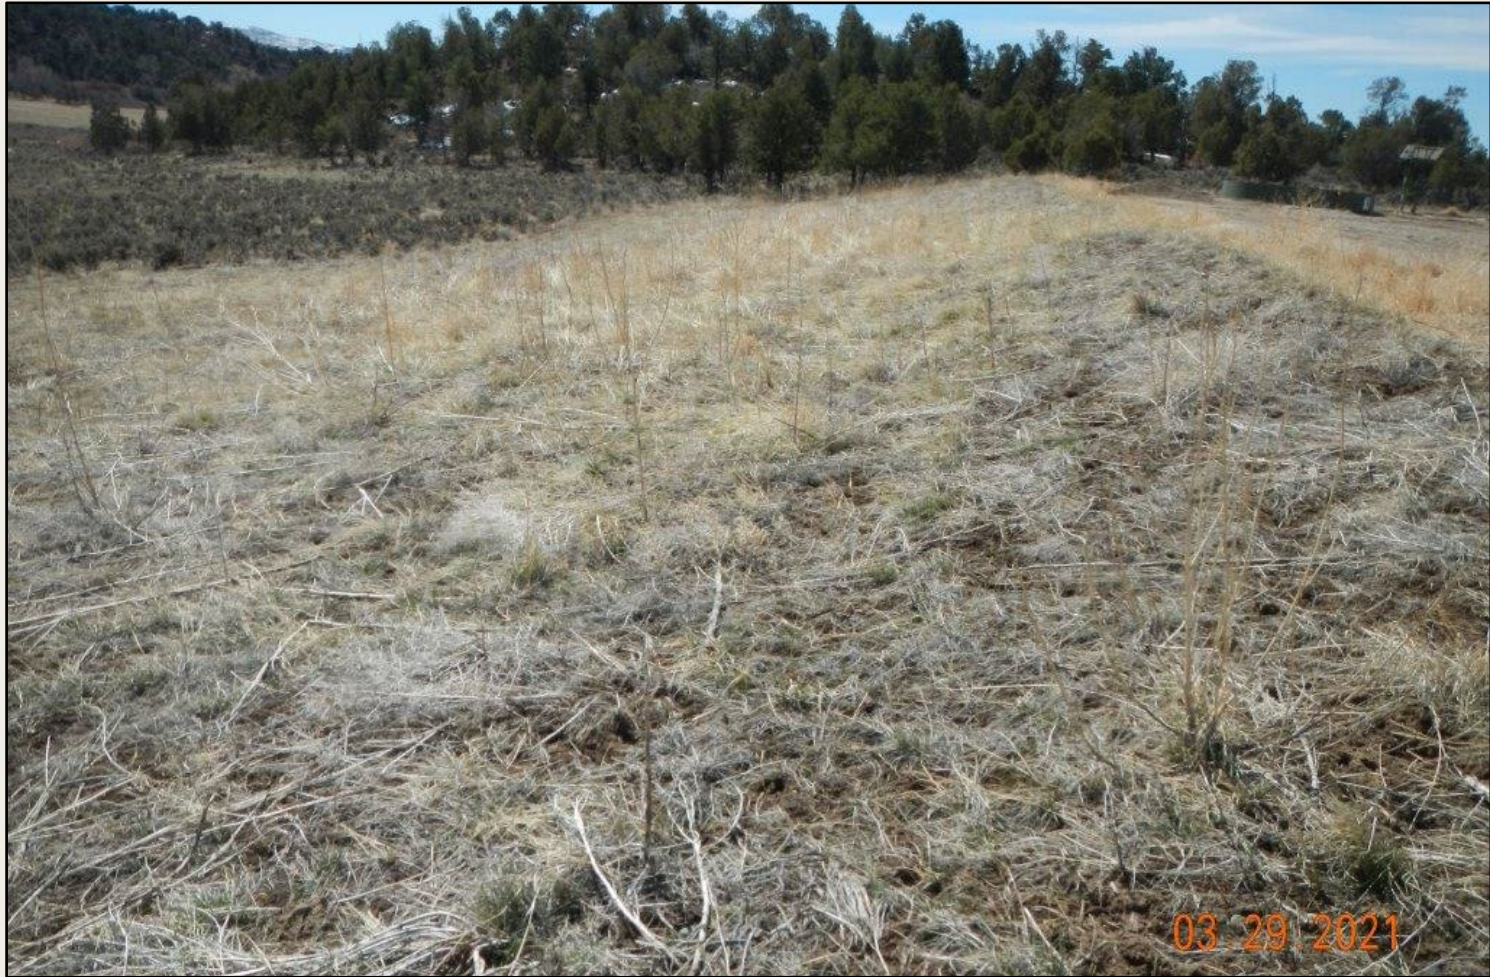
Photo 2. View of the eastern fill slope facing southward. Revegetation appears to be progressing with grasses such as western wheatgrass and crested wheatgrass. Early seral annual weeds such as tumble mustard are dense within the revegetation areas.

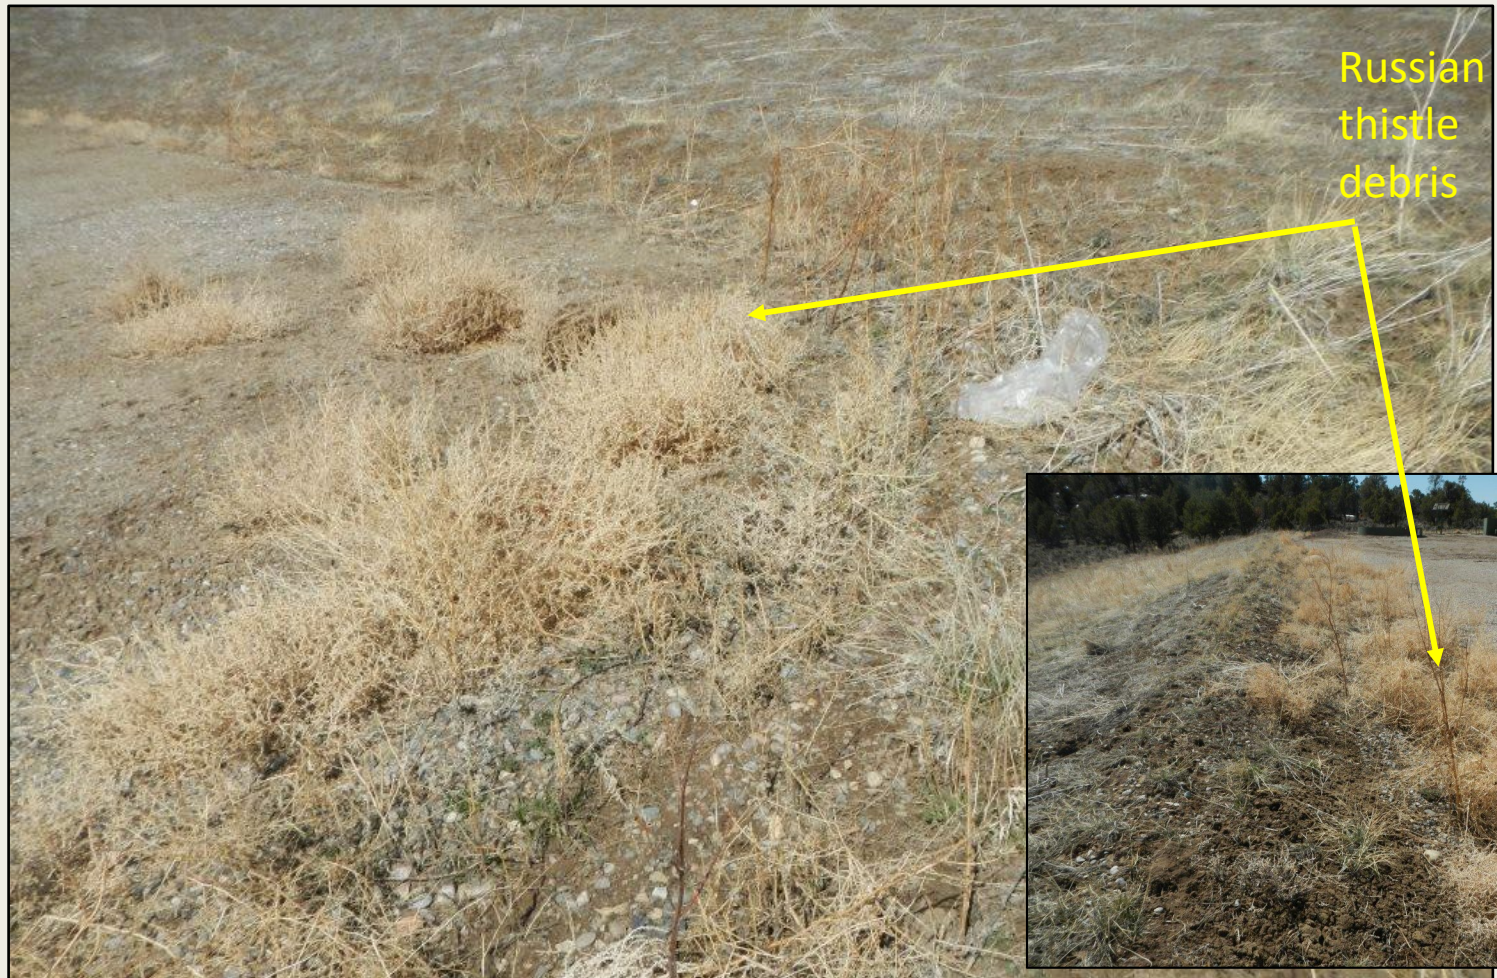
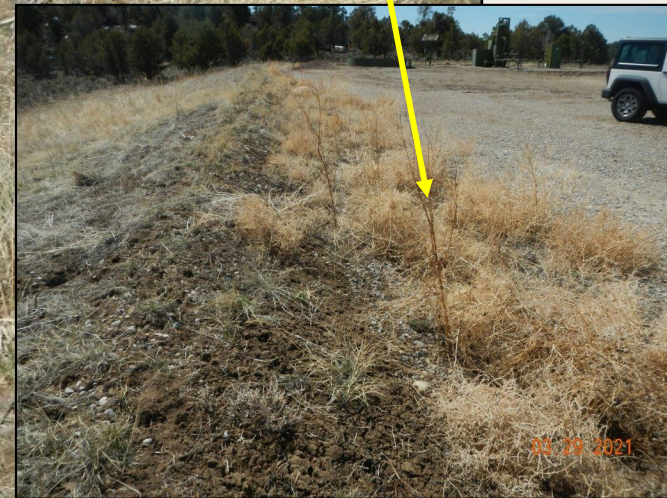
Photo 3. View of dense Russian thistle and plastic debris within the southeastern corner. Inset shows more Russian thistle debris that needs to be removed.

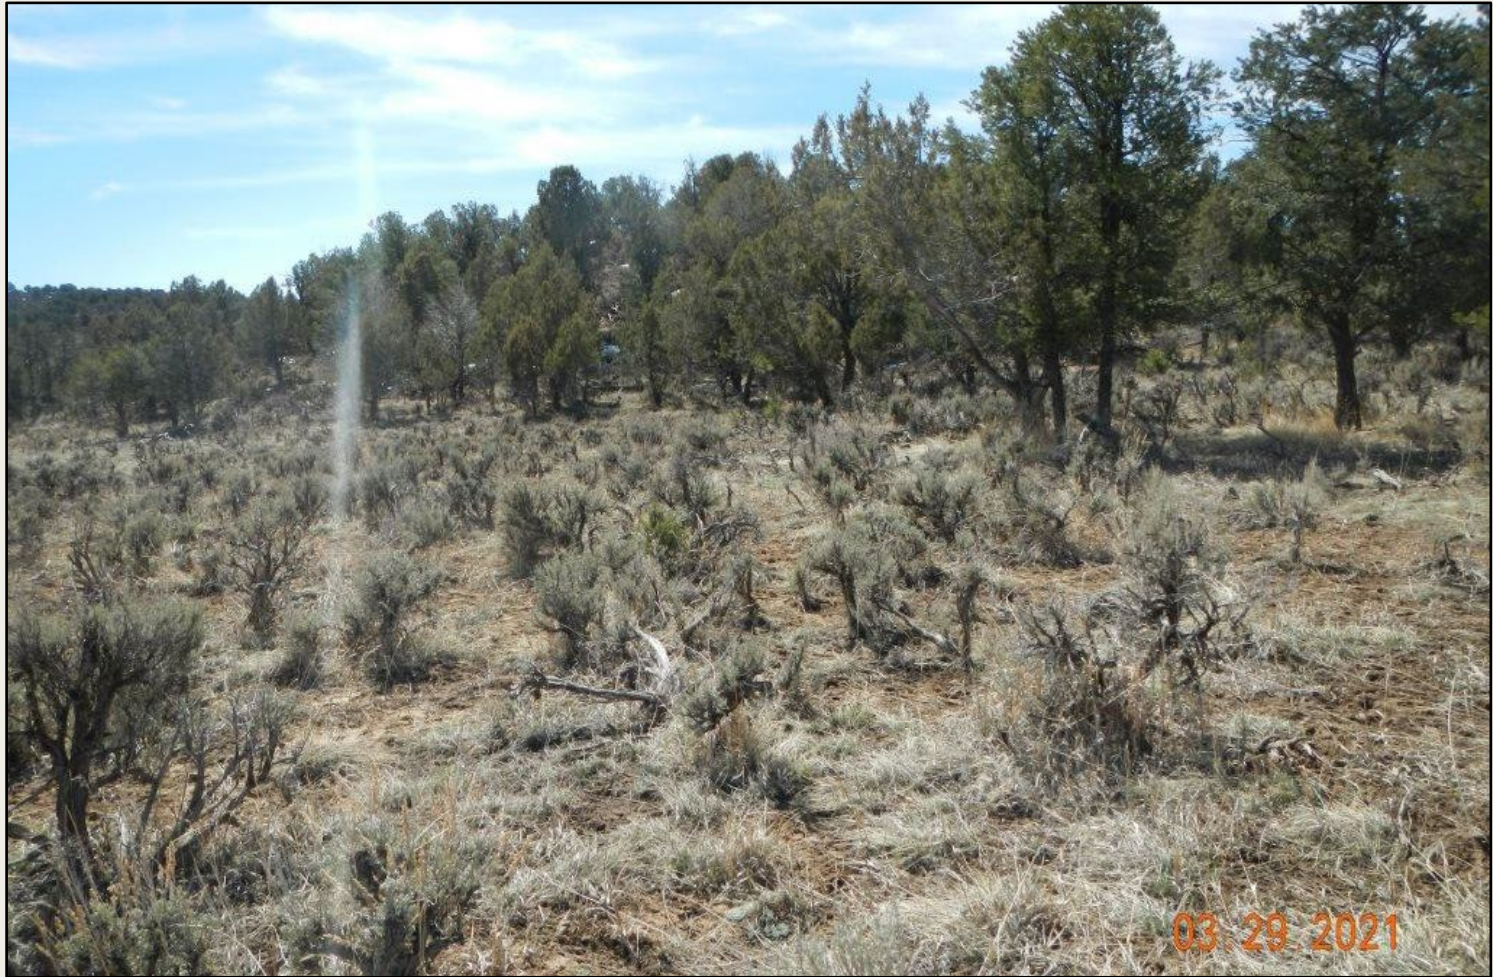
Photo 4. View of reference area comprised of pinyon and juniper woodland with sagebrush , blue grama, and black sage observed in the understory.
