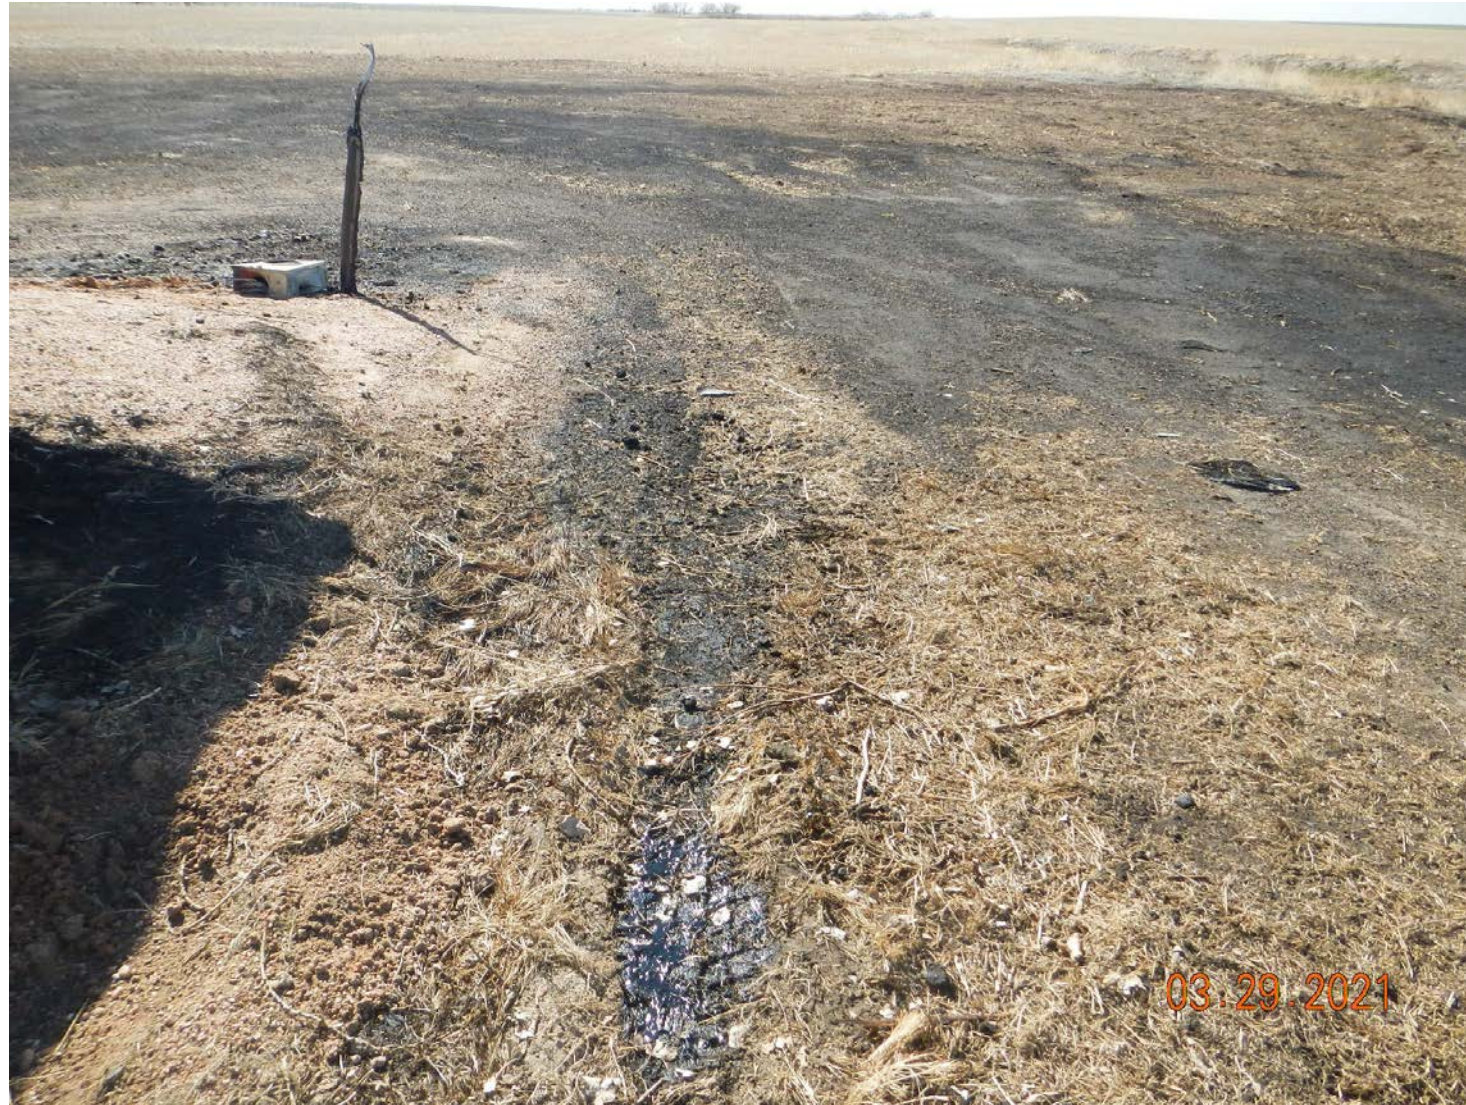
- Photo 2 – View west from north side of pumping unit. Oily soil in tiretrack

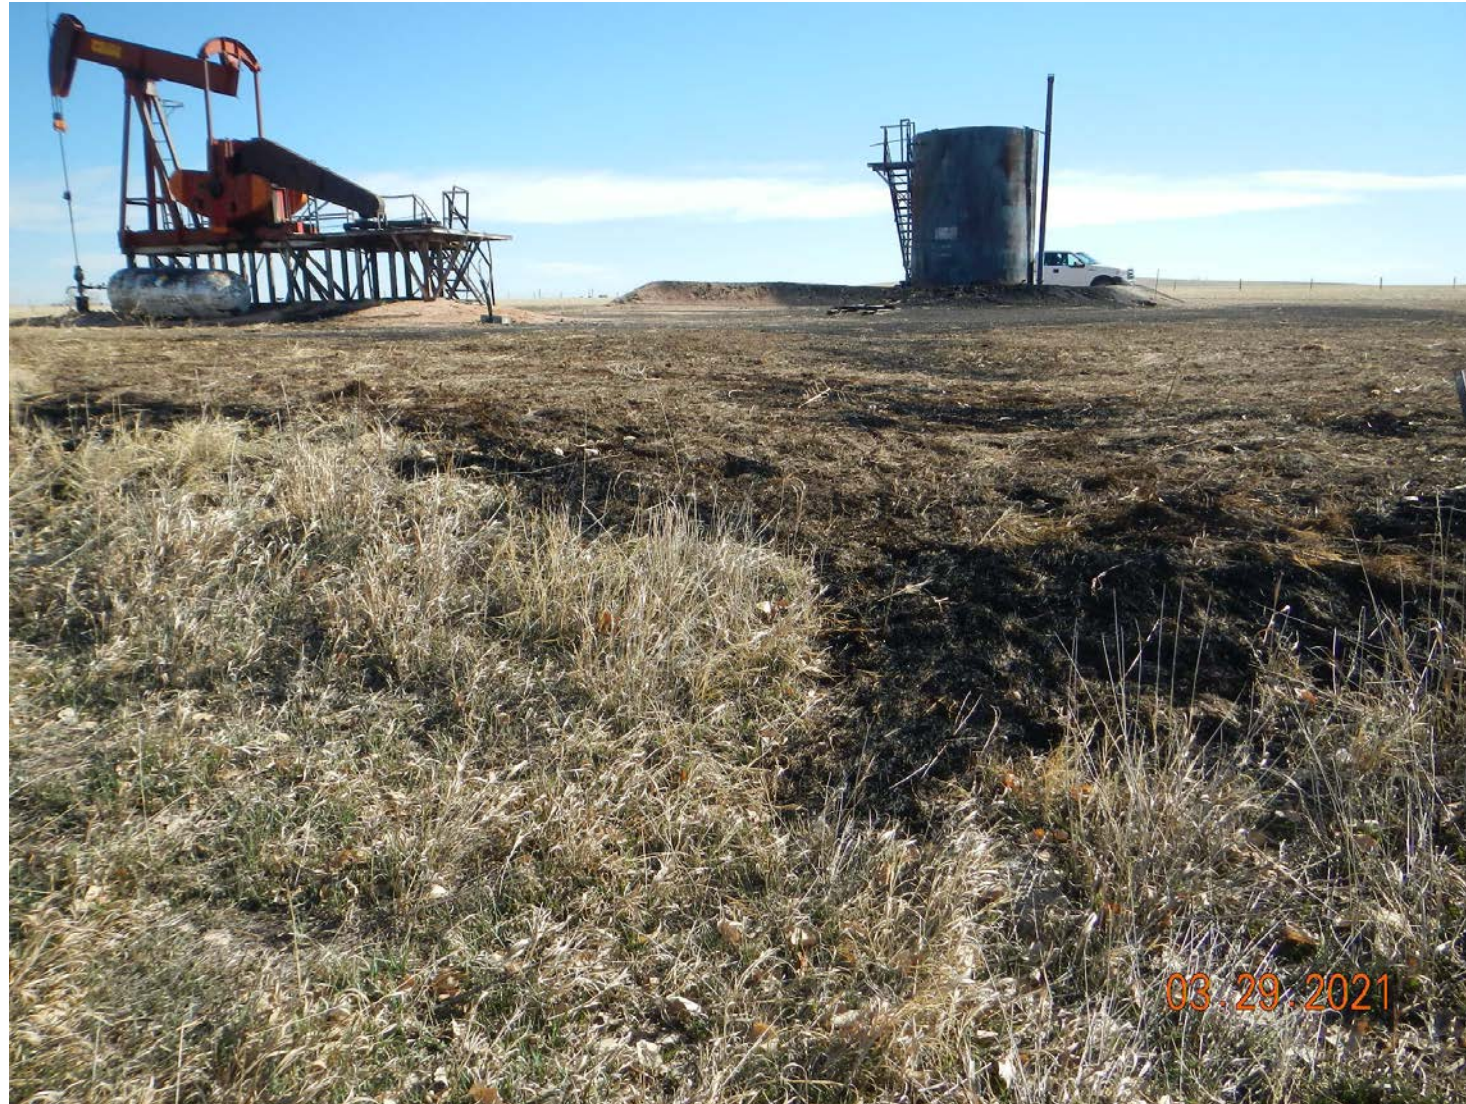
- Photo 3 – View south north side of location. Northern extent of fire impact

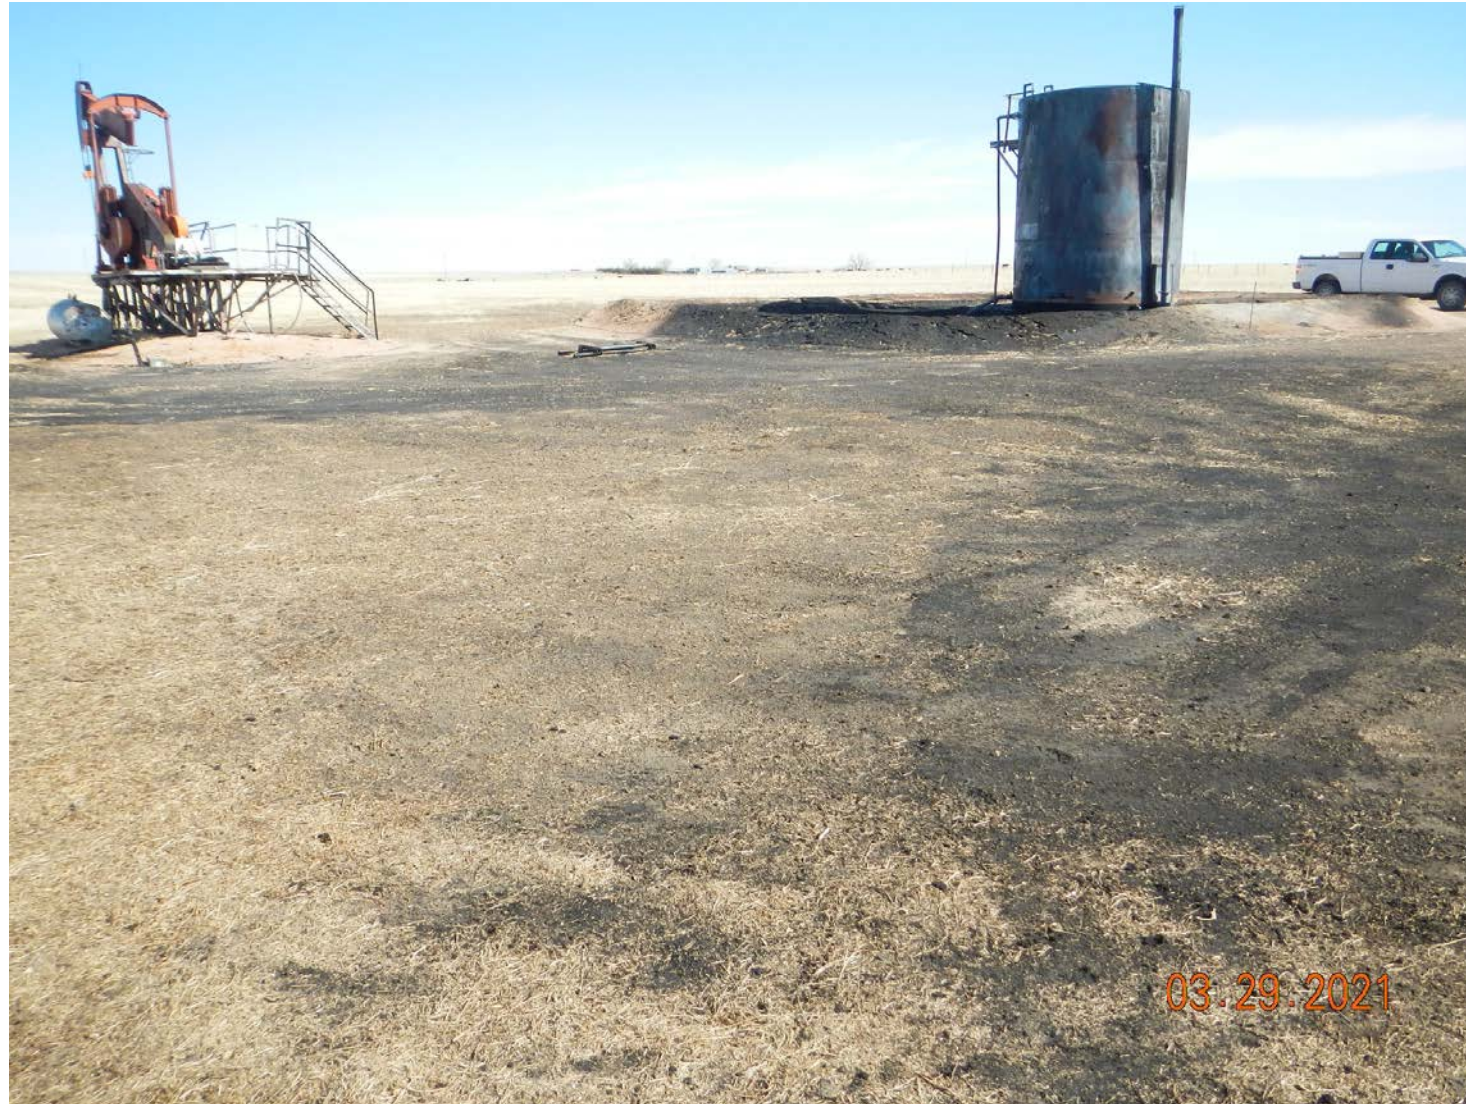
- Photo 4 – View southeast from northwest area of location. Lobes of burnt spilled oil/water

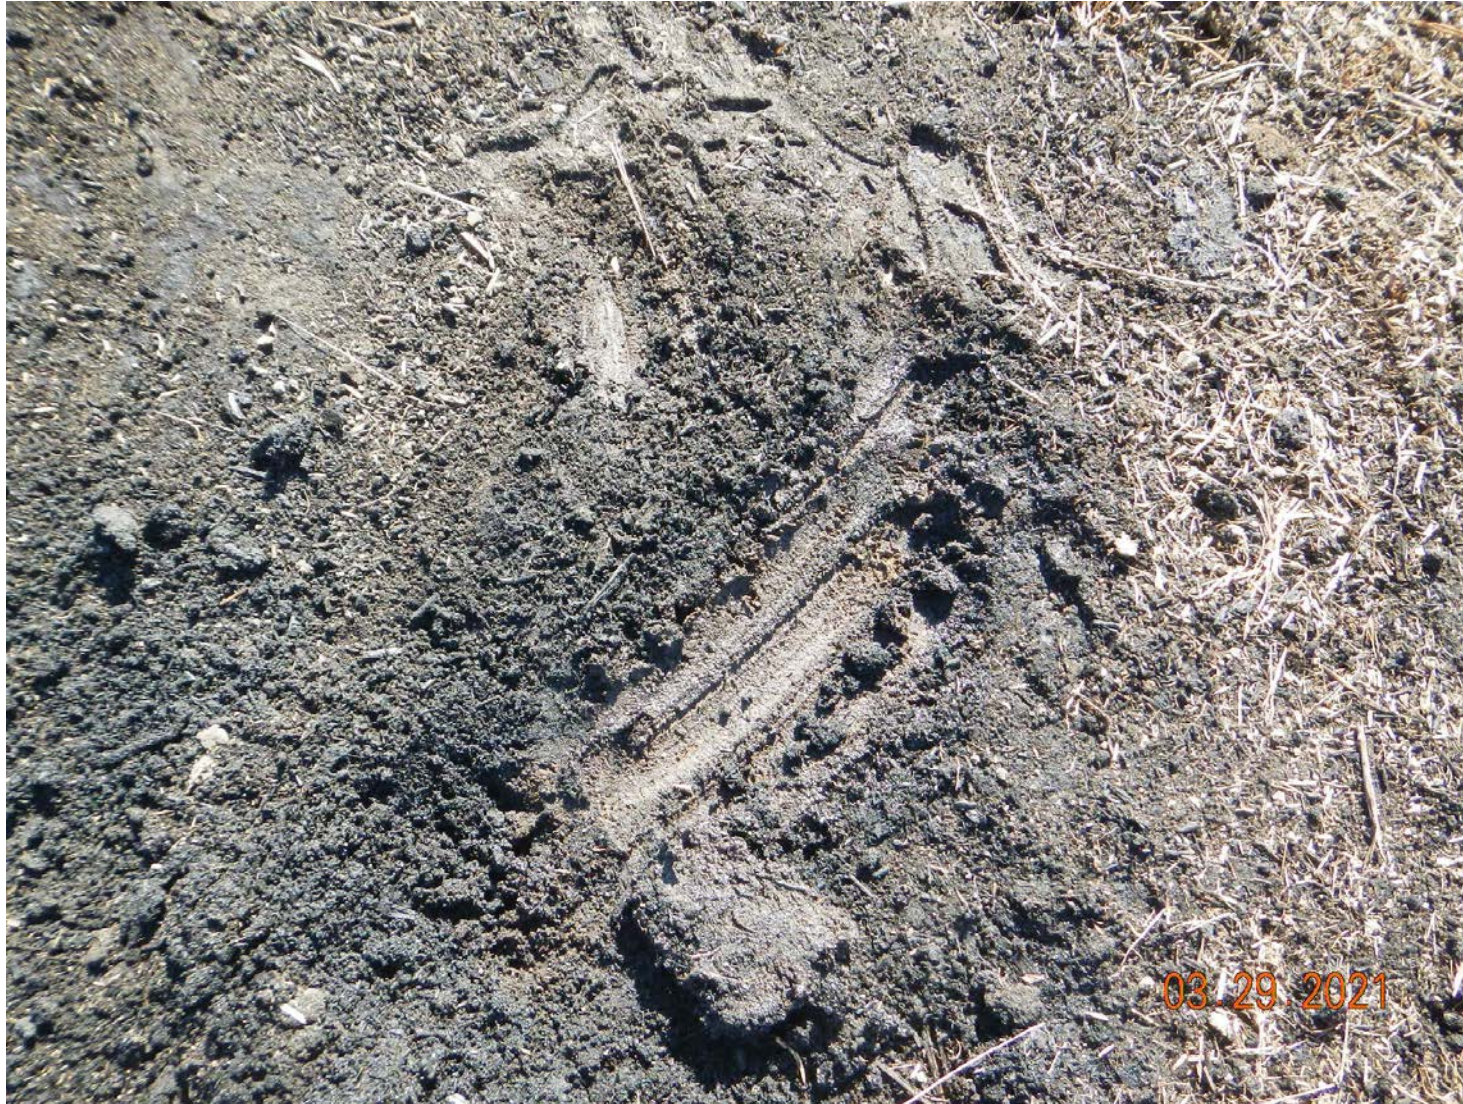
- Photo 5 – Oily soil within spill area

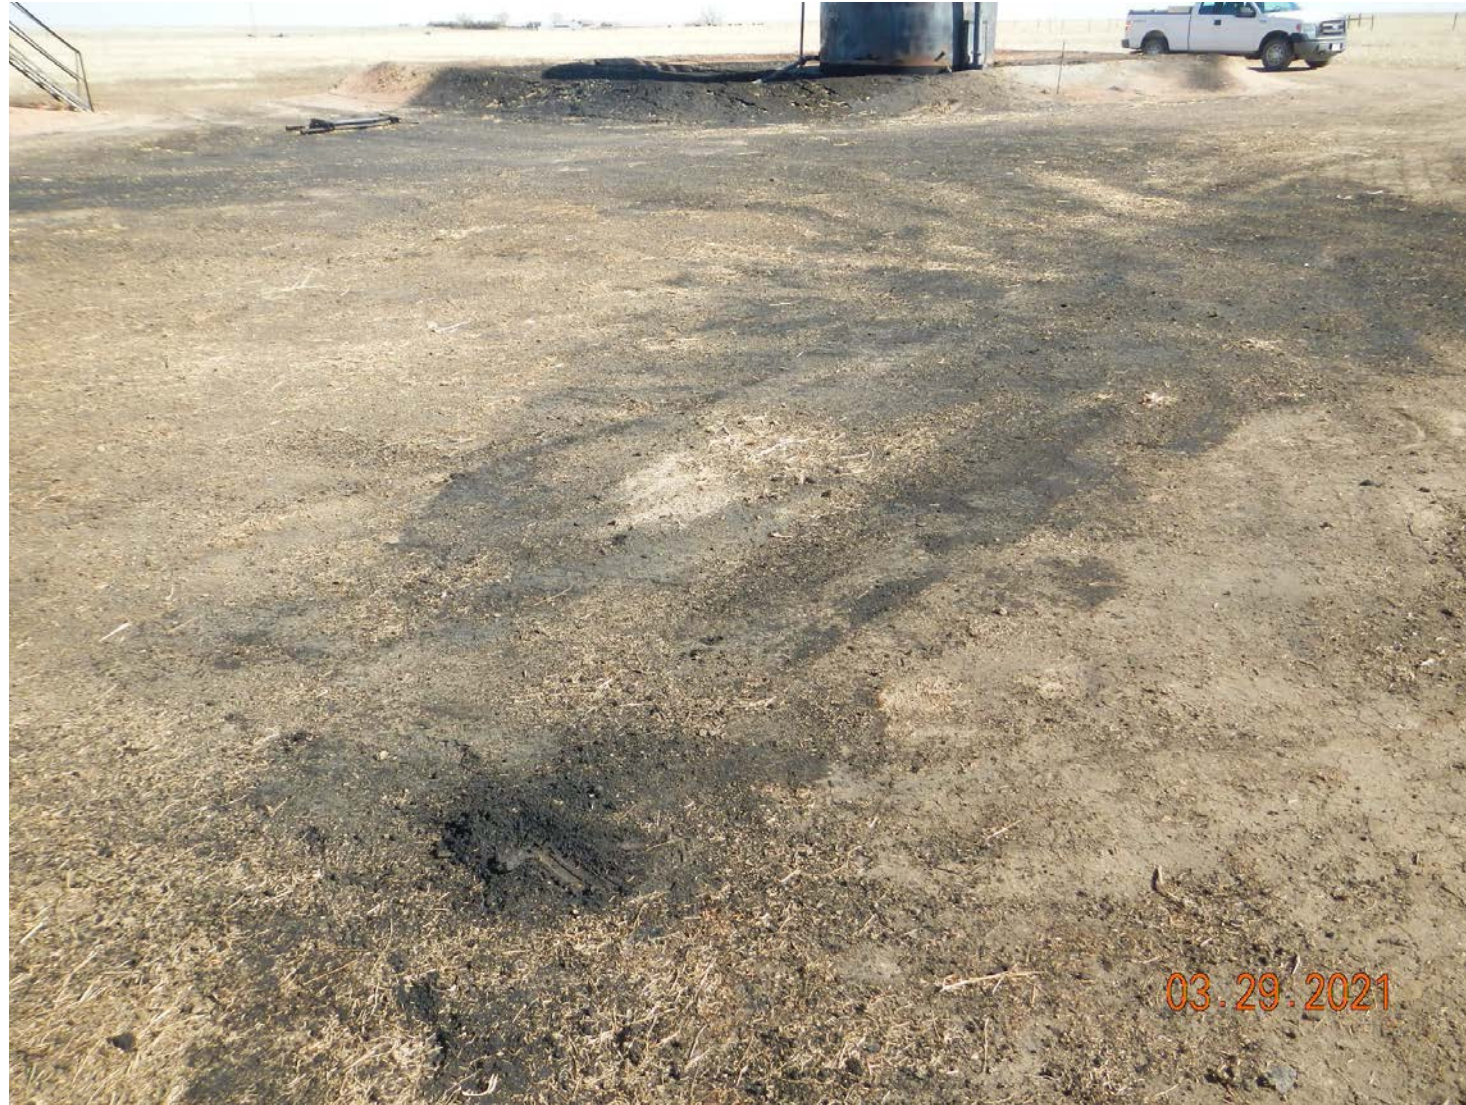
- Photo 6 – Oily soil within spill area

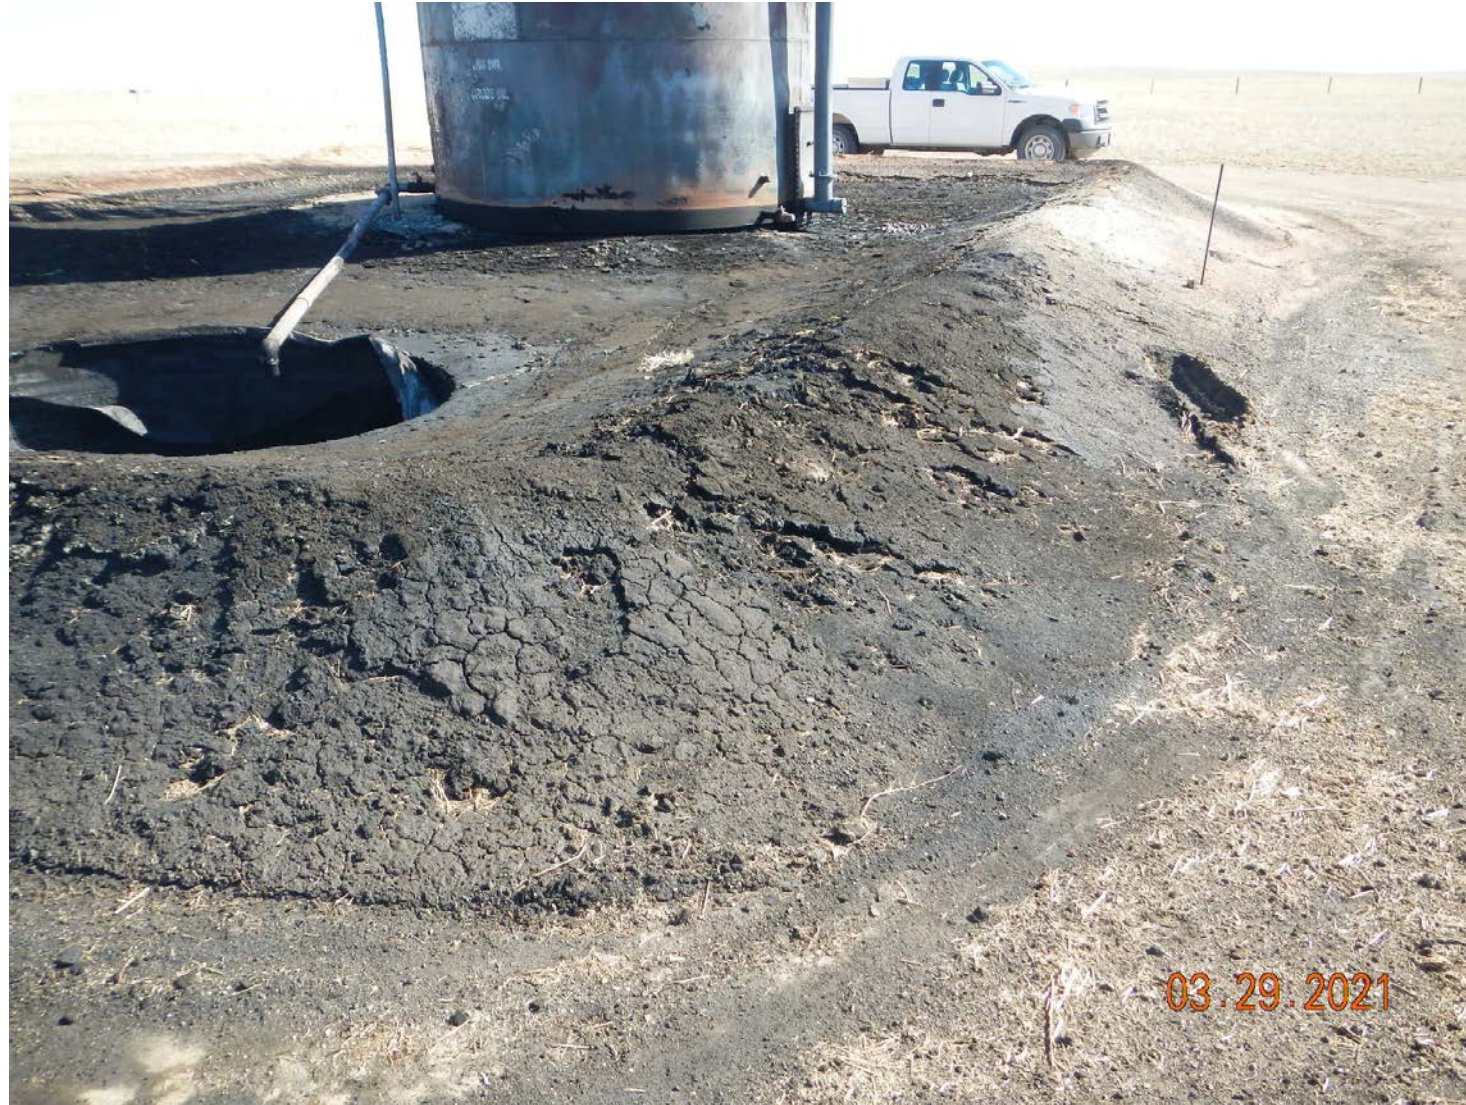
- Photo 7 – Burnt oil residue on and in berms and remains of burned partially buried water vault

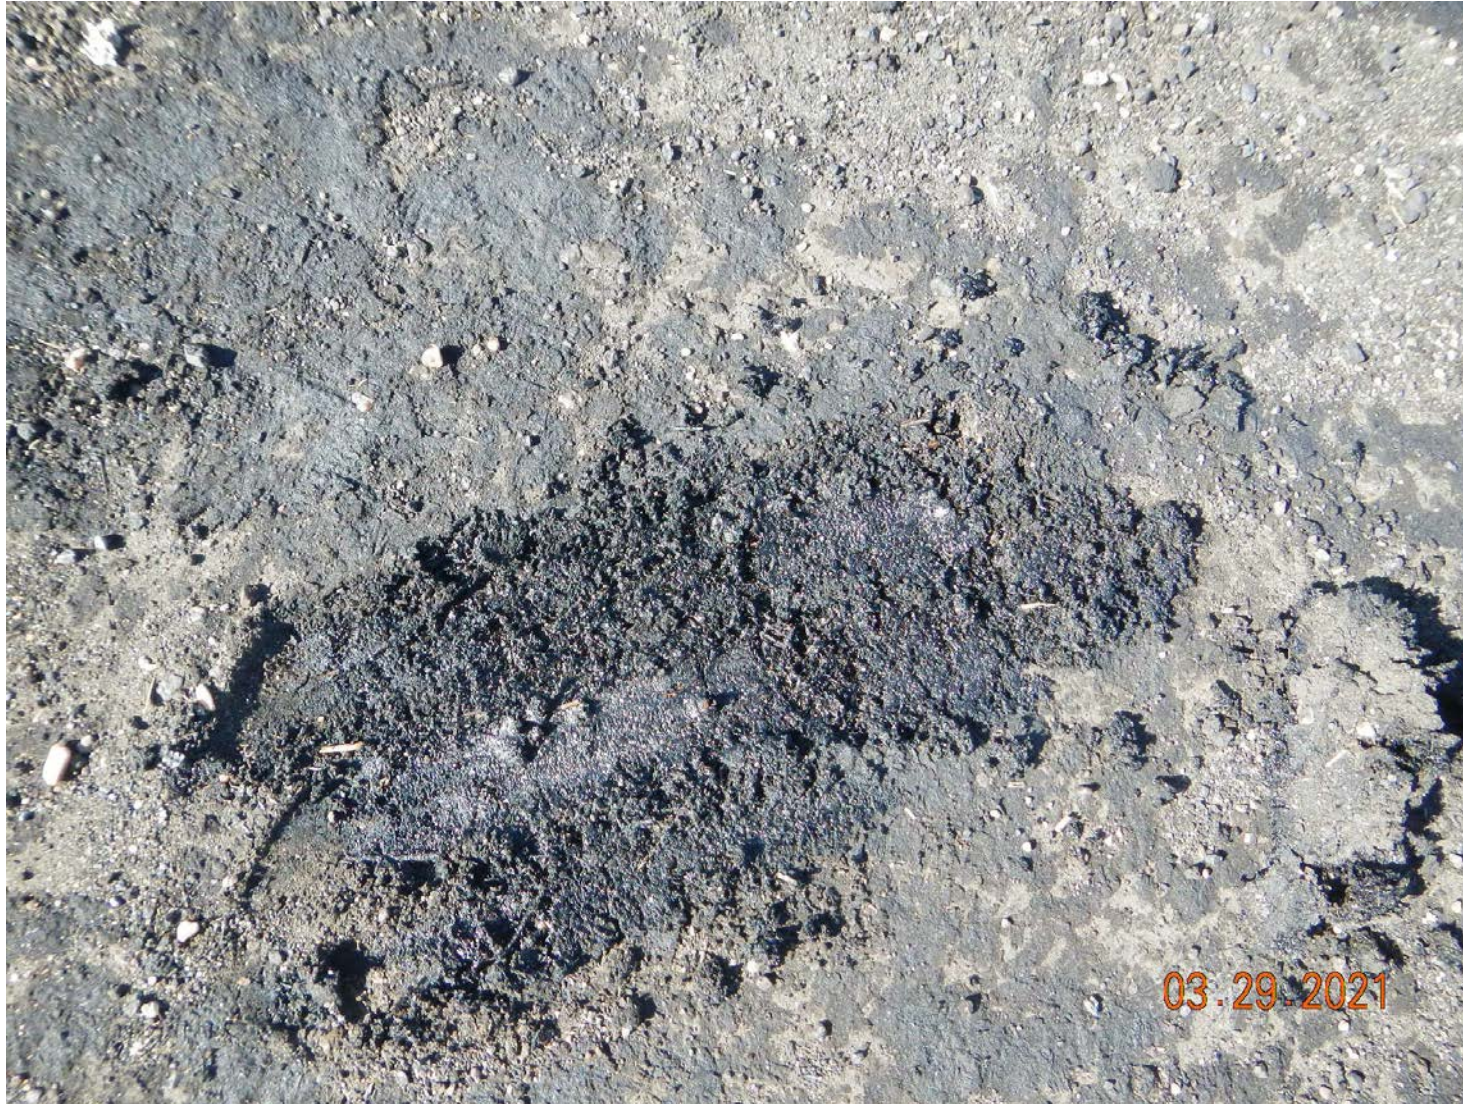
- Photo 8 – Burnt oil Oily soil within spill area

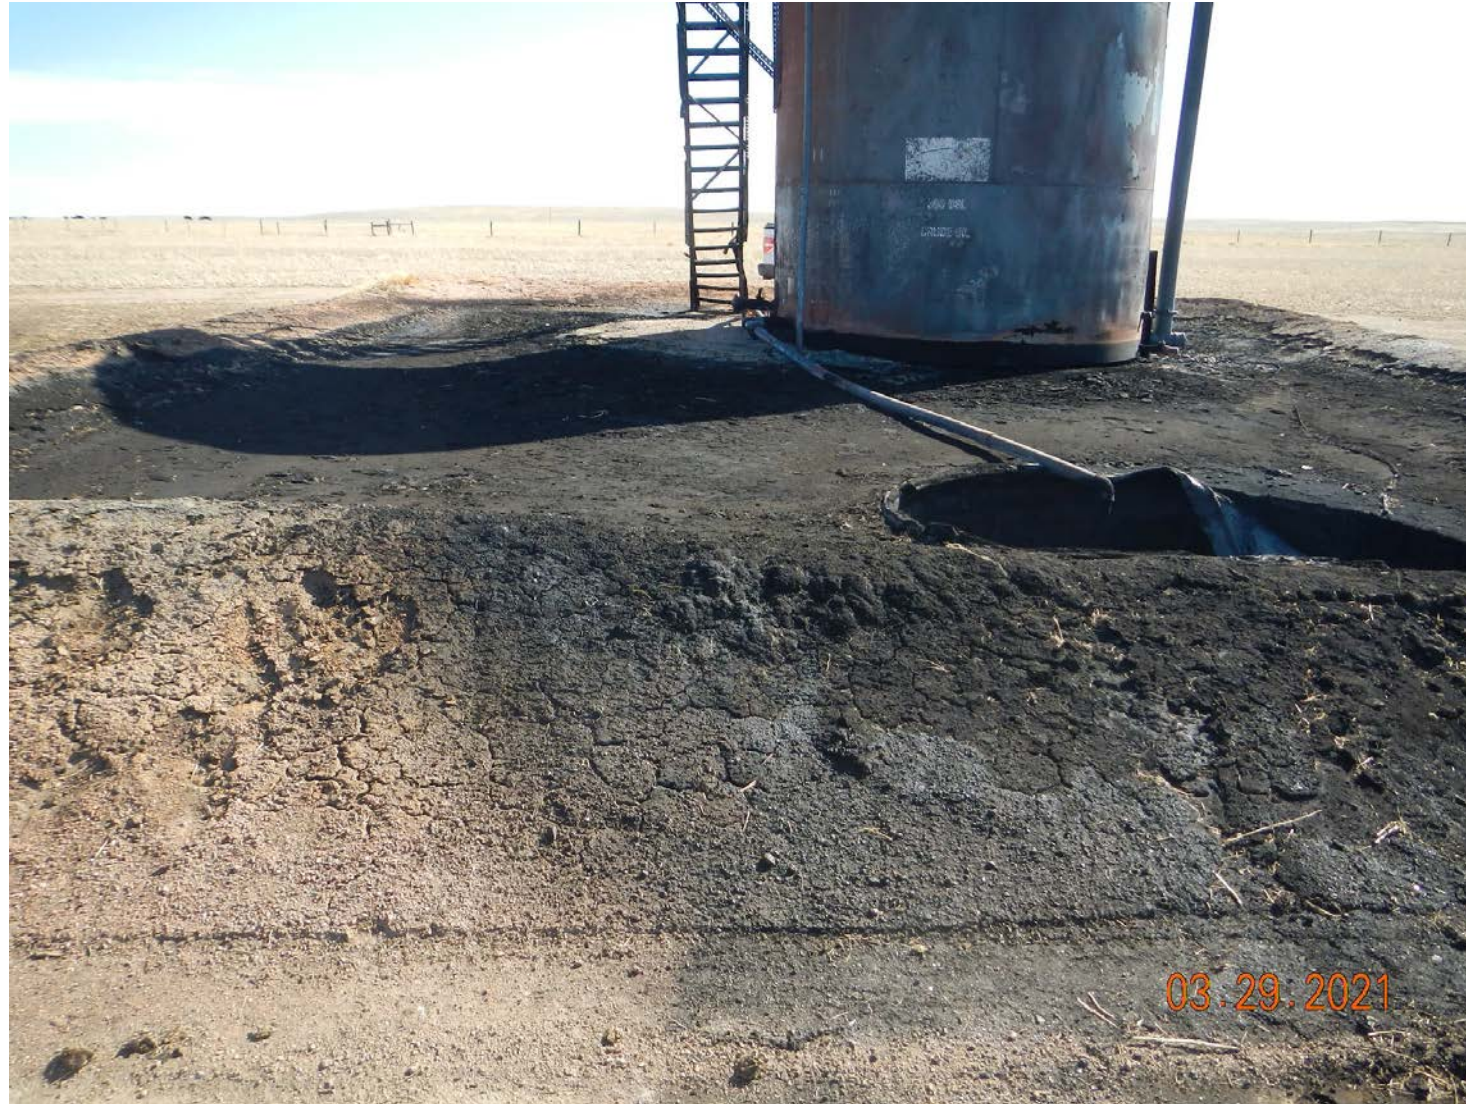
- Photo 9 – Burnt fluid line on berms

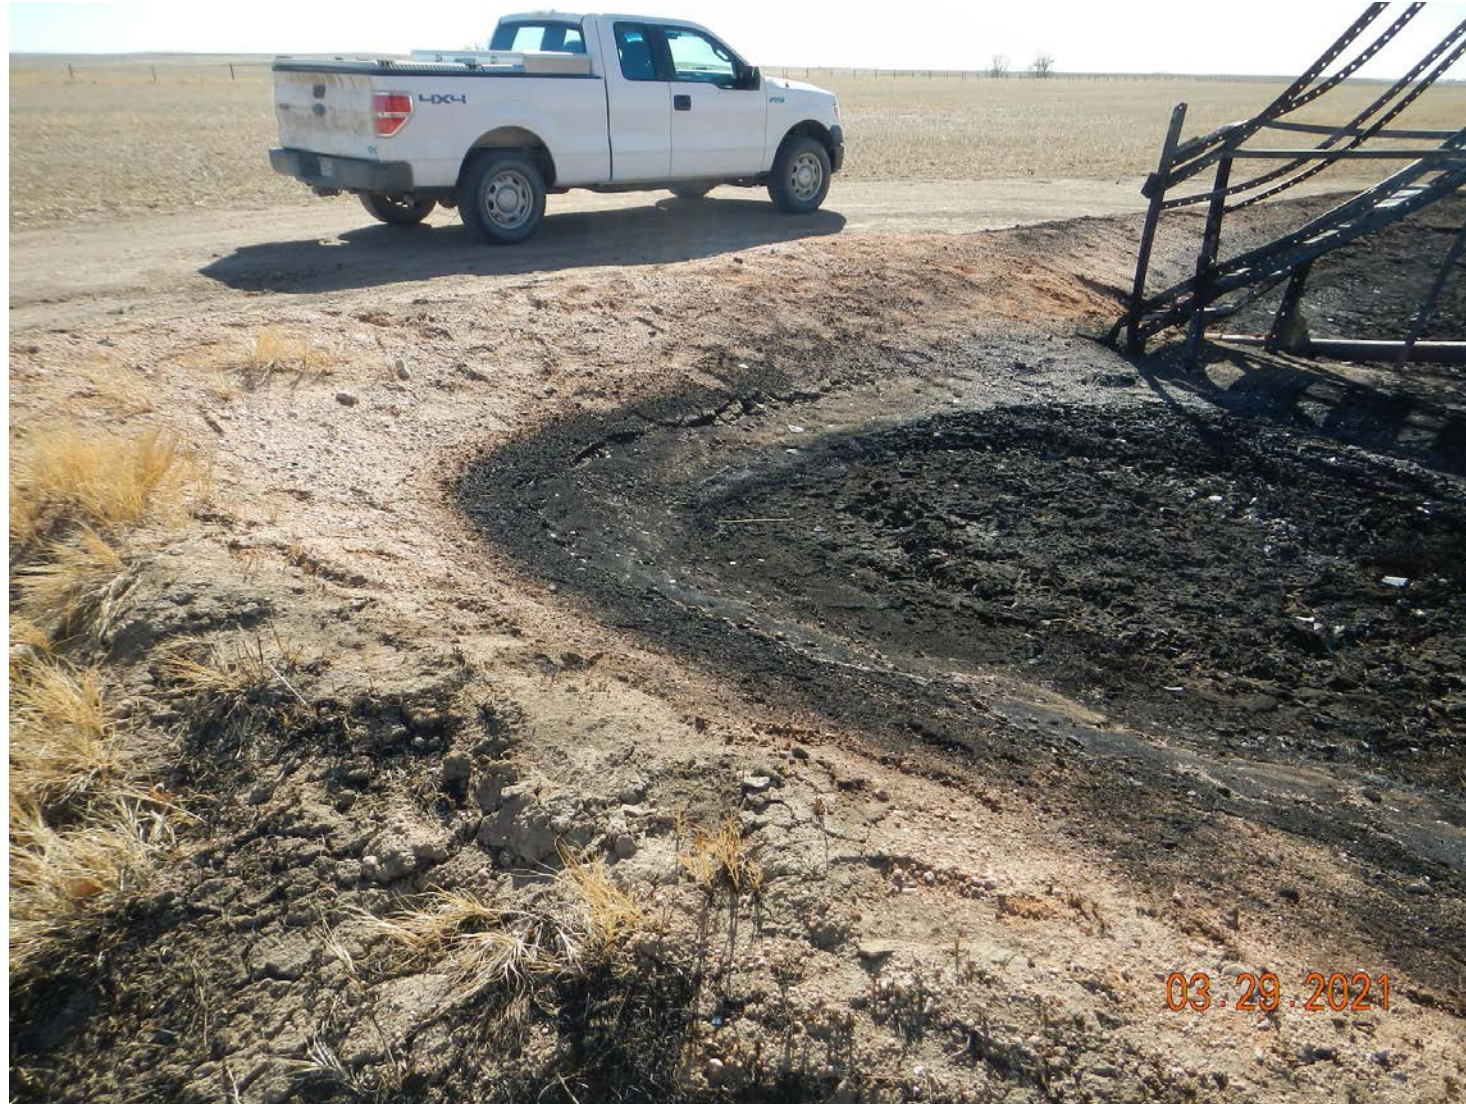
- Photo 10 – Burnt fluid line on berms

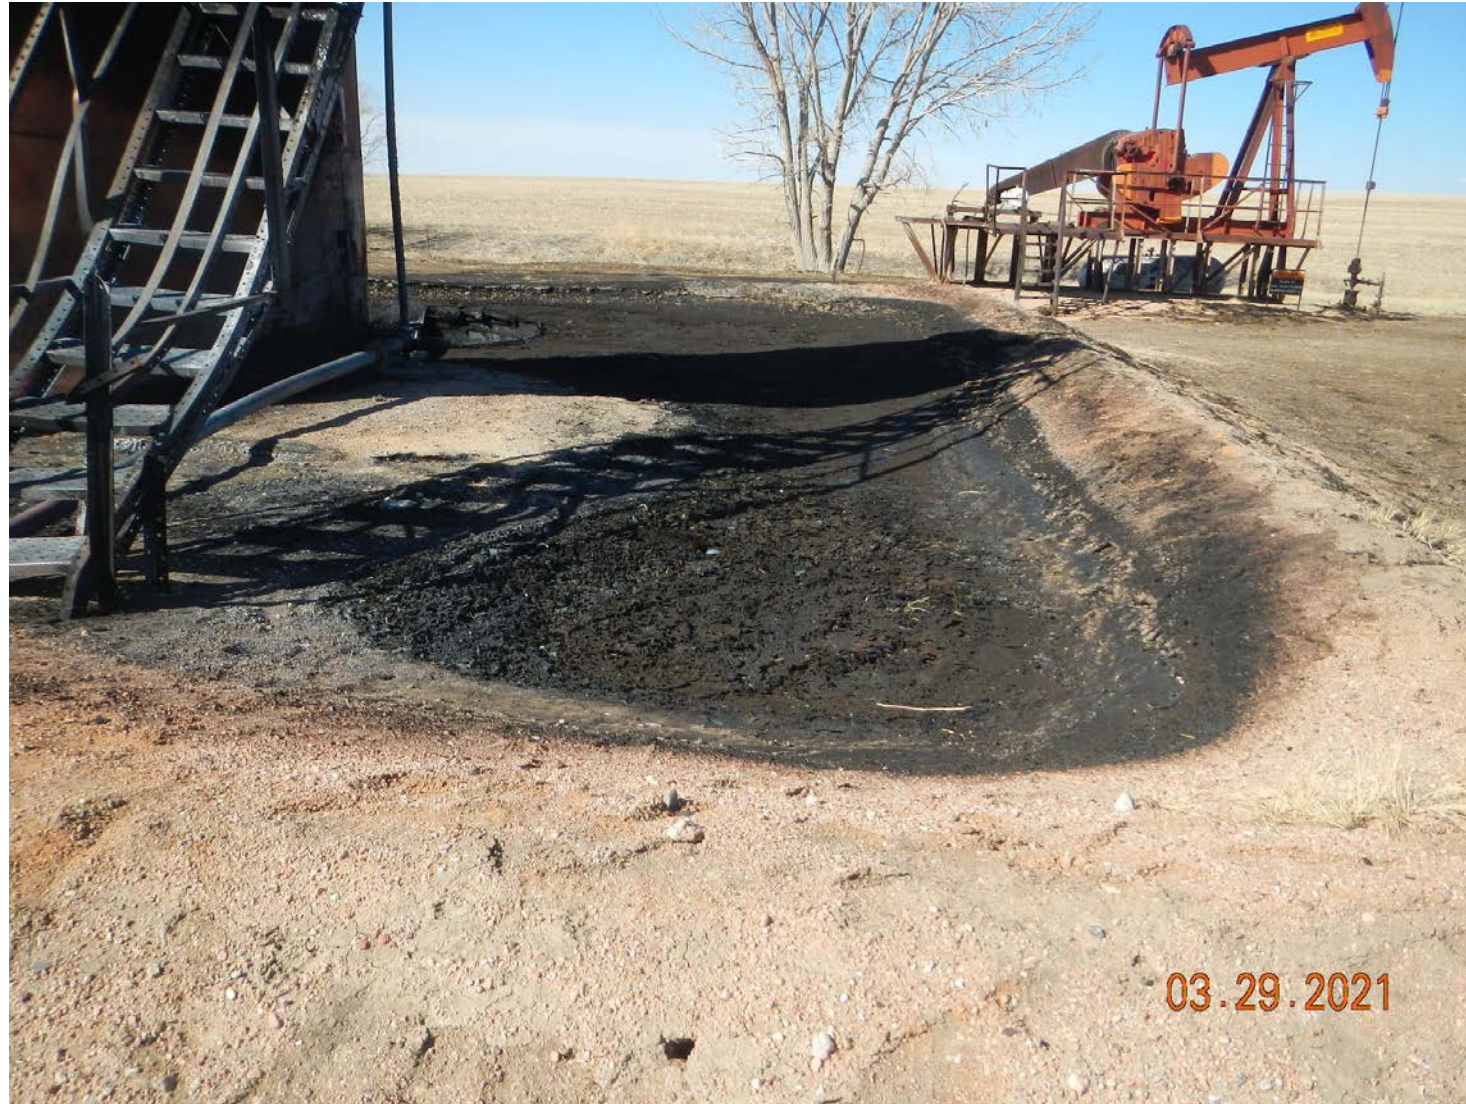
- Photo 11 – Burnt fluid line on berms

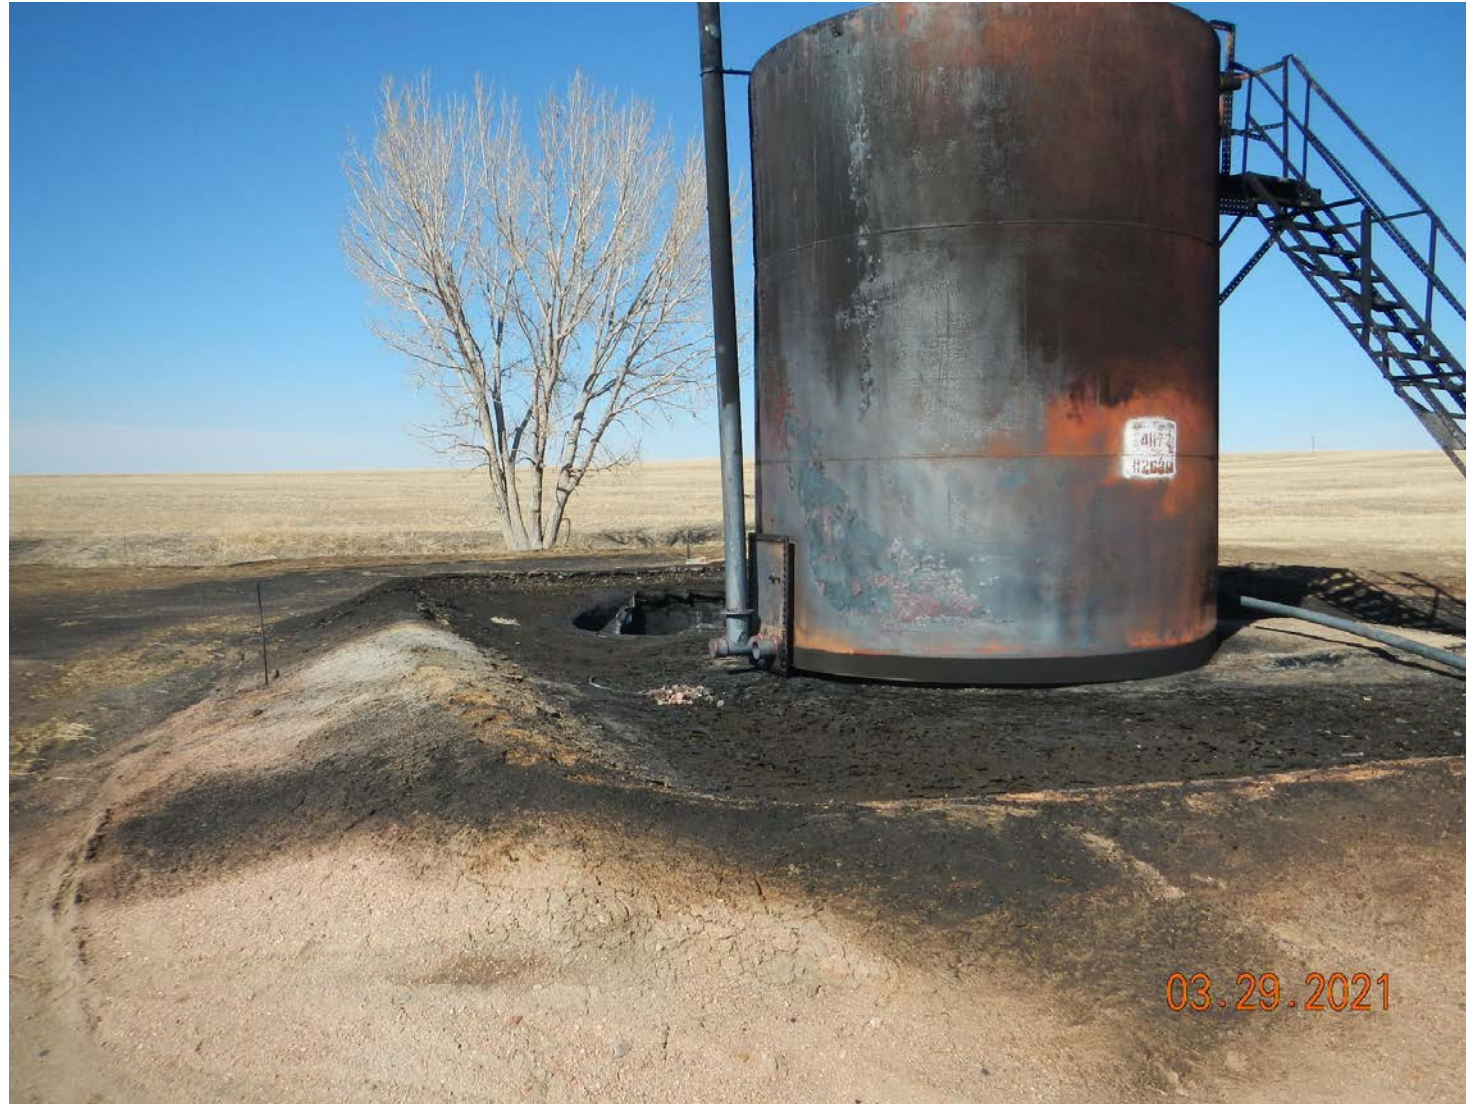
- Photo 12 – Burnt fluid line on berms, fluid appears to have overtopped northwest berm area and spread on location

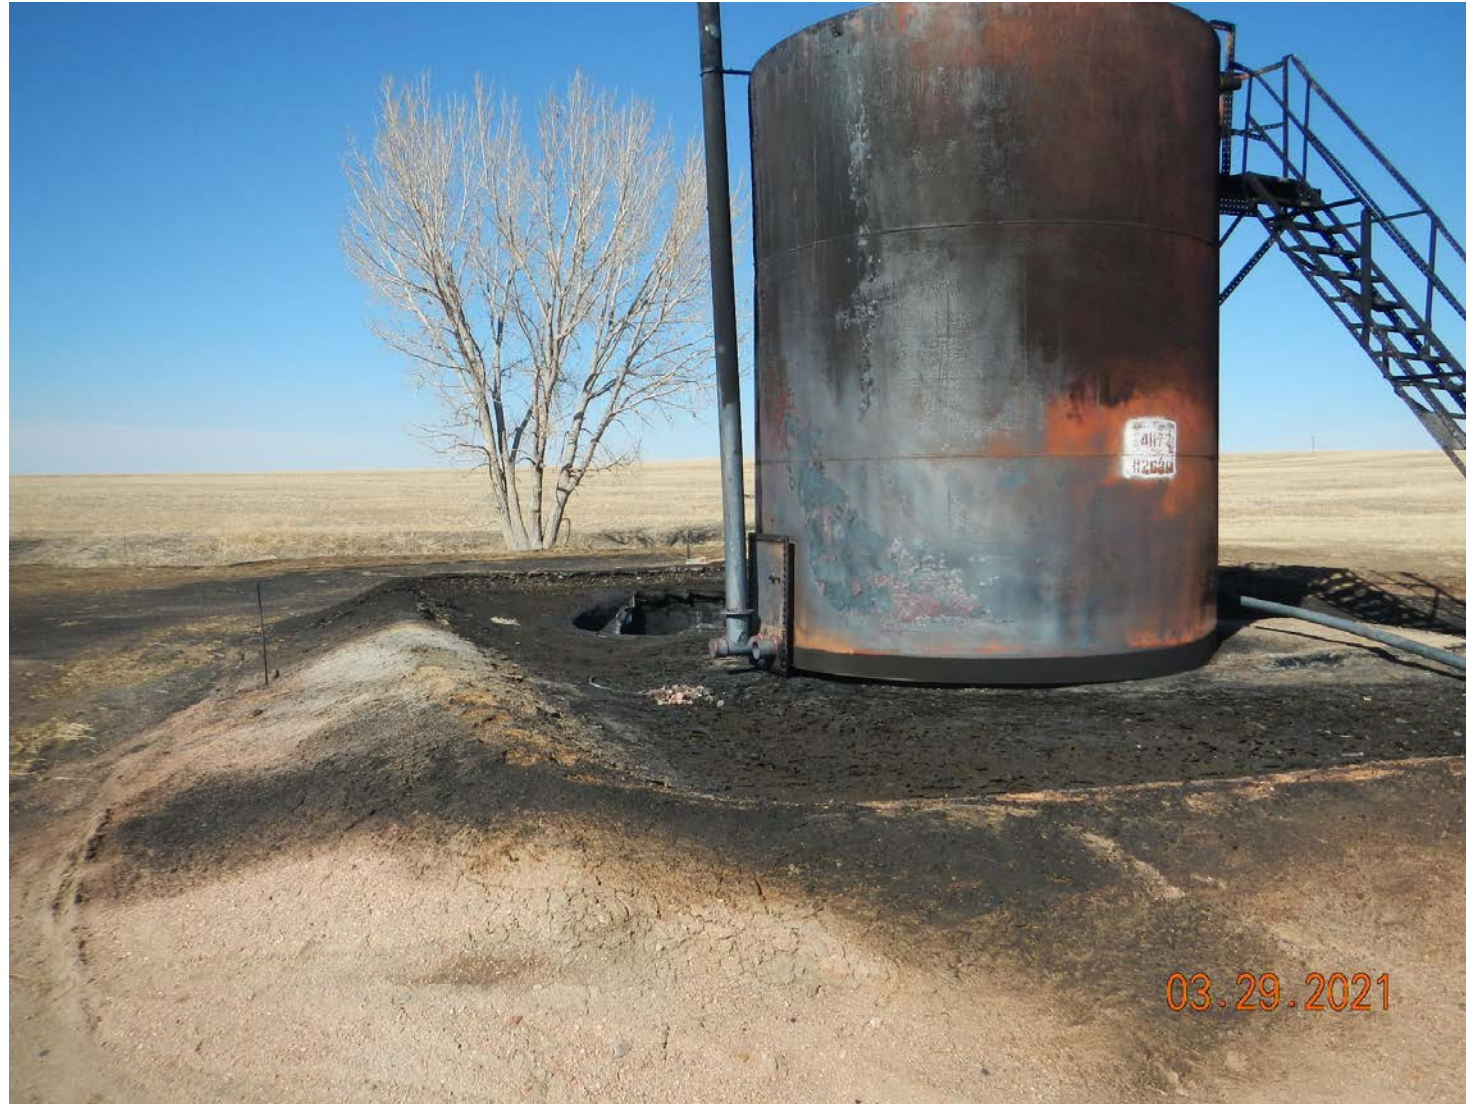
- Photo 13 – Burnt fluid line on berms, fluid appears to have overtopped northwest berm area and spread on location
