# Inspection Photos

Operator: SG INTERESTS I LTD # 77330

Location ID: 418697

Gunnison County, CO

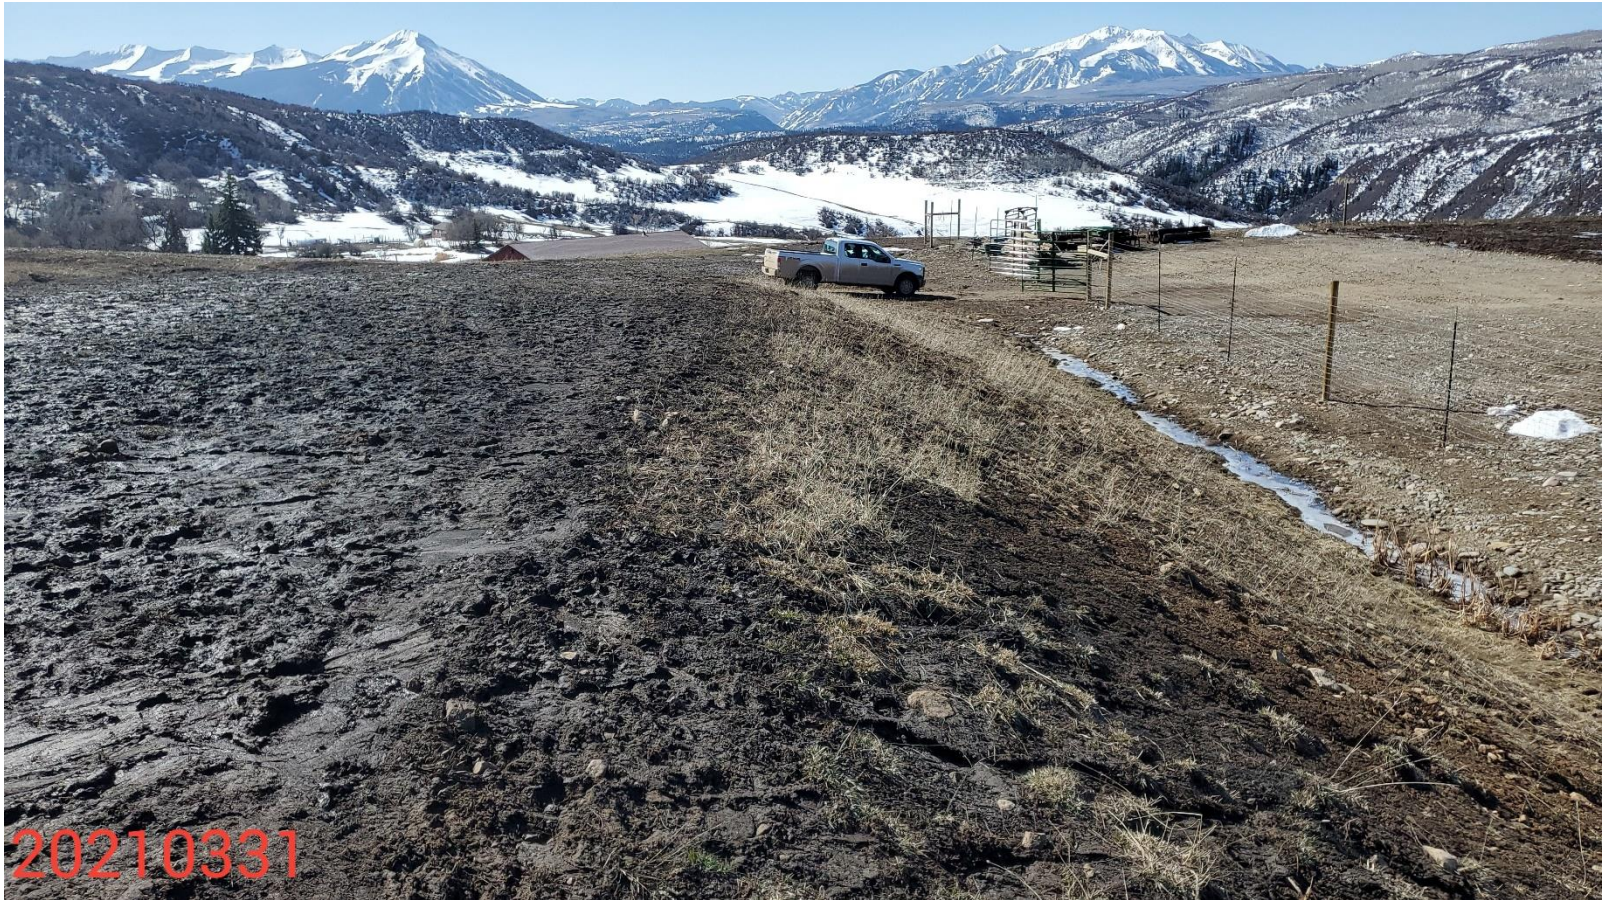
**Photo 1:** Photos 1-3 taken from the northeast corner of the Location. Photos provide an overview of the Location from south, southwest to west.

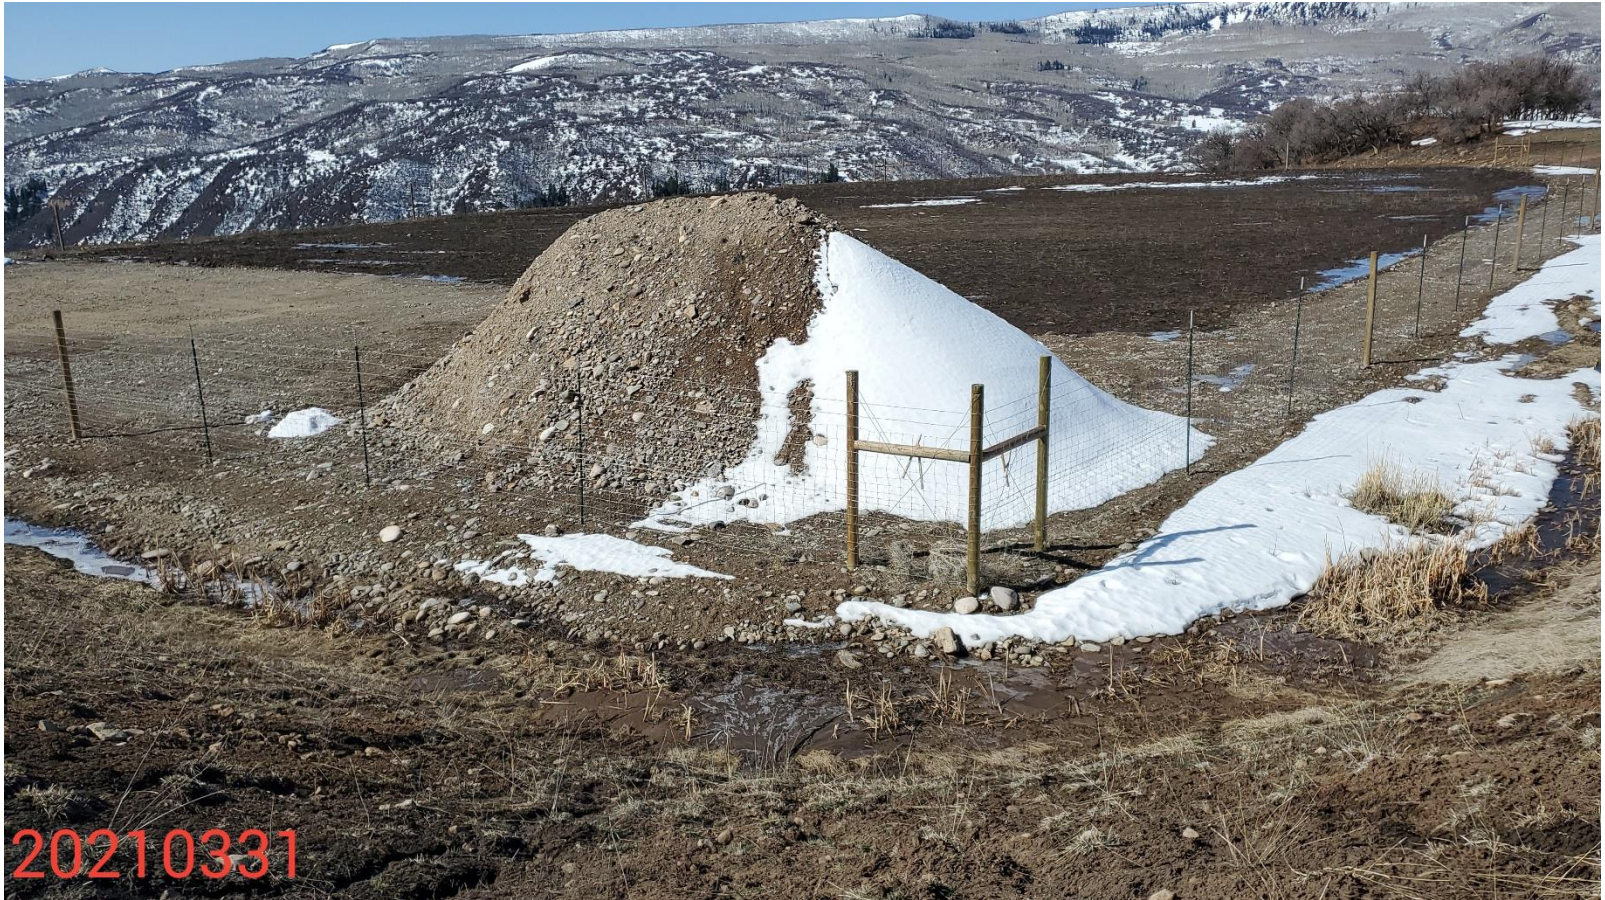
**Photo 2:** See comments under photo 1.

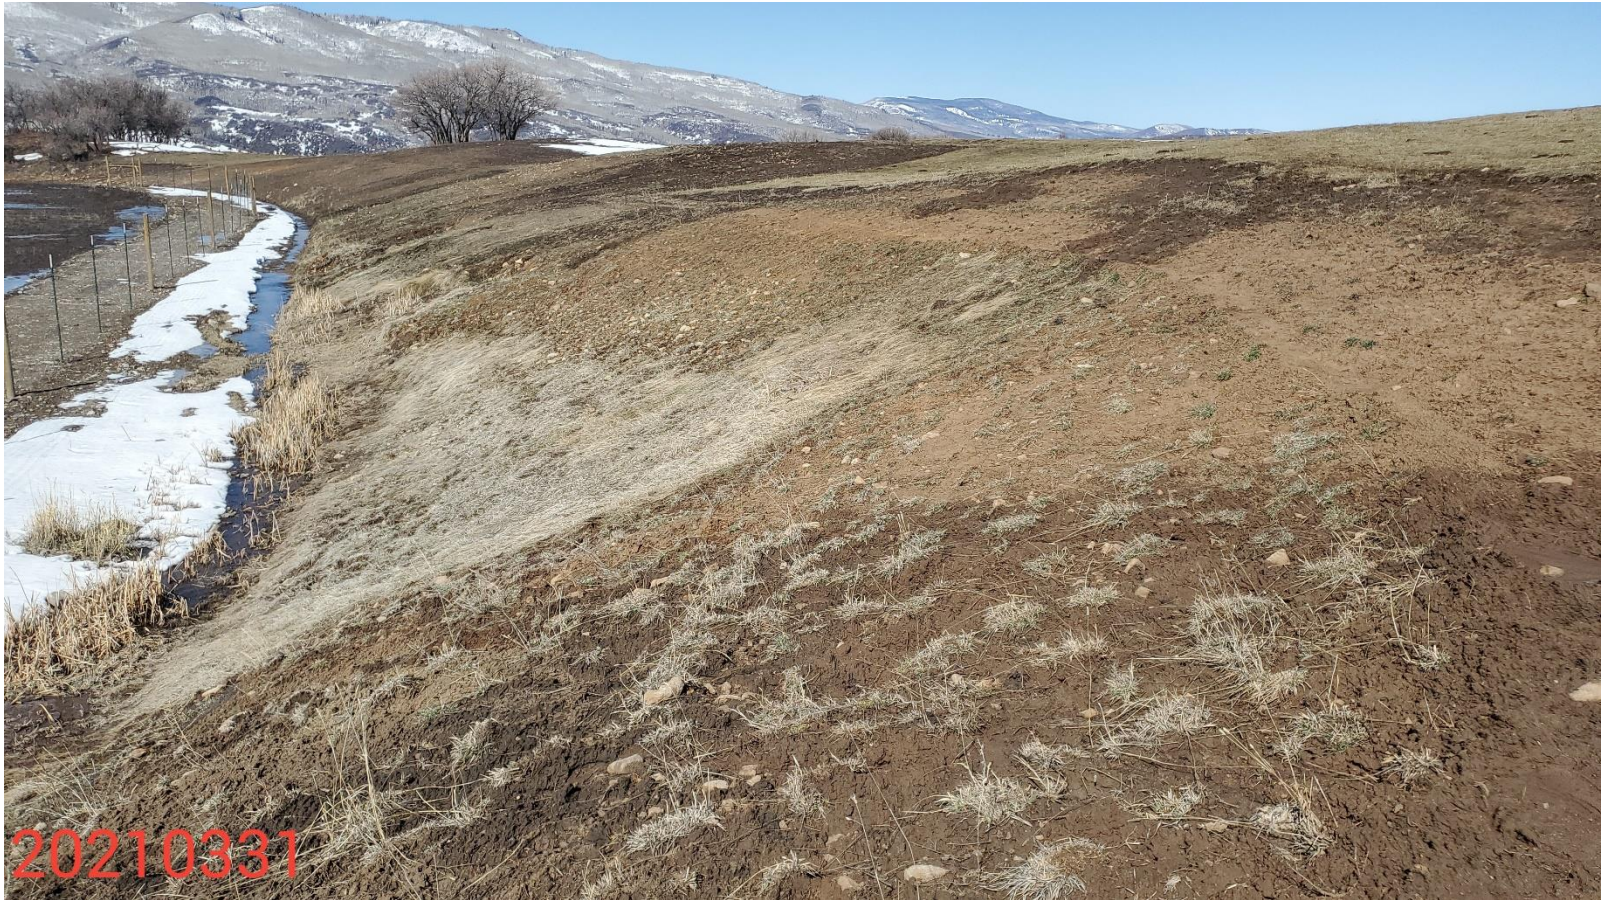
**Photo 3:** See comments under photo 1.

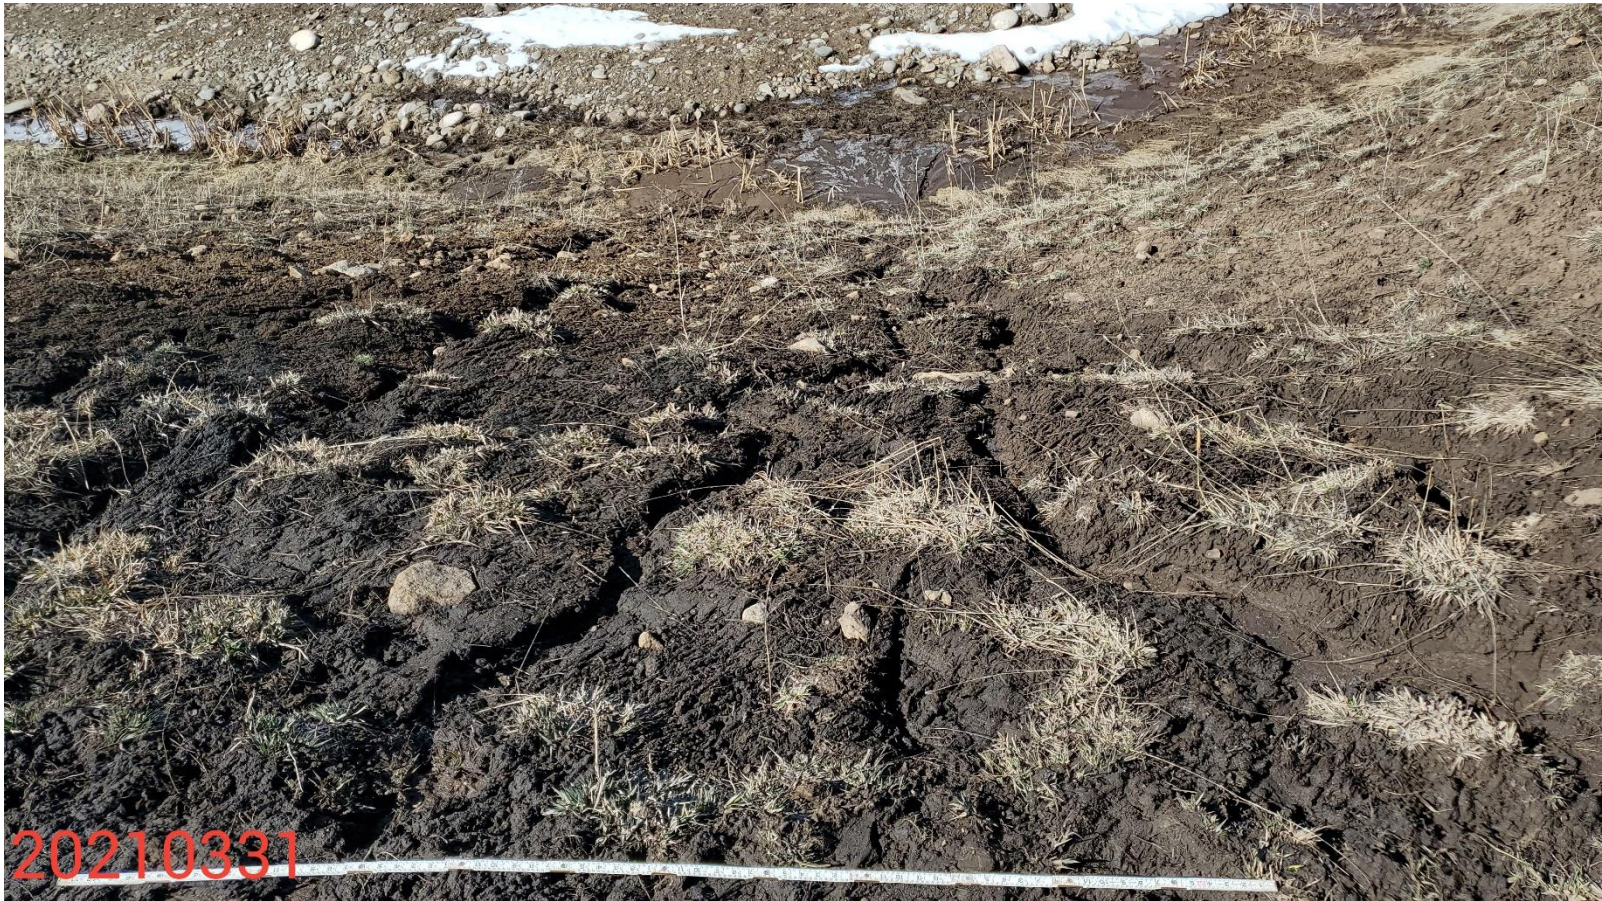
**Photo 4:** Photo taken from the northeast corner of the Location, facing southwest. Photo shows control measures to protect and stabilize the Location remain missing or insufficient; erosion degradation evident. 6 foot measuring stick for reference.

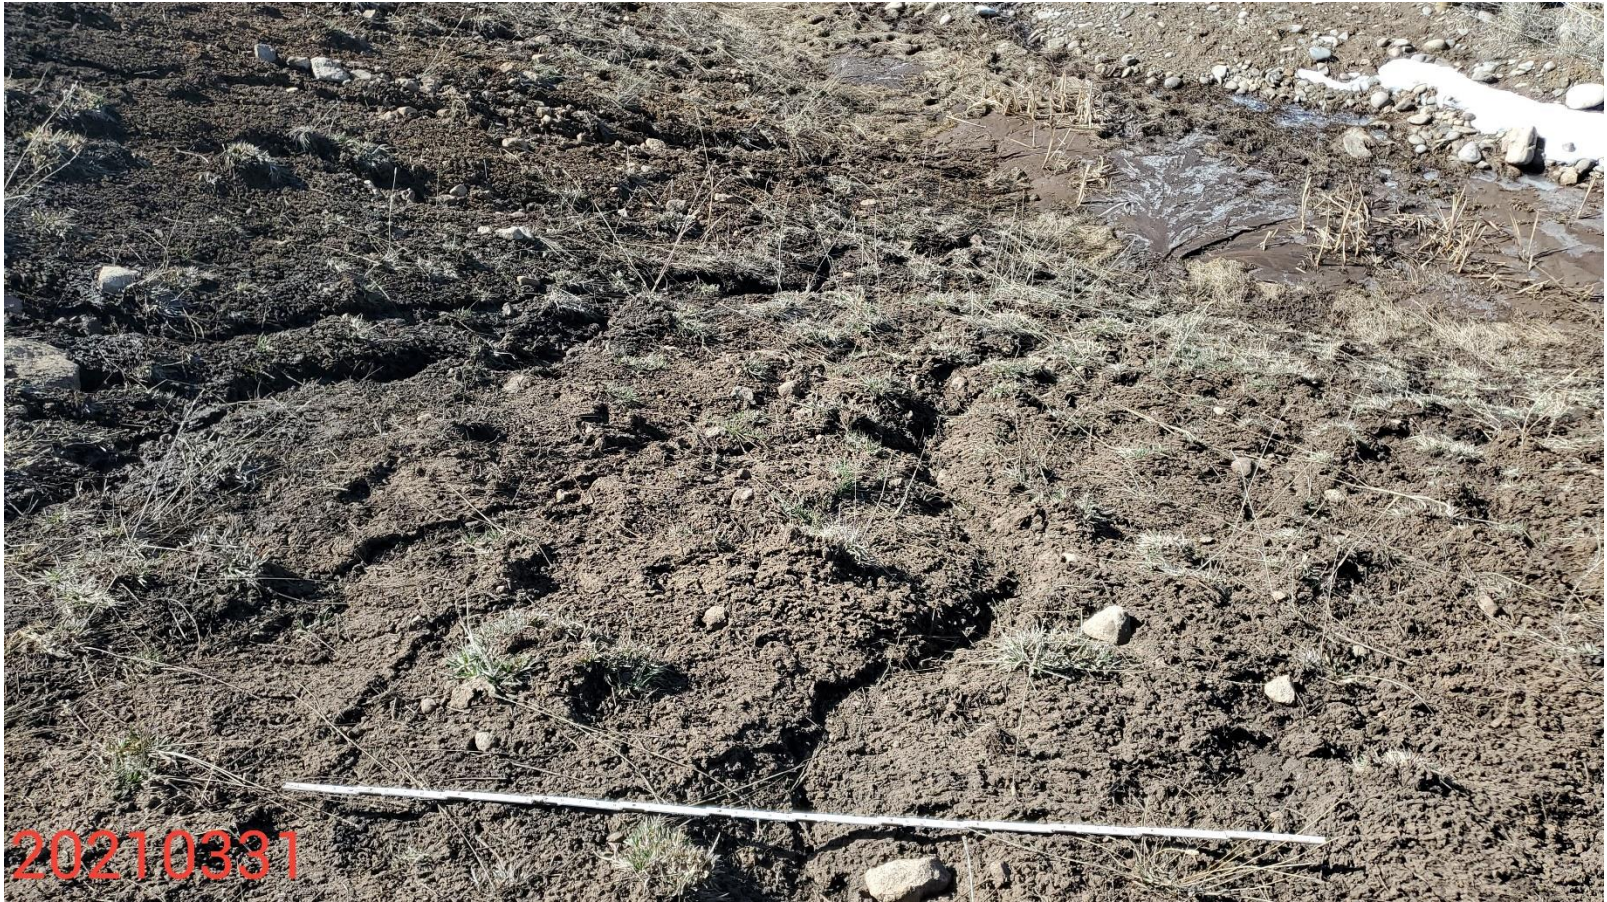
**Photo 5:** Photo taken from the northeast corner of the Location, facing southwest. Photo shows control measures to protect and stabilize the Location remain missing or insufficient; erosion degradation evident. 6 foot measuring stick for reference.

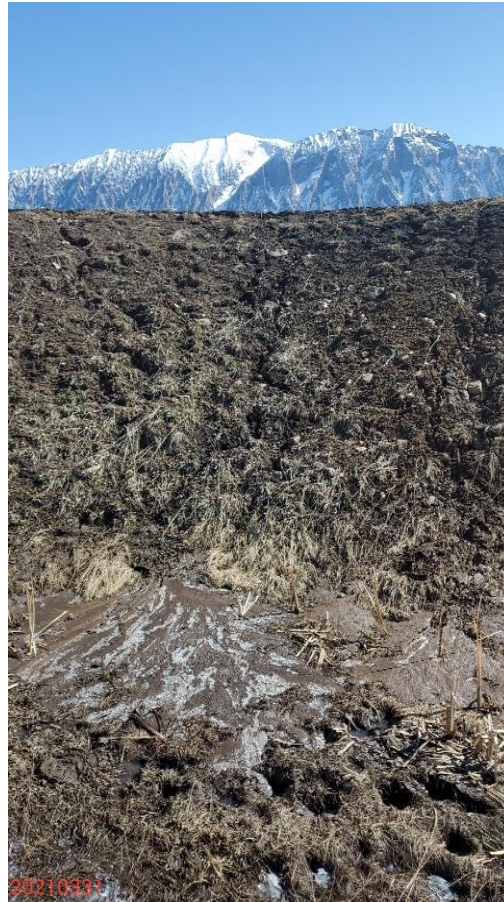
**Photo 6:** Photo taken from the northeast corner of the Location, at the toe of the cut slope, facing northwest. Photo shows control measures to protect and stabilize the Location remain missing or insufficient; erosion degradation evident.

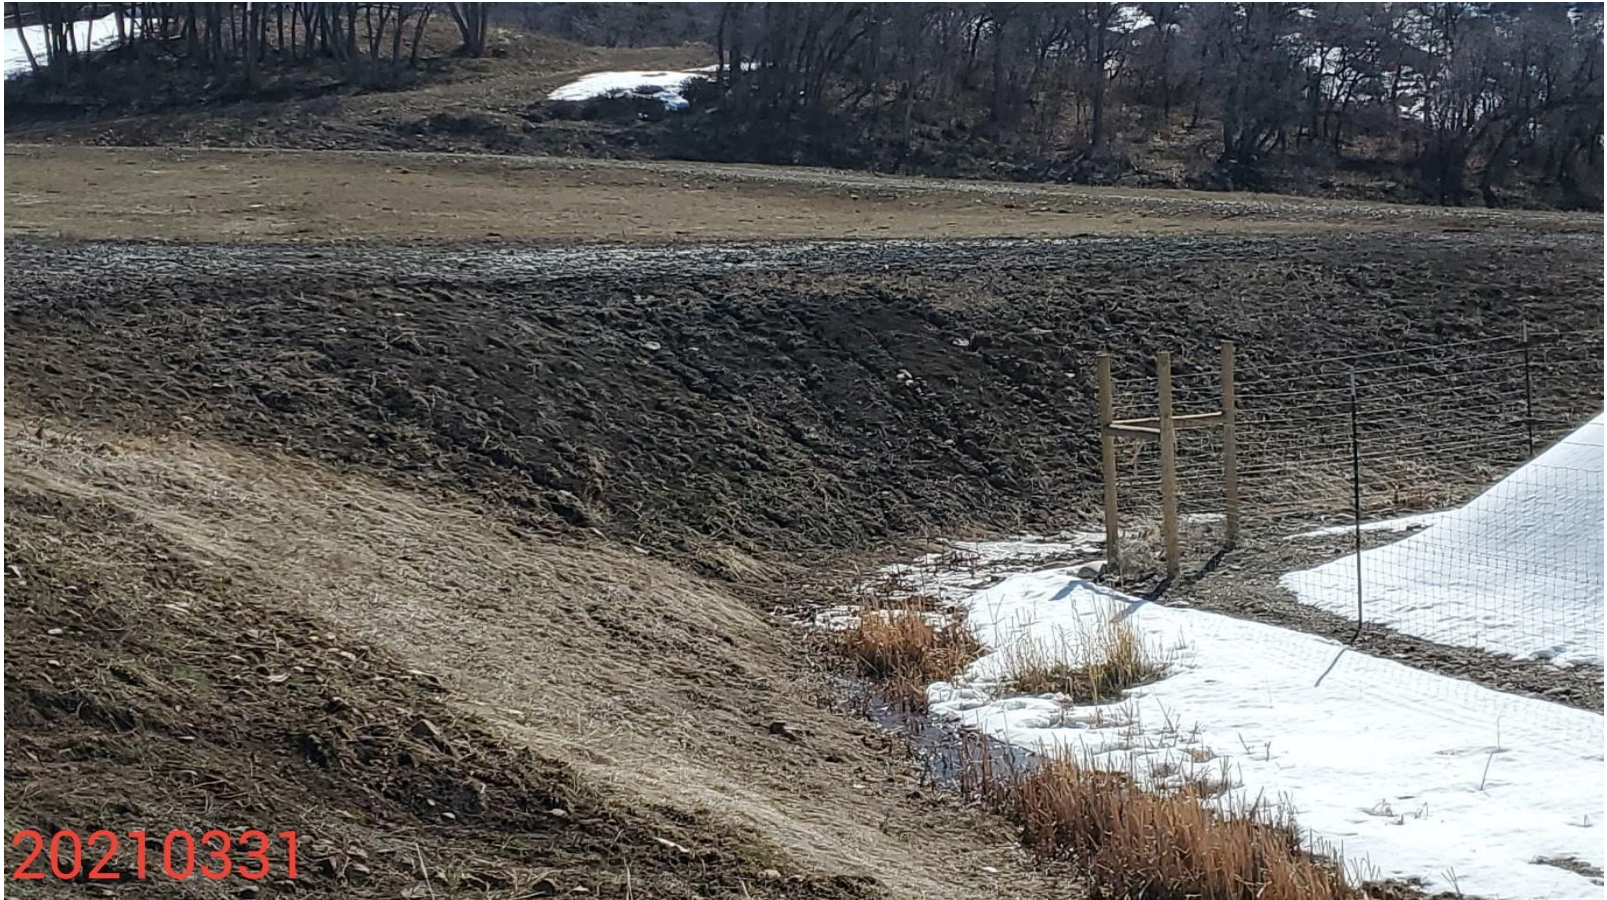
**Photo 7:** Photo taken from the northeast end of the Location, facing southeast. Photo shows cut slopes observed in photos 4-6. Photo shows control measures to protect and stabilize the Location remain missing or insufficient; erosion degradation evident.

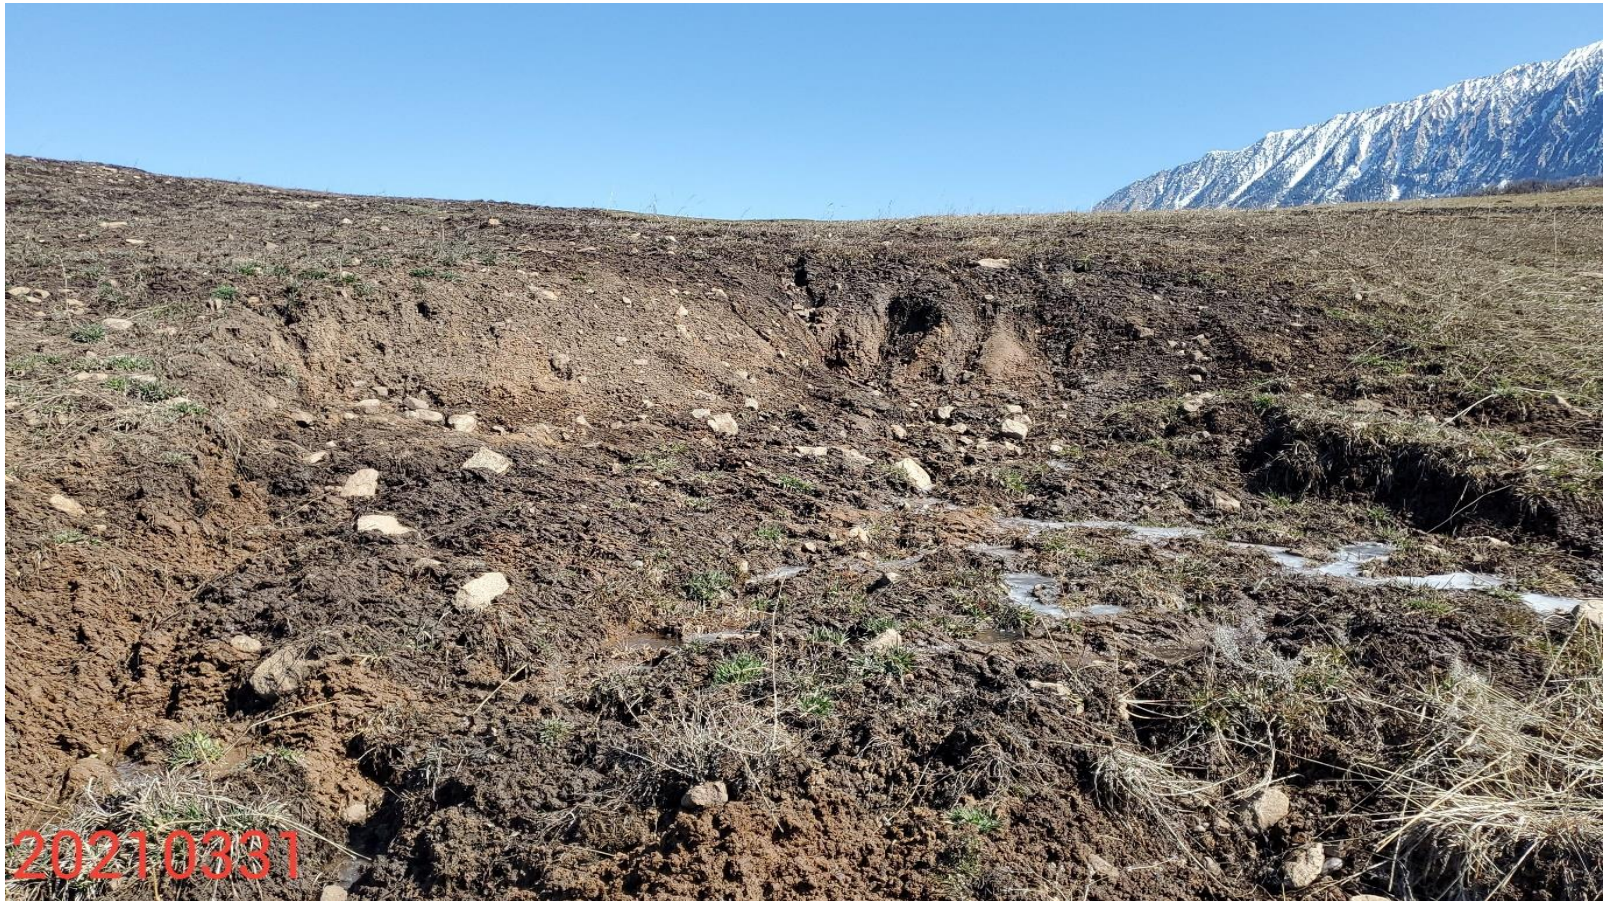
**Photo 8:** Photo taken from the slopes on the north end of the Location. Photo shows control measures to protect and stabilize the Location remain missing or insufficient; erosion degradation evident.

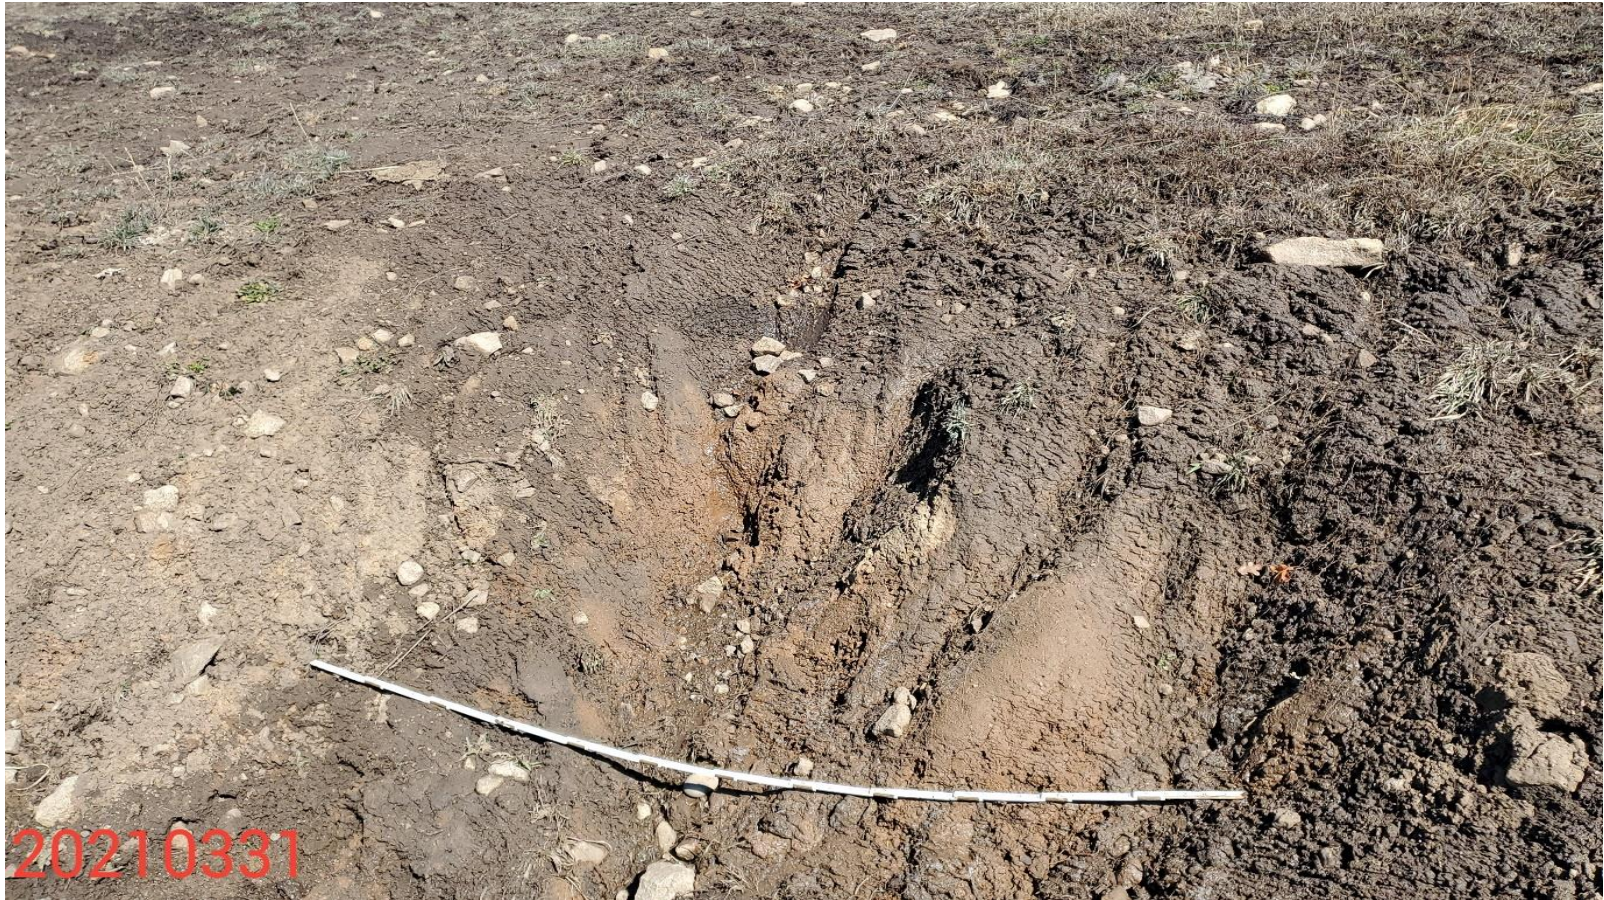
**Photo 9:** Continued from photo 8. Photo shows control measures to protect and stabilize the Location remain missing or insufficient; erosion degradation evident. 6 foot measuring stick for reference.

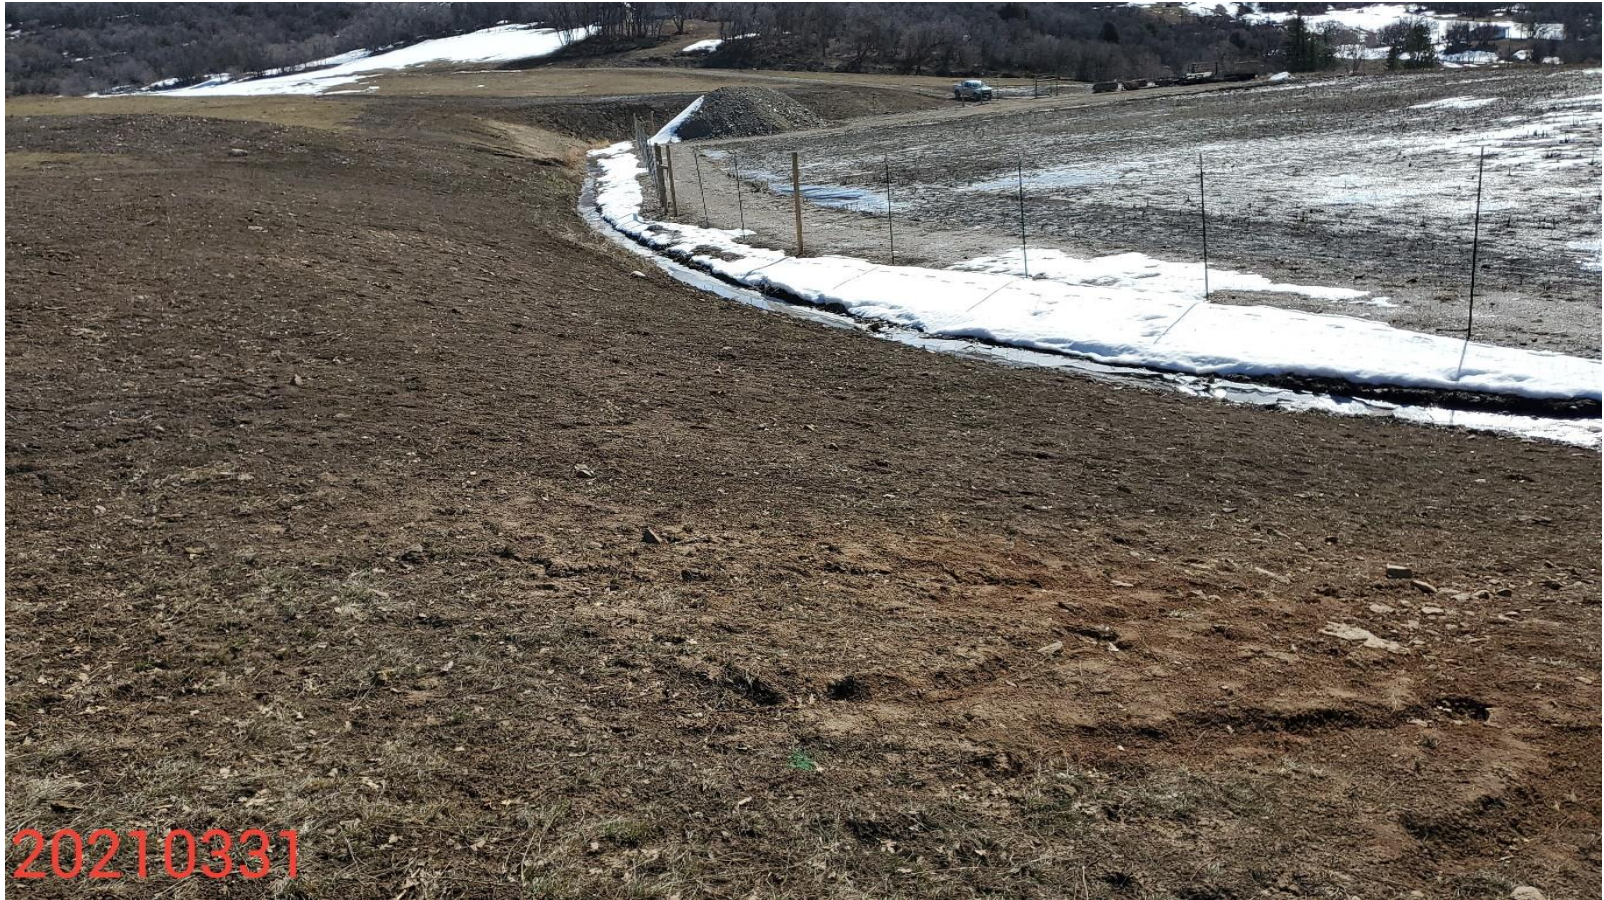
**Photo 10:** Photos 10-12 taken from the northwestern area of the Location. Photos provide an overview of the Location from east, south to west. Photos also show control measures to protect and stabilize the Location remain missing or insufficient.

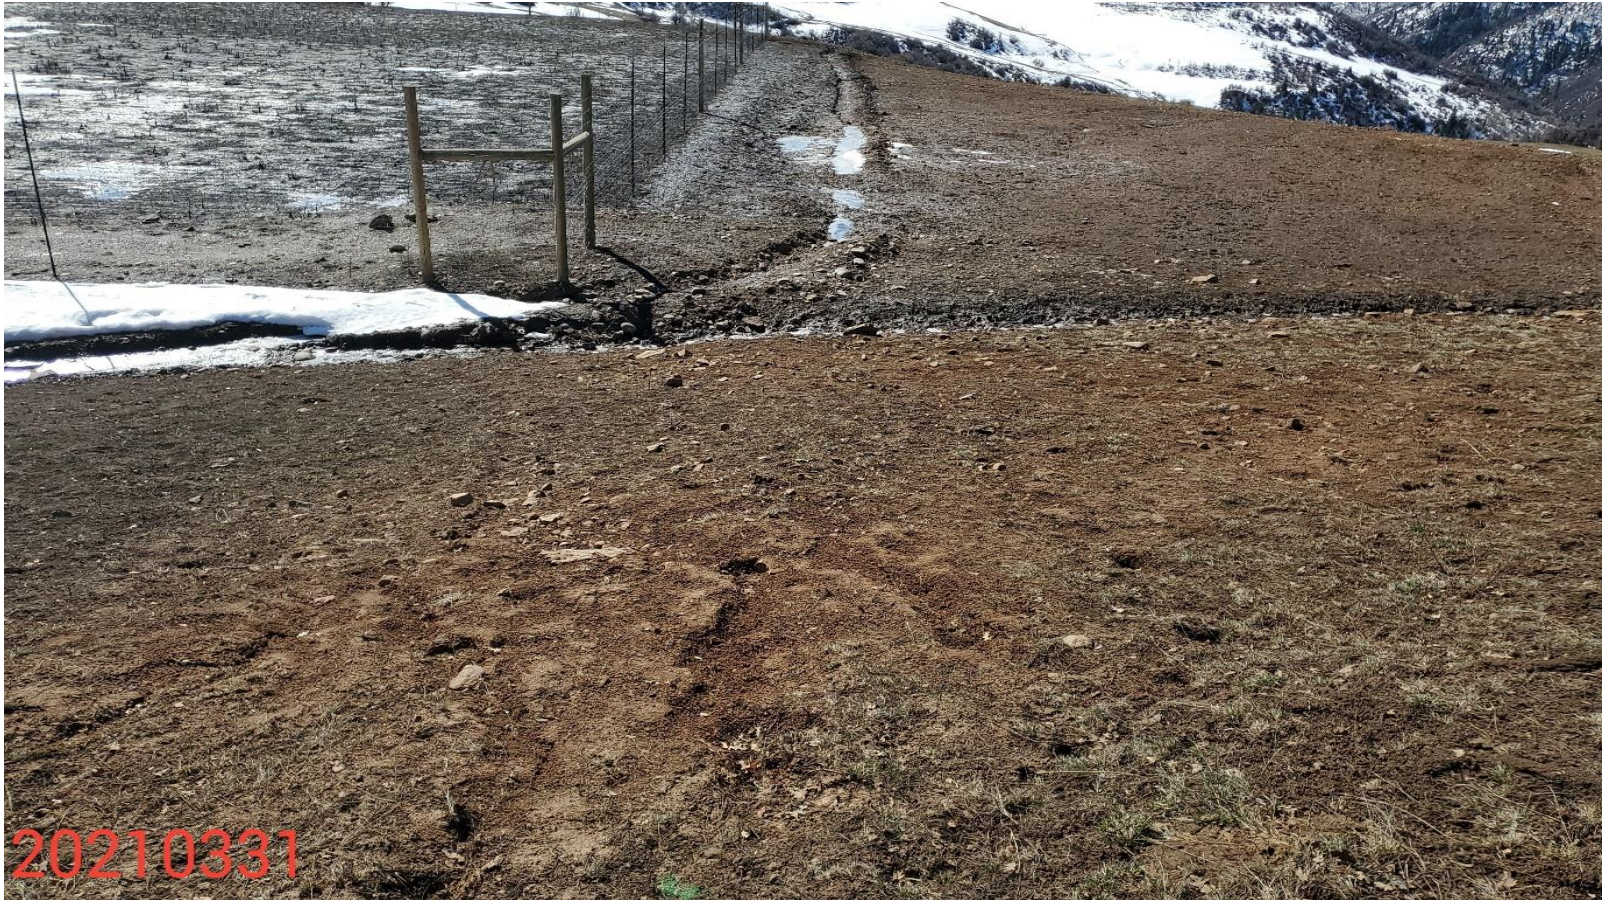
**Photo 11:** See comments under photo 10.

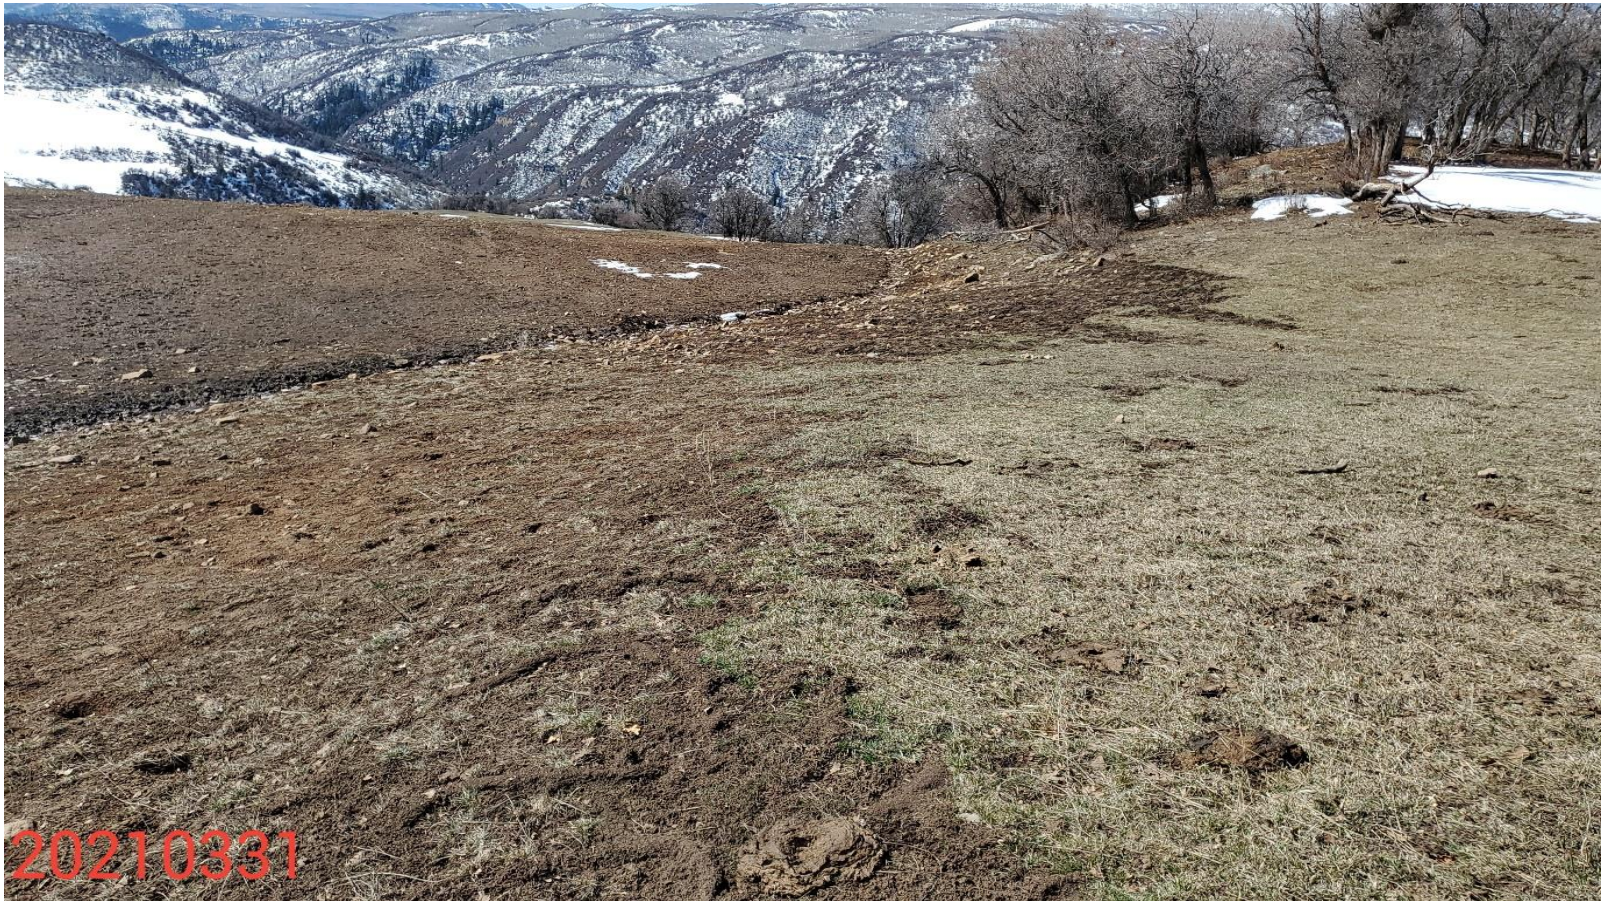
**Photo 12:** See comments under photo 10.

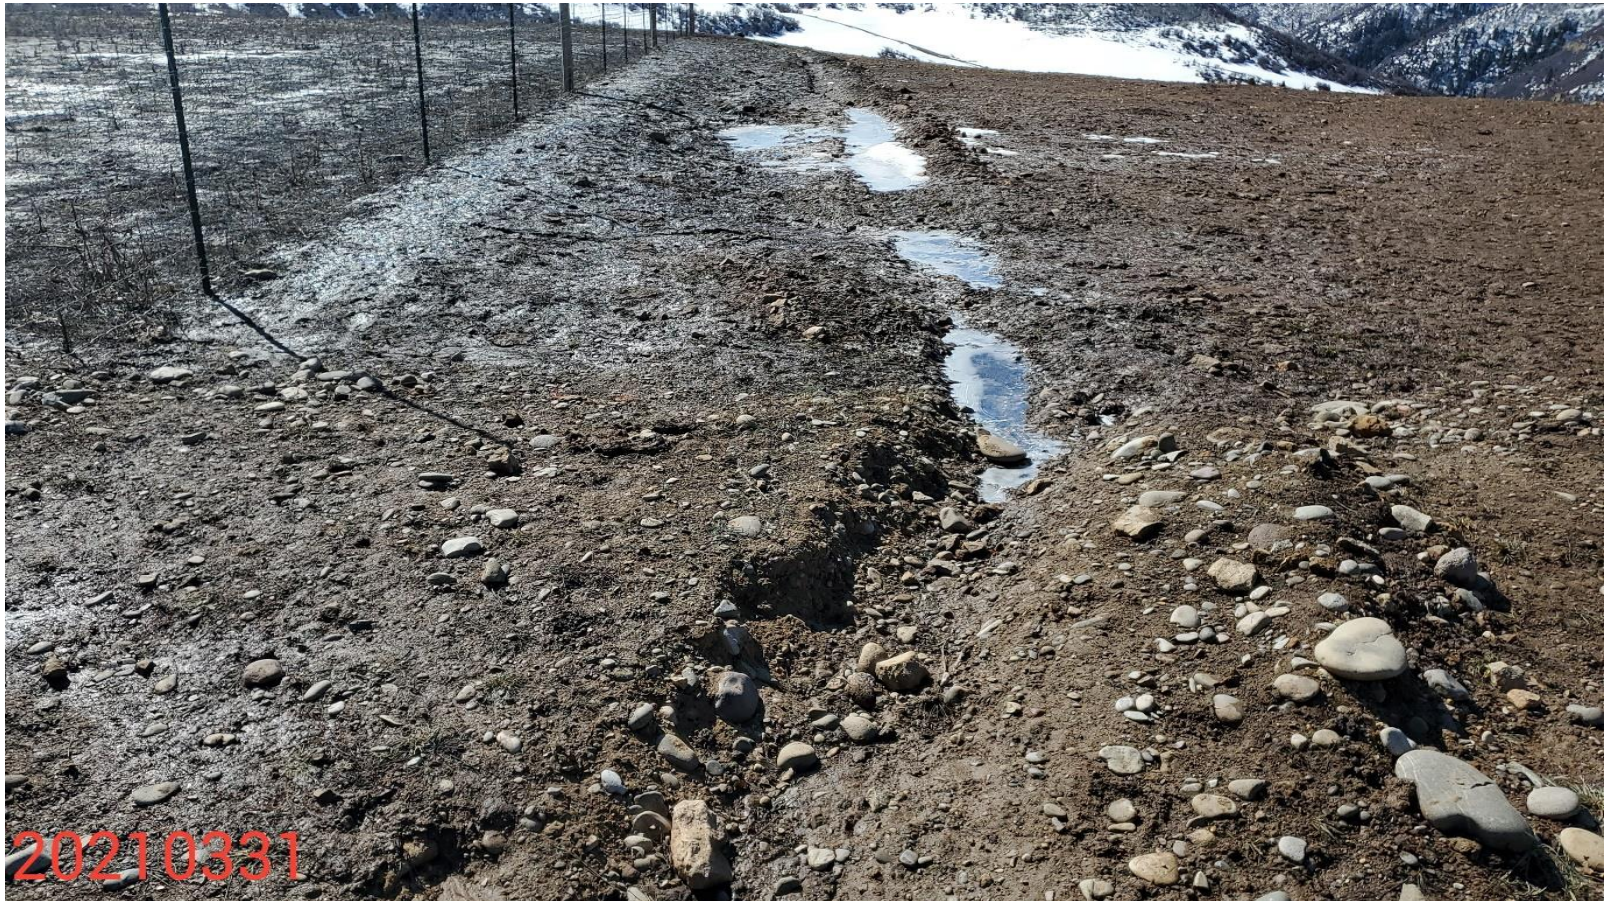
**Photo 13:** Photo taken from the west end of the Location. Photo shows the stormwater ditch has not been constructed in accordance with good engineering practices; ditch filled with sediment.

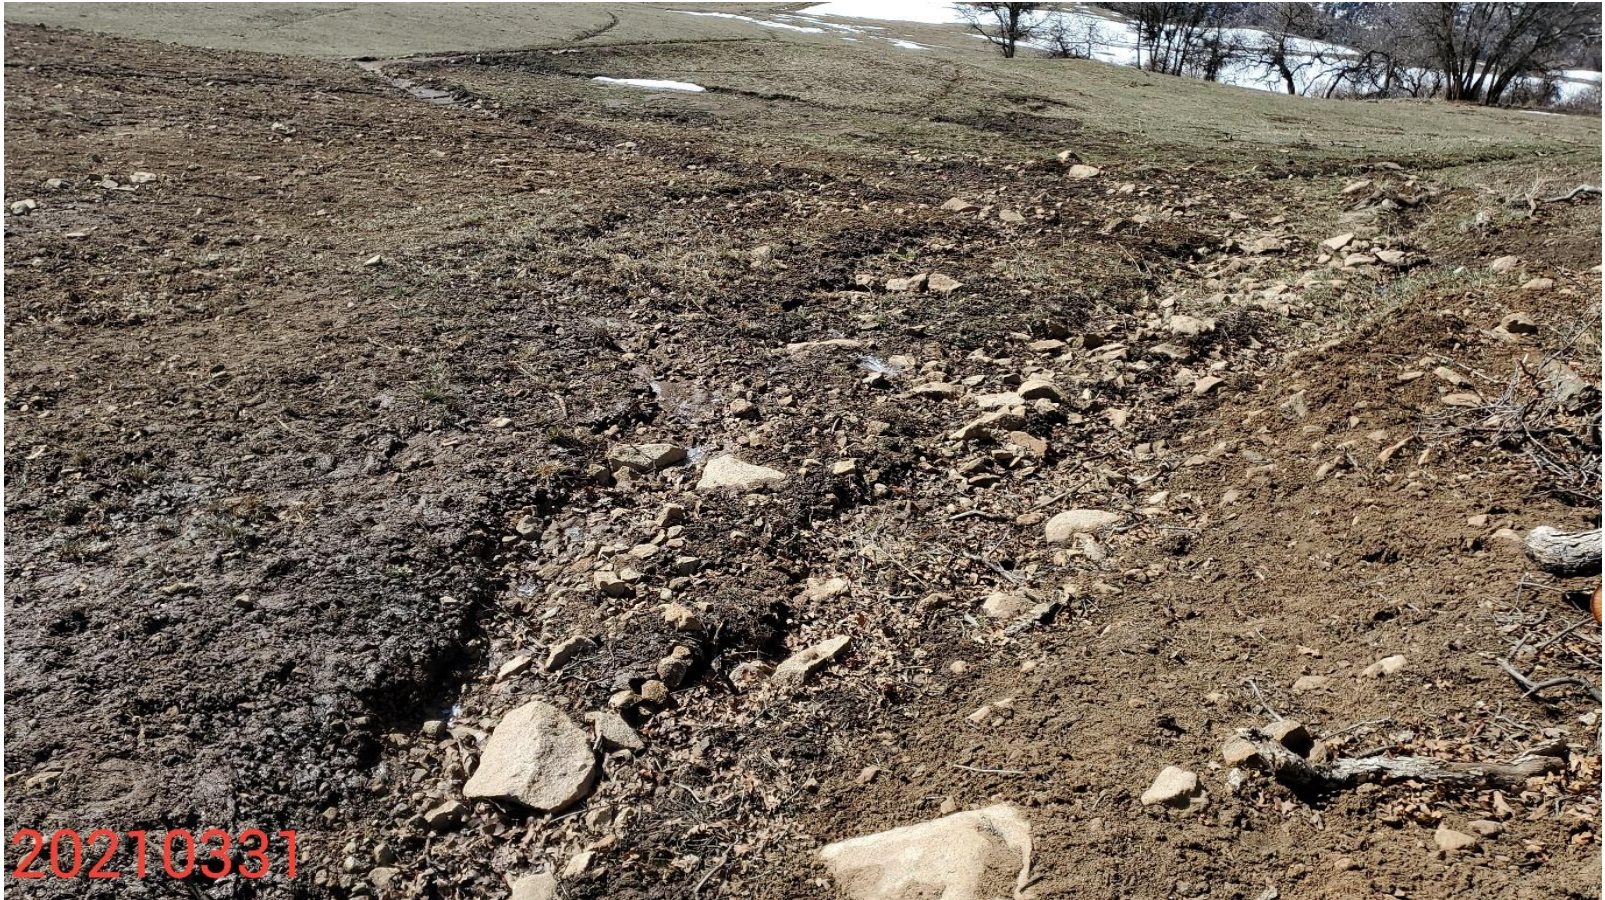
**Photo 14:** Photo taken from the northwestern end of the Location, facing southwest. Photo shows stormwater ditch BMPs have not been constructed in accordance with good engineering practices, including an appropriate outlet to allow for sediment laden-free stormwater discharge; erosion degradation evident.

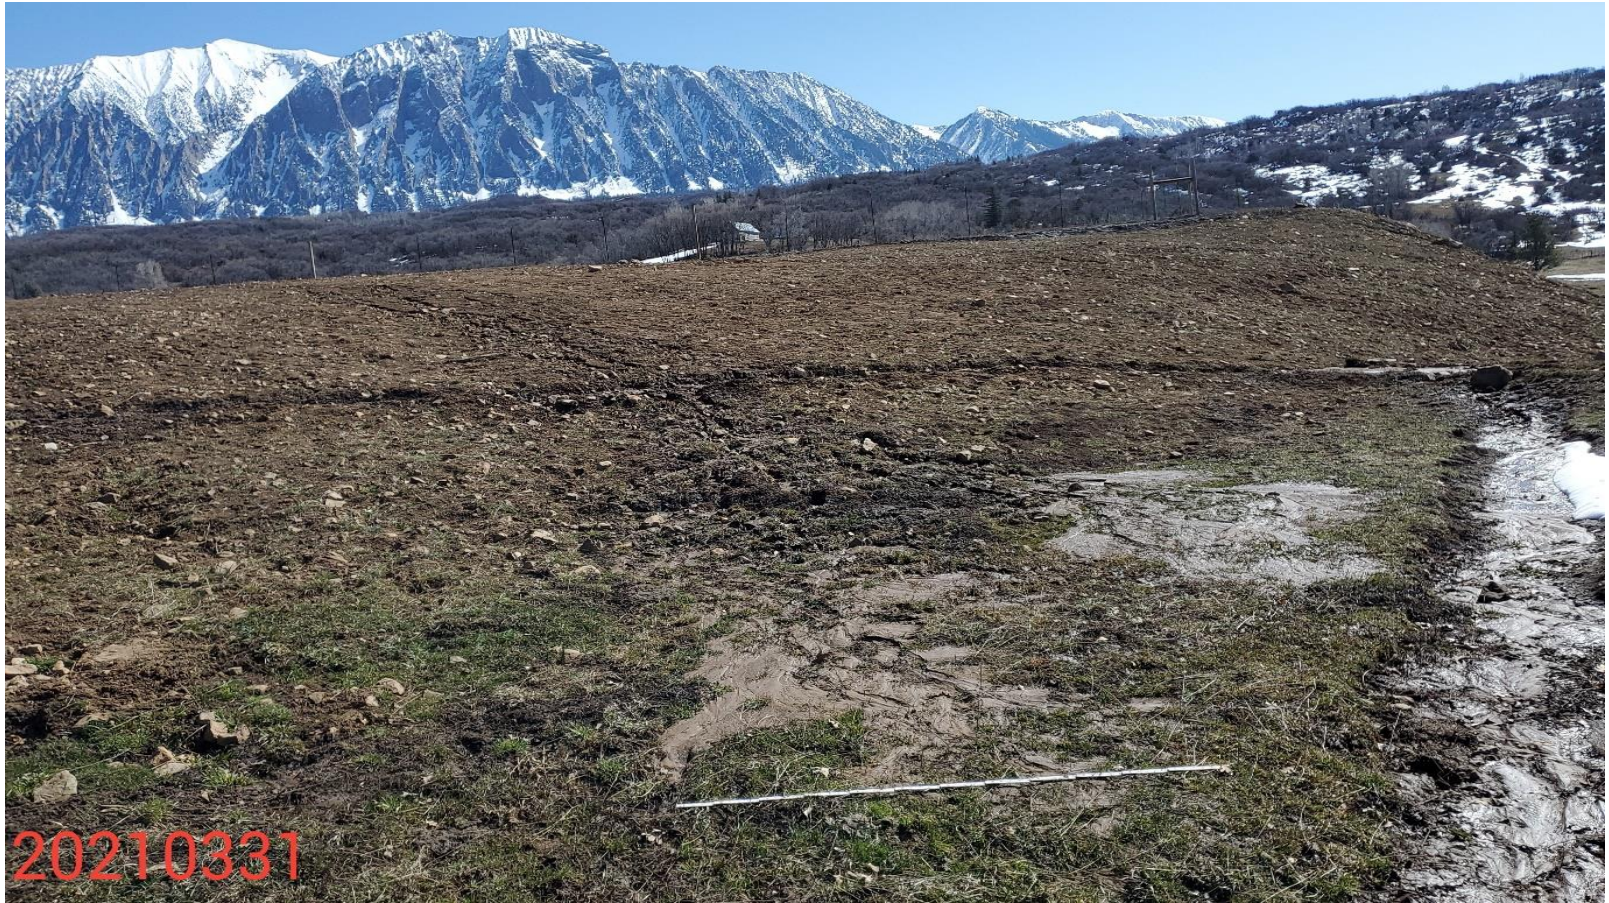
**Photo 15:** Photo taken from the western end of the Location, facing east. Photo shows control measures to protect and stabilize the Location remain missing or insufficient; ditch has filled with sediment; erosion degradation evident; off-site sediment transport evident. 6 foot measuring stick used for reference.

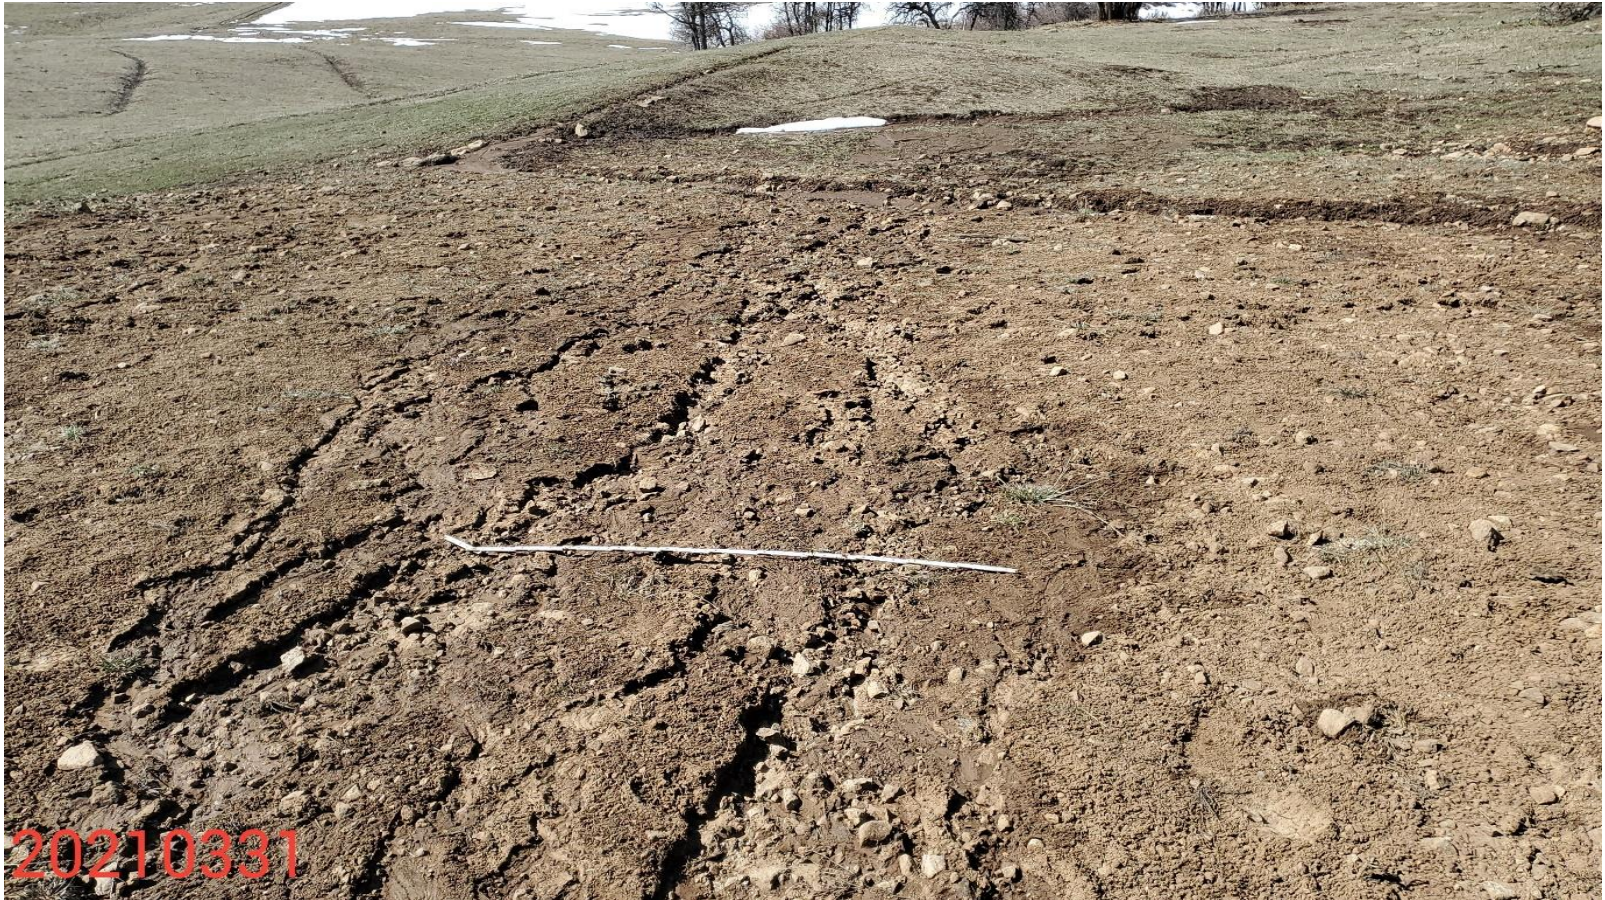
**Photo 16:** Photo taken from the western areas of the Location, facing west. Photo shows control measures to protect and stabilize the Location remain missing or insufficient; ditch has filled with sediment; erosion degradation evident; off-site sediment transport evident. 6 foot measuring stick used for reference.
